**NYC Parks**

# **East River Esplanade**

Work in Progress & Planned Capital Work

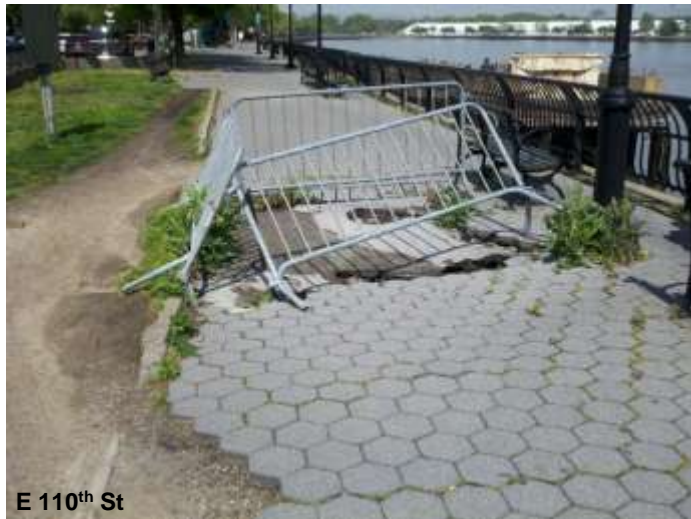
E 110<sup>th</sup> St

Land-based restoration of depressions, sinkholes and other localized, surface hazards

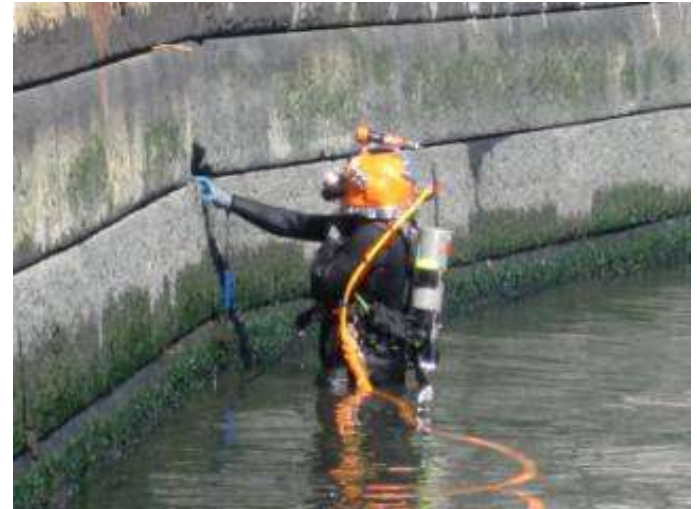
- Over 10,000 linear feet inspected
- Characteristic grout loss along granite fascia block joints
- Loose/displaced/missing fascia blocks in various locations
- Exposed concrete seawall surfaces exhibit cracking, spalling and/or erosion

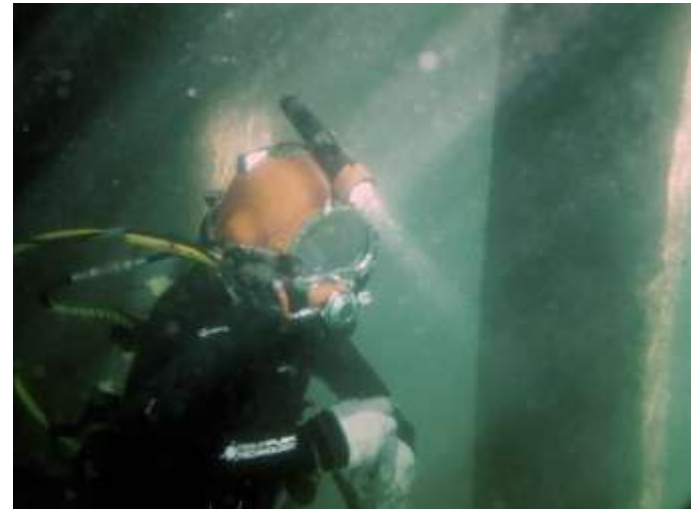
- Over 11,000 linear feet inspected
- Overall moderate marine borer activity observed
- Minor to severe timber deterioration along the East River

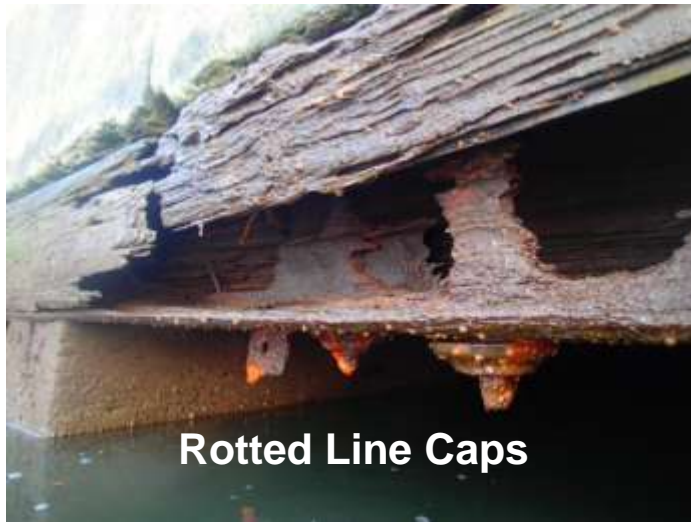
**Rotted Line Caps**

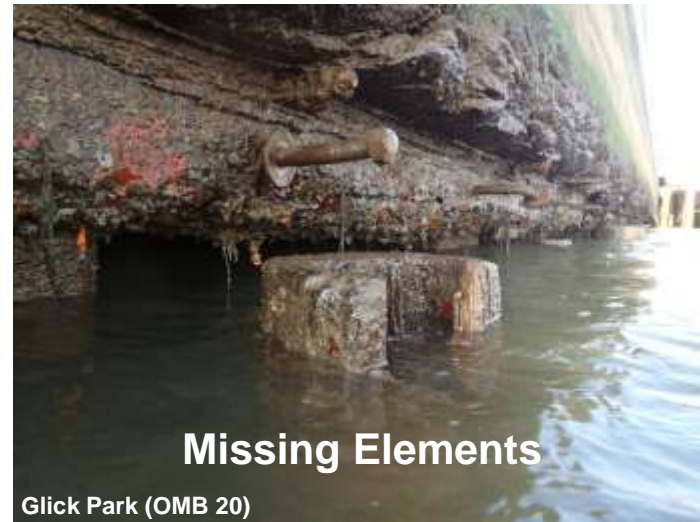
Glick Park (OMB 20)

**Missing Elements**

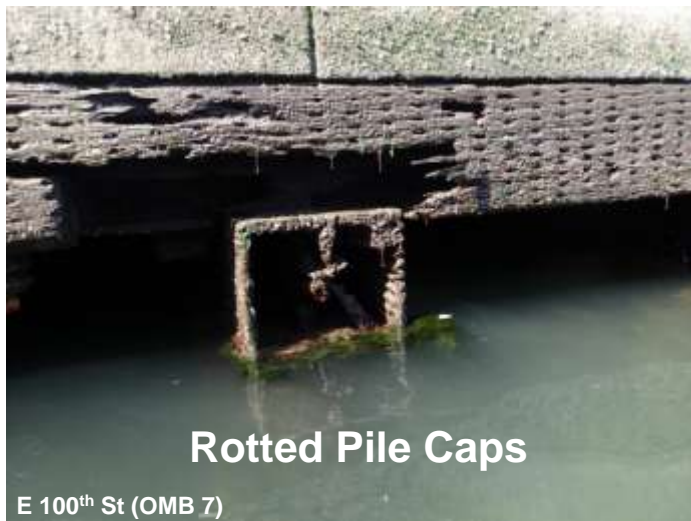
E 100<sup>th</sup> St (OMB 7)

**Rotted Pile Caps**

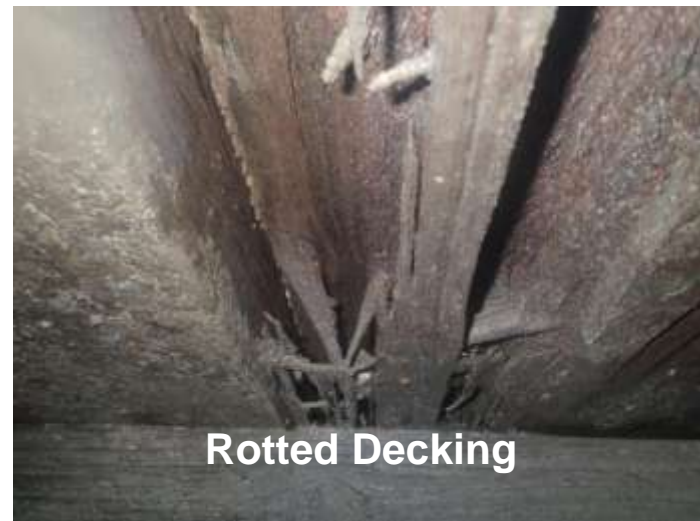
**Rotted Decking**

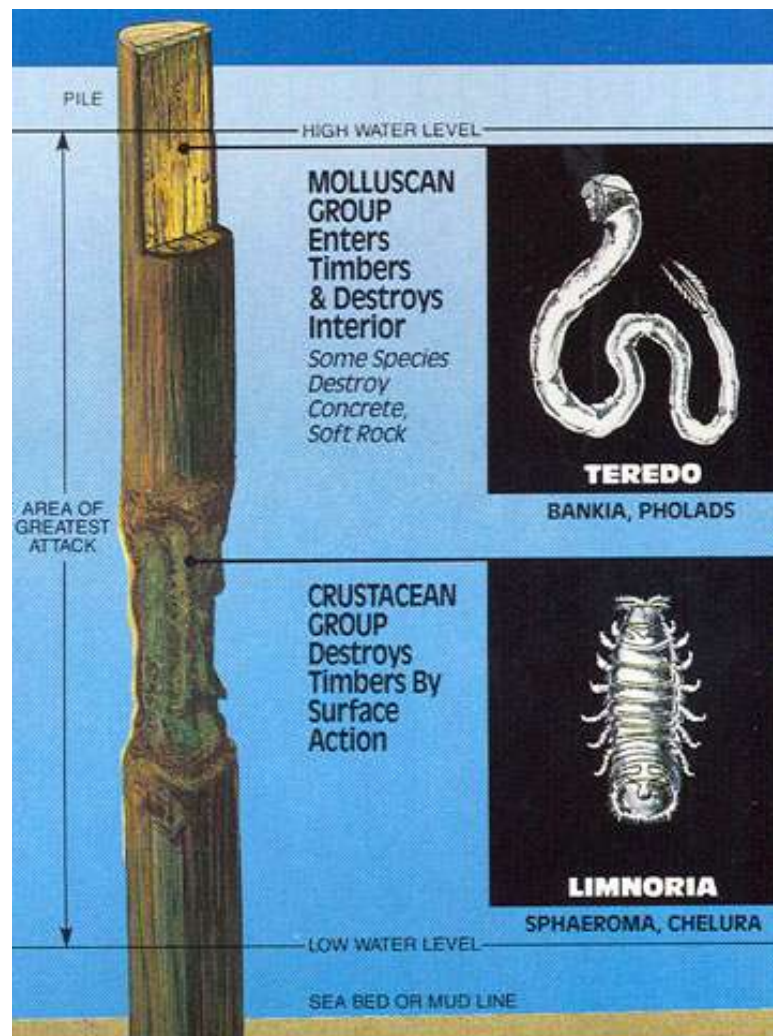
- Mollusc or crustacean that destroys wood by boring into and eating it.
- Clearer water provides conditions favorable for sea life (incl. marine borers)
- Gradual loss of timber creosote treatment leads to increase in marine borer attack.
- Primary cause of increasingly rapid rate of timber deterioration along the East River.
