LIGHTHOUSE

LIGHTHOUSE PARK,
ROOSEVELT ISLAND, NY 10044

TITLE:
PHOTO SURVEY -
MASONRY & SITE
CONDITIONS

TITLE:
PHOTO SURVEY -
LANTERN& OBSERVATION
DECK CONDITIONS

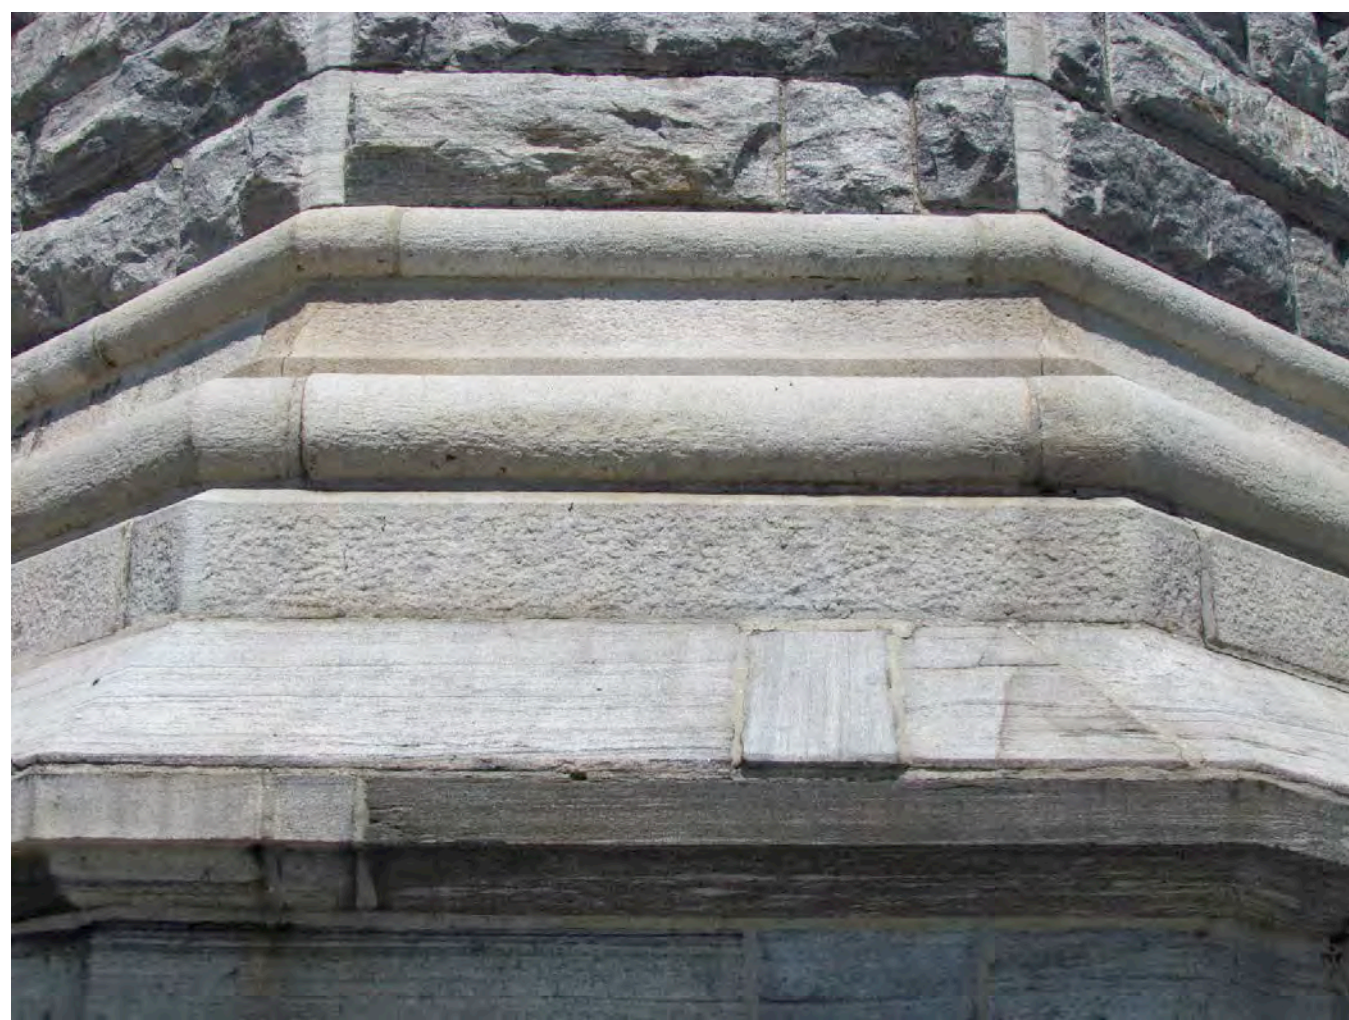
3 STONE CRACKING at MOLDING
BASE at DISPARATE LOCATIONS

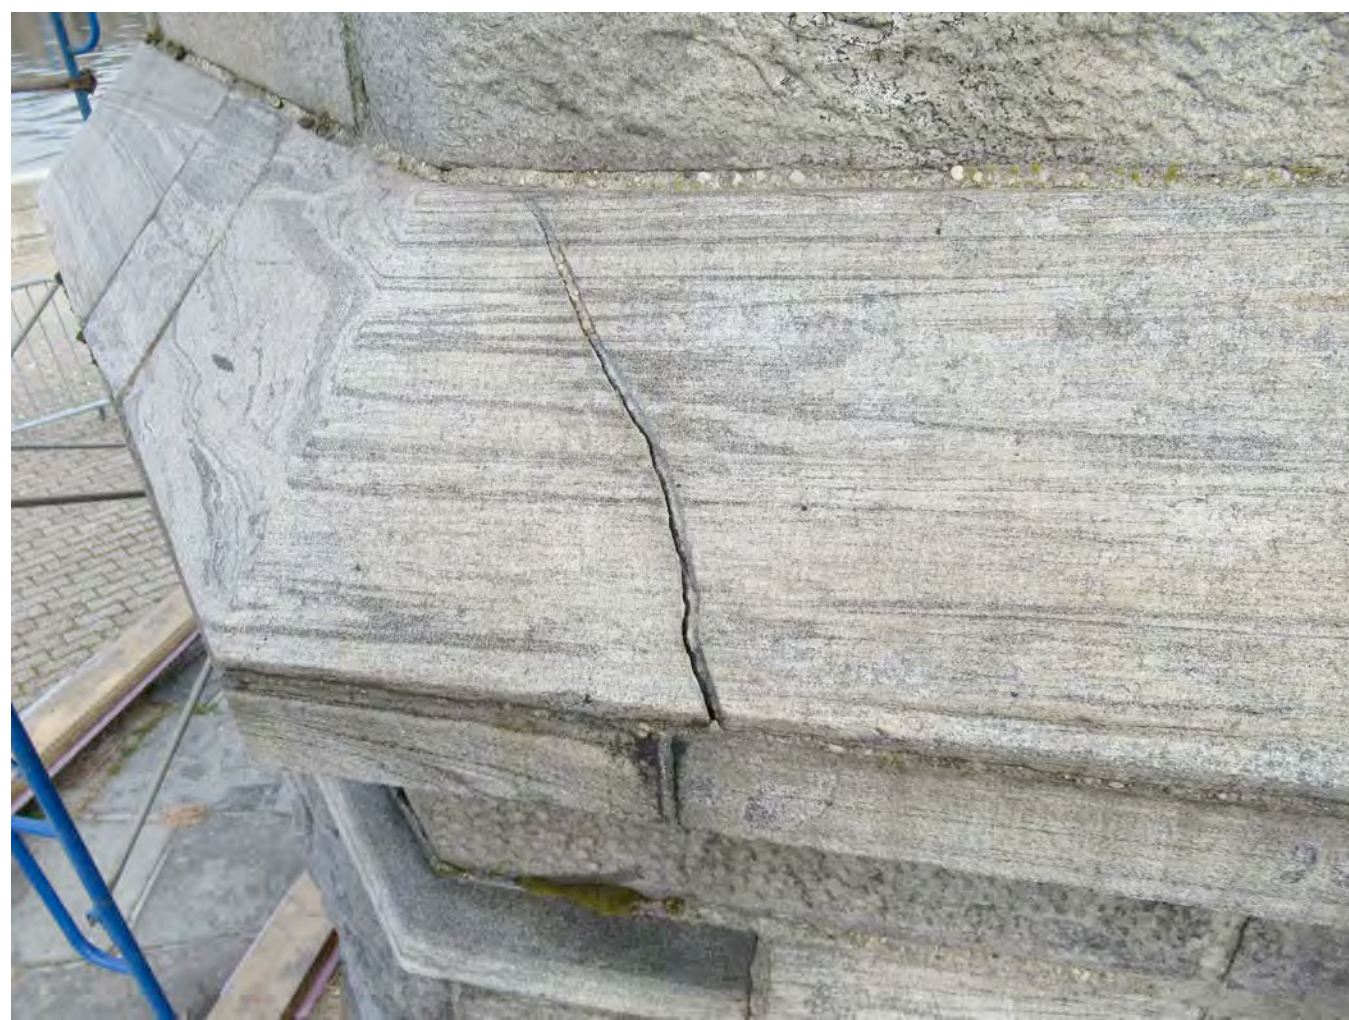
4 STONE CRACKING at MOLDING
BASE at DISPARATE LOCATIONS

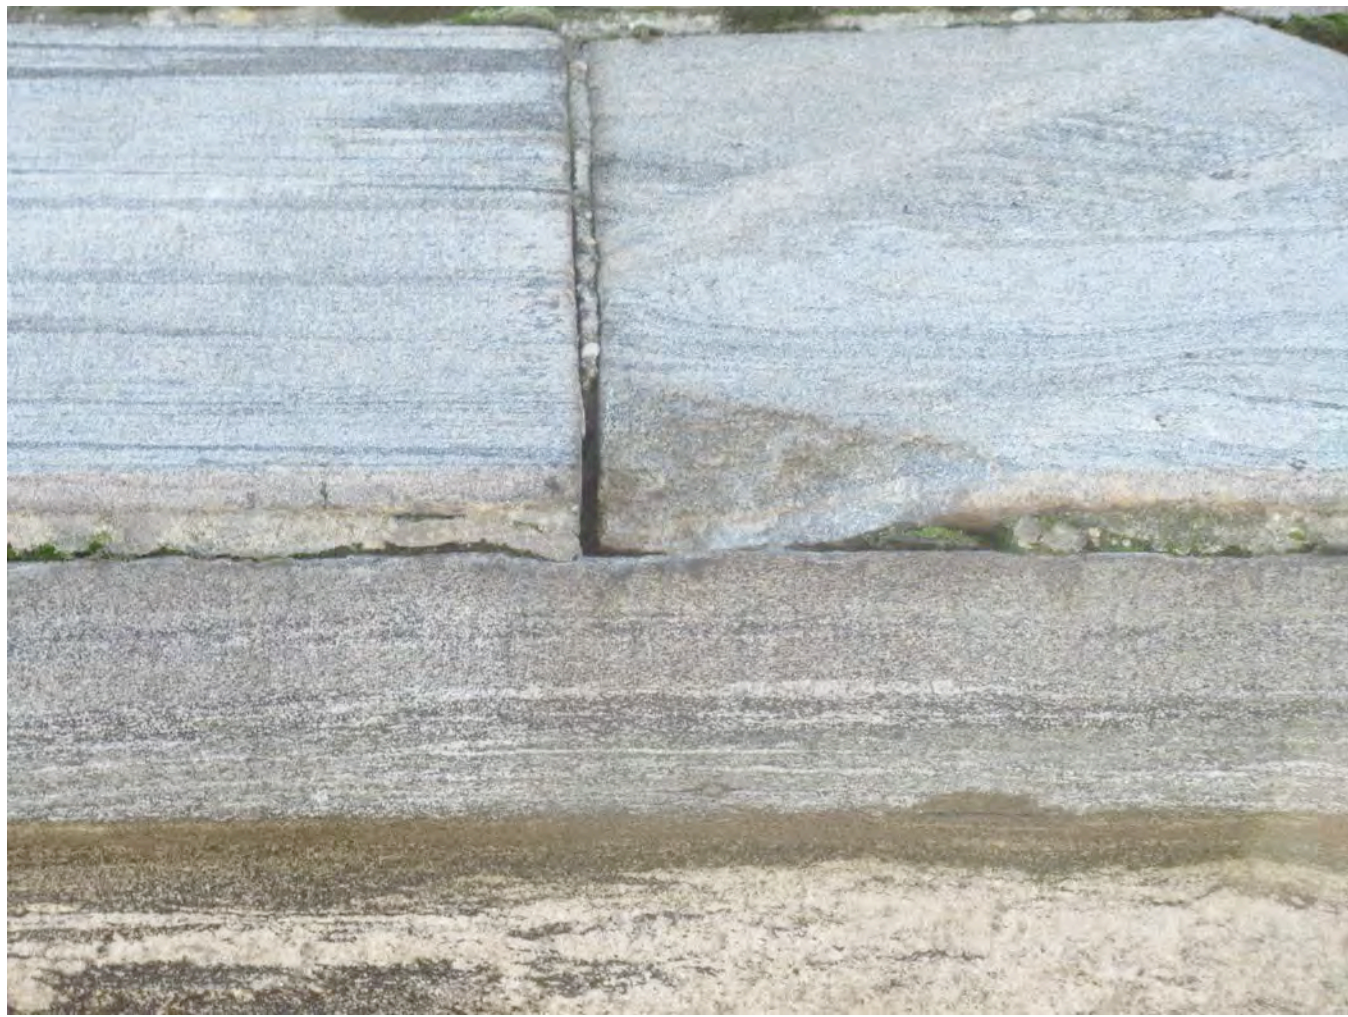
5 STONE SPALL at MOLDING
BASE at DISPARATE LOCATIONS

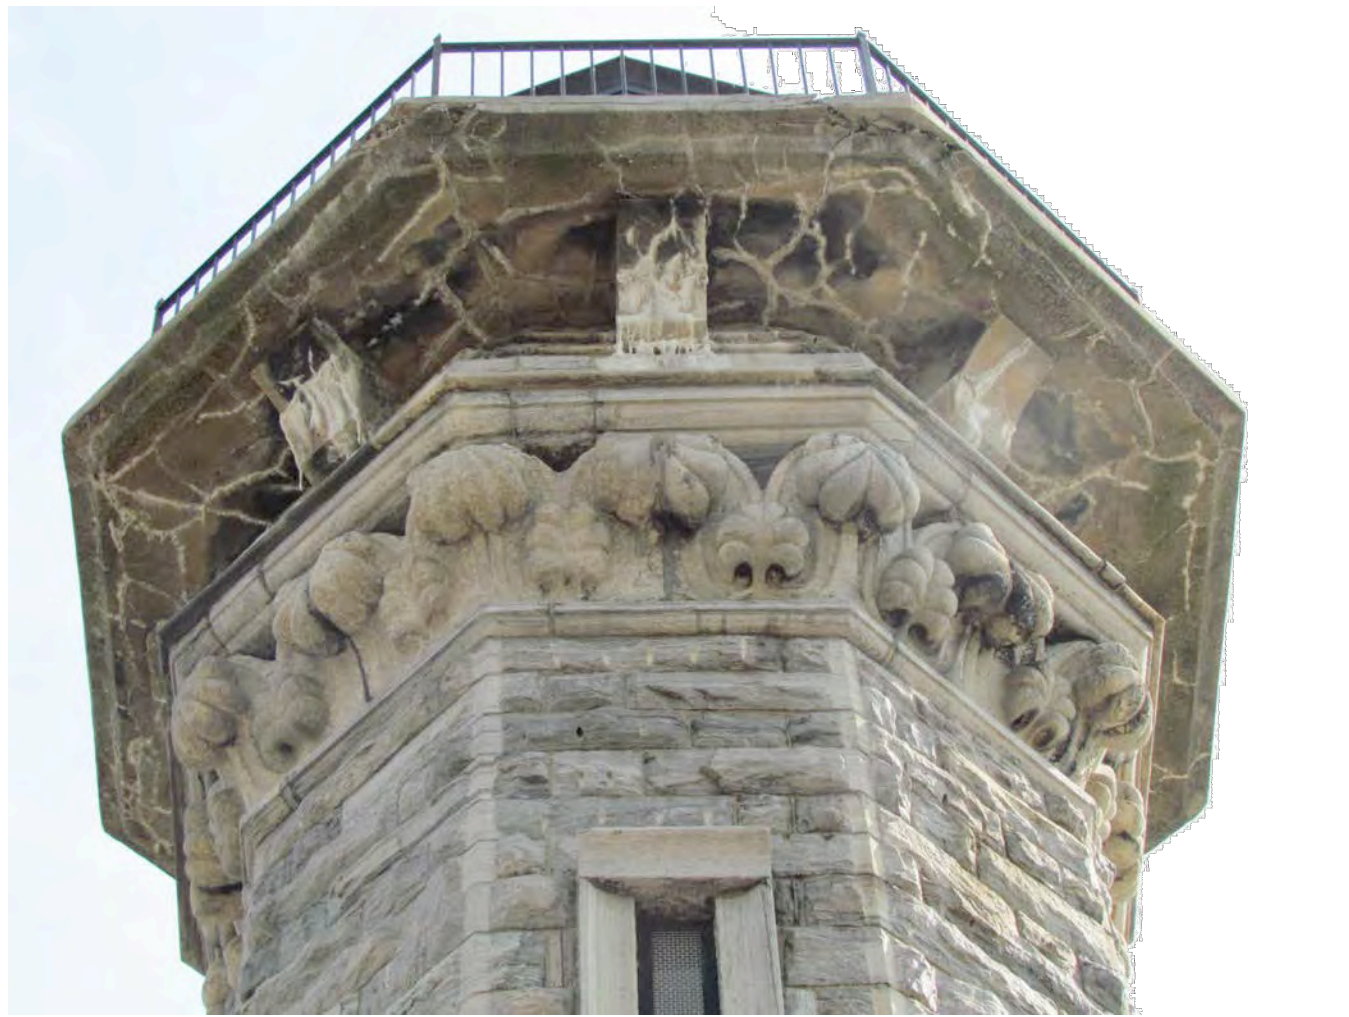
6 DETERIORATED, NON-ORIGINAL CONCRETE DECK
ALL ELEVATIONS, TYPICAL CONDITION

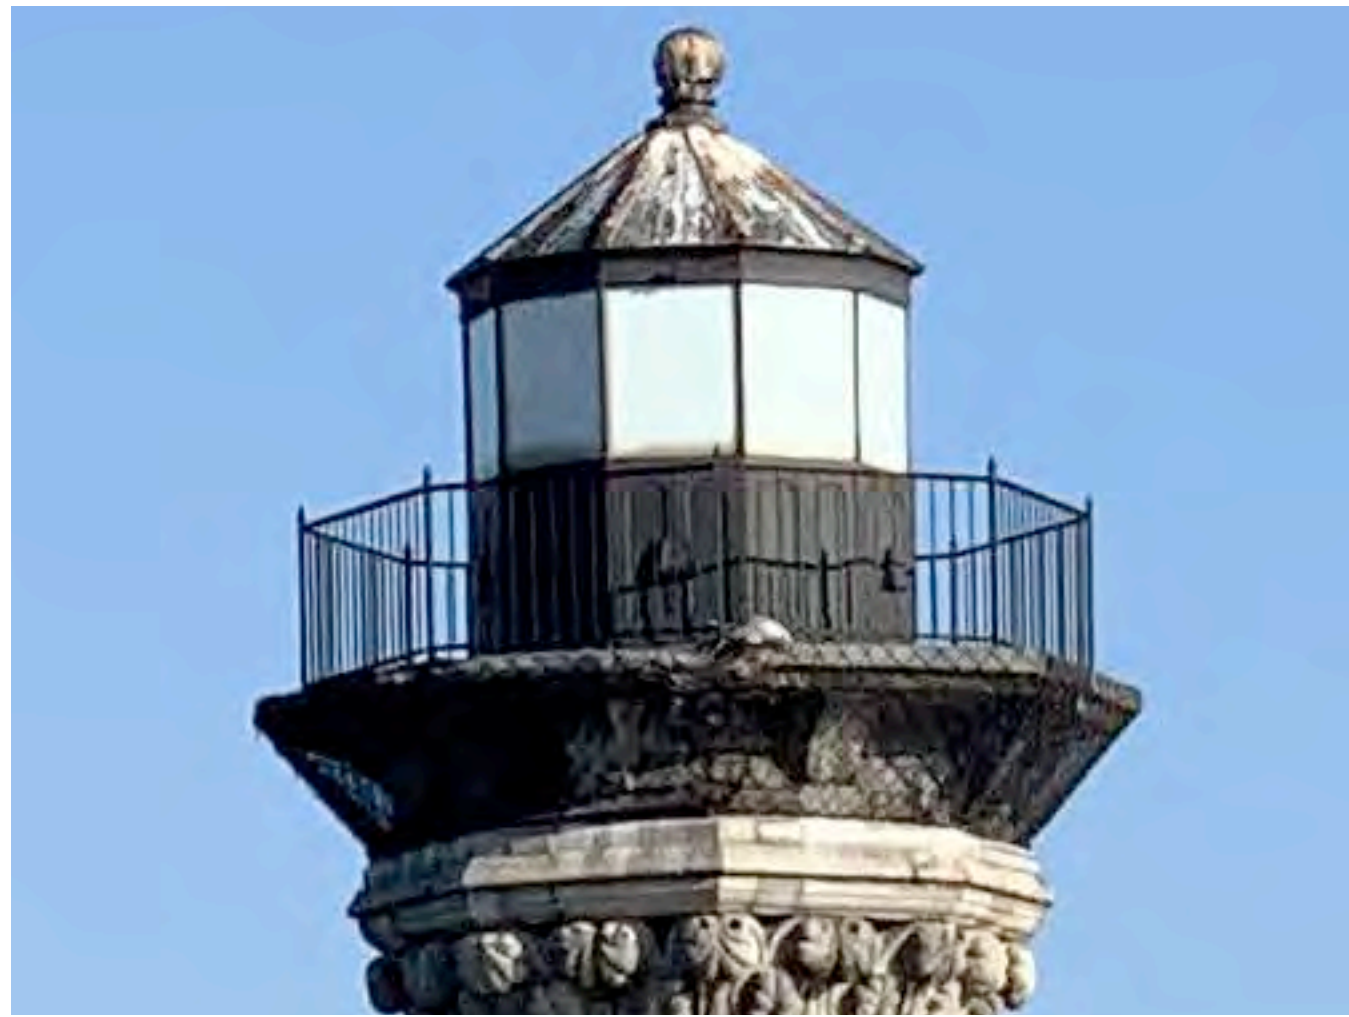
7 TEMPORARY PROTECTION AS INSTALLED
OBSERVATION DECK

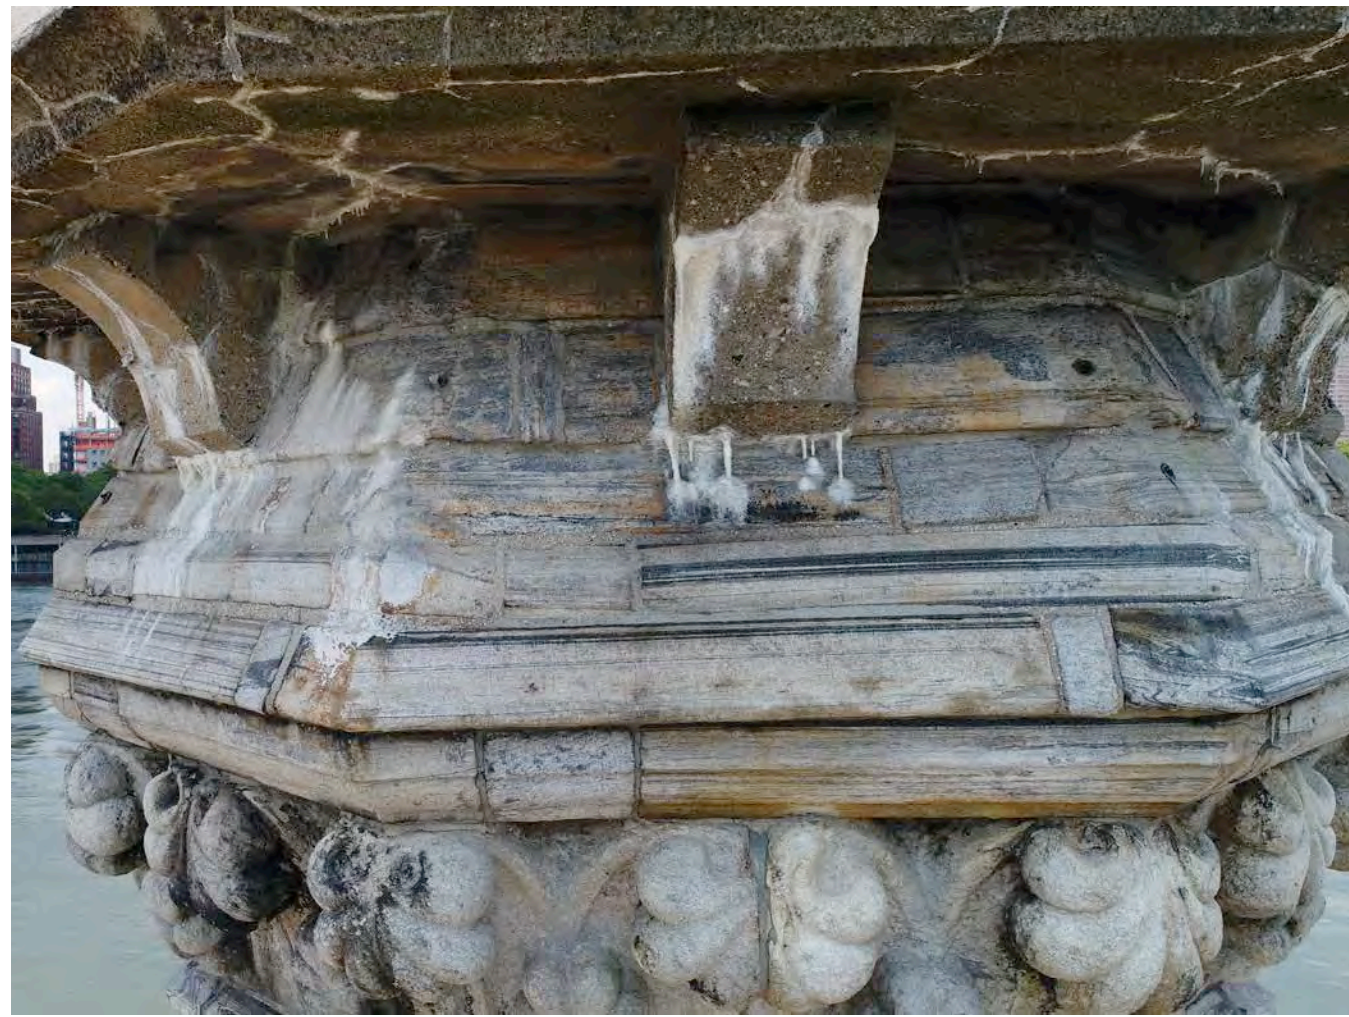
8 REMNANT OF METAL BRACKET ANCHORAGE
STEPPED STONE PROFILE at CAPITAL, EACH OUTSIDE CORNER OF THE OCTAGONAL TOWER

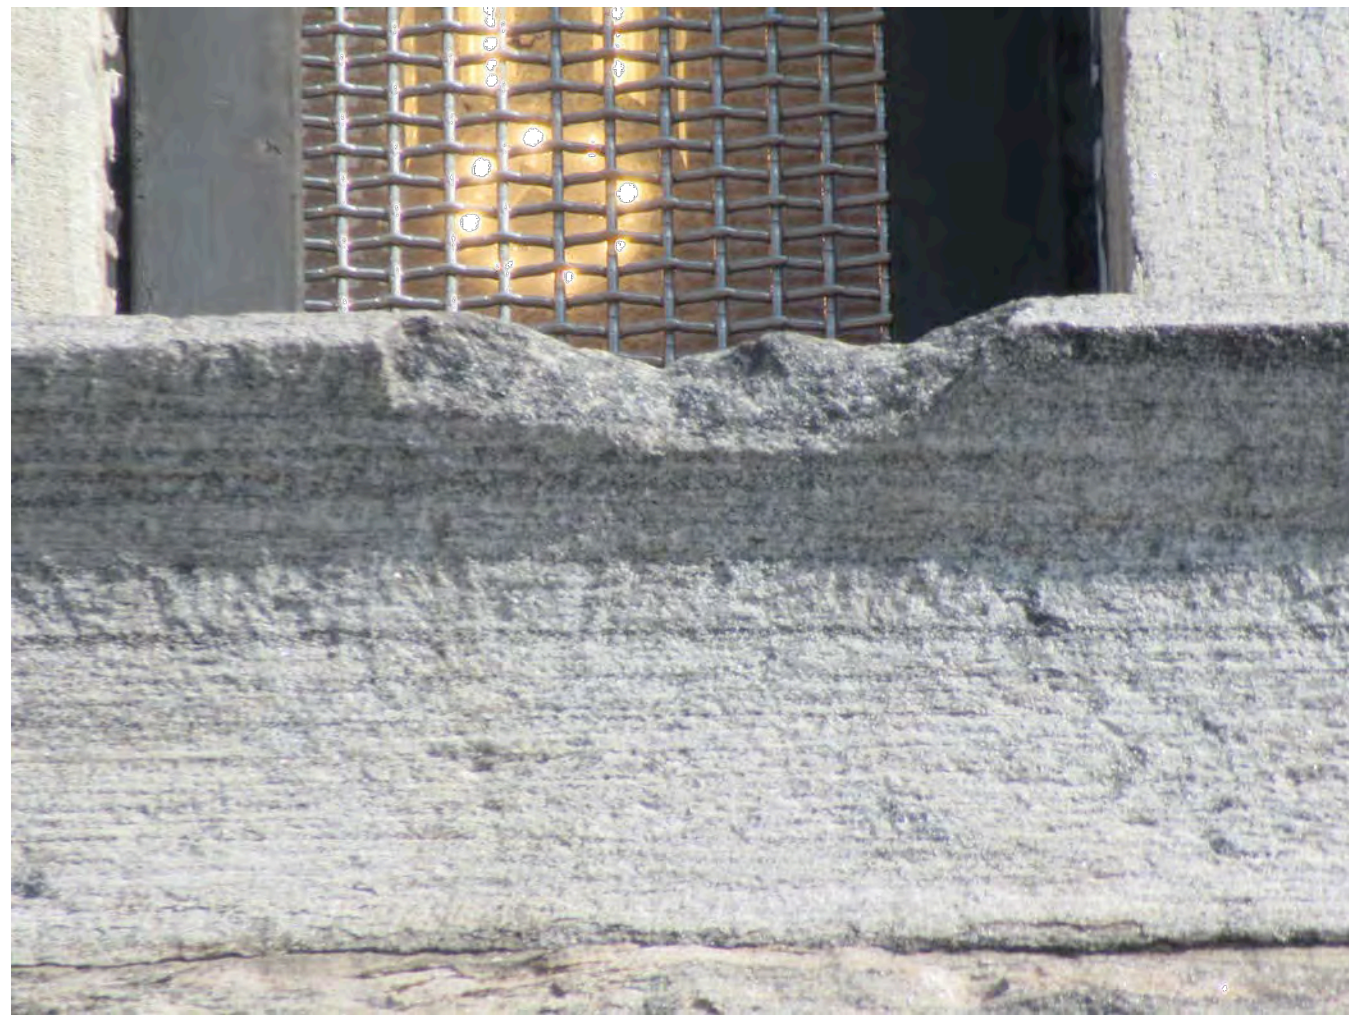
12 STONE SPALL
WINDOW SURROUND, TYPICAL CONDITION

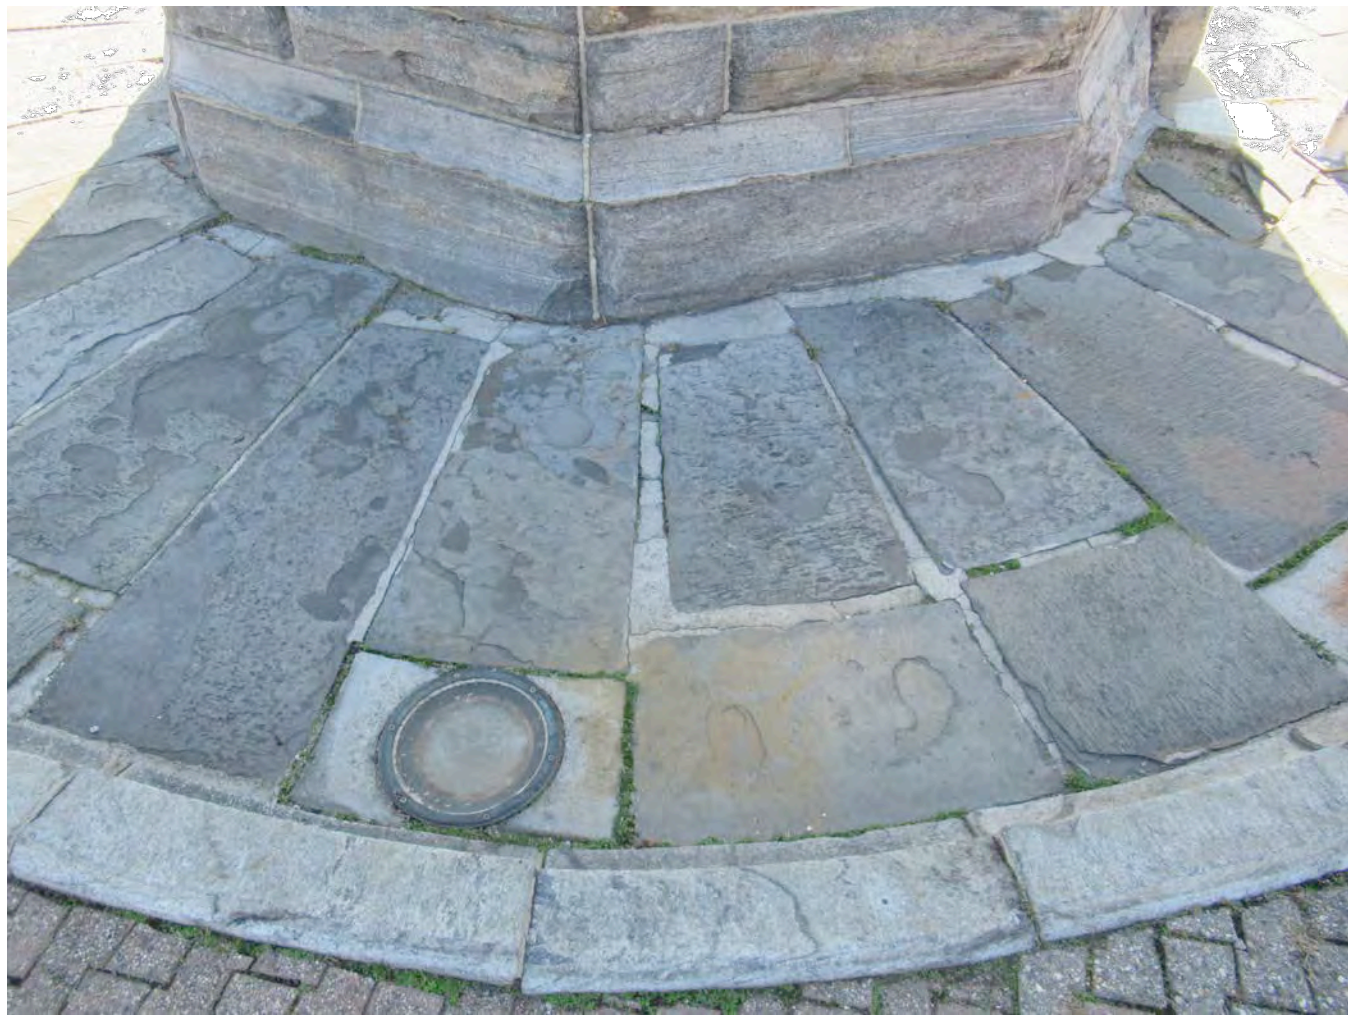
13 DISPLACED, SKEWED, ERODED & SPALLED FLAGSTONES / INCOMPATIBLE PATCHING MATERIAL
DEPRESSED PAVED AREA

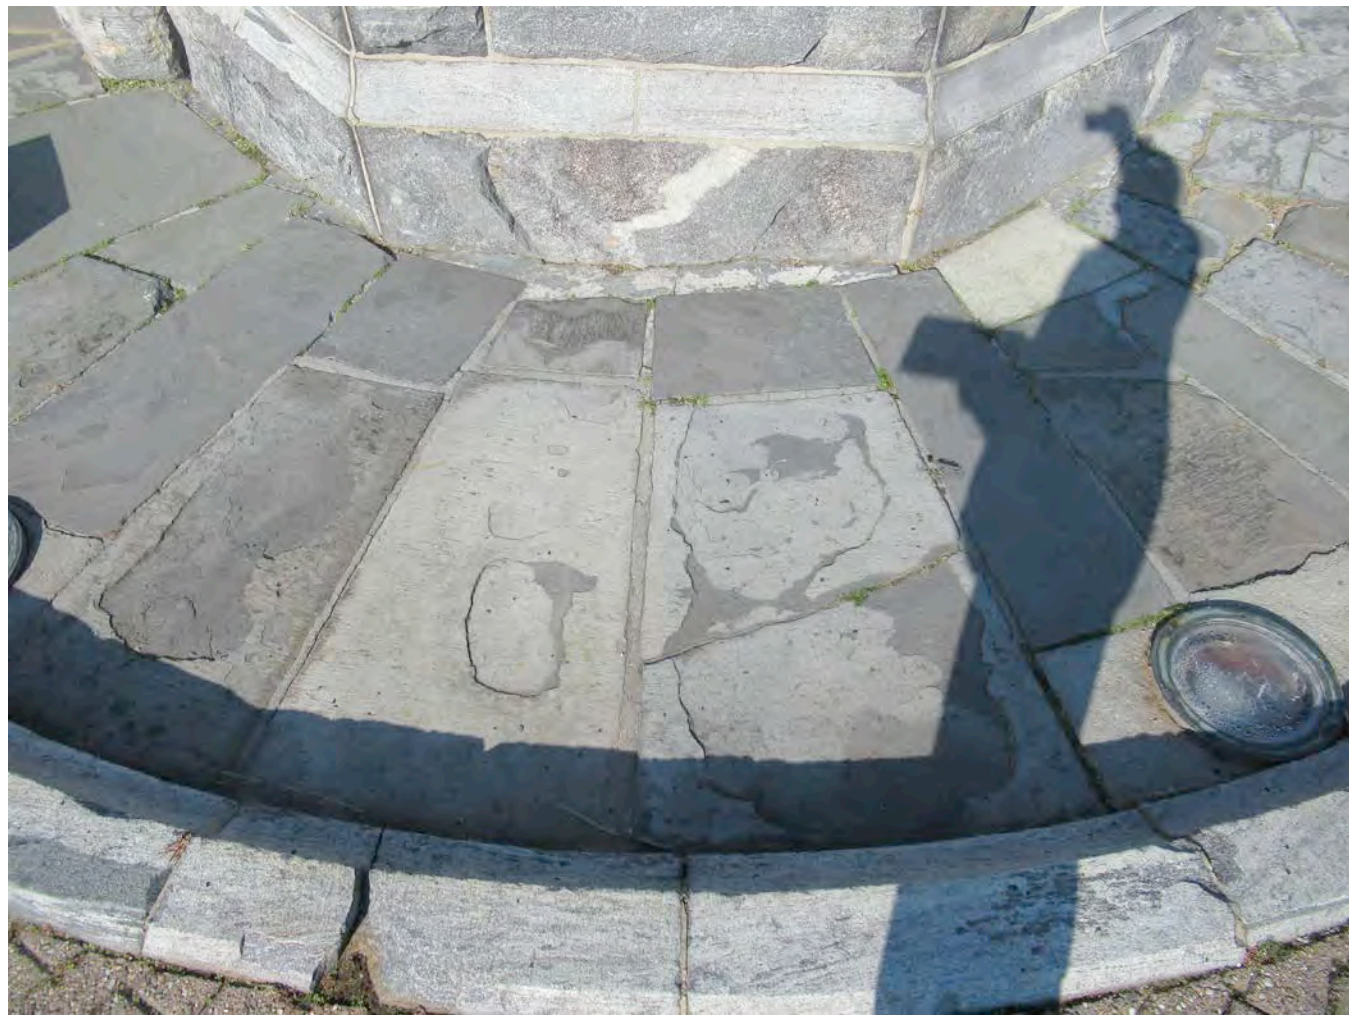
14 DISPLACED, SKEWED, ERODED & SPALLED FLAGSTONES / INCOMPATIBLE PATCHING MATERIAL
DEPRESSED PAVED AREA

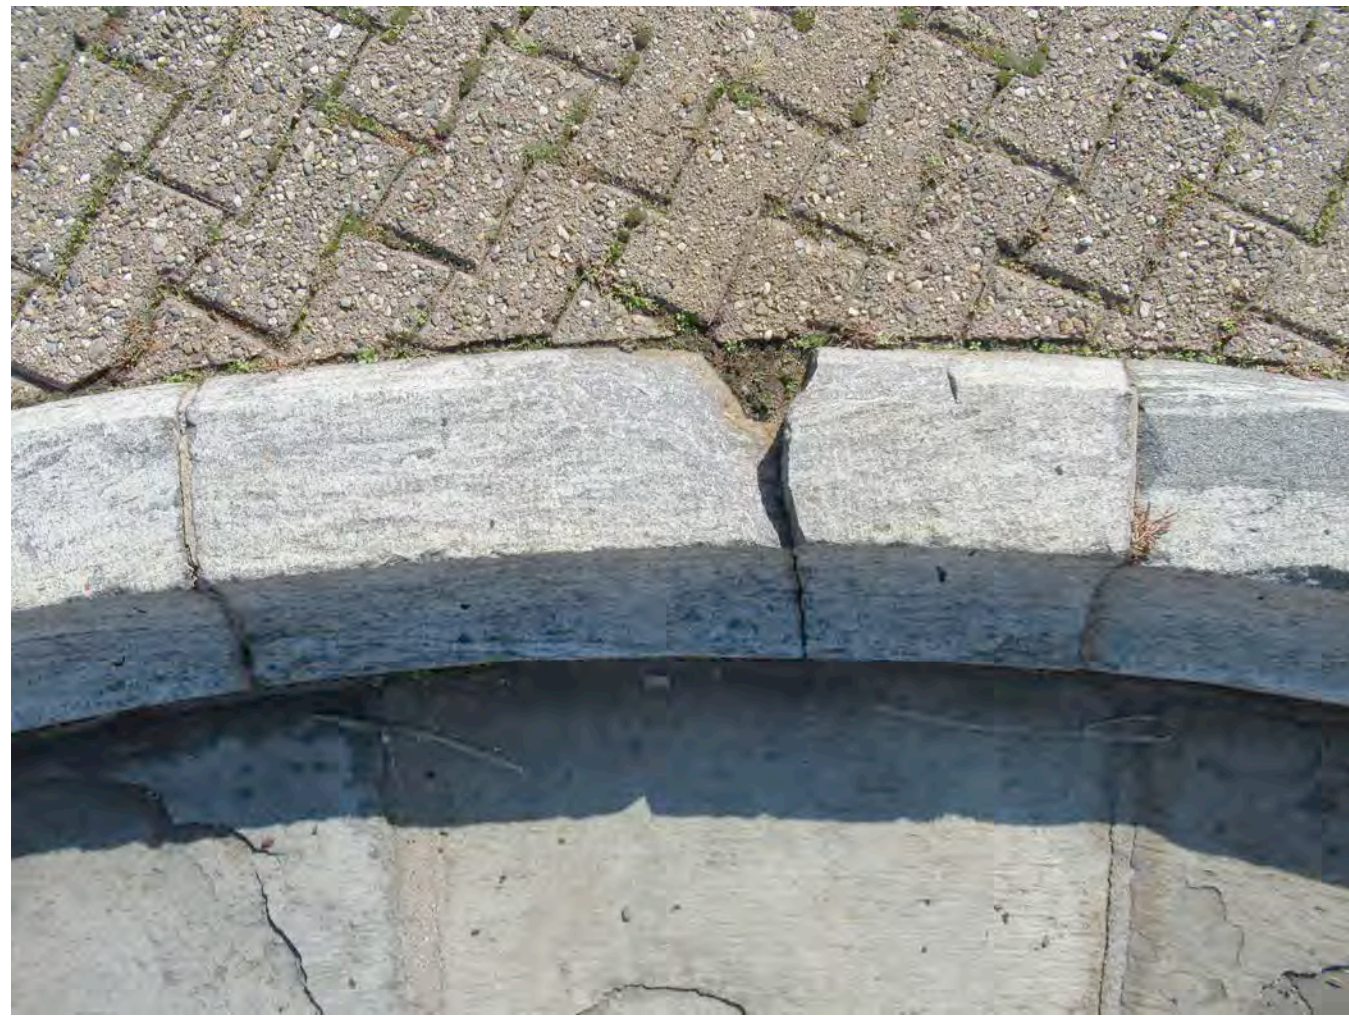
15 CRACK at STONE CURB
DEPRESSED PAVED AREA

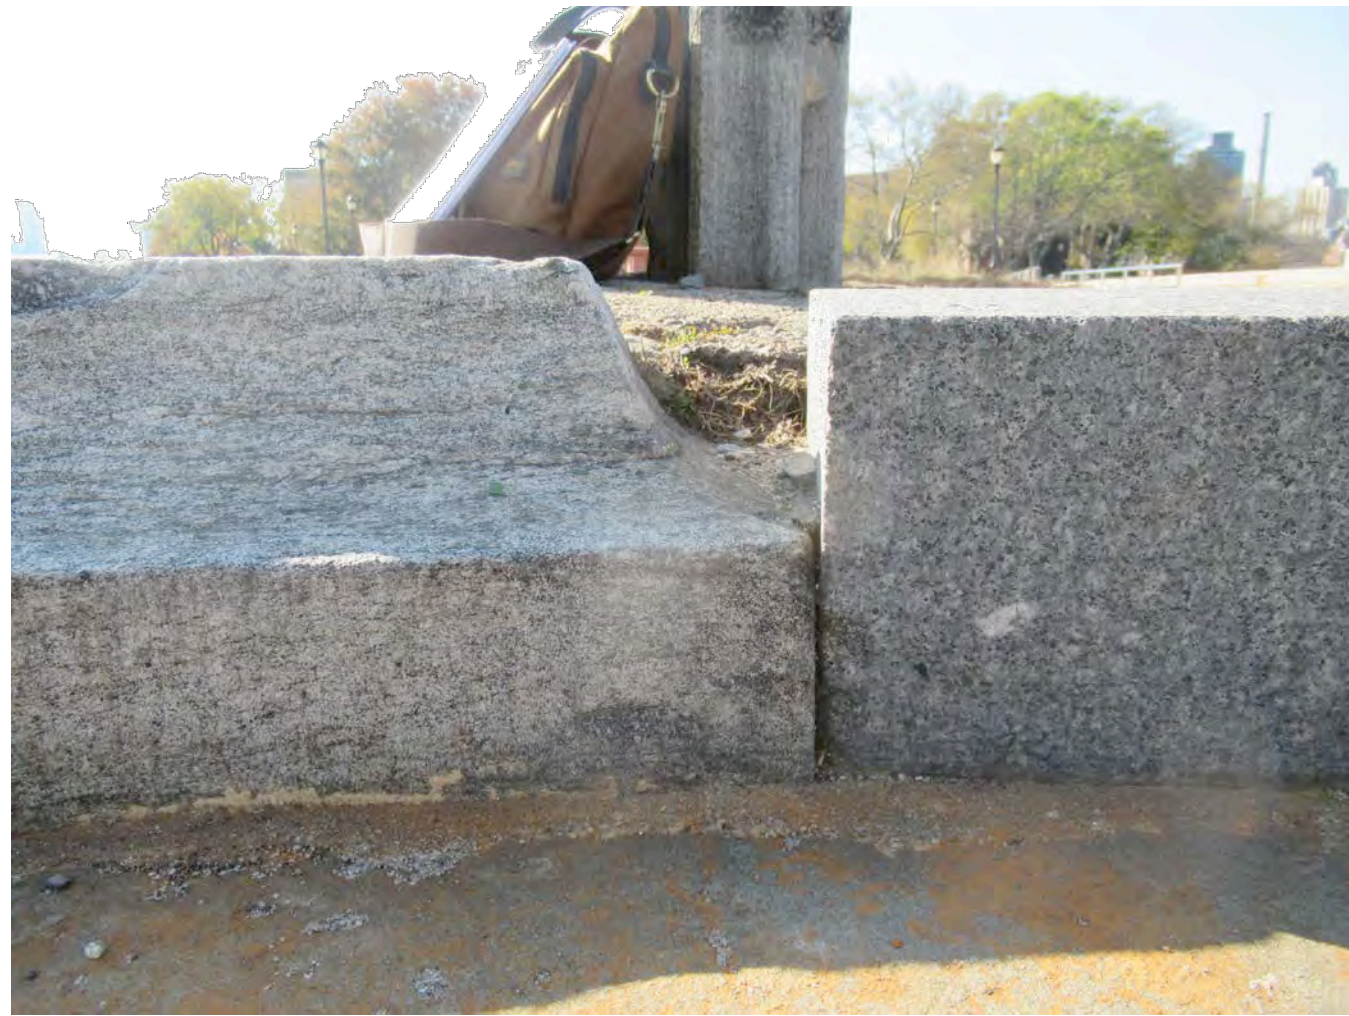
16 DETAIL VIEW OF STONE CURB END UNIT w/ NON-ORIGINAL STONE STEP at RIGHT
DEPRESSED PAVED AREA

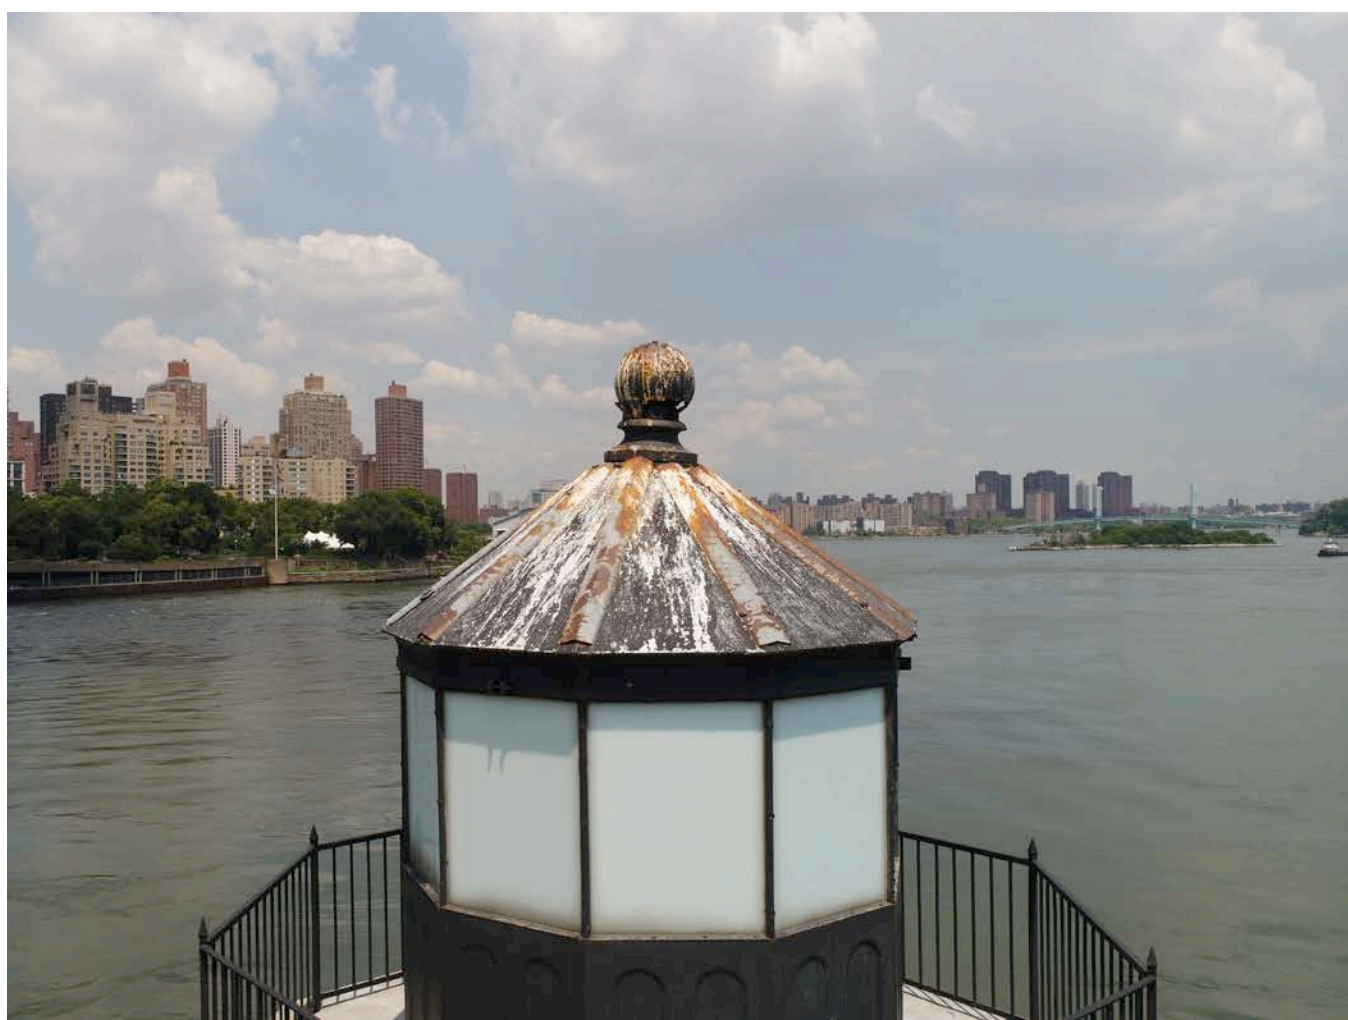
1 PAINT FAILURE, CORROSION OF METAL JOINT COVER & DISPLACED SECTIONS OF CAST IRON LANTERN ROOF

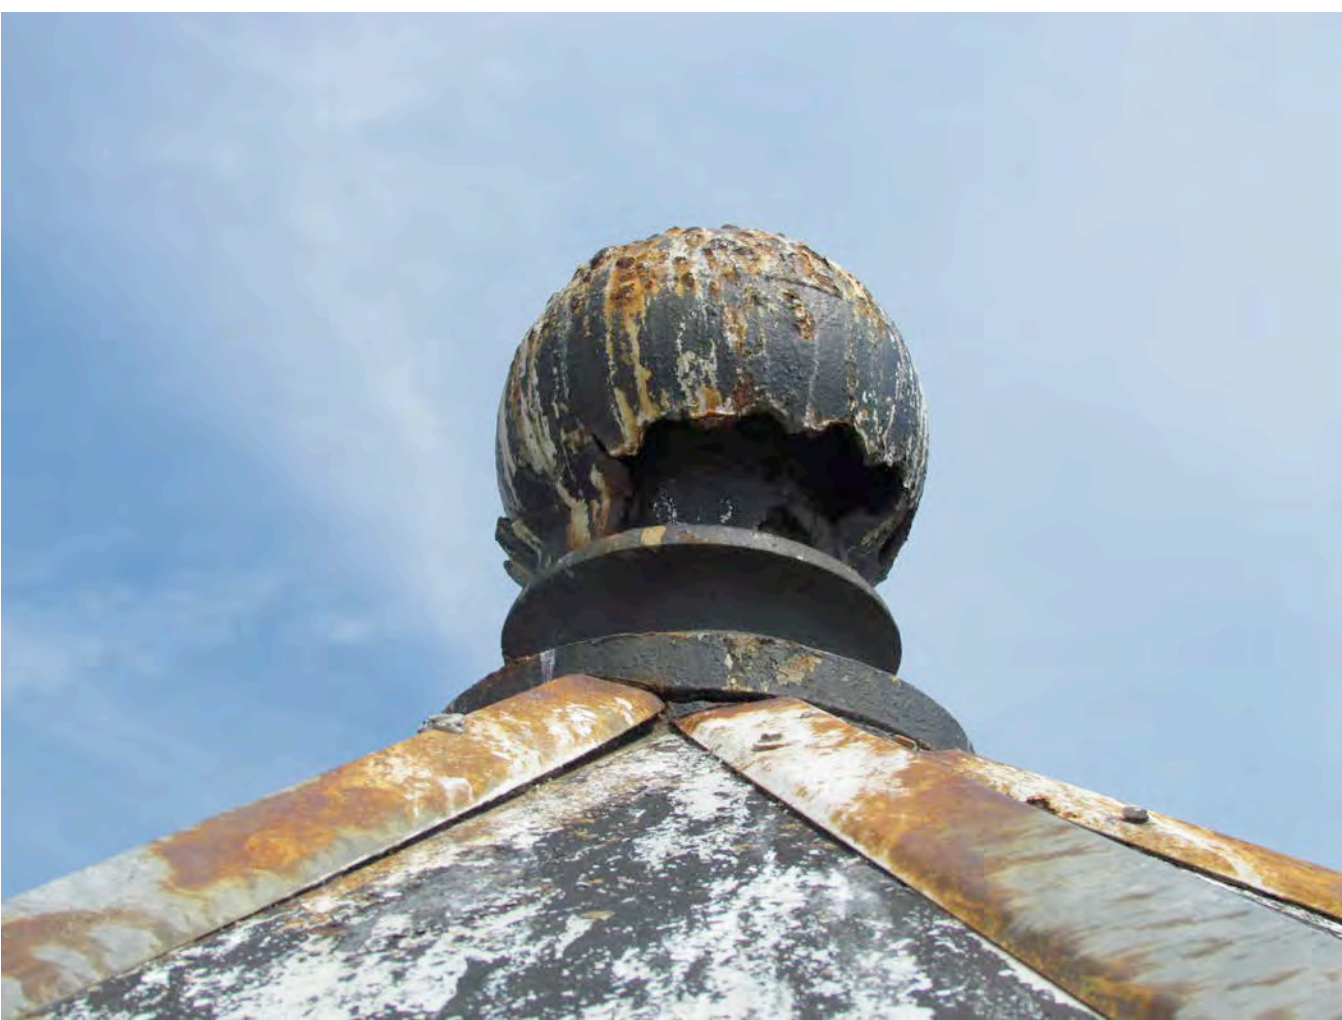
2 FRACTURED CAST IRON VENTILATOR ORB LANTERN ROOF

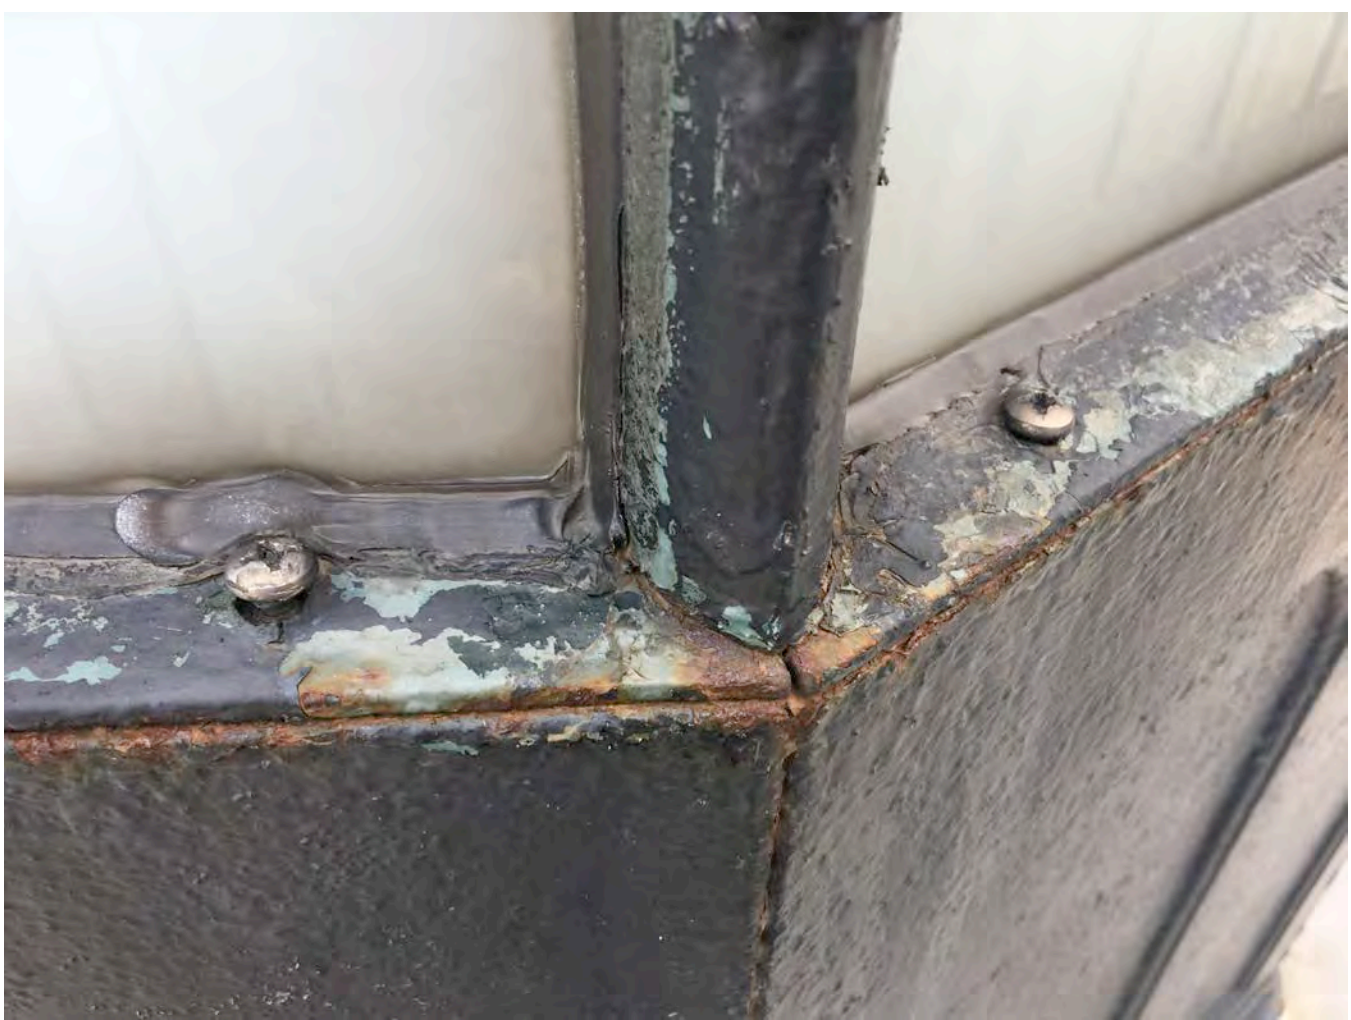
3 PAINT FAILURE, CORROSION OF UNDERLYING METAL & LOOSE FASTENERS LANTERN PARAPET WALL TOP

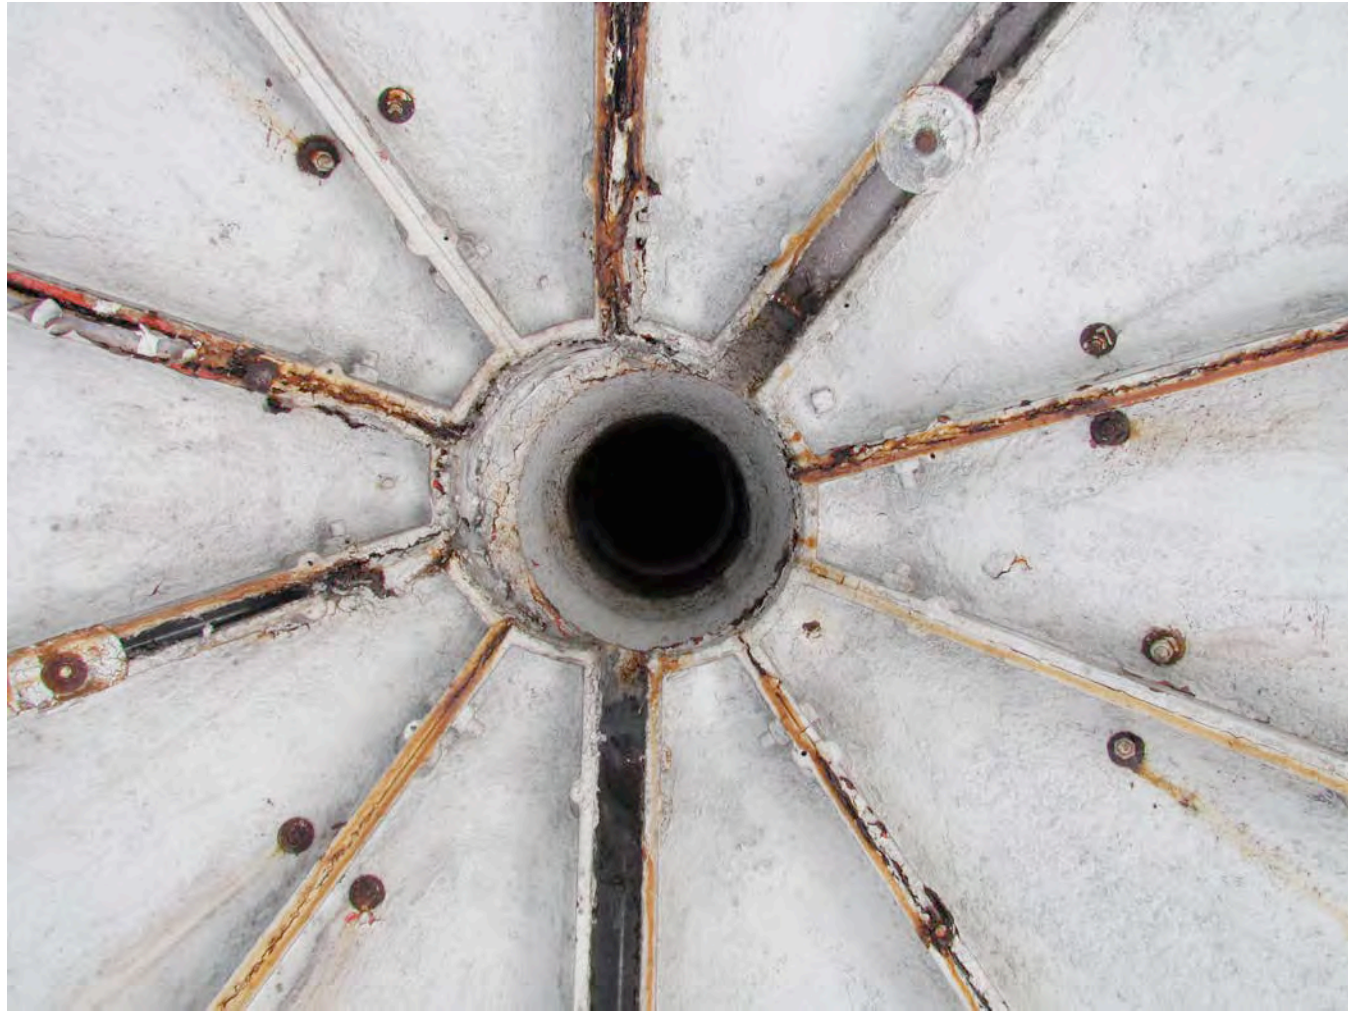
5 CAST IRON PANEL SEPARATION, PAINT FAILURE & GALVANIC CORROSION LANTERN ROOF

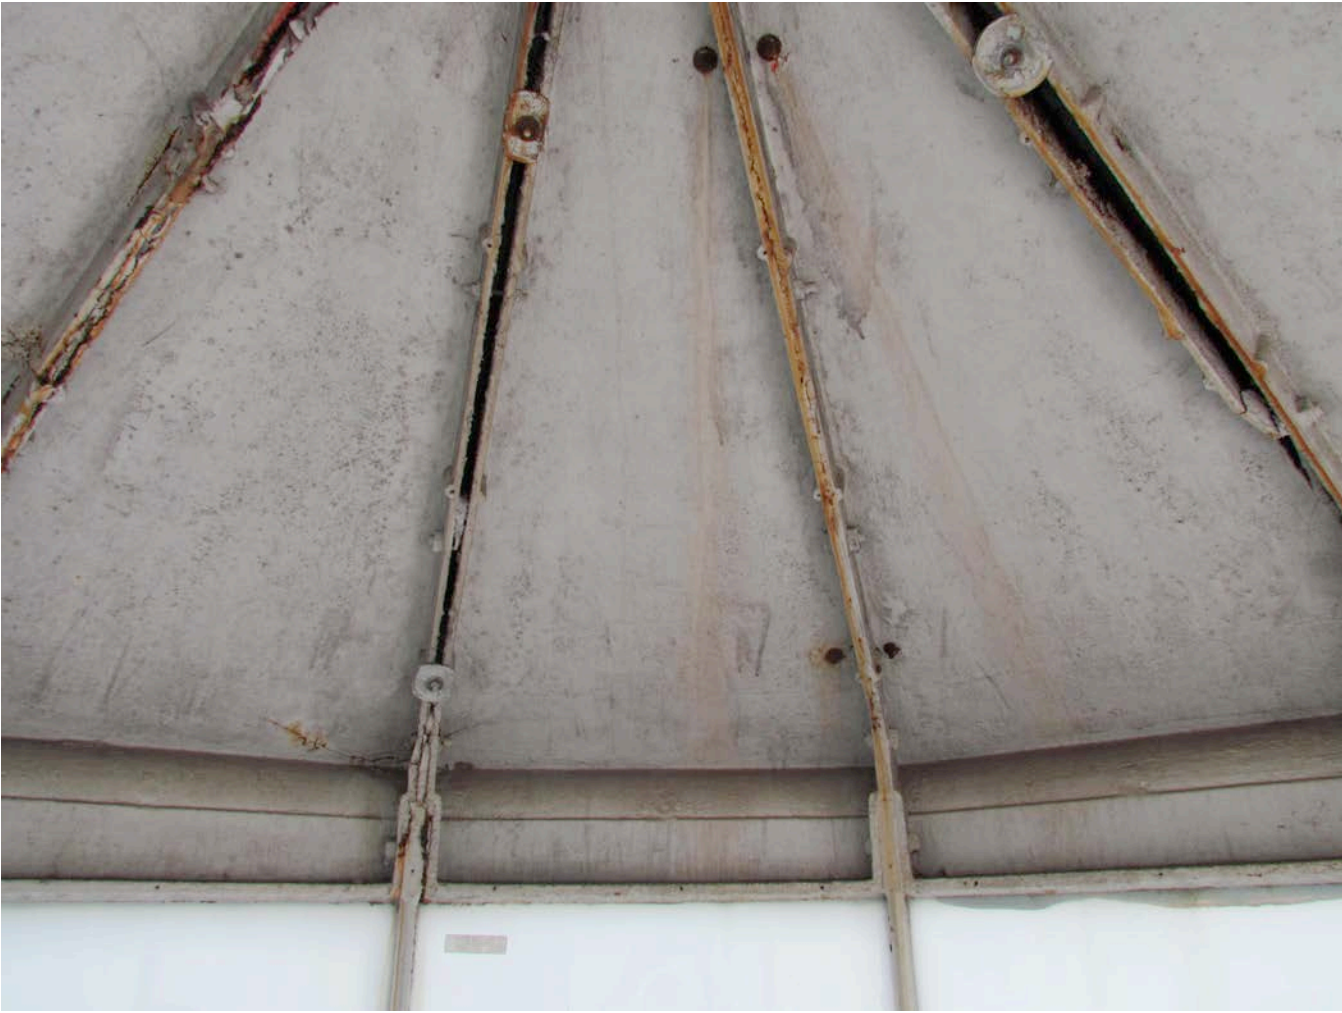
6 CAST IRON PANEL SEPARATION, PAINT FAILURE & GALVANIC CORROSION LANTERN ROOF
