LIGHTHOUSE

LIGHTHOUSE PARK,
ROOSEVELT ISLAND, NY 10044

TITLE:
PHOTO SURVEY -
MASONRY & SITE
CONDITIONS

TITLE:
PHOTO SURVEY -
LANTERN& OBSERVATION
DECK CONDITIONS

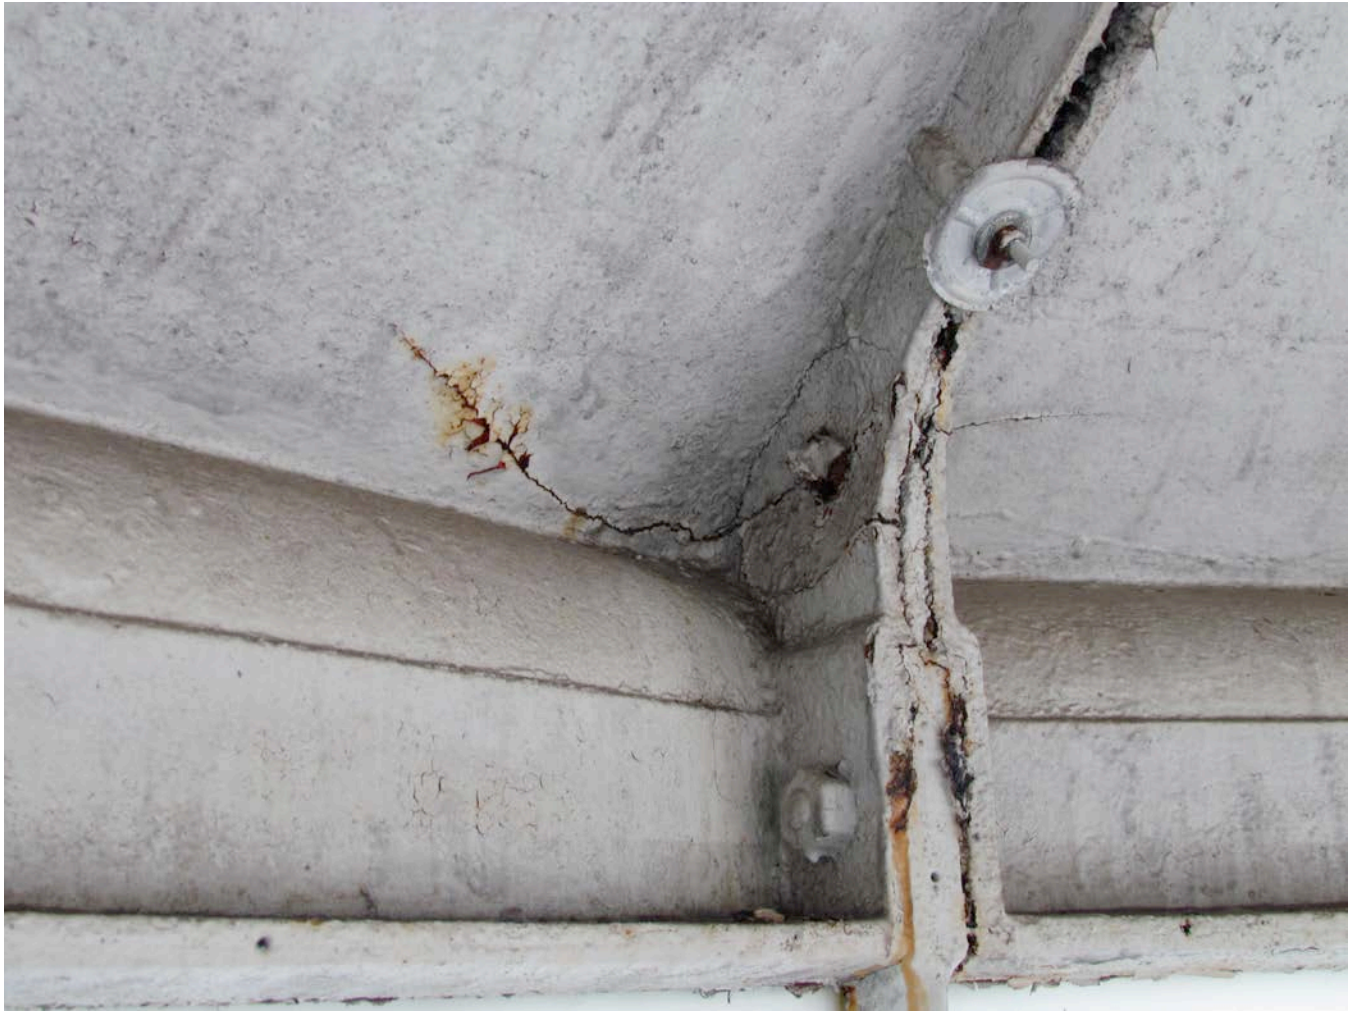
7 CRACKED CAST IRON PANEL, PAINT FAILURE & GALVANIC CORROSION LANTERN ROOF

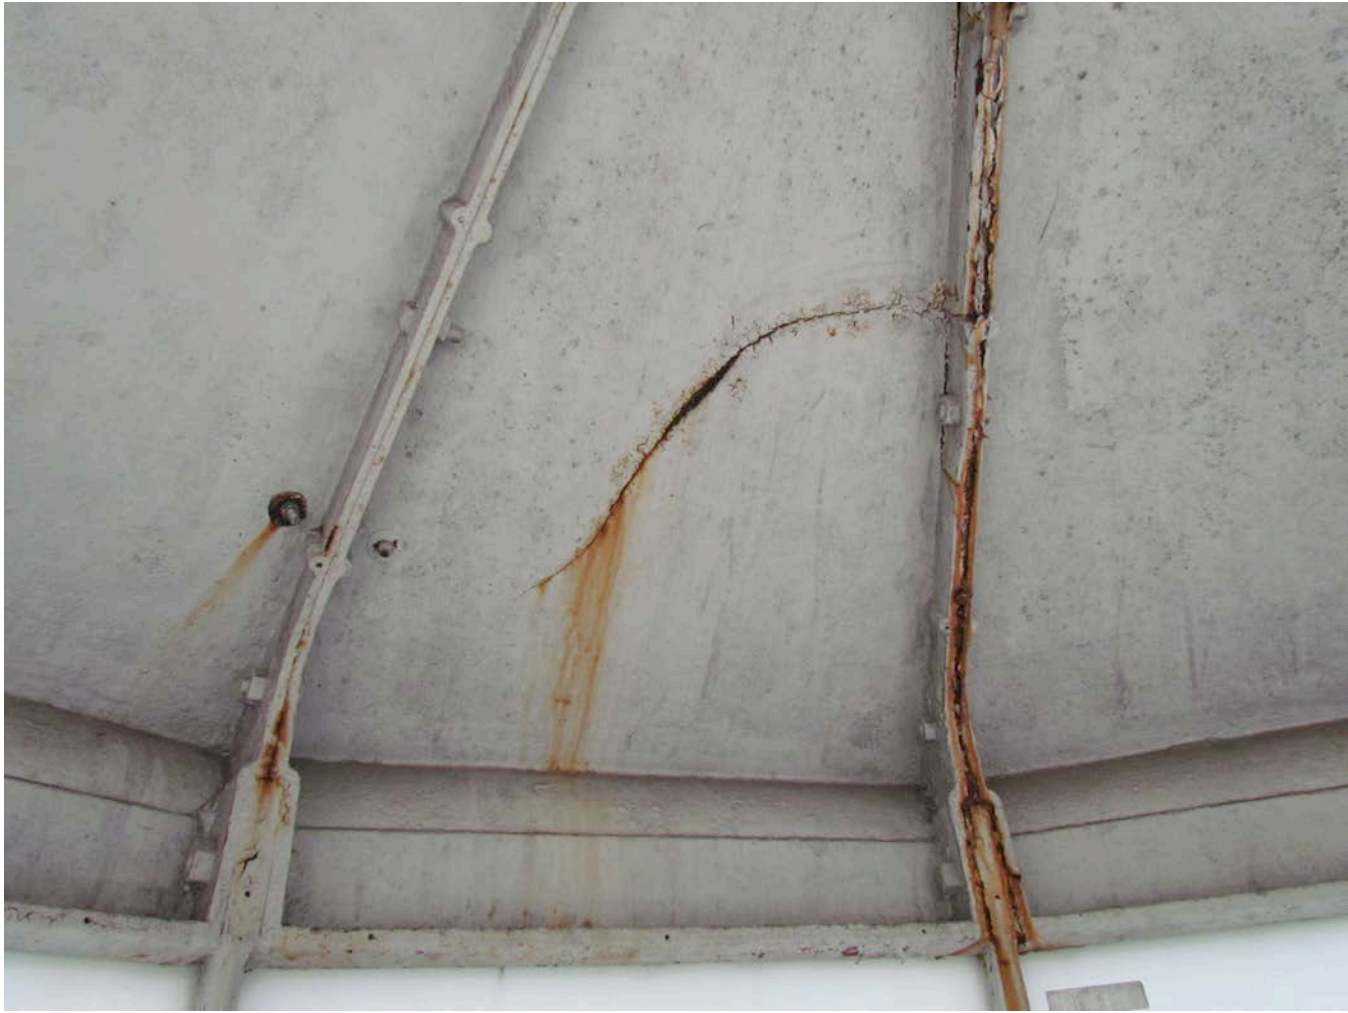
8 CRACKED CAST IRON PANEL, PAINT FAILURE & GALVANIC CORROSION LANTERN ROOF

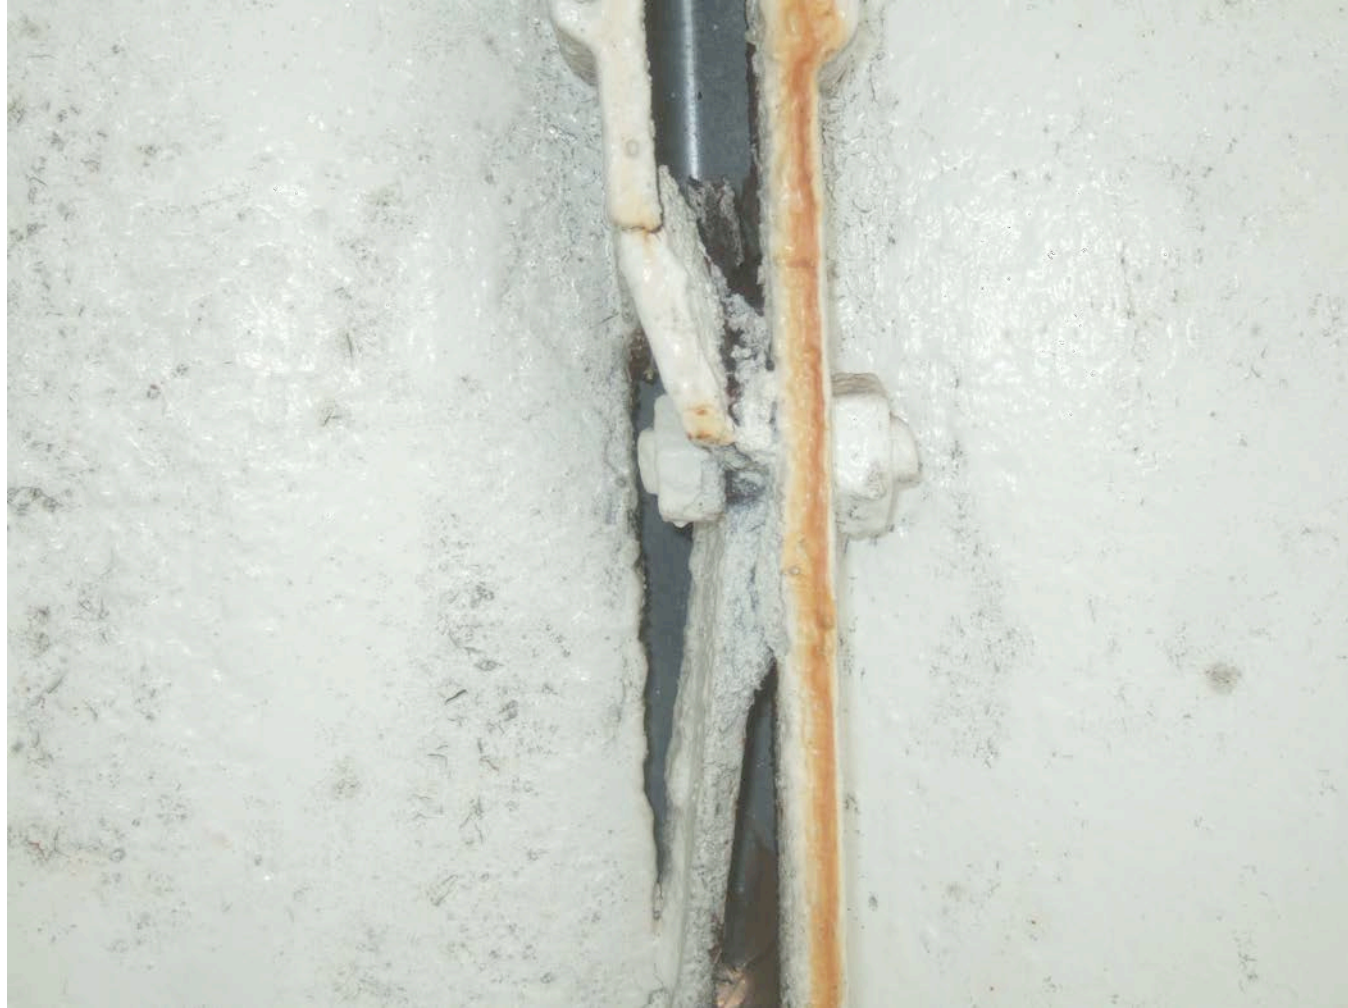
9 CAST IRON PANEL SEPARATION & DEFORMATION LANTERN ROOF

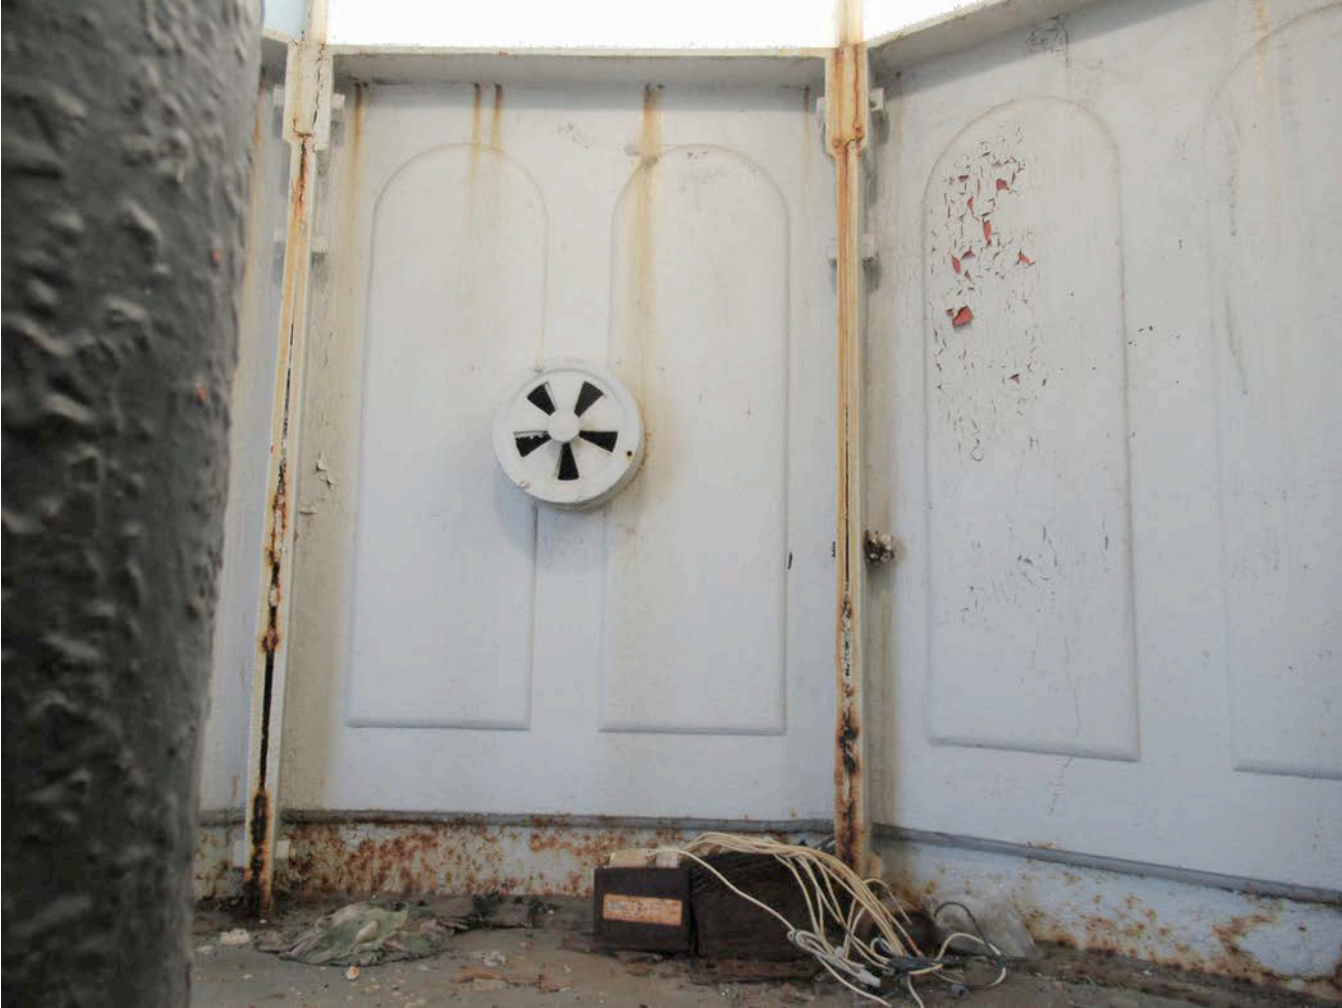
10 PAINT FAILURE & GALVANIC CORROSION LANTERN PARAPET WALL

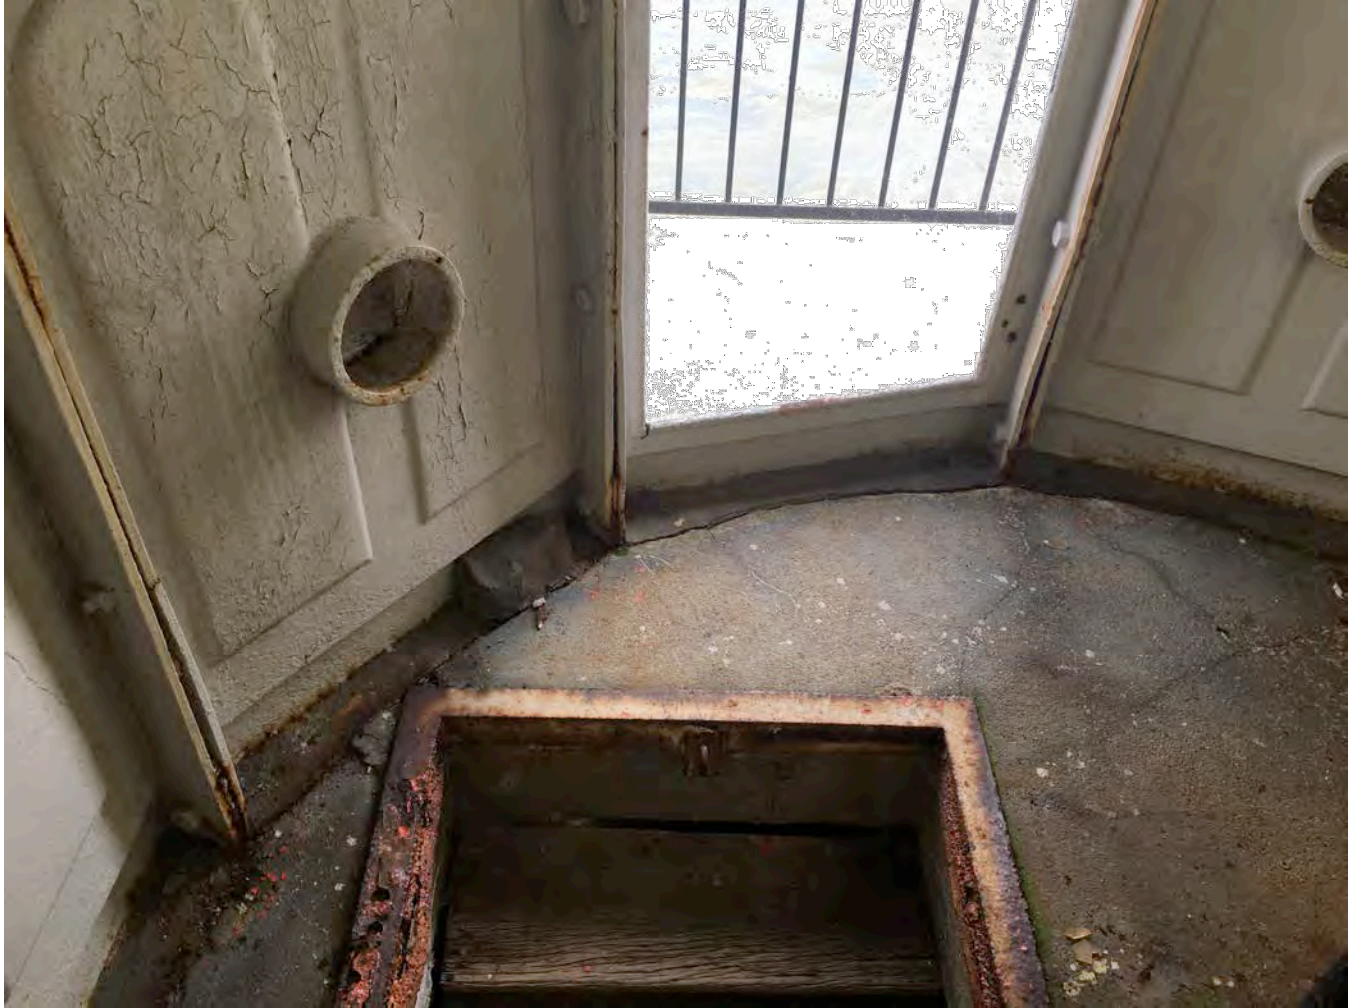
11 PAINT FAILURE, CORROSION OF UNDERLYING METAL & SEPARATION B/N LANTERN & DECK LANTERN PARAPET WALL & OBSERVATION DECK HATCH

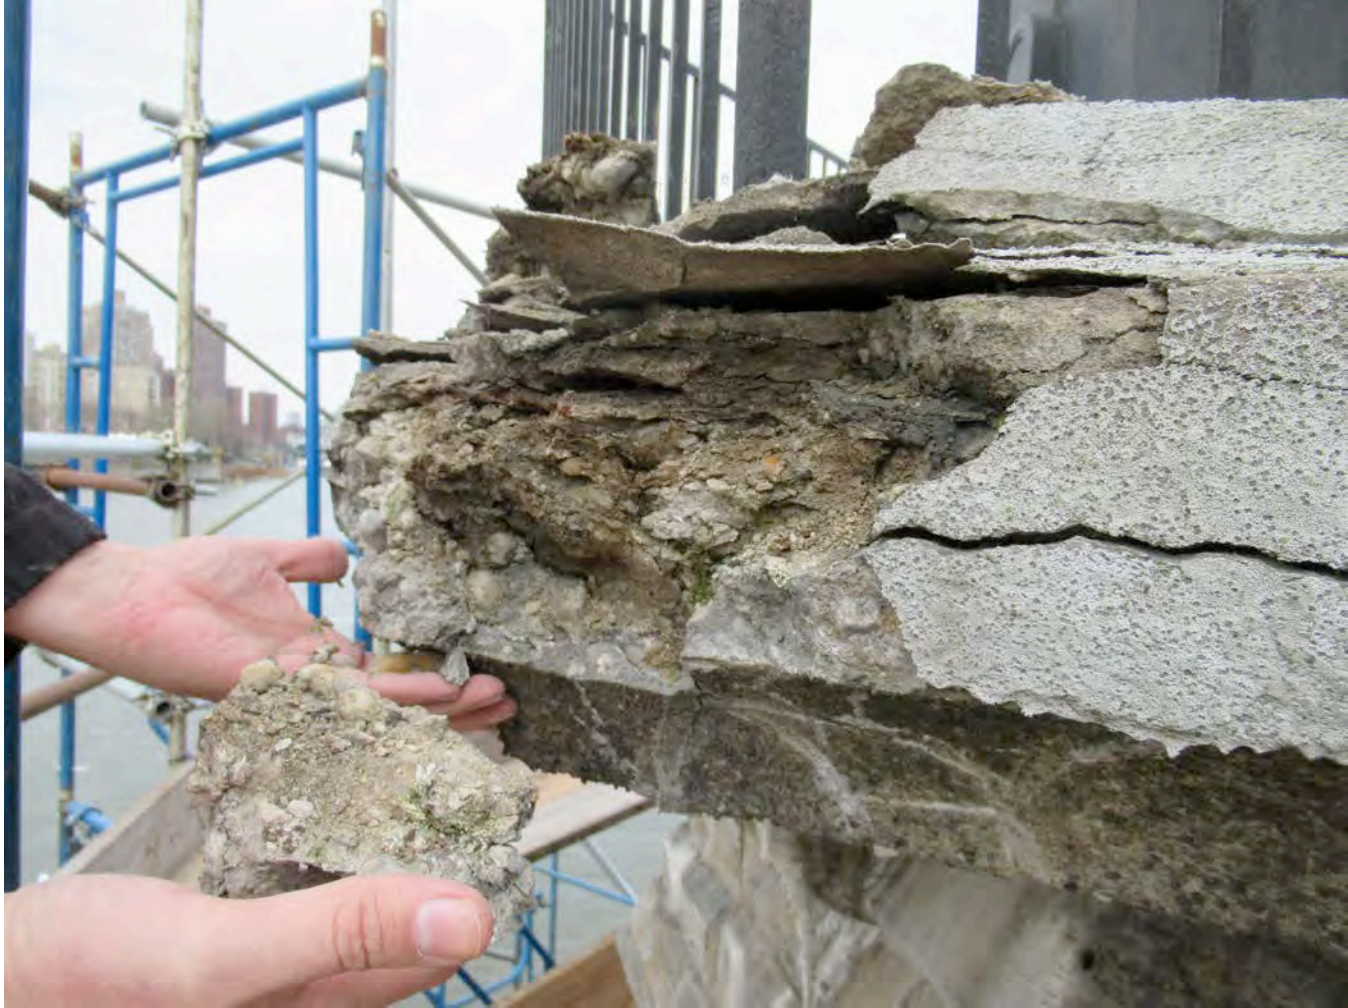
12 SEVERELY CRACKED, SPALLED CONCRETE & DELAMINATED TRAFFIC SURFACE OBSERVATION DECK

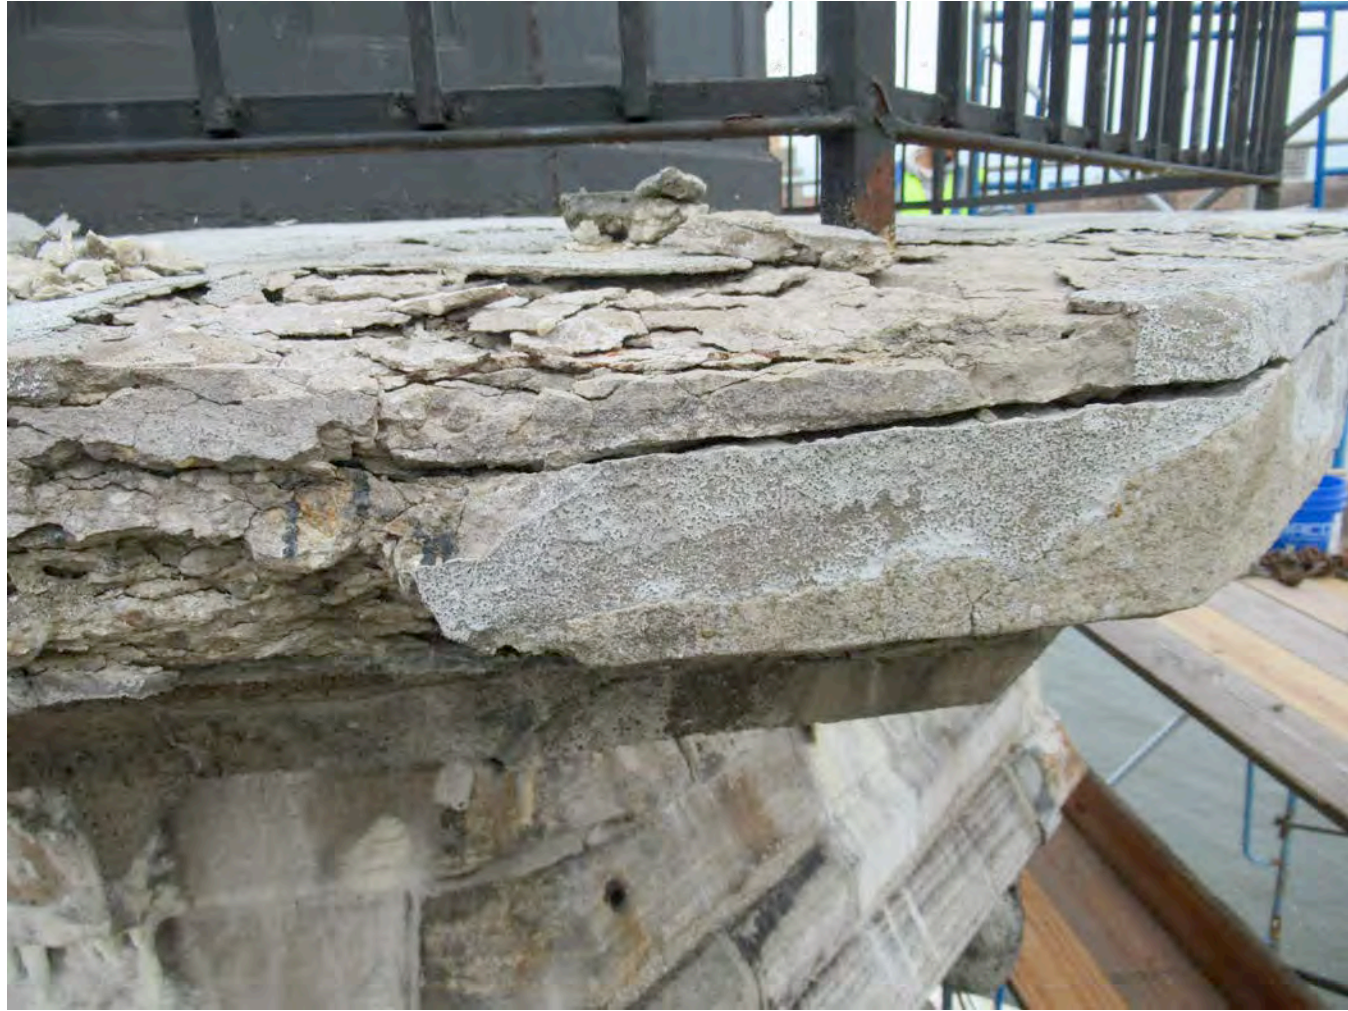
13 SEVERELY CRACKED, SPALLED CONCRETE & DELAMINATED TRAFFIC SURFACE OBSERVATION DECK

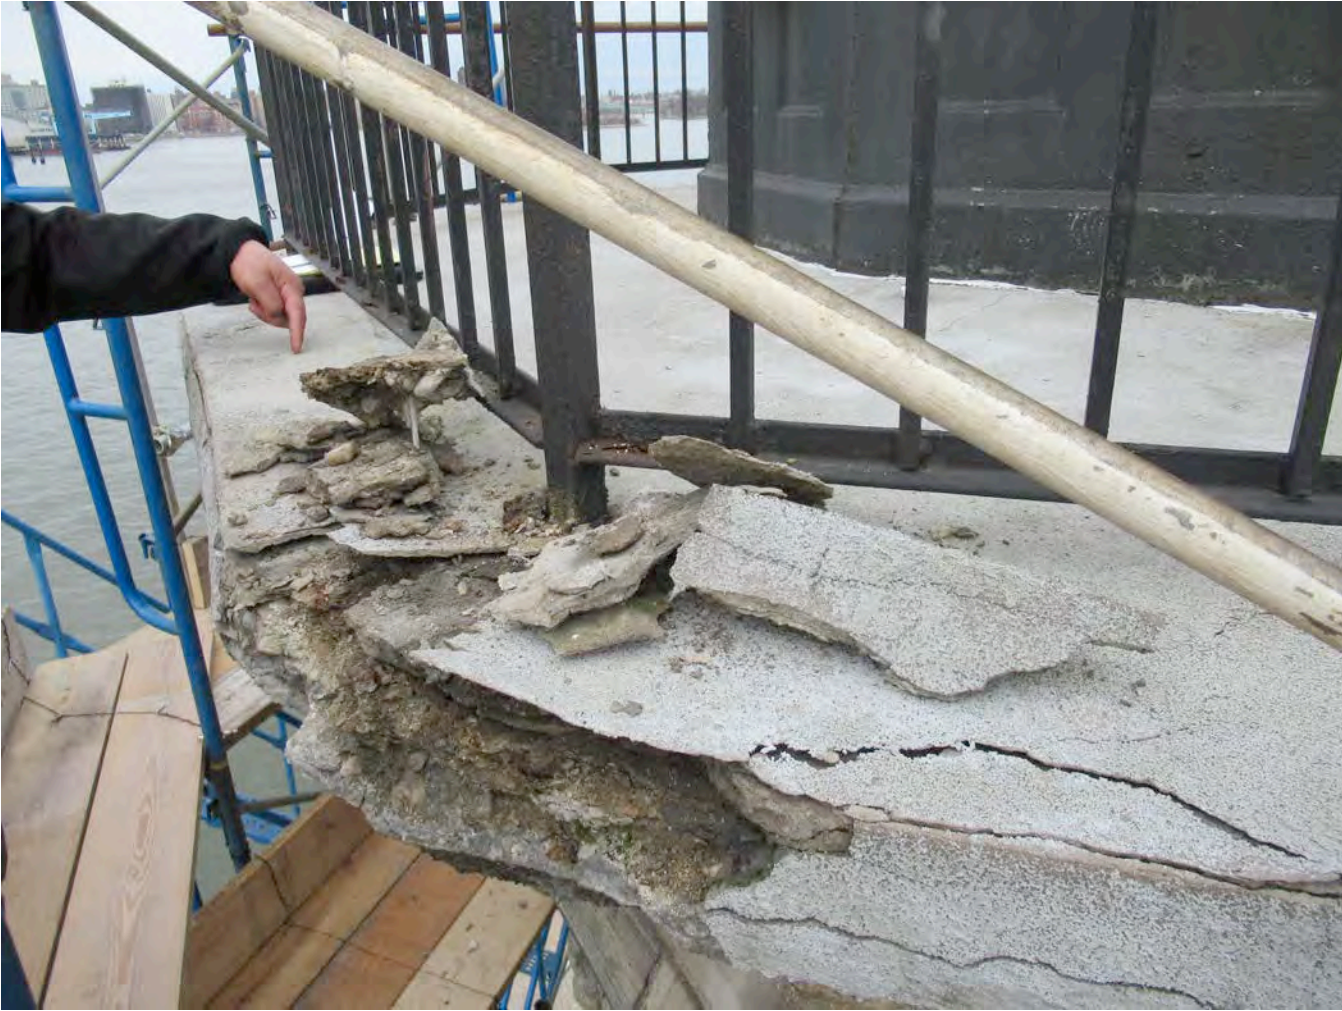
14 SEVERELY CRACKED, SPALLED CONCRETE & DELAMINATED TRAFFIC SURFACE OBSERVATION DECK

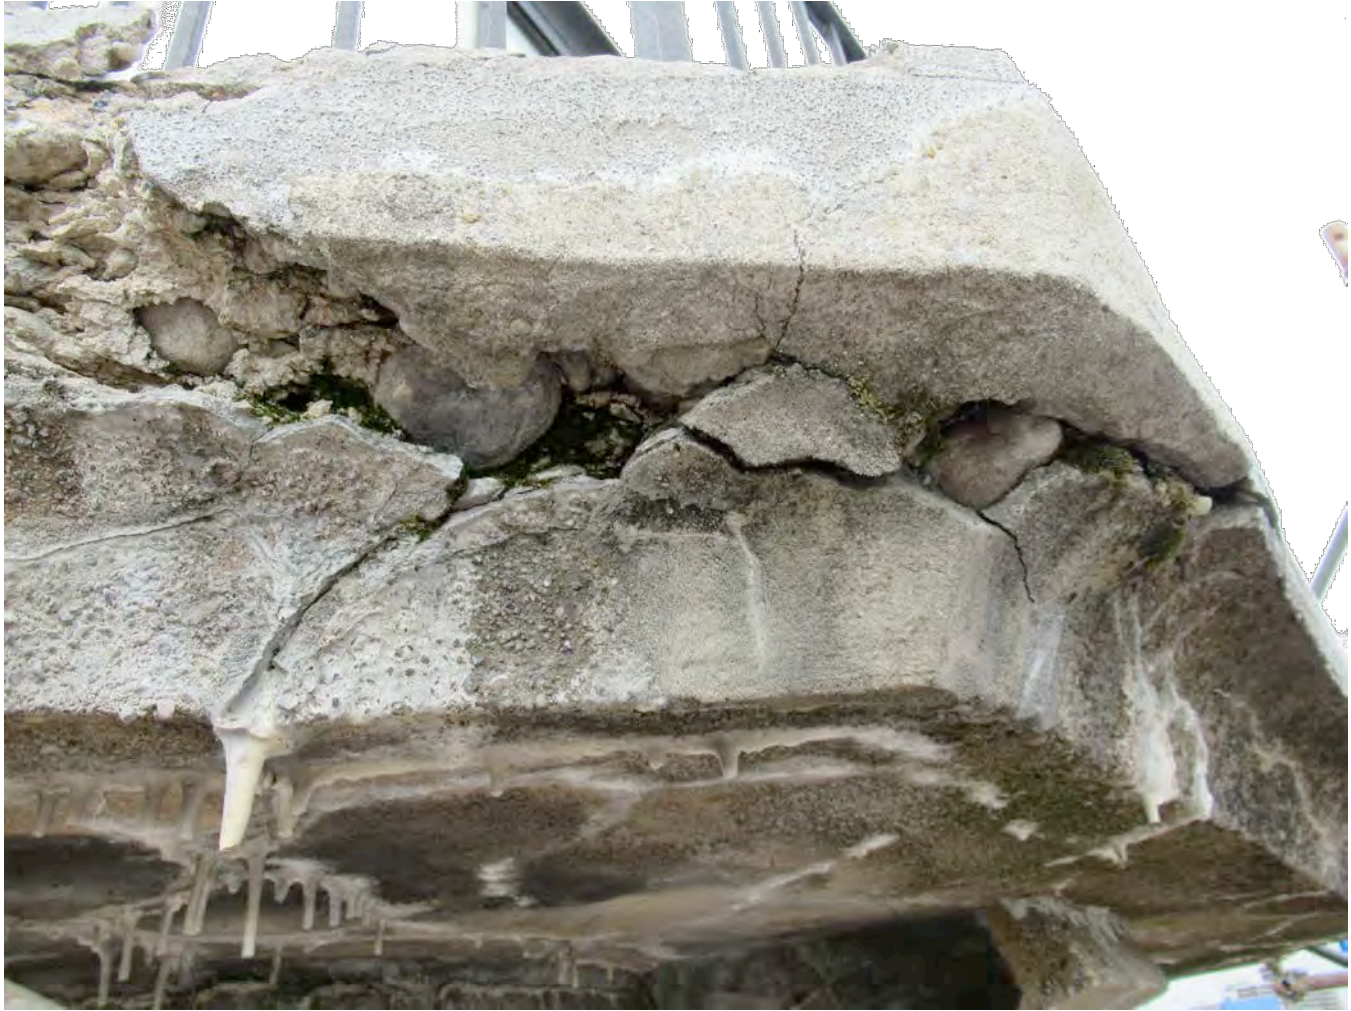
15 DETERIORATED MASONRY MORTAR JOINTS OBSERVATION DECK

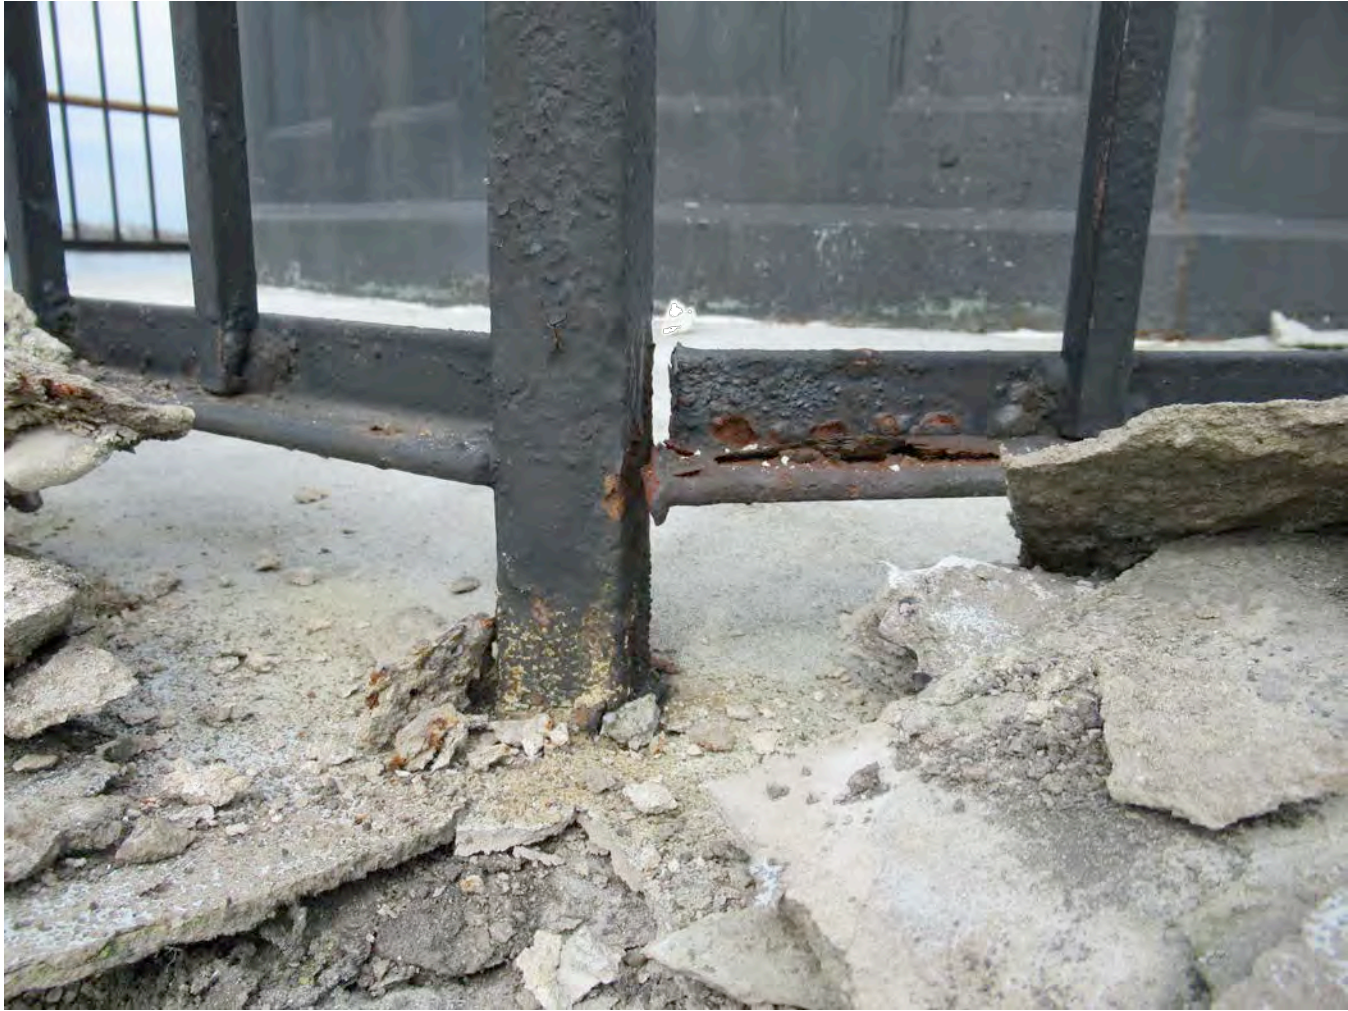
16 PAINT FAILURE, CORROSION OF UNDERLYING METAL & CONNECTION FAILURE METAL RAILING
