Americas Society
Historic Restoration including
Roofing Replacement & Façade Repair
680 Park Avenue
New York, NY 10065

680 Park Avenue – Upper East Side Historic District
Historic Restoration / Façade Repairs & Roofing Replacement

**End
of
Presentation
for
Community Board 8 Manhattan
Landmarks Committee Presentation
HISTORIC RESTORATION including
ROOFING REPLACEMENT & FAÇADE REPAIRS at
Americas Society
680 Park Avenue
New York, NY 10065
6/15/2020**

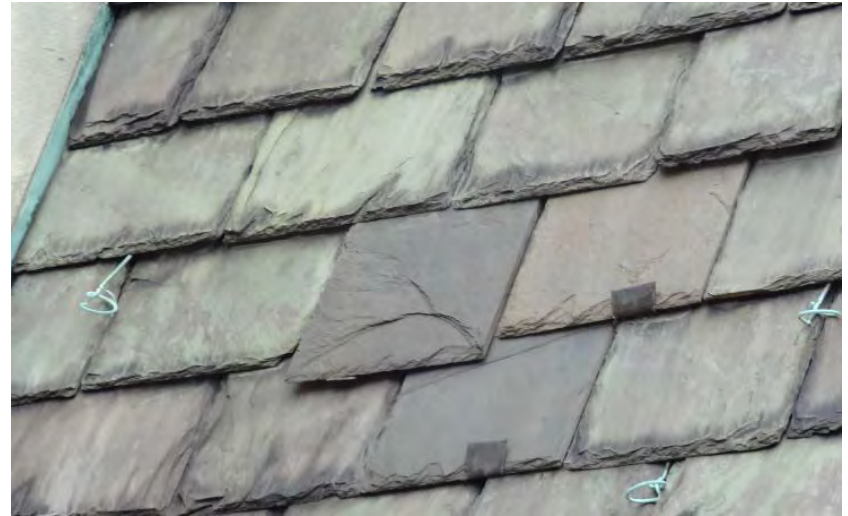
Loose Slate Tiles

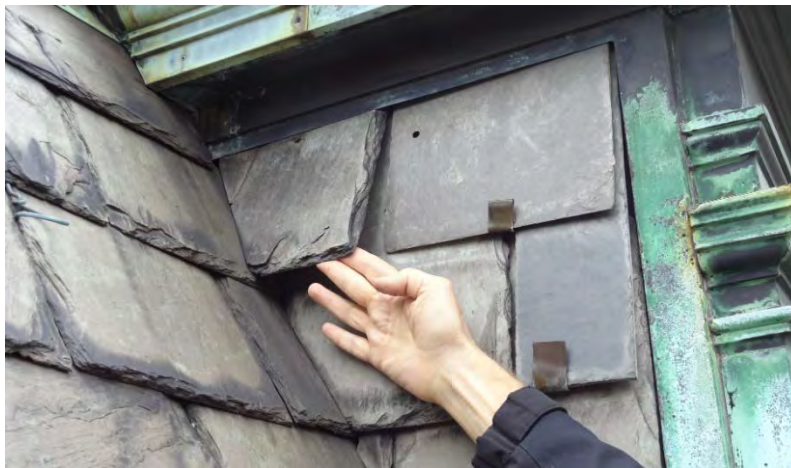
Loose Slate Tiles

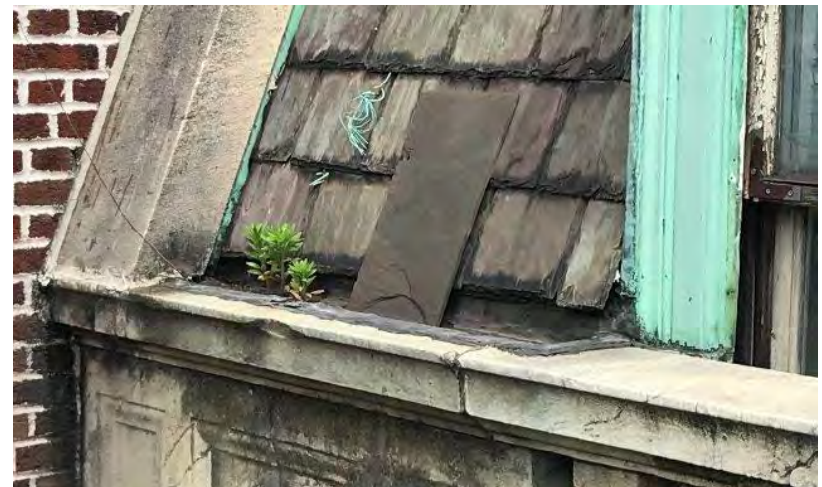
Slate tile fallen off & resting along stone balustrade

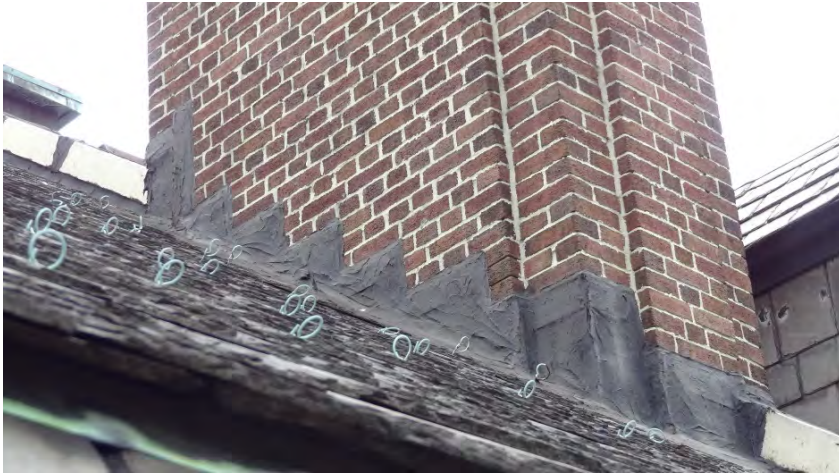
Leaking Roof at NE Chimney – Copper Step Flashing covered in Tar

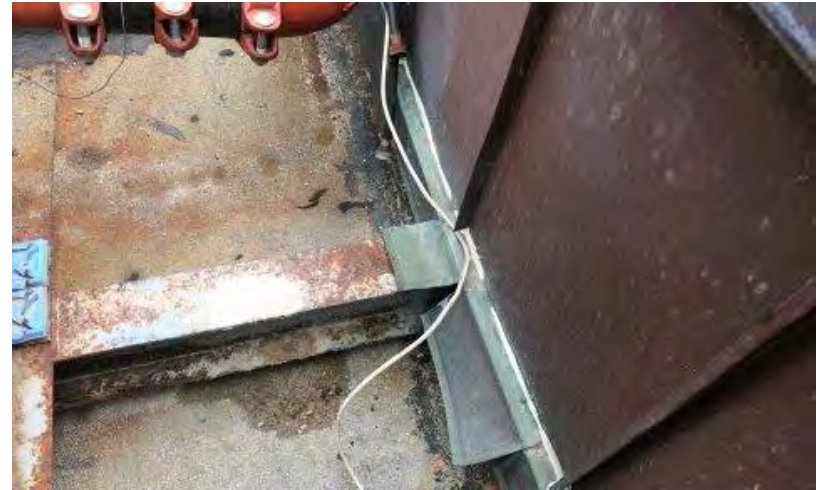
Rusted Damaged Beams at Mechanical Roof

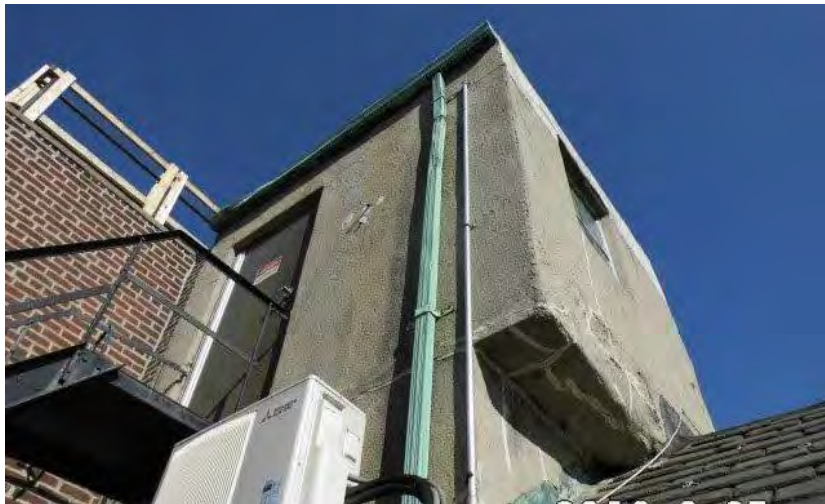
Caulked Cracked Stucco at West & South Walls of Elevator Bulkhead

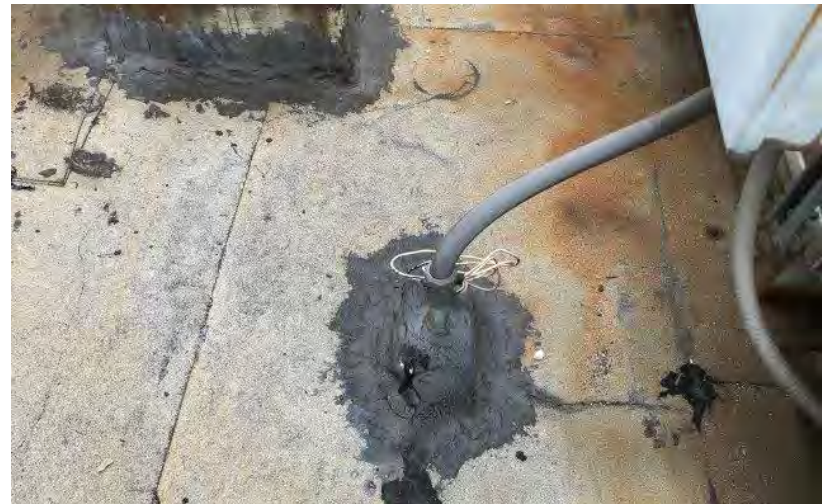
Conduits Penetrated Mechanical Roof

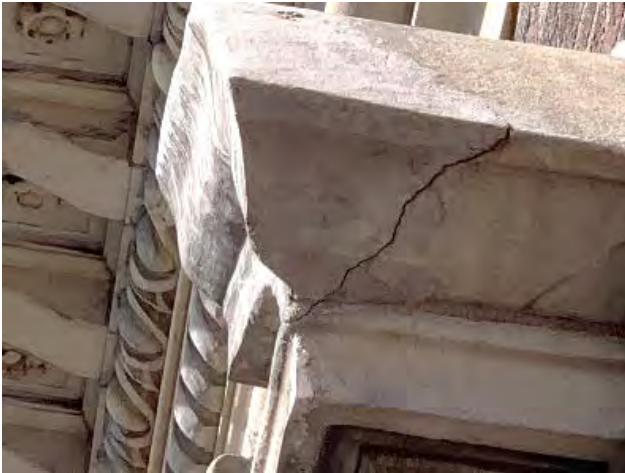
Cracked right corner at previously repaired window pediment at 68th S façade.

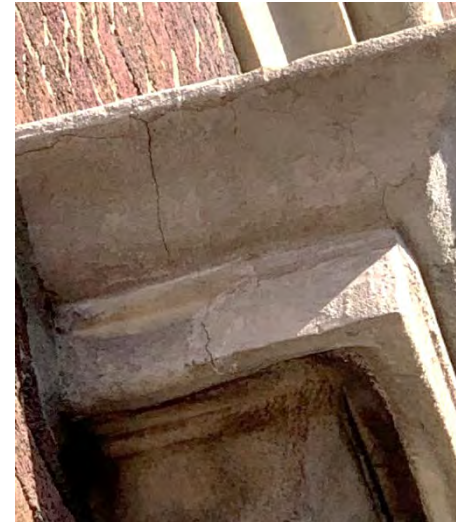
Cracked left side of stone window cornice at 68th Street façade.

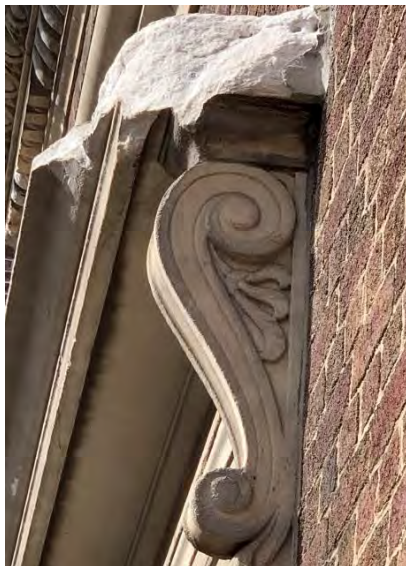
Broken right corner of stone window cornice at 68th Street façade.

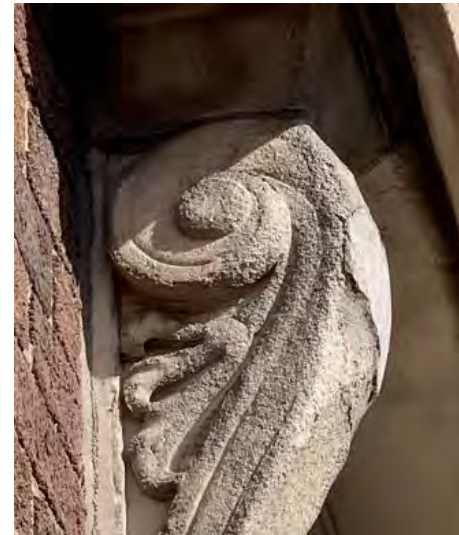
Eroded stone window scrolls at 68th Street façade.

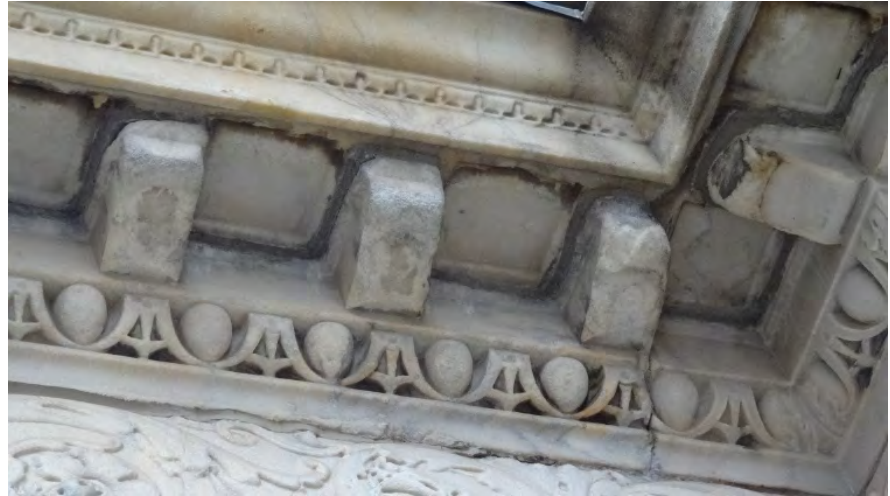
Severely eroded marble dentils at underside of portico cornice.

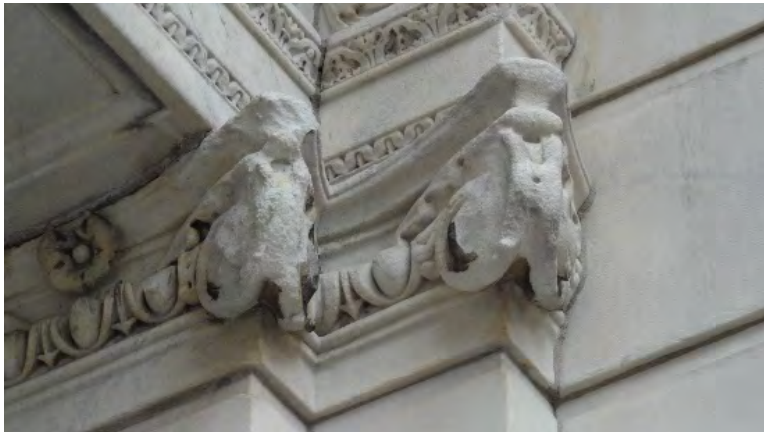
Severely eroded marble capitals at portico's left and right pilasters.

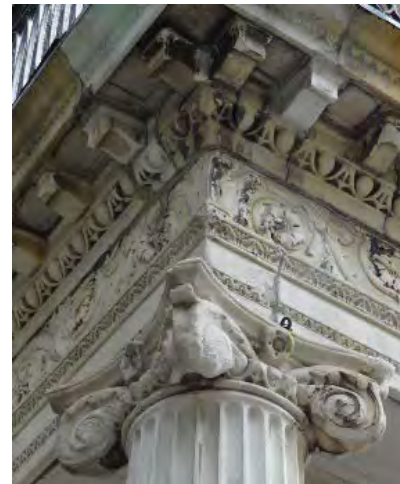
Severely eroded marble capitals at portico's left & right columns.

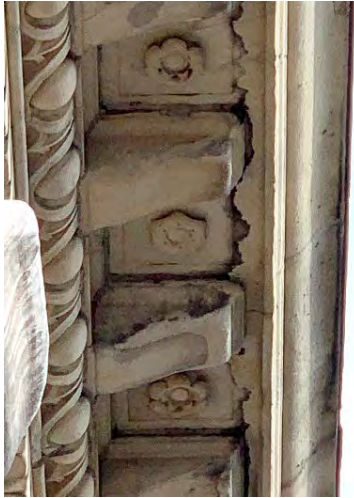
Severely eroded/deteriorated brackets at underside of top cornice.

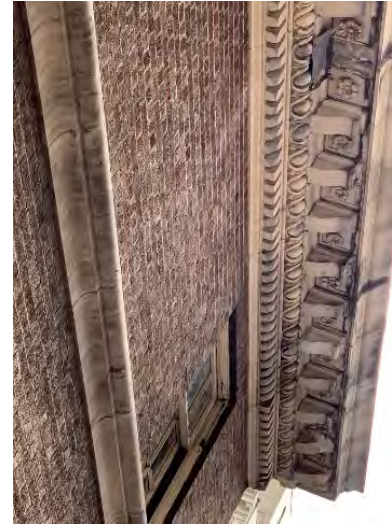
Severely eroded/deteriorated dentils at underside of top cornice.

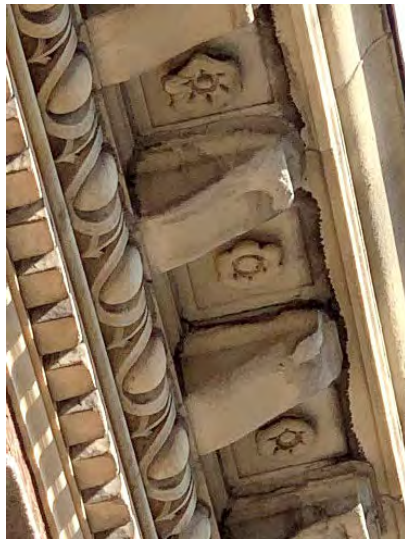
Severely eroded/deteriorated brackets at underside of top cornice.

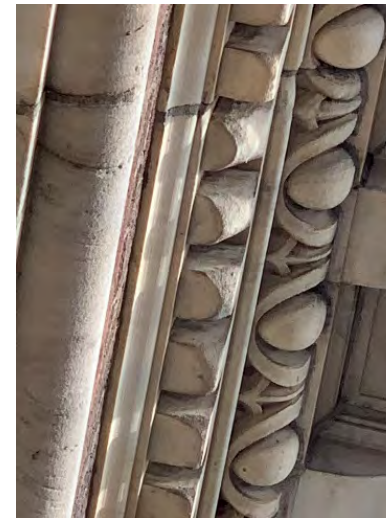
Severely eroded/deteriorated dentils at underside of top cornice.

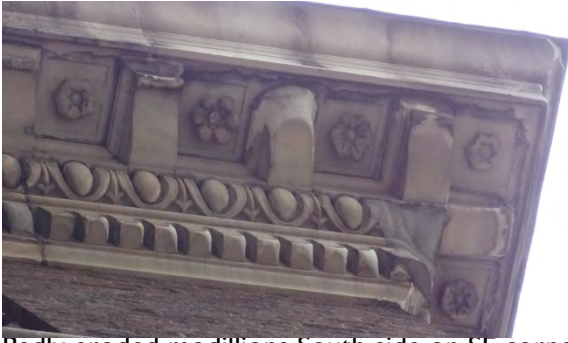
Badly eroded modillions South side on SE corner of cornice.

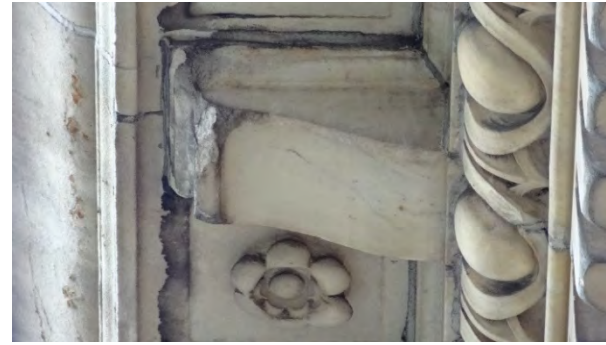
Typical eroded Modillion at cornice

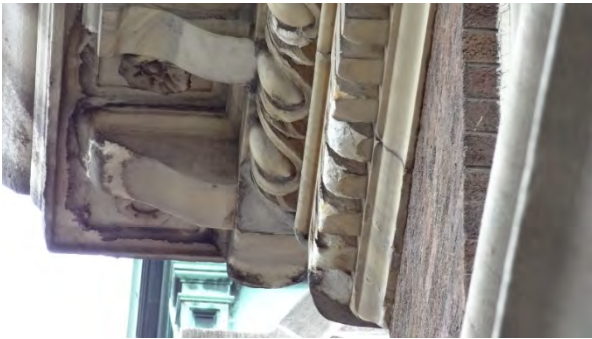
Badly eroded modillions East side on SE corner of cornice.

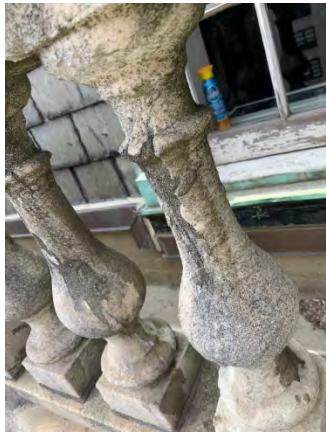
Severely eroded and deteriorated balusters at roof balustrade.

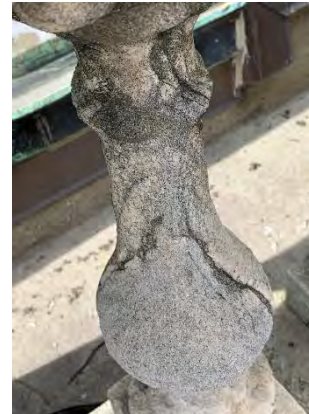
Severely eroded and deteriorated balusters at roof balustrade.

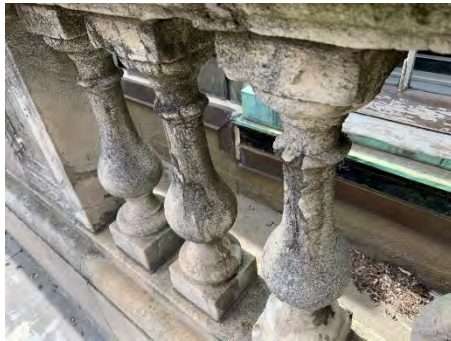
Severely eroded and deteriorated balusters at roof balustrade.

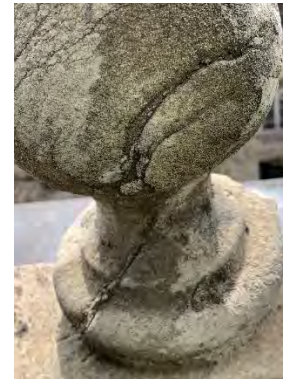
Severely eroded and deteriorated balusters at roof balustrade.

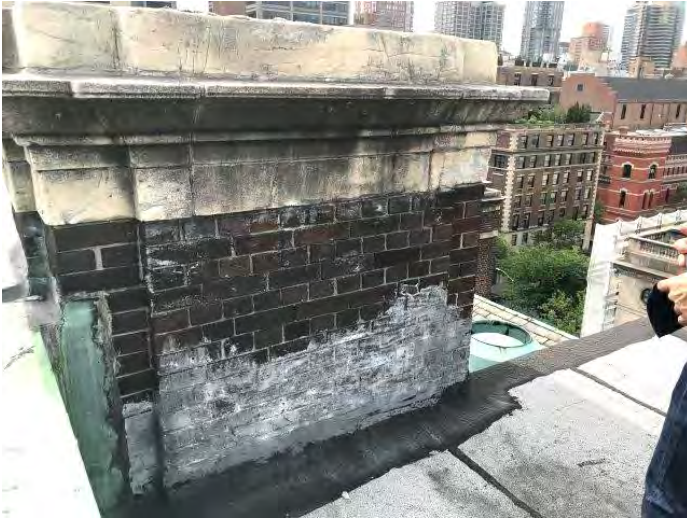
Tarred west face of chimney on east side of elevator bulkhead roof

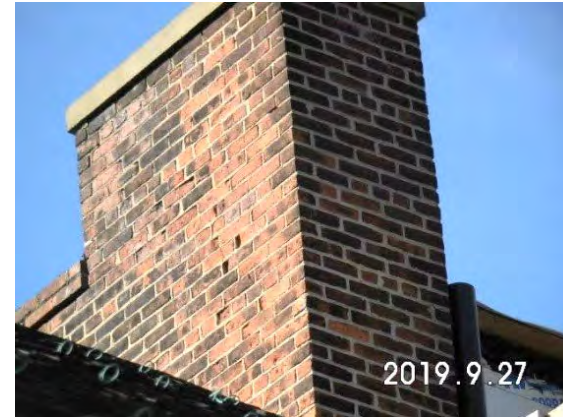
Delaminated brickwork on south face of NE party wall parapet

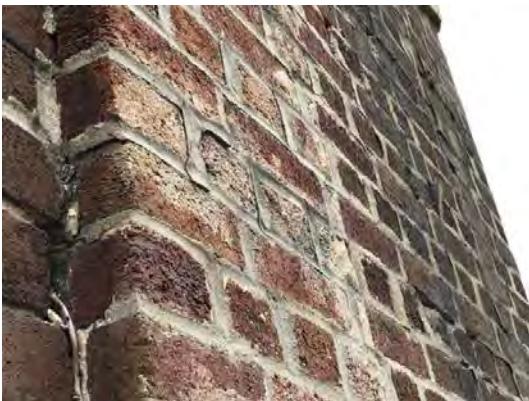
Eroded brickwork and efflorescence at chimney

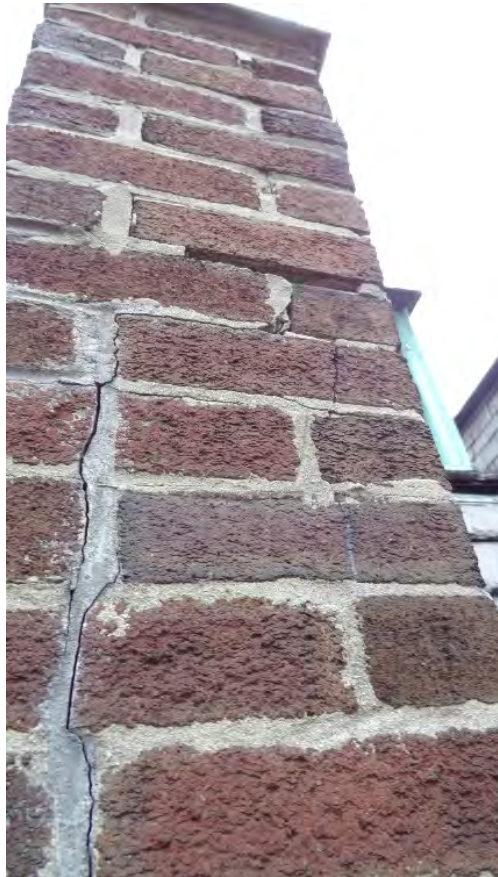
Cracked parapet at NE corner of setback roof

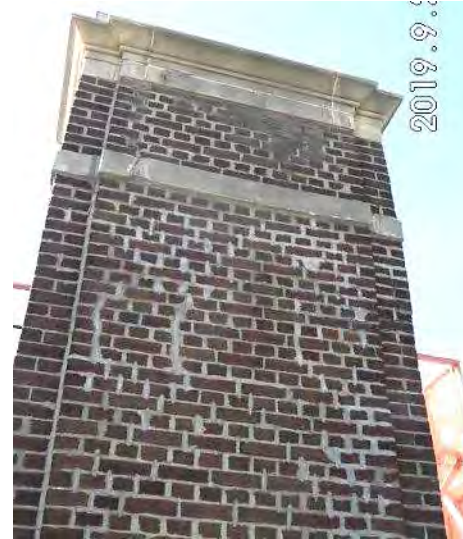
Cracks at chimney

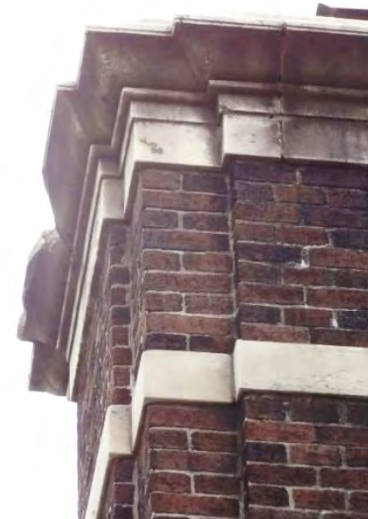
Deteriorated chimney capstone
