## **829 MADISON AVENUE**

PRESENTATION TO THE  
LANDMARKS PRESERVATION COMMISSION

OCTOBER 27, 2022

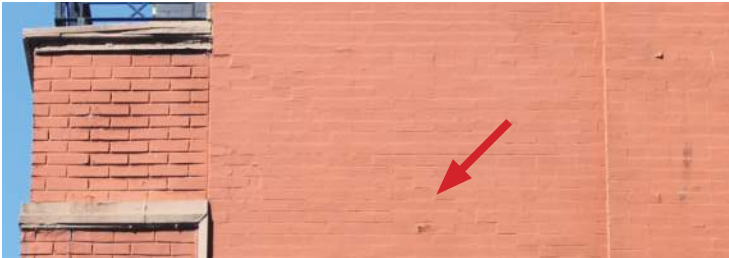
**Description:**  
Areas with visible misalignment or separation of brick masonry units.

SOUTH ELEVATION: Brick displacement observed at SW corner.

- B-CR:**
- Proposed treatments:**
1. After paint removal, investigate brick surfaces for cracks or misalignments previously concealed by paint coating.
  2. Consult with Structural Engineer.
  3. Allow for brick replacement at cracked areas.

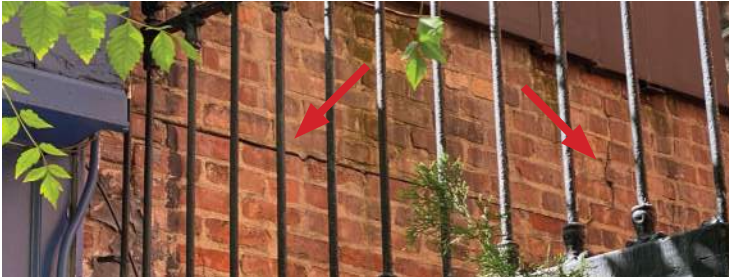
EAST ELEVATION: Cracked mortar observed on SE corner.

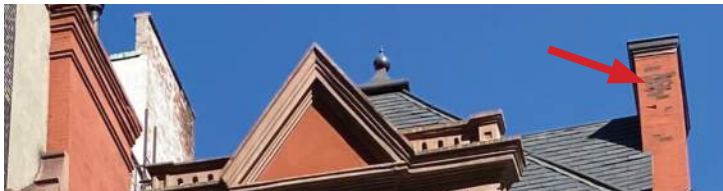
**Description:**  
Areas with visible separation of the paint coating from brick masonry surfaces. Peeling paint is commonly caused by incompatibility with the substrate, presence of moisture behind the paint or by disaggregation of the substrate.

WEST ELEVATION: Peeling paint at brick..

- B-PL:**
- Proposed treatments:**
1. Remove all existing paint coatings using chemical paint removers designed for use on historic brick.
  2. Clean exposed brick surfaces and survey for damaged bricks or missing mortar which were previously concealed by paint coatings.
  3. Replace cracked or damaged bricks with new bricks to match existing.
  4. Repoint open or damaged mortar at joints with new mortar to match existing.
  5. Provide mineral silicate coating designed for use on porous, historic masonry, may be considered in a color approved by LPC.

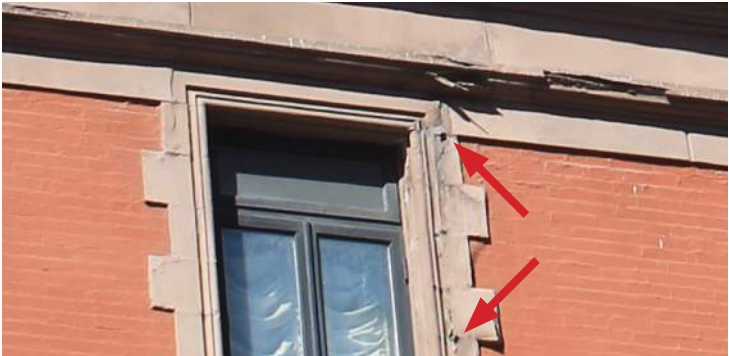
NORTH ELEVATION: Crack at granite unit.

- B-PL:**
- Proposed treatments:**
1. Remove all existing paint coatings using chemical paint removers designed for use on natural sandstone.
  2. Clean exposed stone surfaces.
  3. Survey for cracks, incipient spalls or missing mortar which were previously concealed by paint coatings; and provide repairs.
  4. Repoint open or damaged mortar at joints with new mortar to match existing.
  5. If loss of profile is extensive under removed paint coatings, a mineral silicate patch repair, Dutchman repair or full unit replacement will be required.

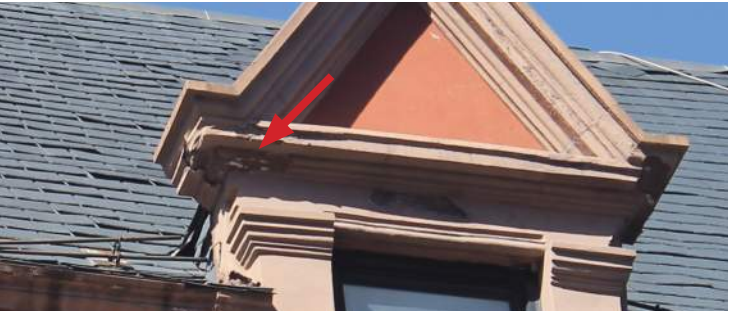
**Description:**  
Loss at a localized section of stone resulting in a change of original profile. Spalls may be caused by several factors including corrosion jacking or impact, etc.

SOUTH ELEVATION: Spall at sandstone cornice at dormer window.

- Proposed treatments:**
1. Less than 1/2" in depth - tool to sound stone.
  2. 1/2" to 2" in depth - Survey area for signs of displacement.
    - If unit is not displaced, patch with a cementitious, vapor-permeable, mineral-based mortar formulated for patching exterior, non-polished stone in a color to match existing surrounding stone.
  3. 2" in depth or greater - Survey area for signs of displacement.
    - If unit is not displaced, install a Dutchman repair with stone material to match surrounding in type, color, texture, etc.
  4. Loss greater than 25% of unit - provide full unit replacement.

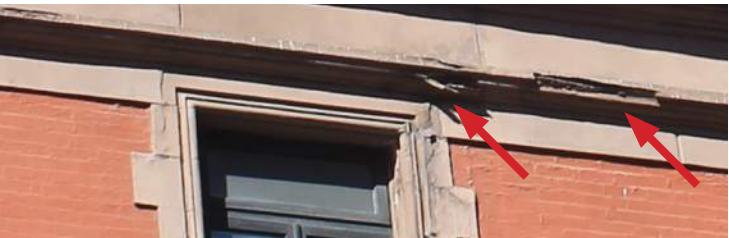
SOUTH ELEVATION: Spalls at sandstone cornice above 3rd floor window.

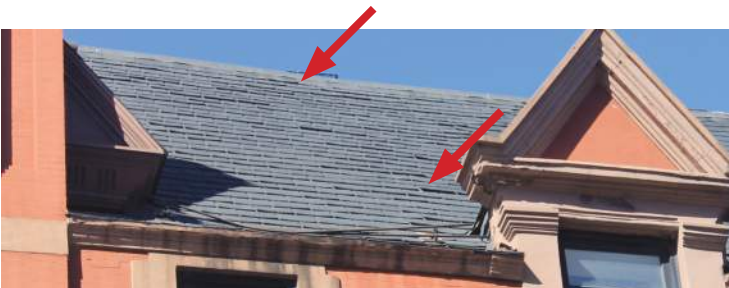
**Description:**  
Several deteriorated roof elements were observed during our visit, including: Warped composite roof tiles, evidence of water infiltration, etc.

SOUTH ELEVATION: Displaced composite tiles.

- Proposed treatments:**
- 1. Remove deteriorated materials.
  - 2. Remove and replace roof drain(s) at flat roofs. New drains to match existing.
  - 3. Provide new resin roof system at flat portions of roof.
  - 4. Provide replacement faux slate roof tiles at pitched roof, including all relevant underlayment and associated flashings.
  - 5. ALT - Investigate existing roof assembly, flashing and drainage. Provide localized roof repair(s) to address existing water infiltration.

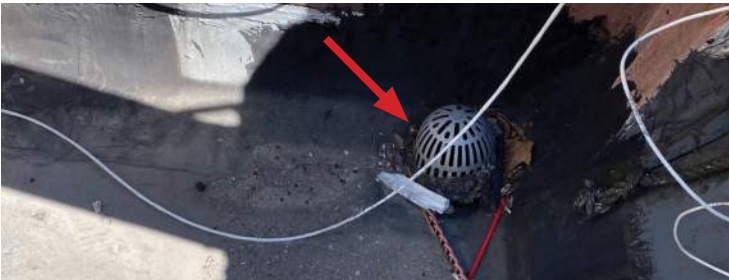
TYP. EXISTING ROOF DRAIN TO BE REPLACED AT FLAT ROOFS.

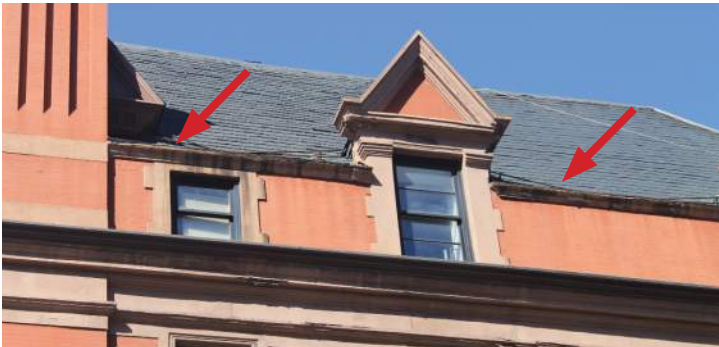
**Description:**  
Existing snow guards at edge of roof along south facade appear bent and damaged when observing from street level.

DAMAGED EXG SNOW GUARDS AT SOUTH FACADE

- Proposed treatments:**
- 1. Provide new snow guards to match existing in material, profile, location, etc.

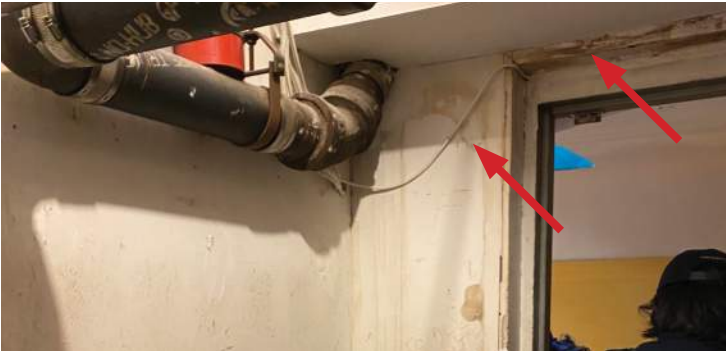
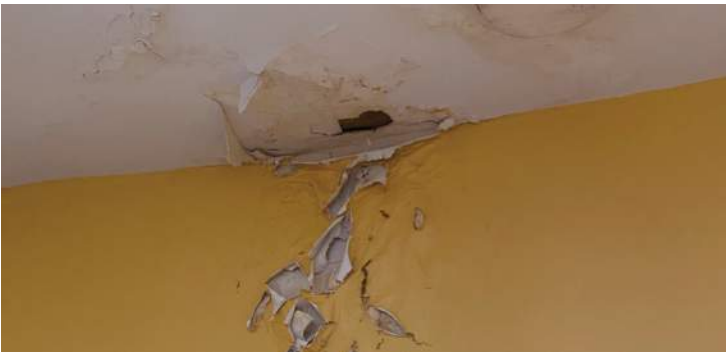
**Description:**  
Significant loss, staining, efflorescence, cracks or other conditions which may arise from contact with water.

PLASTER WALL AT ROOF STAIR LANDING: Deteriorated plaster due to water infiltration.

- Proposed treatments:**
- 1. Investigate source of water infiltration and address. Sources may include but are not limited to, failing roofing material, corrosion at windows, deteriorated facade masonry, etc.
  - 2. Repair leak. Remove damaged plaster, provide new plaster to match existing, prime and paint.

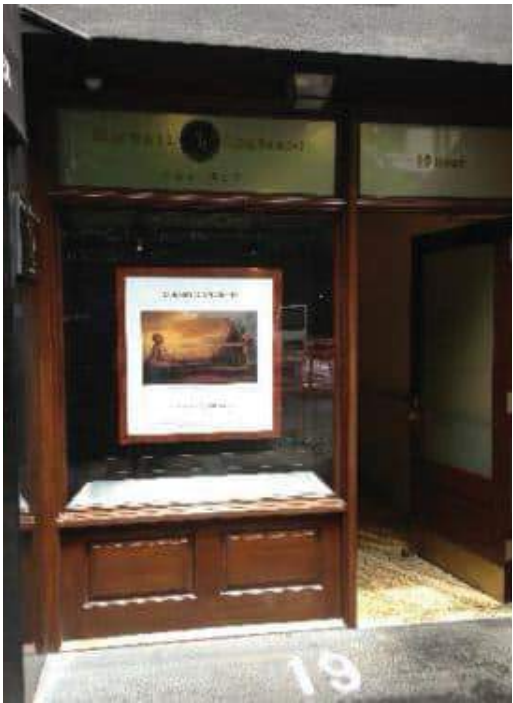
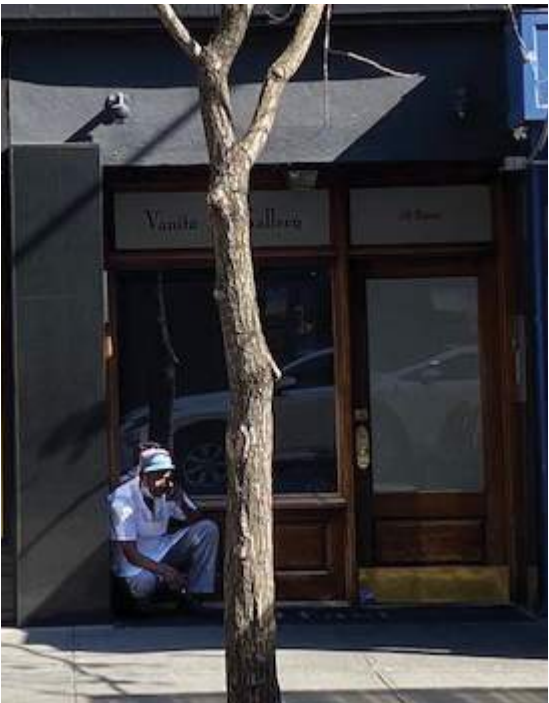
VIOLATION **03-0101** (31-July-2002)  
Replacement of 2nd eastern-most East 69th Street shopfront (Michail Lombardo Gallery) without permit(s)

PREVIOUS MICHAEL LOMBARDO GALLERY  
ENTRANCE STOREFRONT (FROM FACEBOOK)

CURRENT VANITA GALLERY (LOCATED AT 3RD FL )  
ENTRANCE STOREFRONT

**Proposed Solution:** Existing storefront to be revised and reviewed by LPC.

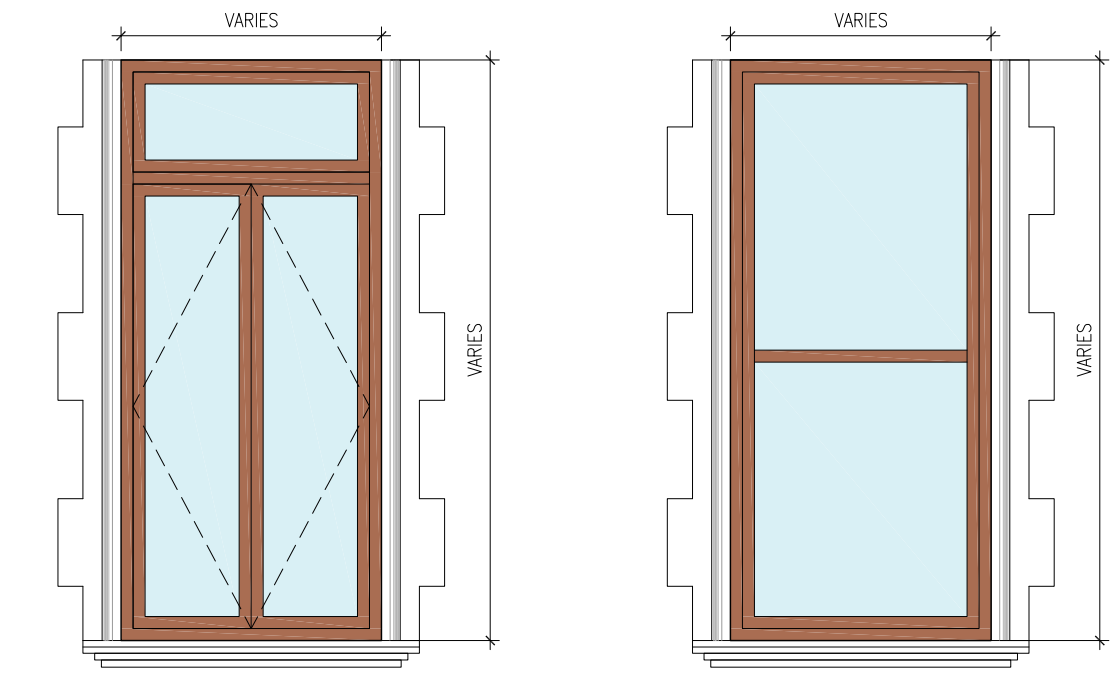
VIOLATION **03-0103**: (31-July-2002)  
Replacement of 3rd and 4th floor windows without permit(s). All the casement windows on these floors to be replaced with the historic one-over-one double hung window with historic profile brickmold.

EXISTING CASEMENT WINDOWS

**Proposed Solution:** Existing nine casement windows to be replaced with one over one aluminum double hung windows with historic profile brickmold.

EXISTING NINE CASEMENT WINDOWS TO BE REPLACED WITH ONE OVER ONE DOUBLE HUNG WINDOWS WITH HISTORIC PROFILE BRICK MOLD.
