The East River Esplanade

Located on the East River between East 62nd Street and East 125th Street In the borough of Manhattan

July 13, 2017

East River Esplanade Phase I Update

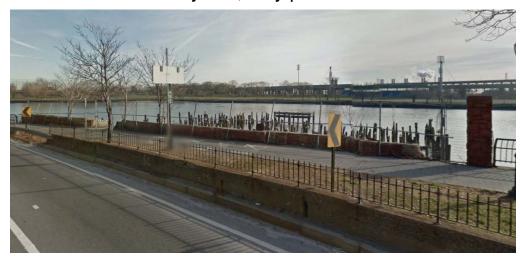
View from FDR Drive Northbound, pre-collapse

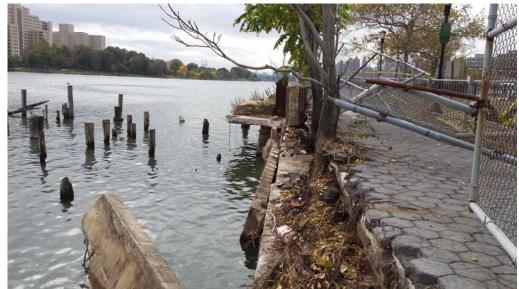
- Partial collapse of concrete pier remains, October 2016
- Some damage to bulkhead and esplanade
- Former factory site, only pier remnants and abandoned utilities remain (DCAS jurisdiction)

Partial collapse and loss of bulkhead
