# 60 East 93rd Street

COMMUNITY BOARD 8 PRESENTATION  
1-9-2023

Steven Harris Architects LLP

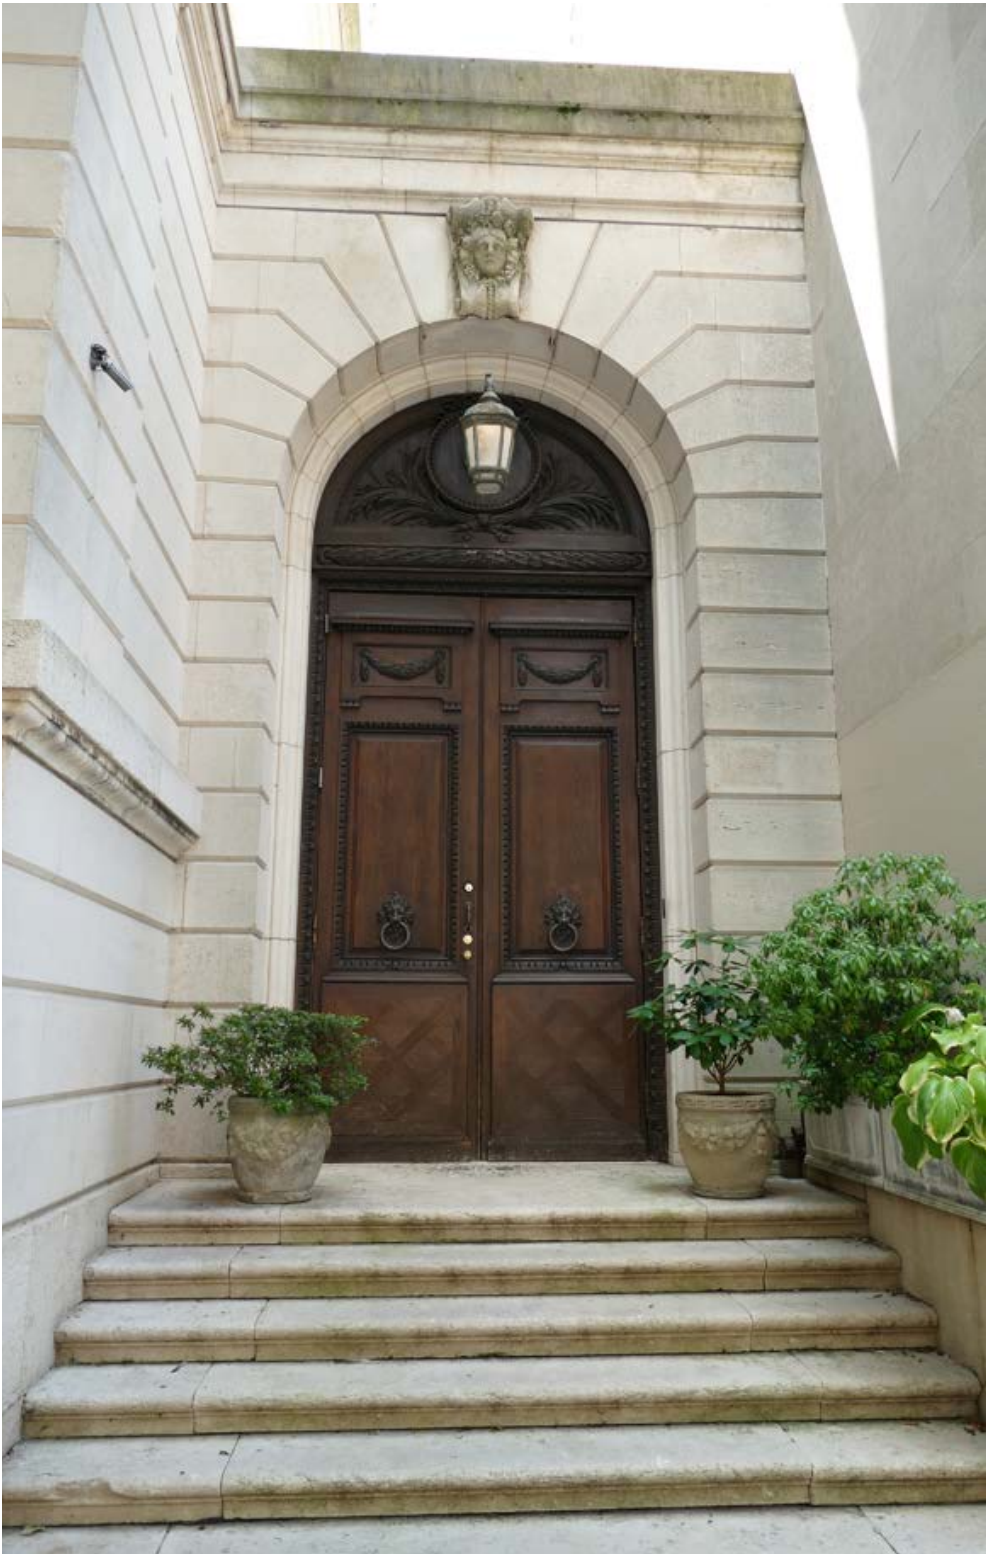
Main entrance. The front entrance door and steps will be restored as part of the preservation scope.

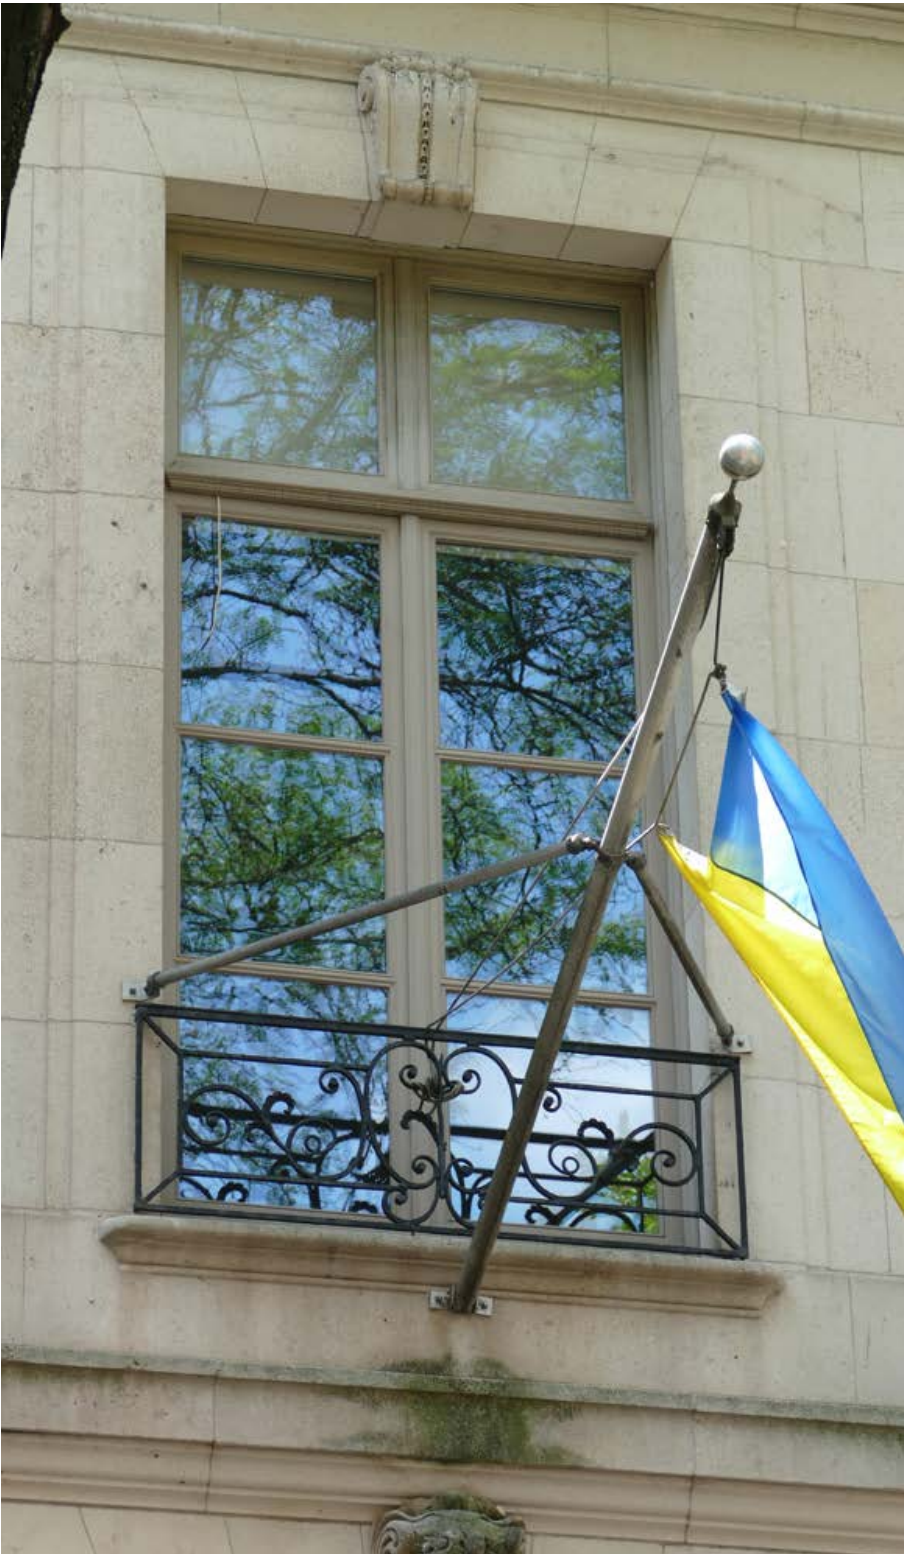
The existing windows at the front facade are retrofitted historic sash with new glazing. The flagpoles will be removed and masonry patched. Biological growth and soiling will be removed.

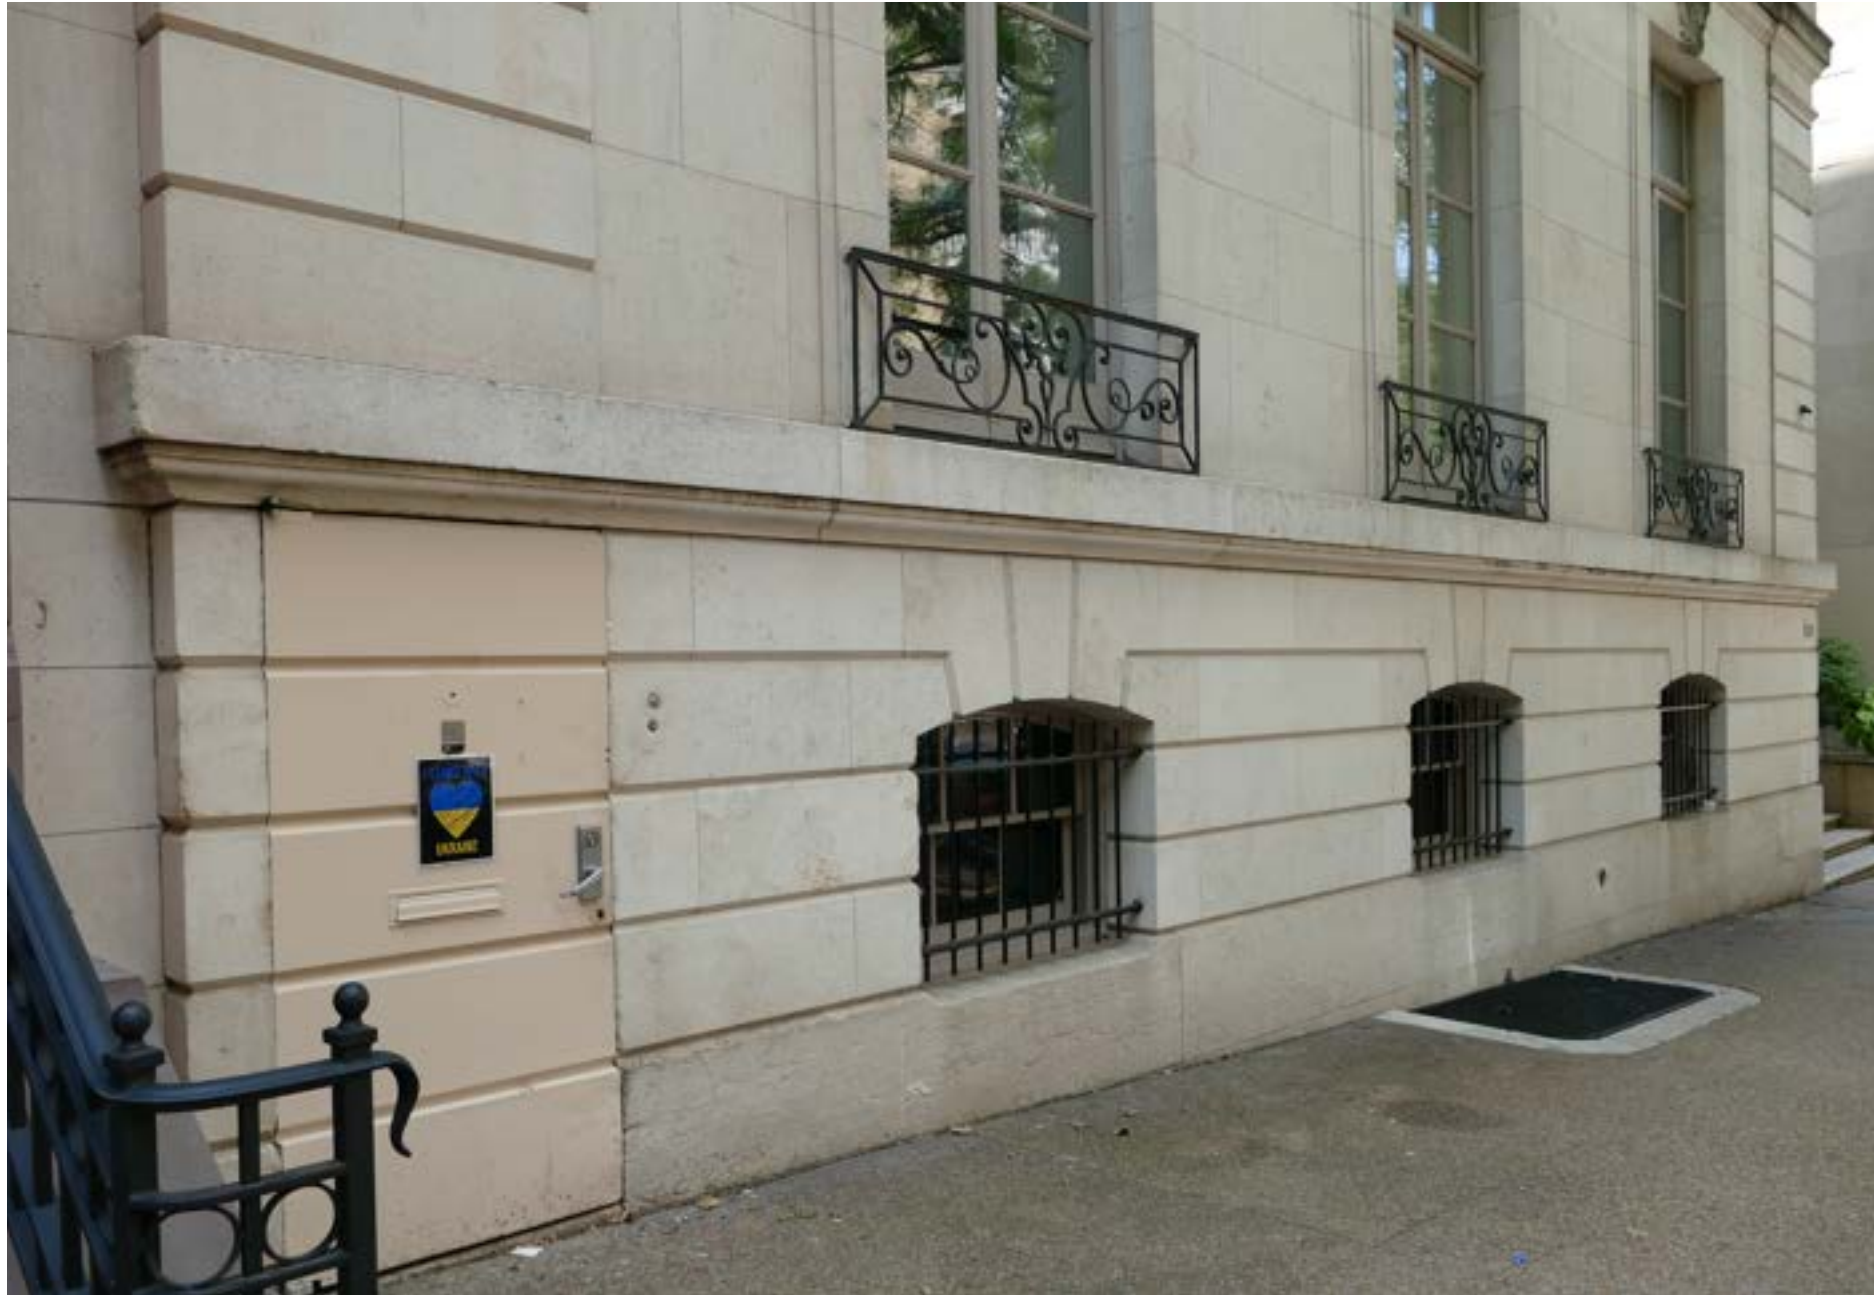
Base of building. The service entrance will be painted to better blend in with the existing masonry.

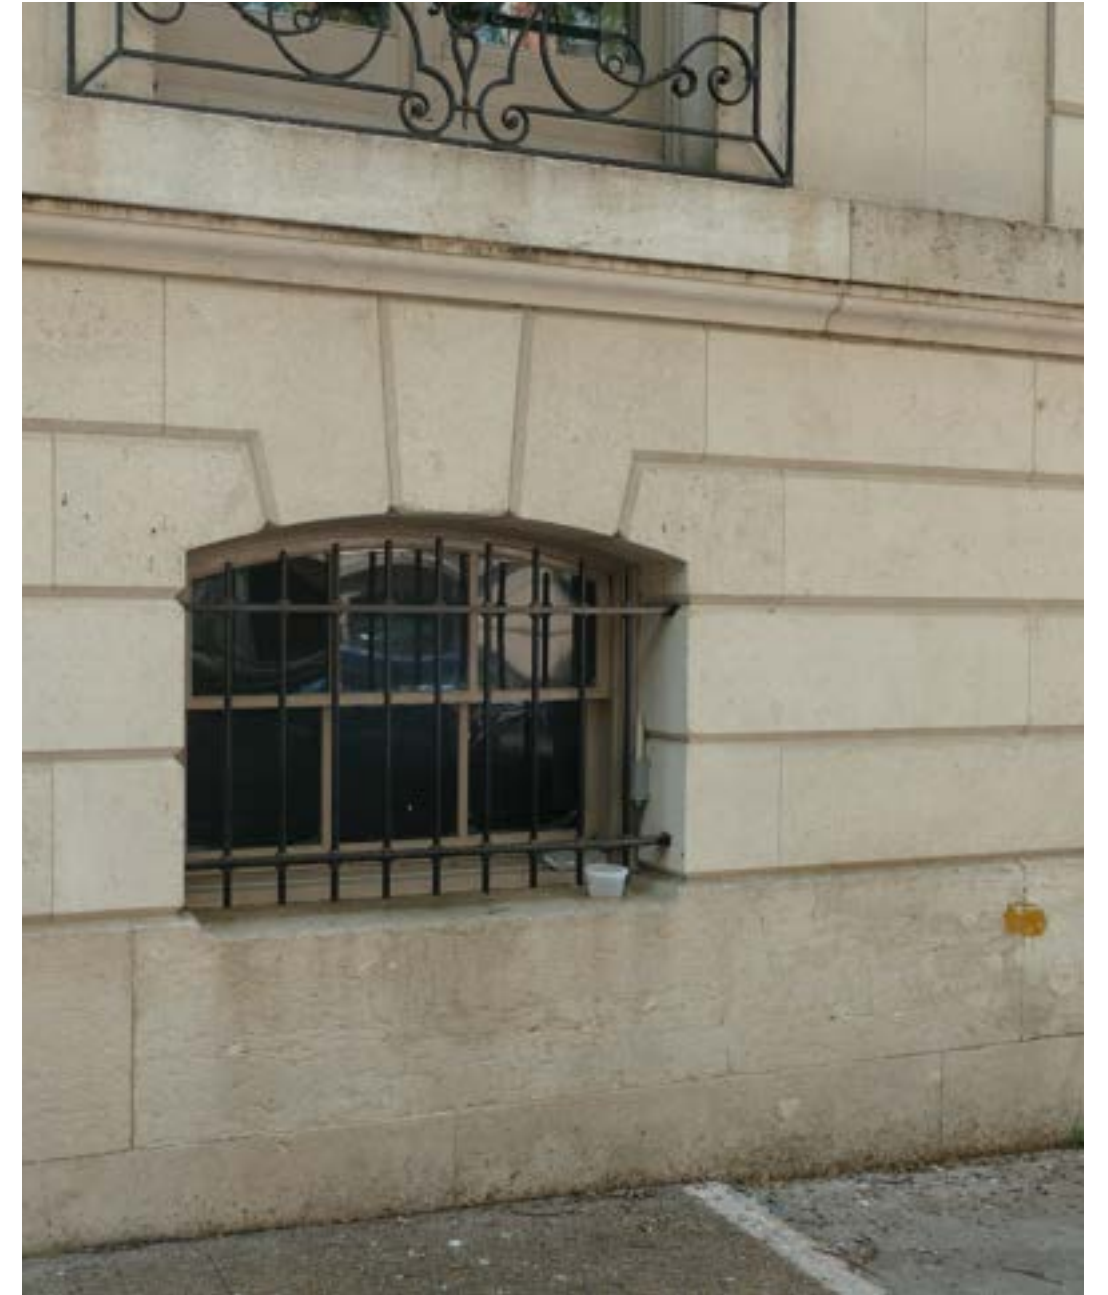
Detail of historic ironwork (to be repaired as necessary) and historic French limestone to be cleaned and repaired.

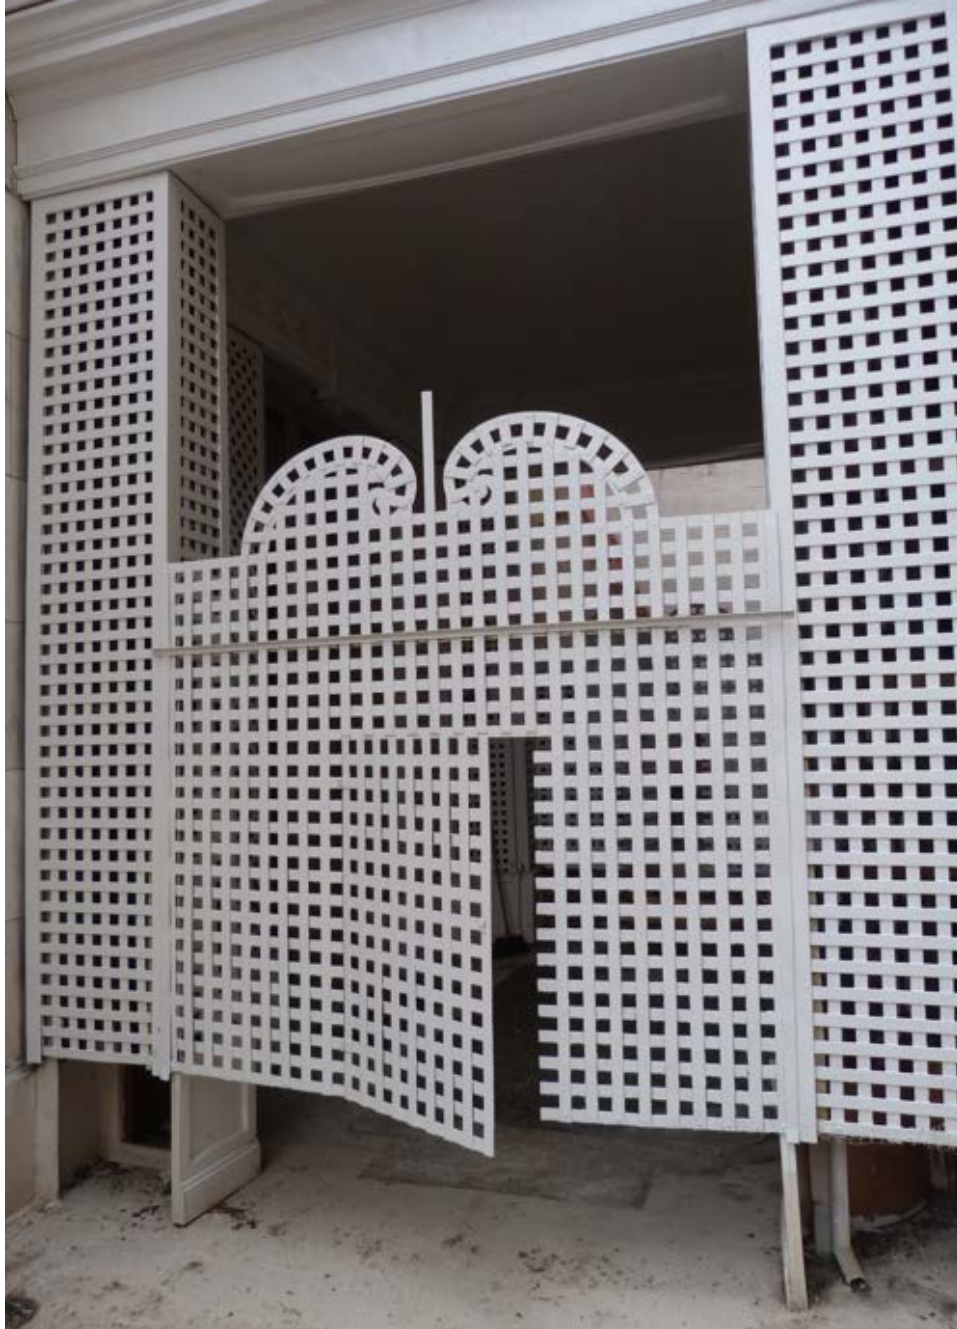
Historic metal to be inspected and repaired as necessary.

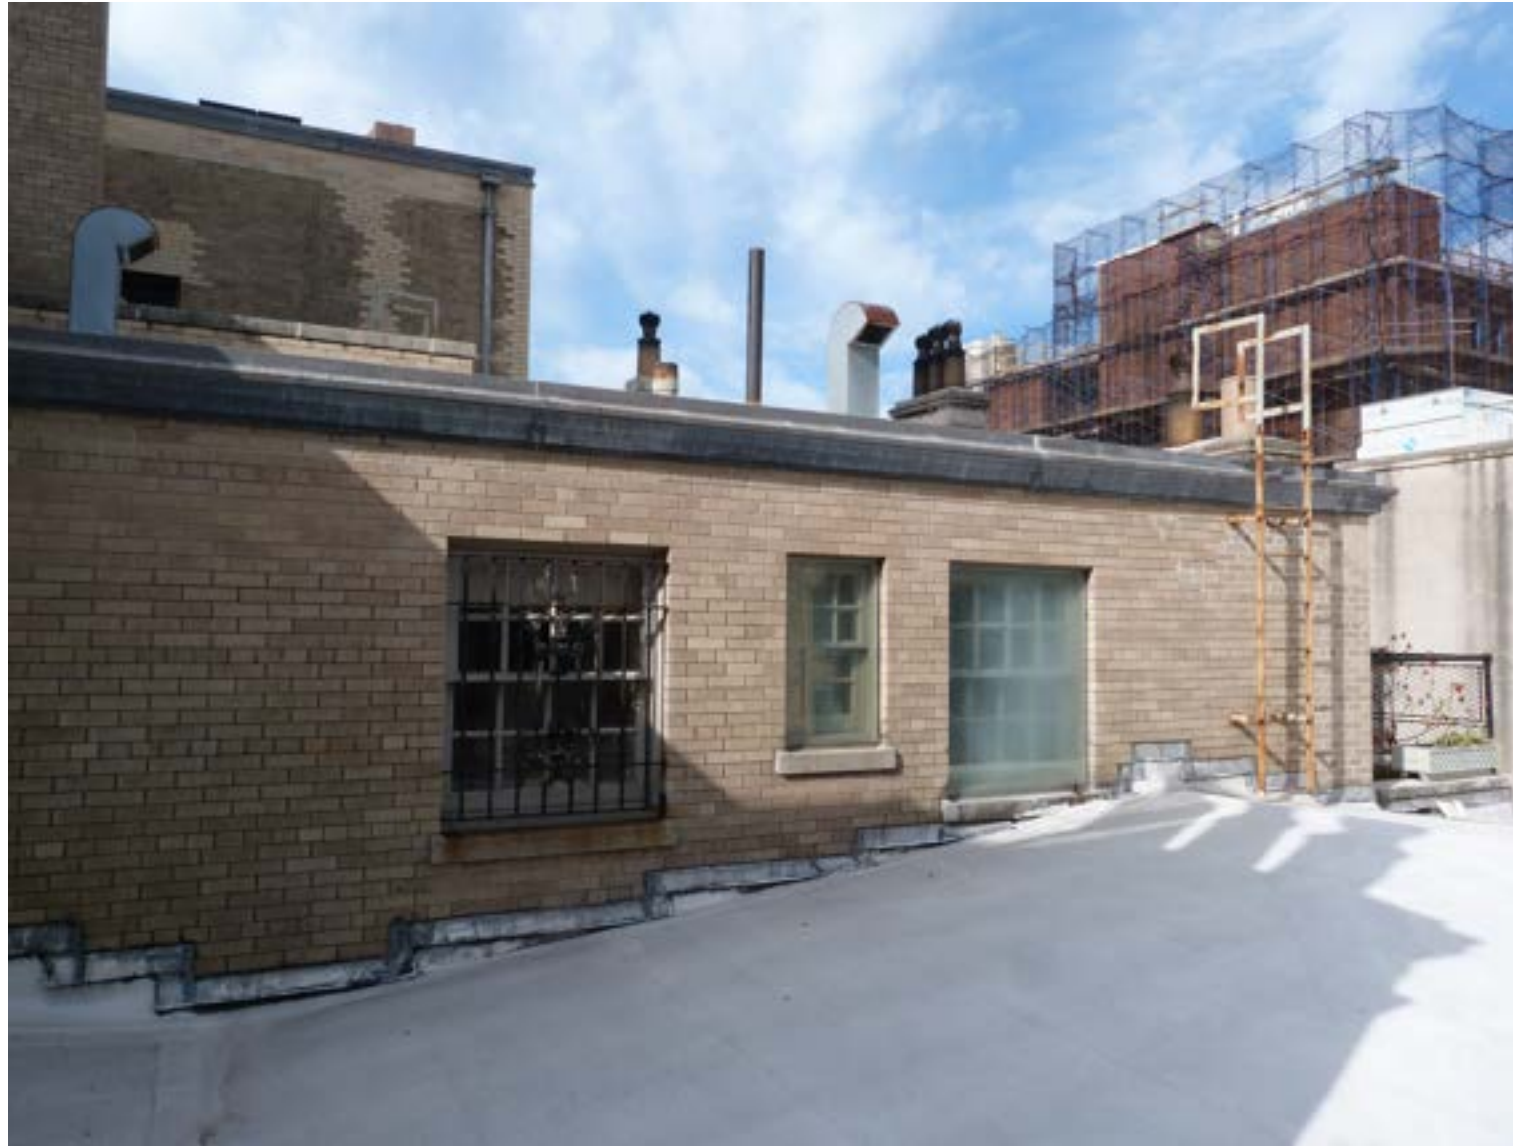
Front elevation of historic penthouse. Non-historic storm windows and grilles will be removed.

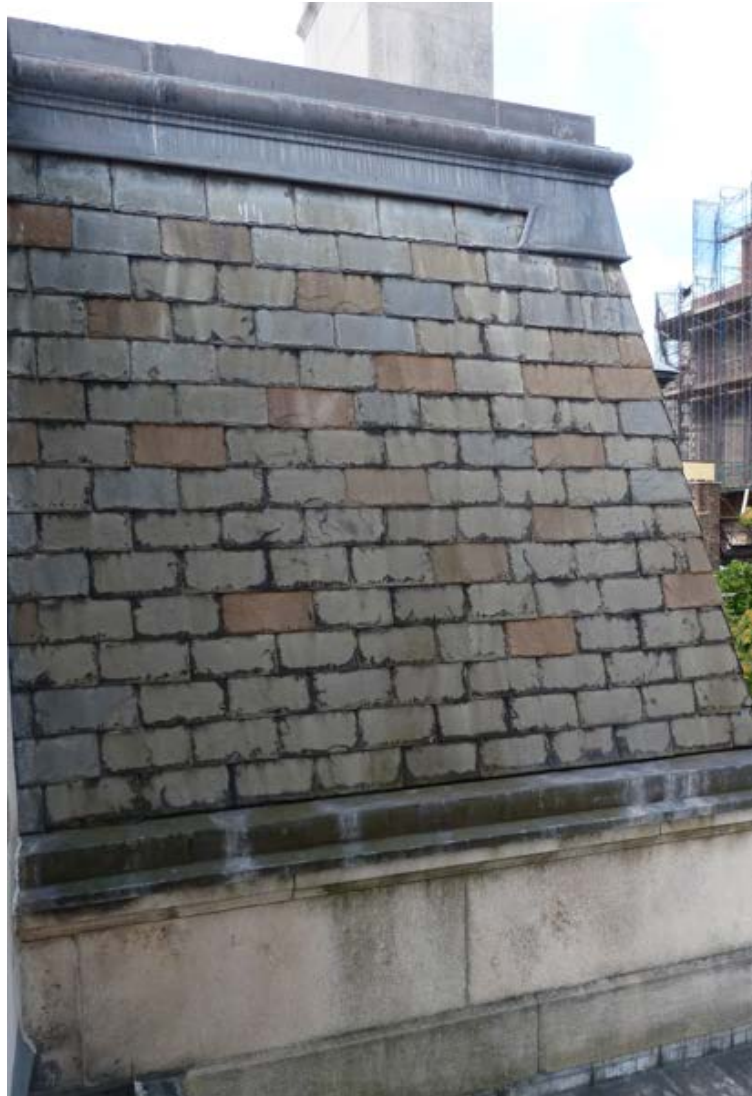
Slate will be repaired or replaced in-kind where necessary.

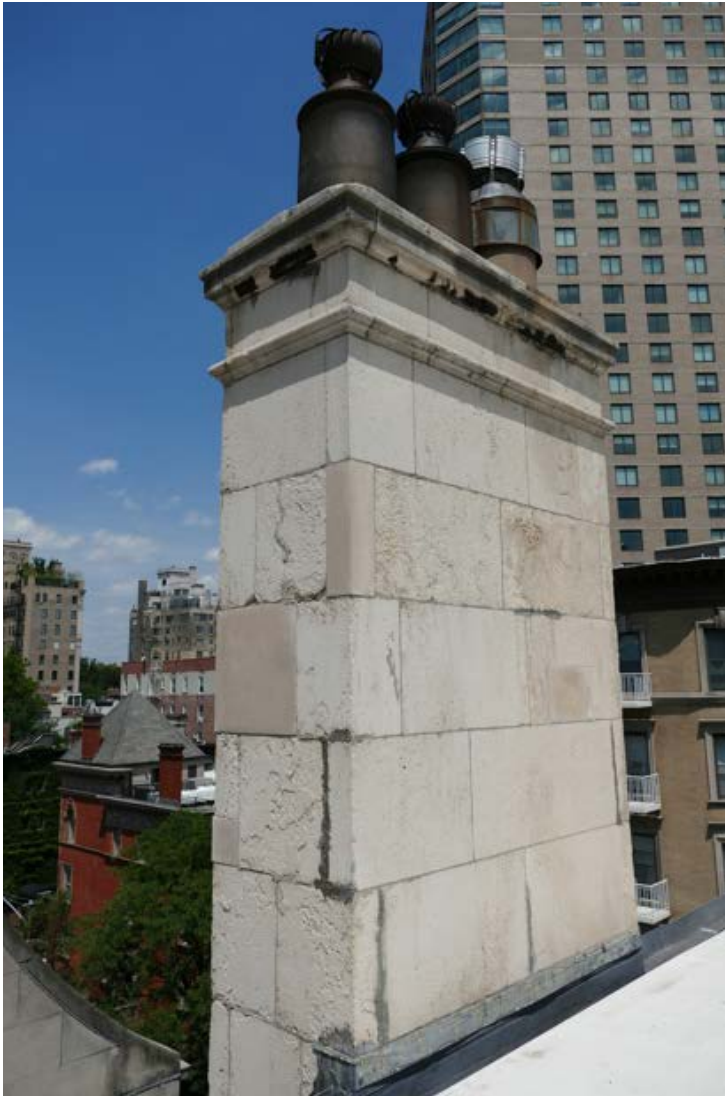
Stone delamination and blackening at chimney. All masonry will be cleaned and repaired.

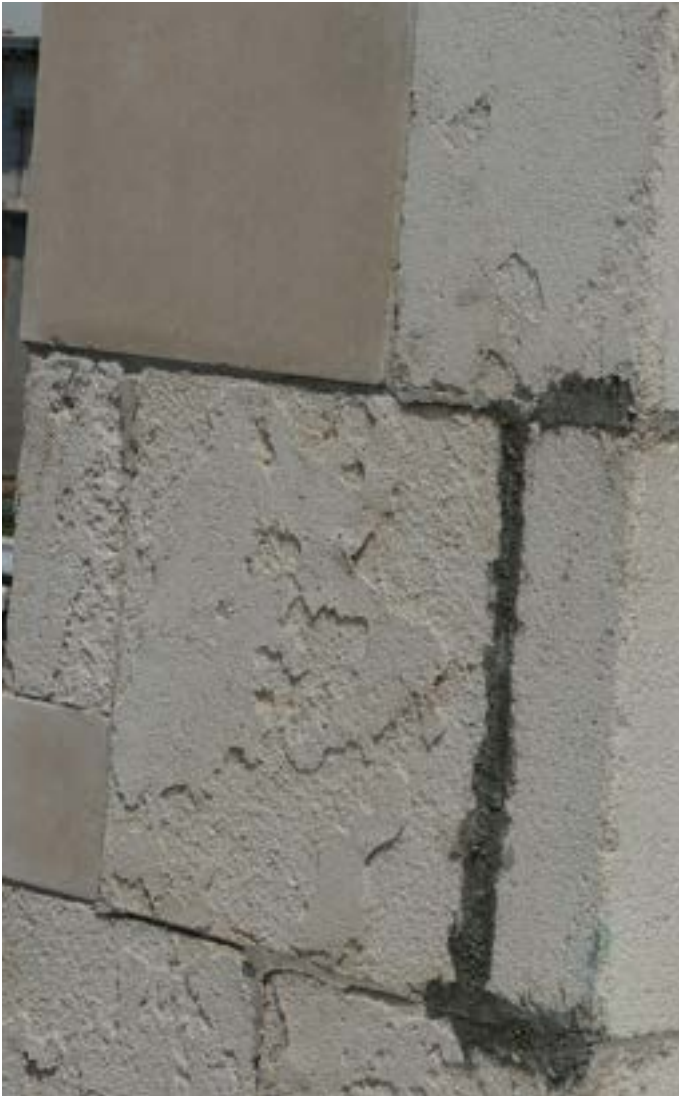
Detail view of stone deterioration at chimney.

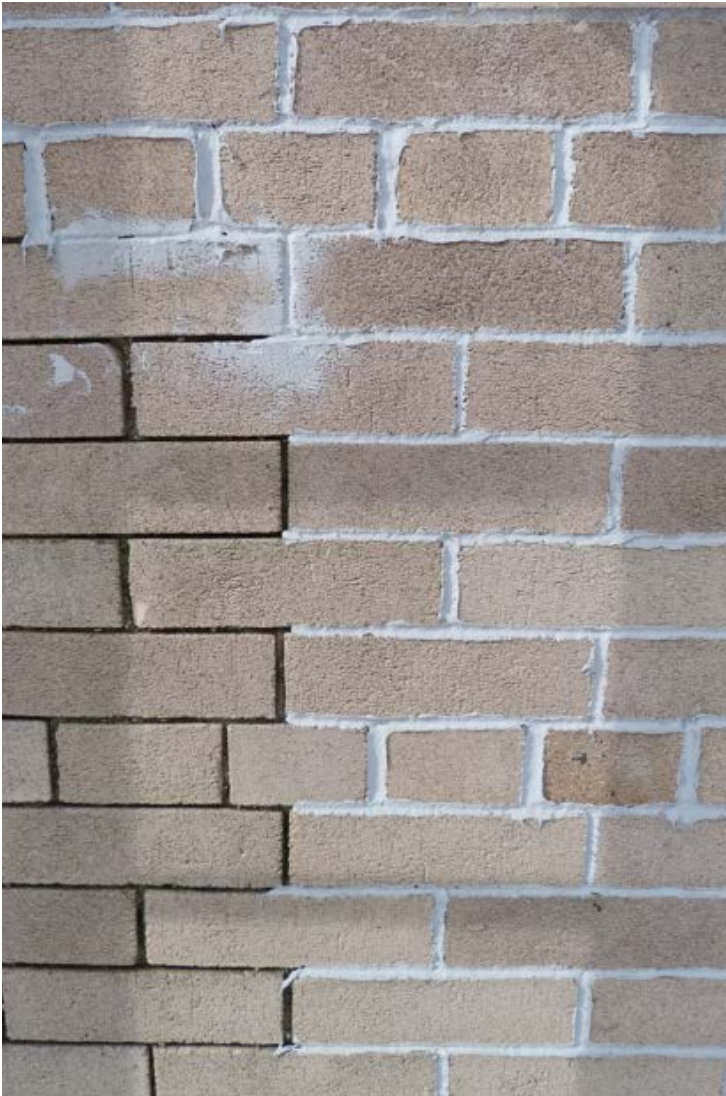
Detail view of poorly done repointing at penthouse elevation.

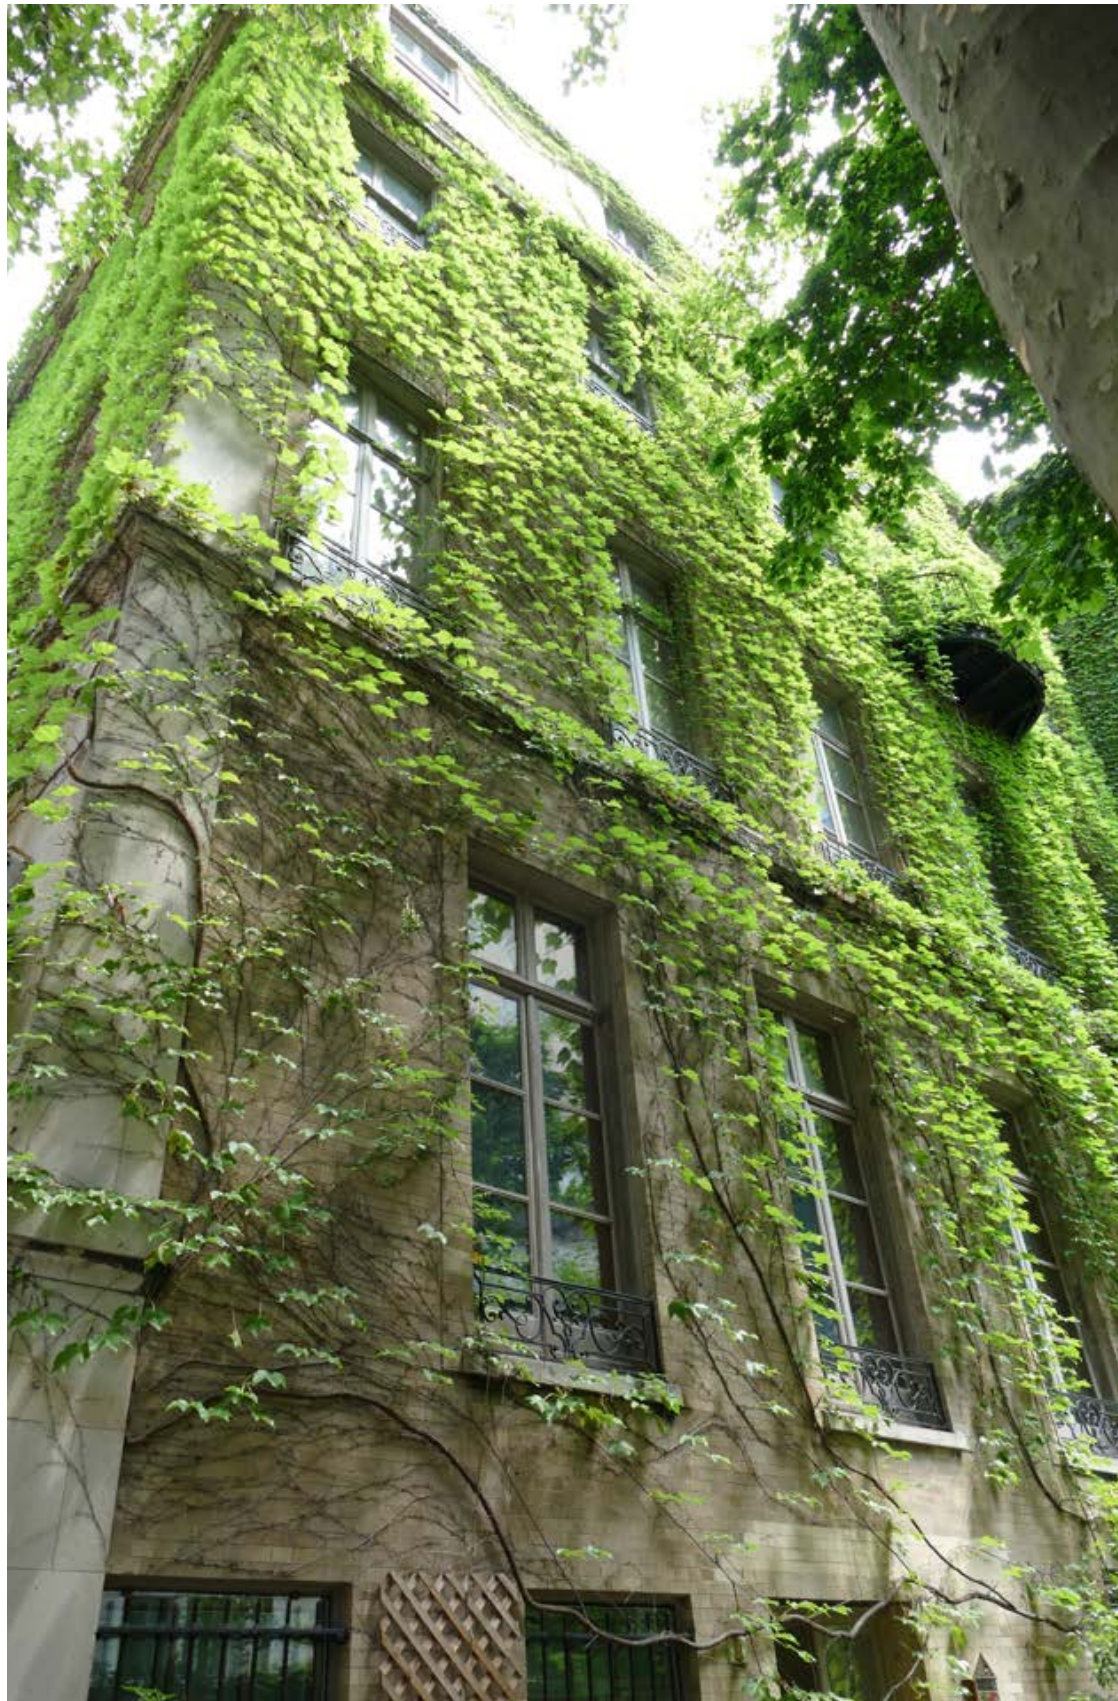
Rear elevation. Vegetation will be removed and the masonry repaired.

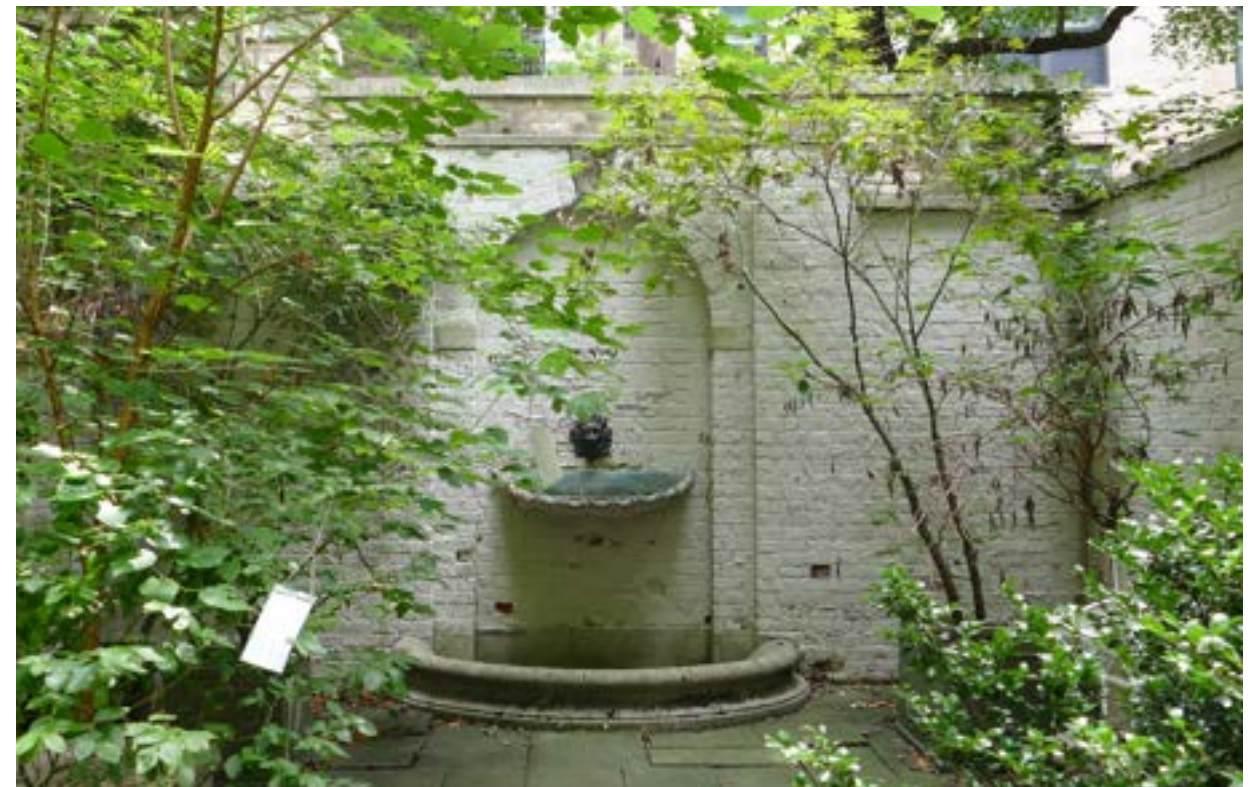
The rear yard brick fence is painted; a historic fountain is located at the eastern end.

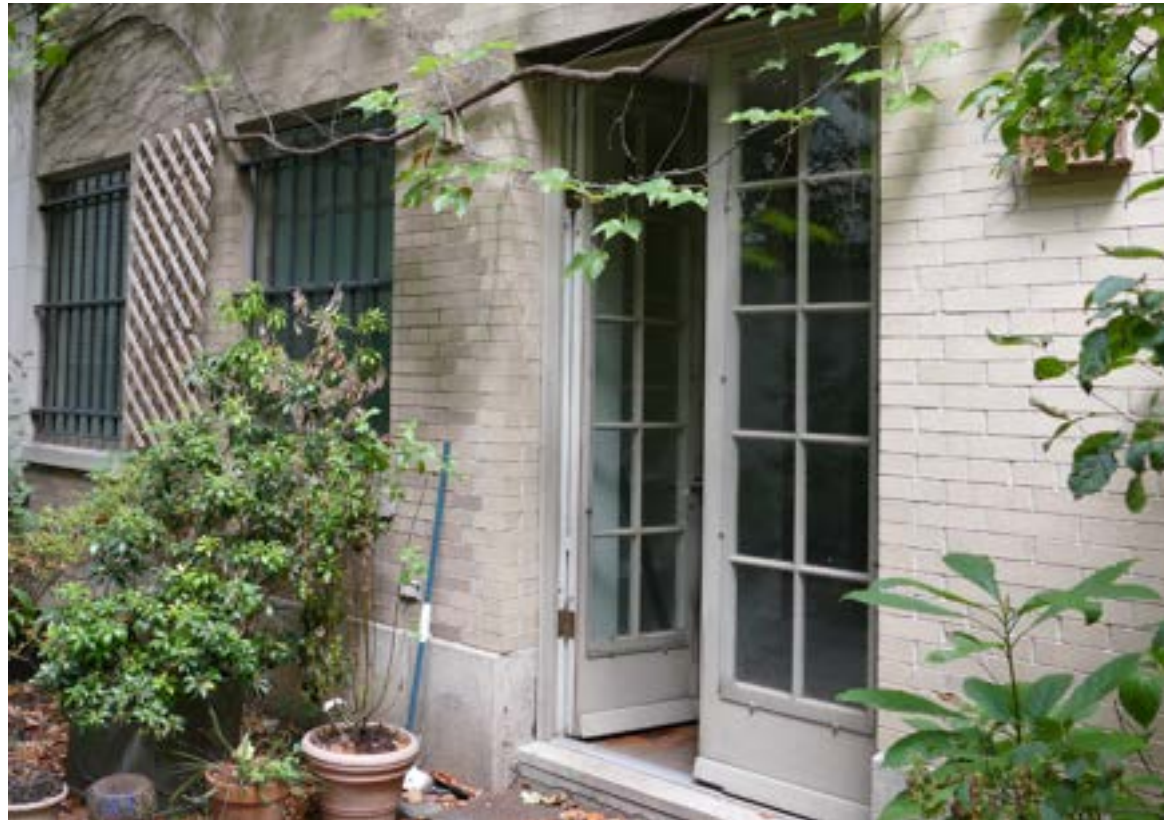
Some masonry openings at the ground floor of the rear elevation have been modified over time.

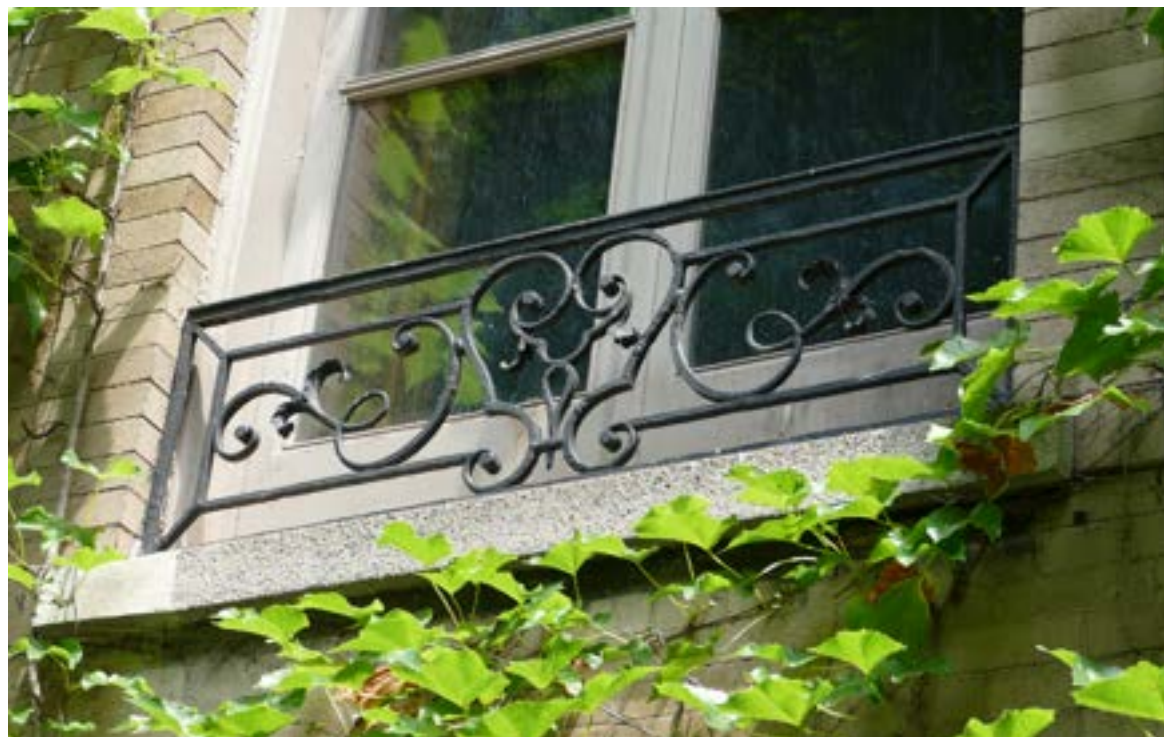
Detail of coated sill and historic ironwork. Historic masonry and metal will be inspected and repaired as necessary.
