1312 Madison Avenue

Expanded Carnegie Hill Historic District

VIO-22-0110-Installation of awning, lighting, paneling, plaque, and menu box at northernmost Madison Avenue storefront ('Hiramasa') without permit(s)

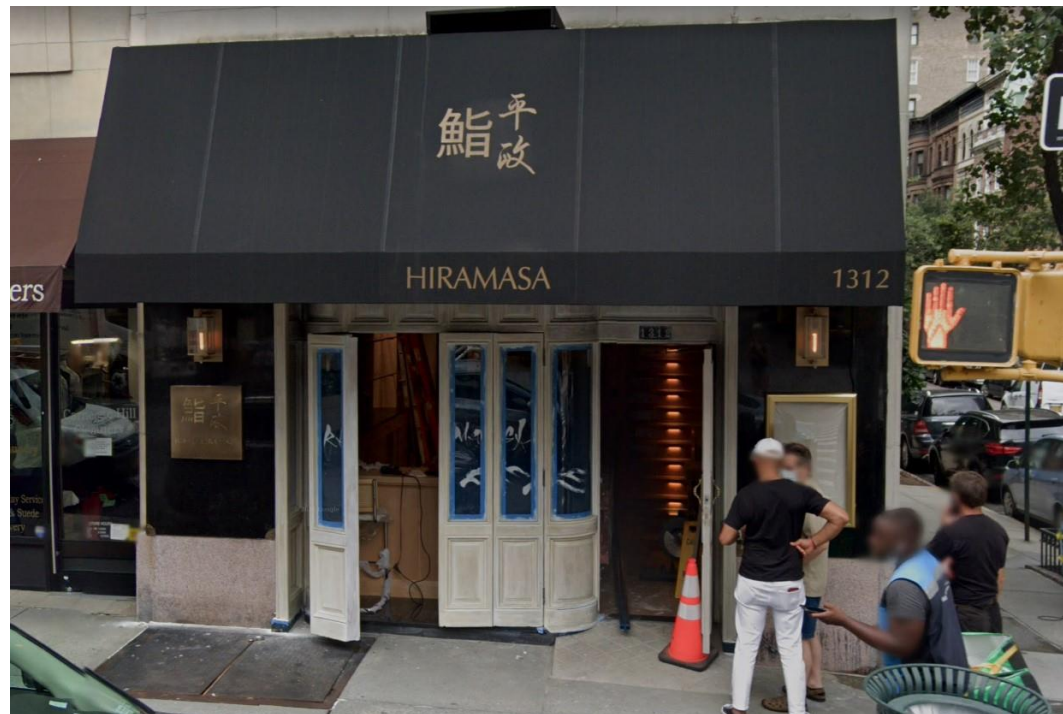
Existing awning conditions

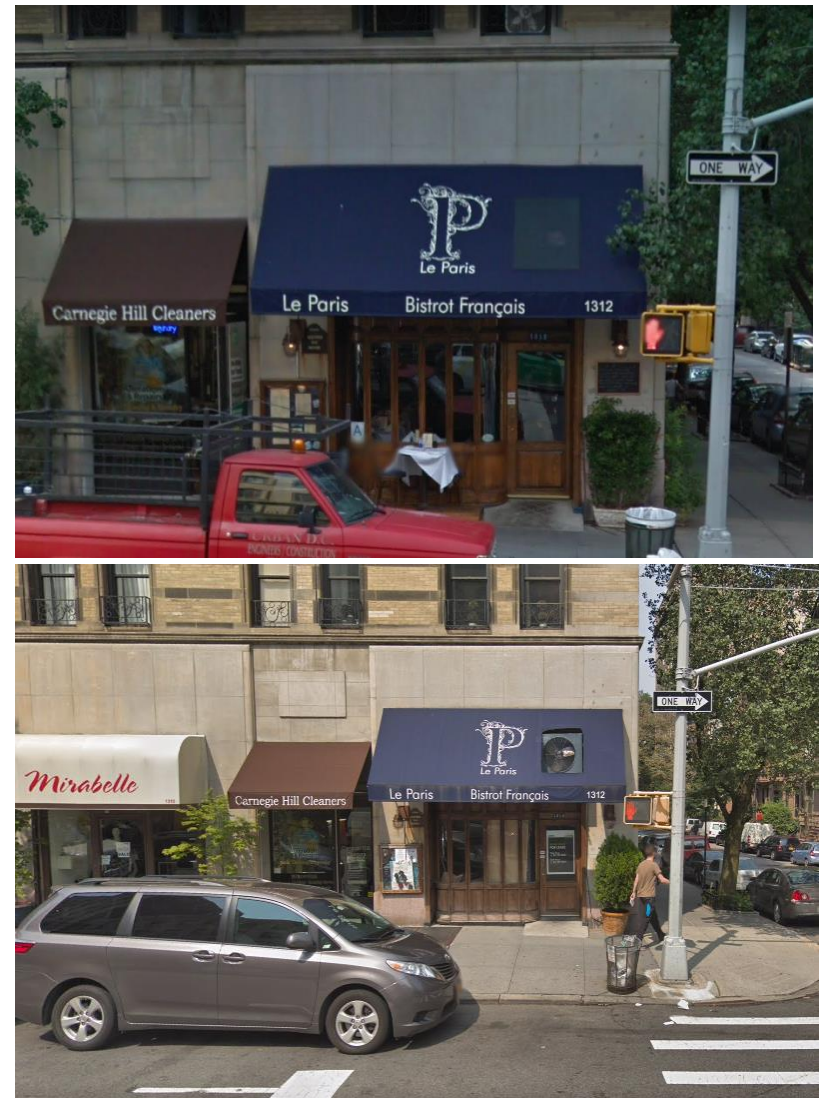
Prior conditions c. September 2012 (top) and August 2018 (bottom) – Google StreetView – didn't appear to have a permit for this work either

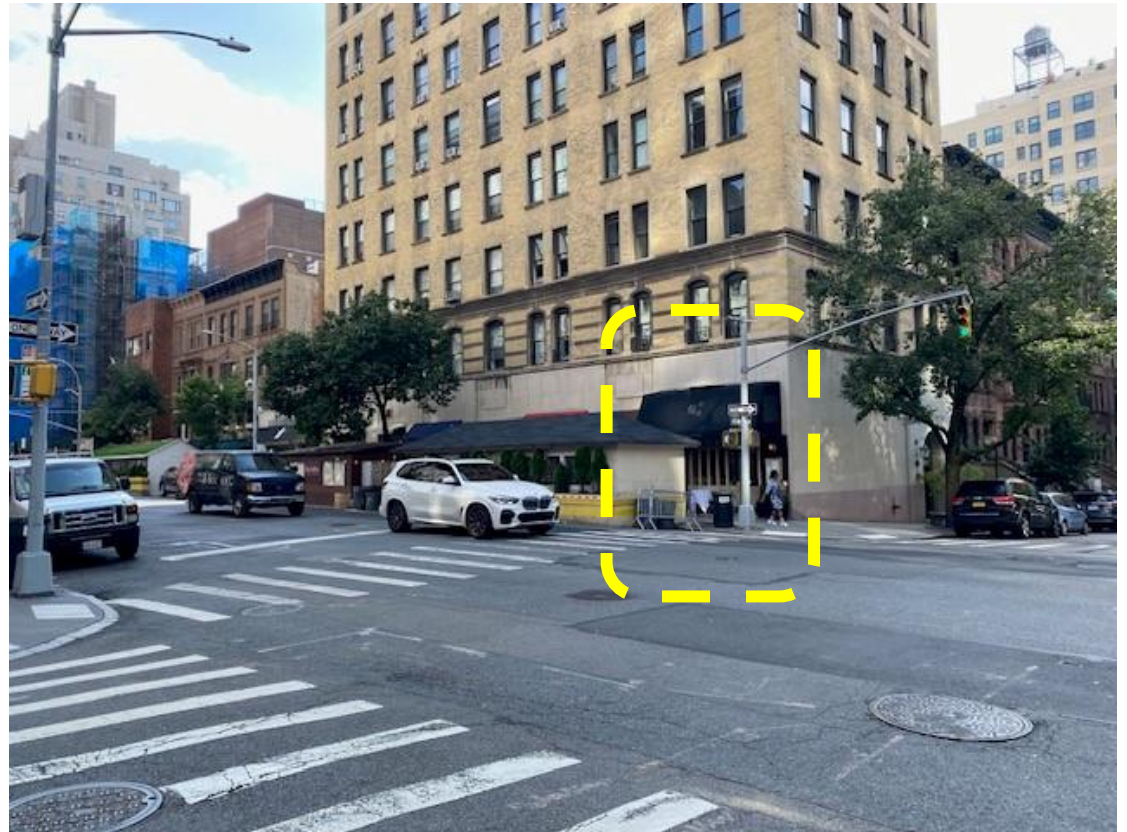
Current conditions – June 2023

Seeking to legalize existing awning as-is and approve replacement of building-mounted HVAC units

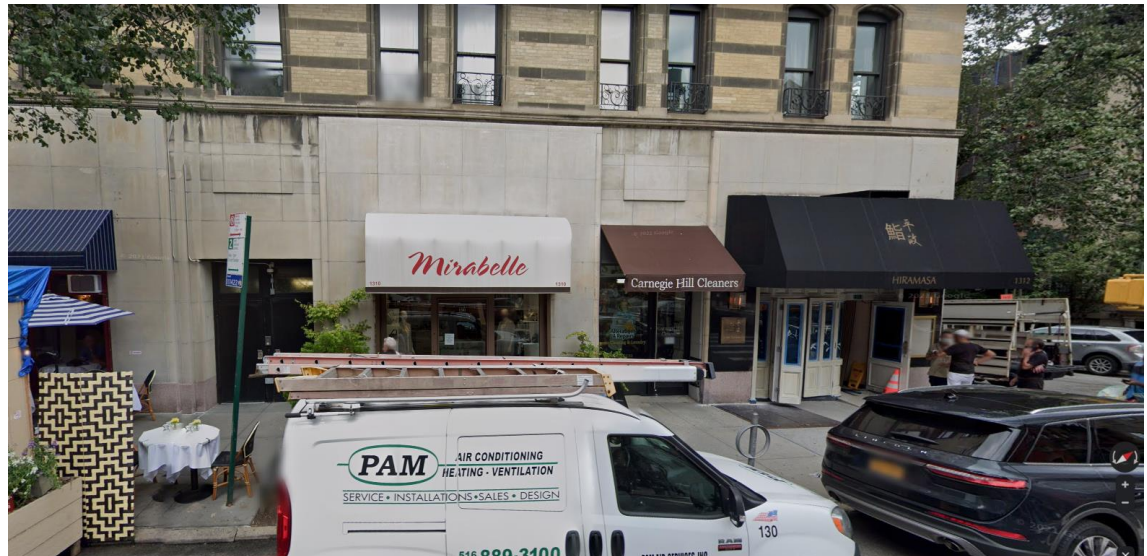
1308-1312 Madison Ave (note: Mirabelle awning is also in violation)

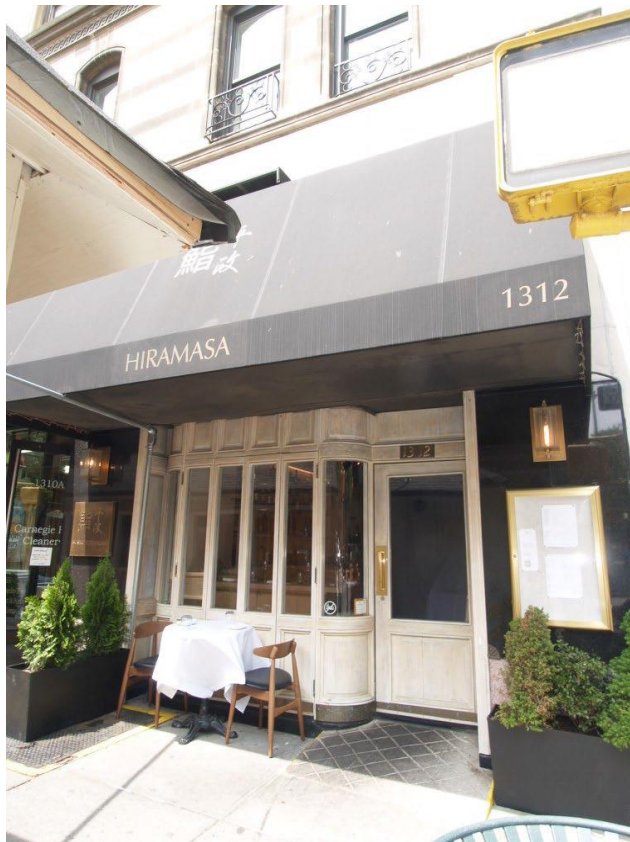
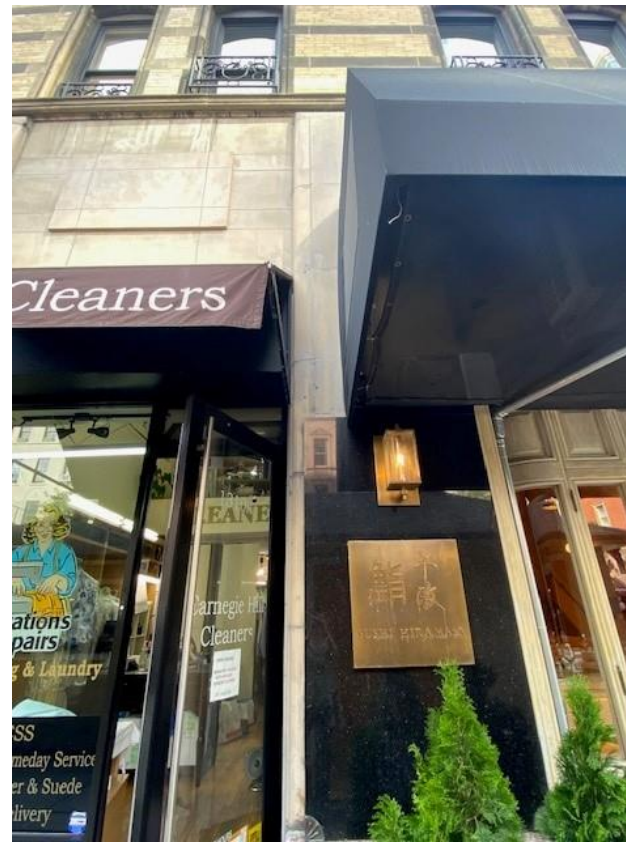
Frame extends beyond the storefront infill/opening and was elongated further from the prior condition.

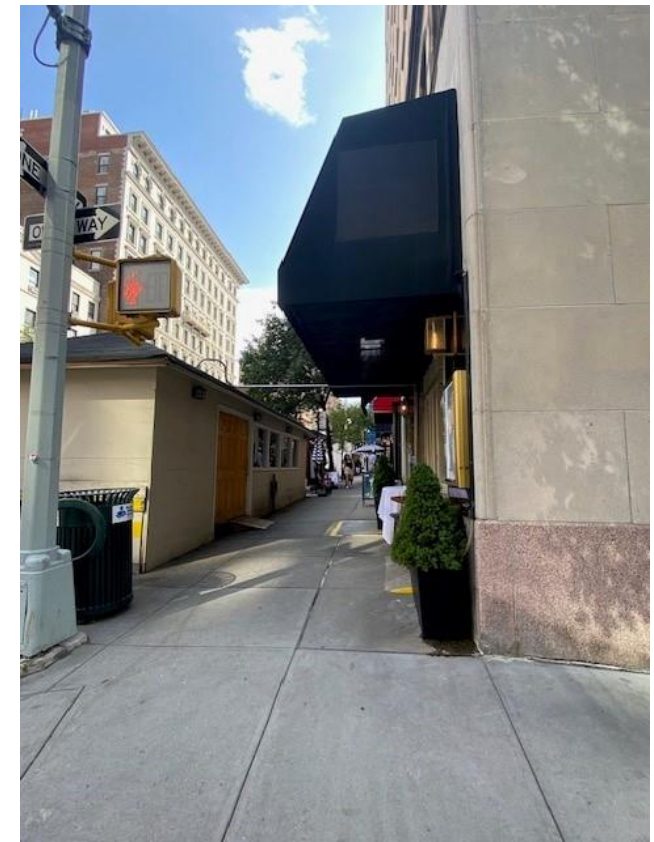
Profile got more boxy to enclose new HVAC units. Also added a fixed skirt, side panels, and mesh at underside

Replaced building-mounted HVAC units and new fixed awning with fixed skirt, closed sides, and enclosure at the underside to conceal HVACs

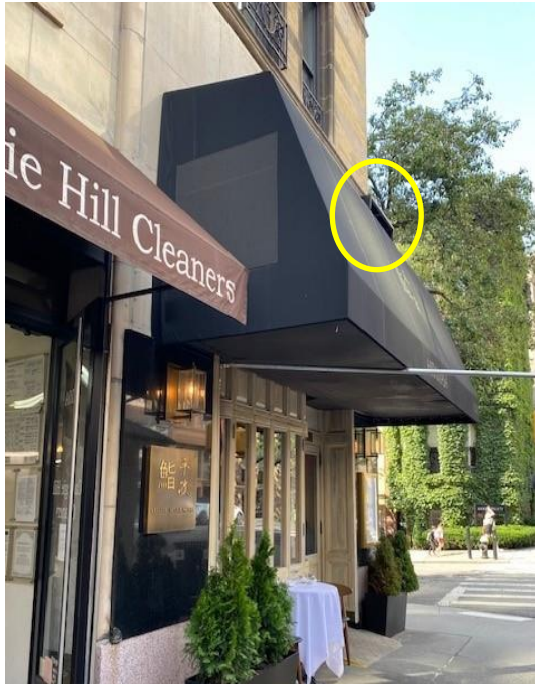
Details showing existing HVAC units with and without mesh enclosure at the underside of the awning. Also installed a small boxed area at top of awning to allow air intake/exhaust. The small vent is nearly invisible from the sidewalk.

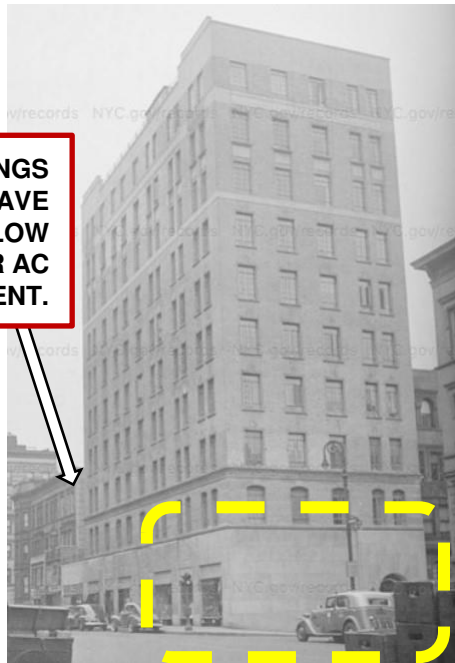
1940s tax photograph showing original stone, without openings for possible louvers on either Madison Avenue or East 93rd Street.

- 1) The building at 1312 Madison Avenue was constructed in an era that predates air conditioning. The stone exterior has no space allotted for louvers or other means of venting, to provide outlets for interior air conditioning condenser units. Therefore, air conditioning condensers must be either outdoors, or significant modifications made to the façade to accommodate interior applications.

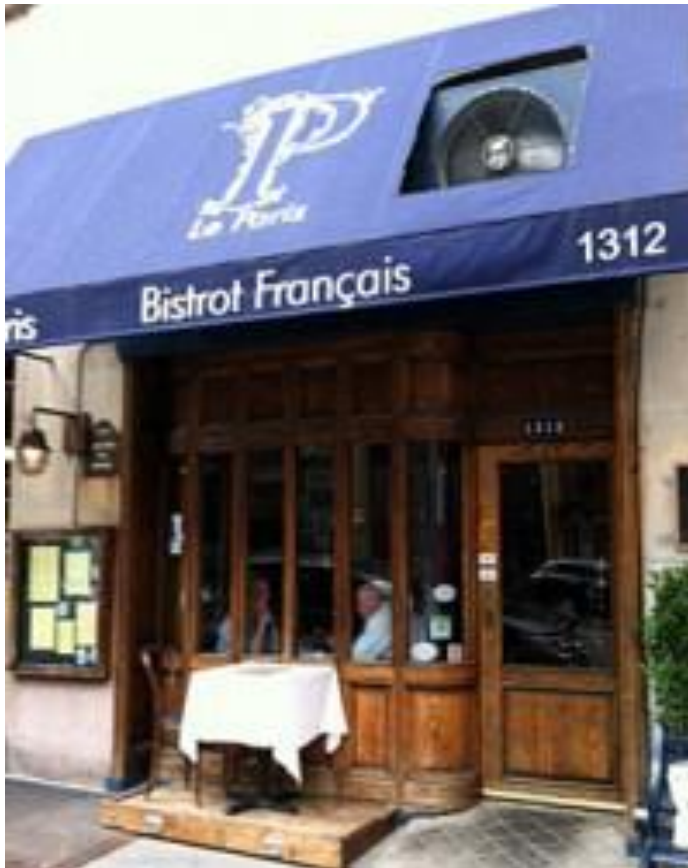
Previous awning, with open sides and bottom, as well as opening for HVAC exhaust.

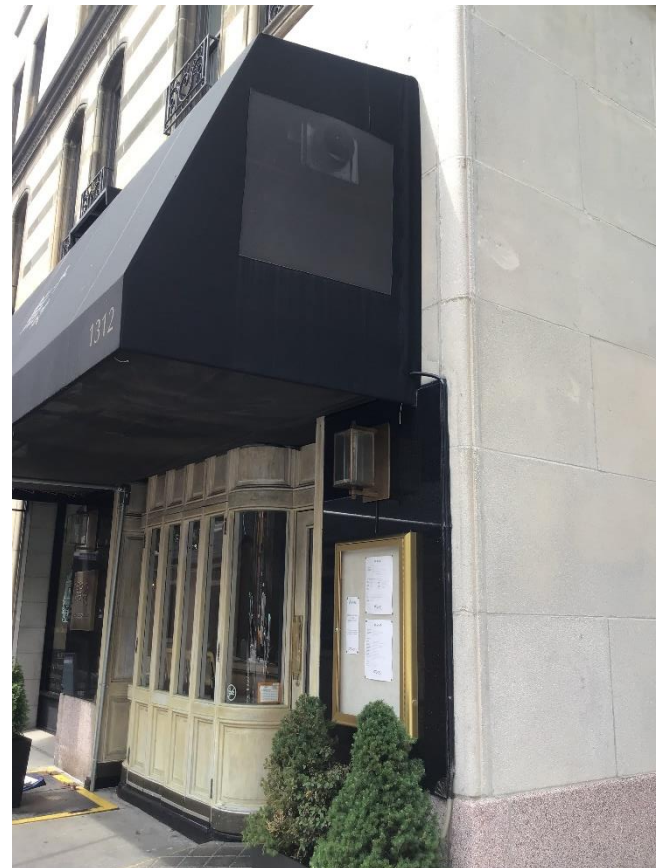
Existing awning, with closed sides and bottom, minimizing visibility of HVAC exhaust.

In conclusion, the current awning, while not strictly in compliance with the guidelines in the District Master Plan for Madison Avenue, is neatly constructed with appropriate fabric, color, graphics, and lettering, and succeeds in concealing the existing AC units. The existing AC units are of the necessary capacity for providing adequate cooling to the restaurant. The width of the awning, while exceeding the original opening, provides the minimum distance to adequately conceal the equipment, while still allowing for proper ventilation. Alternative schemes do not solve the awkward condition. Any future revision would trigger significant renovation work at the interior and a complete replacement of the storefront. To do this work now would be a huge financial burden for this small business. Given the constraints of the site, we believe that this awning is a reasonable solution to a challenging situation and is not a jarring element in the blend of styles and scales that characterize this stretch of Madison Avenue. We respectfully request that the existing installation be approved as currently configured.
