**AREA OF WORK**  
18 East 74th Street,  
New York, NY 10021

**PROPOSED REVISION SUMMARY**

THIS APPLICATION PRIMARILY SEEKS APPROVAL FOR THE REBUILDING OF THE UPPER TWO STORIES (5 & 6) OF THE STREET FACADE WALL .THE CURRENTLY APPROVED APPLICATION CALLS ONLY FOR THE REPLACEMENT OF THE EXISTING WINDOWS ON THE FACADE OF THESE TWO FLOORS.

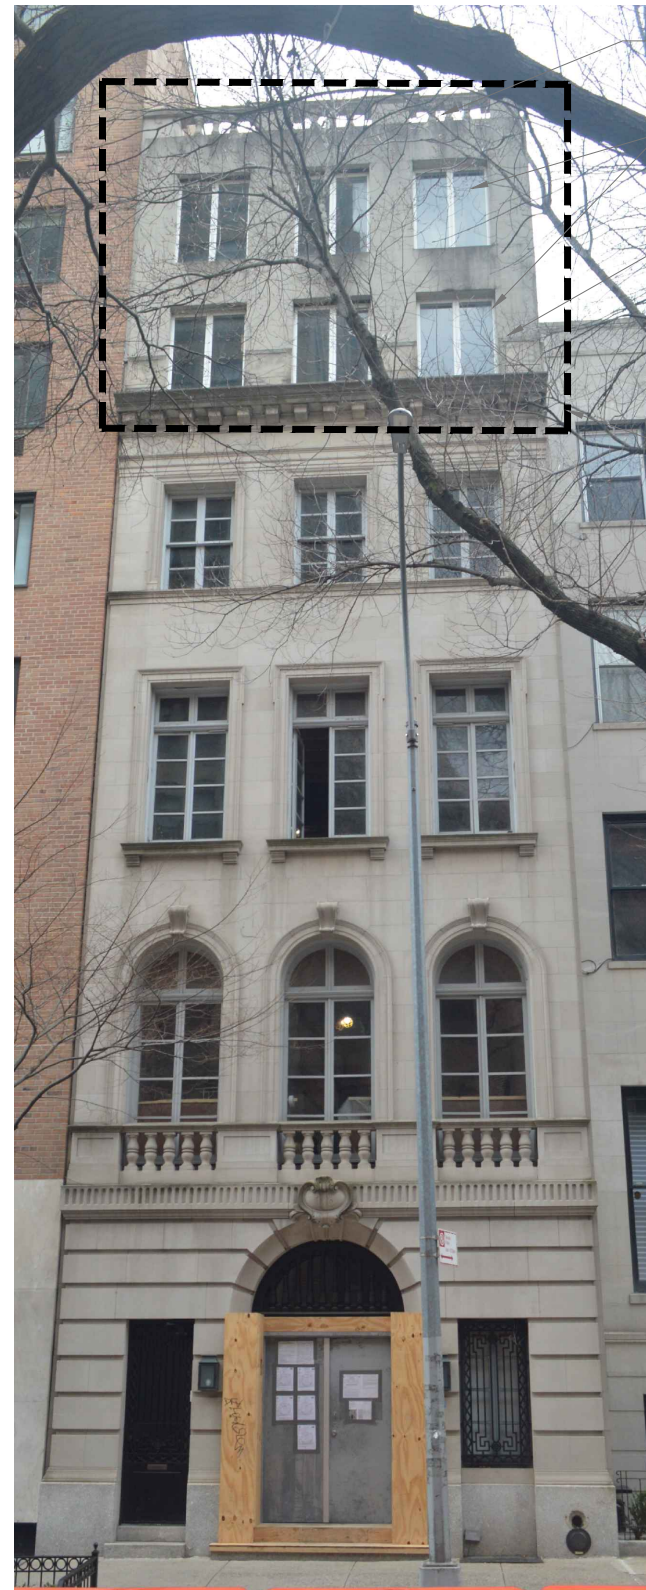
FRONT (NORTH) FACADE - CURRENT

EXTENSIVE STAINING AT EIFS.

NON-HISTORIC PANELS TO BE REMOVED

RECONSTRUCT EXISTING HISTORIC BALUSTRADE

EXISTING NON-HISTORIC WINDOWS TO BE REPLACED WITH NEW HISTORICALLY CONSISTENT WINDOWS

EXISTING NON-HISTORIC EIFS EXTERIOR WALL TO BE REPLACED WITH NEW CAST STONE ASHLAR

AIR CONDITIONER OPENING TO BE INFILLED WITH CAST STONE.

EXISTING GAPS IN LIMESTONE TO BE REPAIRED

SPALLED LIMESTONE TRIM TO BE REPAIRED TO MATCH
