# The East River Esplanade

Located on the East River between East 62nd Street and East 125th Street In the borough of Manhattan

July 13, 2017

Brief Overview
Prescoping Study Recommendations

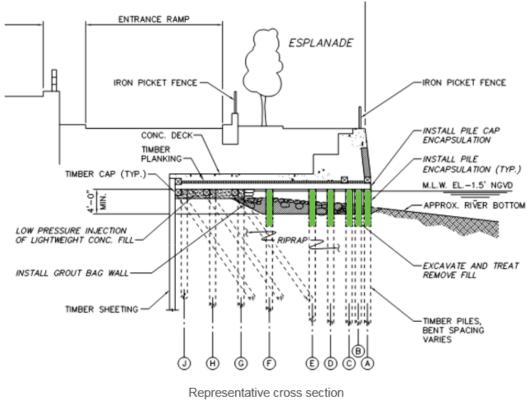
#### **Elemental Repairs**

Repair and/or replace individual elements of a structure (e.g., encapsulation of timber piles)

(details vary according to location)

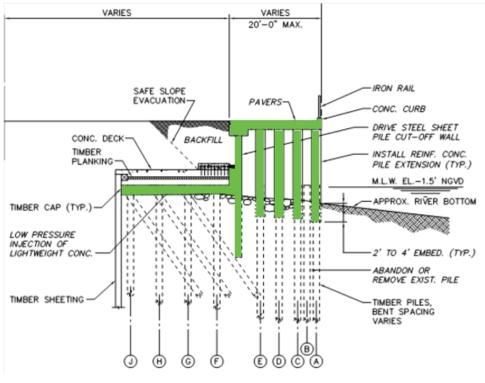
#### **Partial Reconstruction**

Partially demolish platform; install fill under remaining platform; extend or replace timber piles with concrete piles

Representative cross section (details vary according to location)

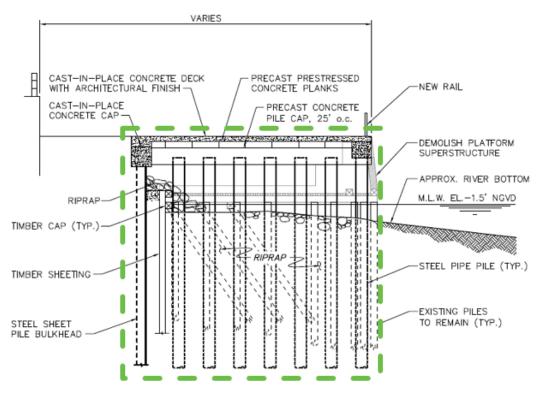
### **Complete Reconstruction**

Demolition of existing platform; replace with new high level platform

Representative cross section (details vary according to location)

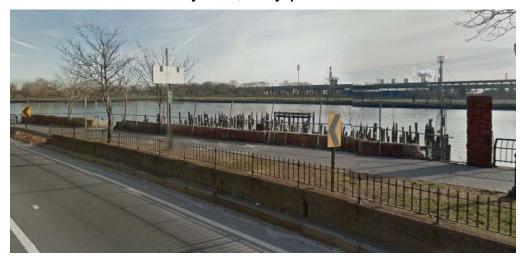
- Partial collapse of concrete pier remains, October 2016
- Some damage to bulkhead and esplanade
- Former factory site, only pier remnants and abandoned utilities remain (DCAS jurisdiction)

View from FDR Drive Northbound, pre-collapse

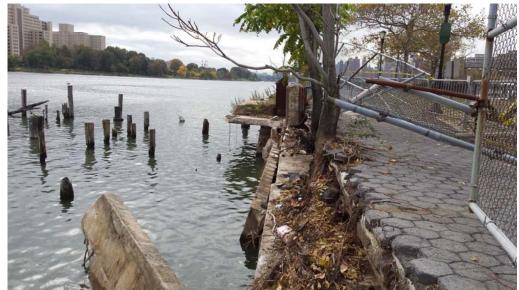
Partial collapse and loss of bulkhead
