54 EAST 66TH STREET

LANDMARKS PRESENTATION:

SUMMARY OF WORK:

- CONVERSION OF MULTIFAMILY TO SINGLE TOWNHOME
- STAIRS AND ELEVATOR BULKHEAD ADDITION AT ROOF
- ADDITION TO EXISTING EXTENSION AT REAR YARD
- NEW WALL AND WINDOW OPENINGS AT REAR YARD
- LEVELING OUT OF ROOF

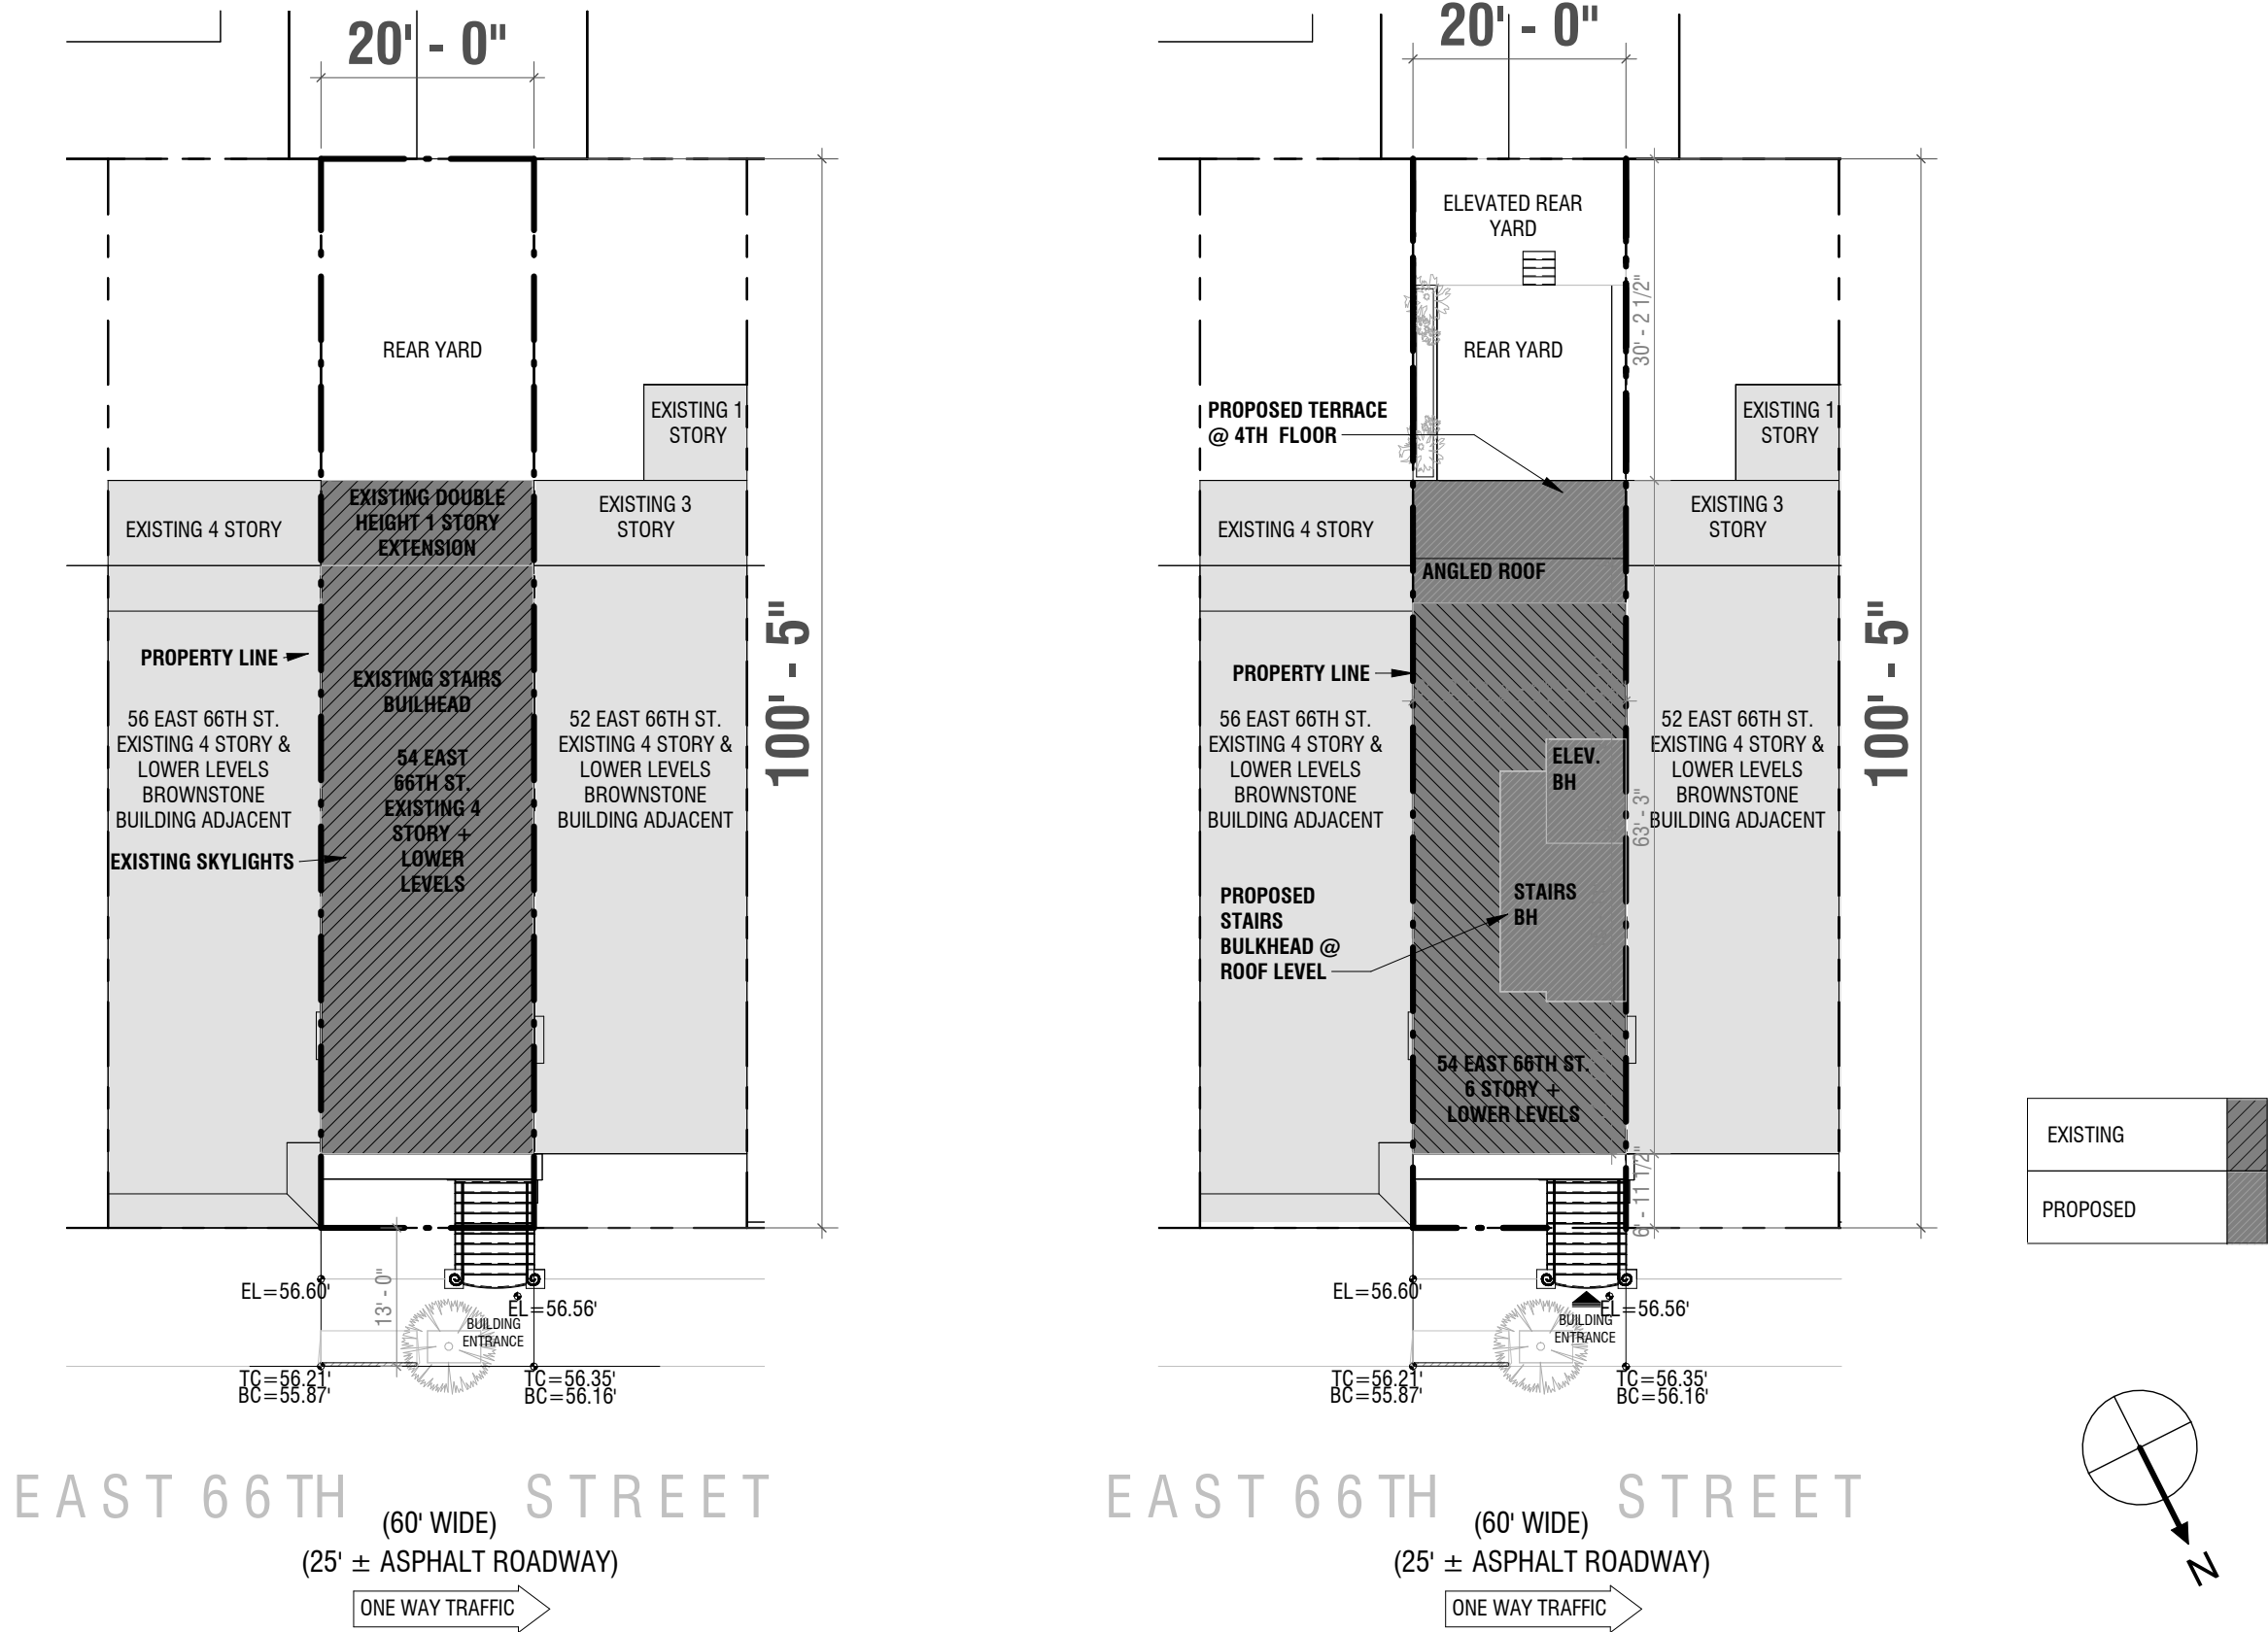
EXISTING PLOT PLAN

PROPOSED PLOT PLAN

ADDRESS: 54 EAST 66TH STREET, NEW YORK NY 10065
BLOCK: 1380
LOT: 45
LOT DIMENSIONS: 20'-0" X 100'-5"
ZONING LOT AREA: 2,008 SF
ZONING LOT DISTRICT: R8B
ZONING MAP: 8c
ZONING FAR: 4.0 (per ZR-23-153)
MAX ZONING AREA: 8,032 SF

EXISTING ZONING AREA: 4,435.84 SF
PROPOSED ZONING AREA: 6,453.65 SF
EXISTING ZONING FAR: 2.20
PROPOSED ZONING FAR: 3.2

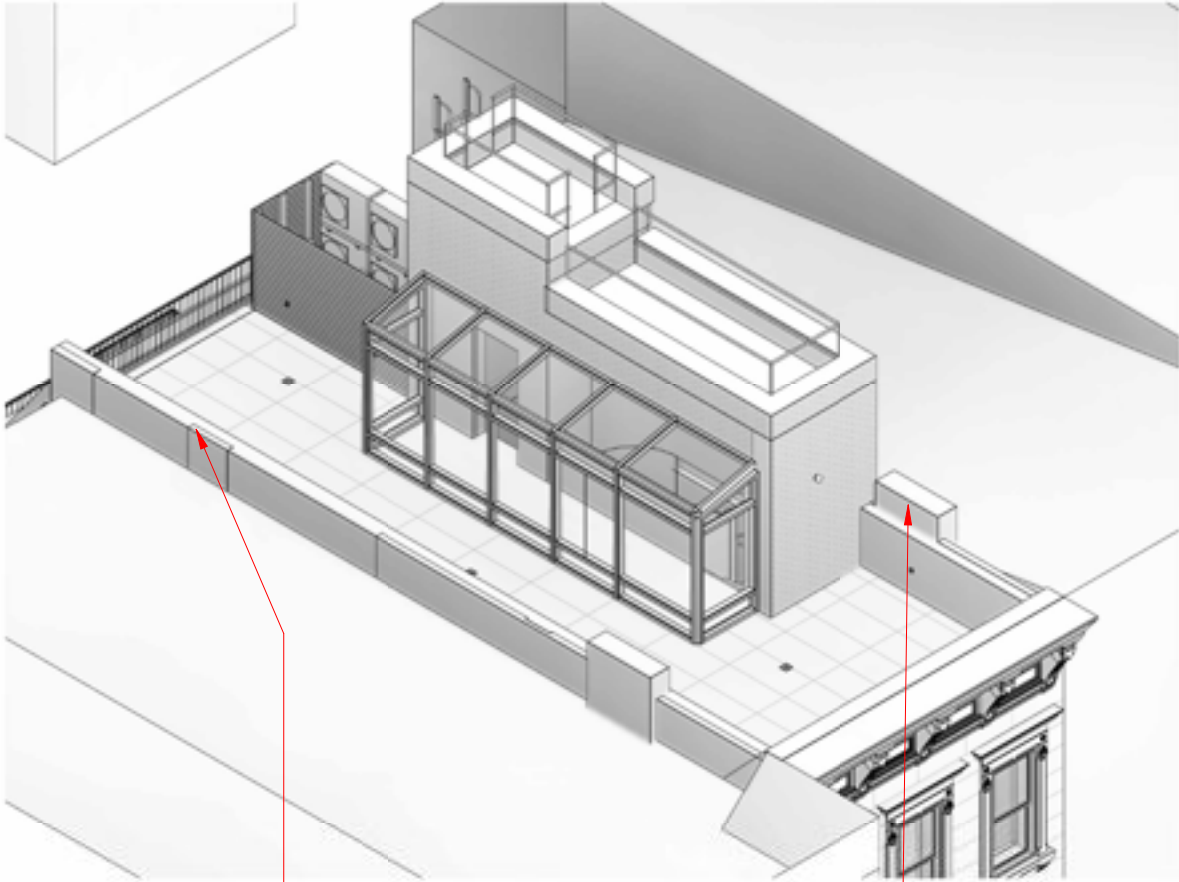
EXISTING EXHAUST DUCTS TO BE REMOVED AND REPLACED, SEE MECHANICAL DRAWINGS FOR DETAILS

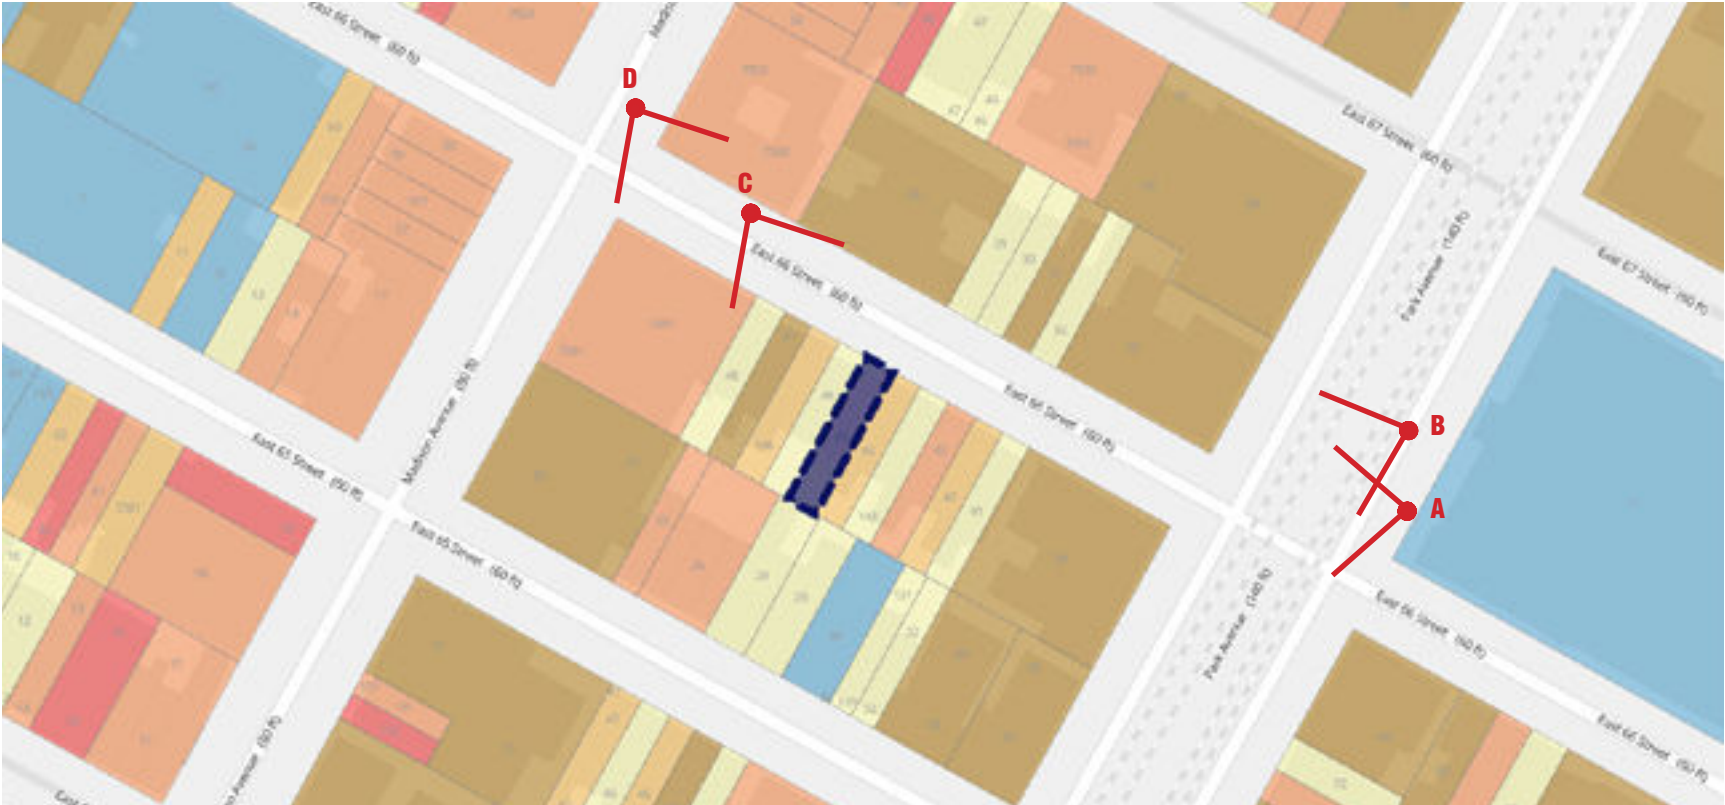
PROPOSED ROOF EXTENSION DOES NOT CROSS VISIBILITY PLANE FROM STREET LEVEL

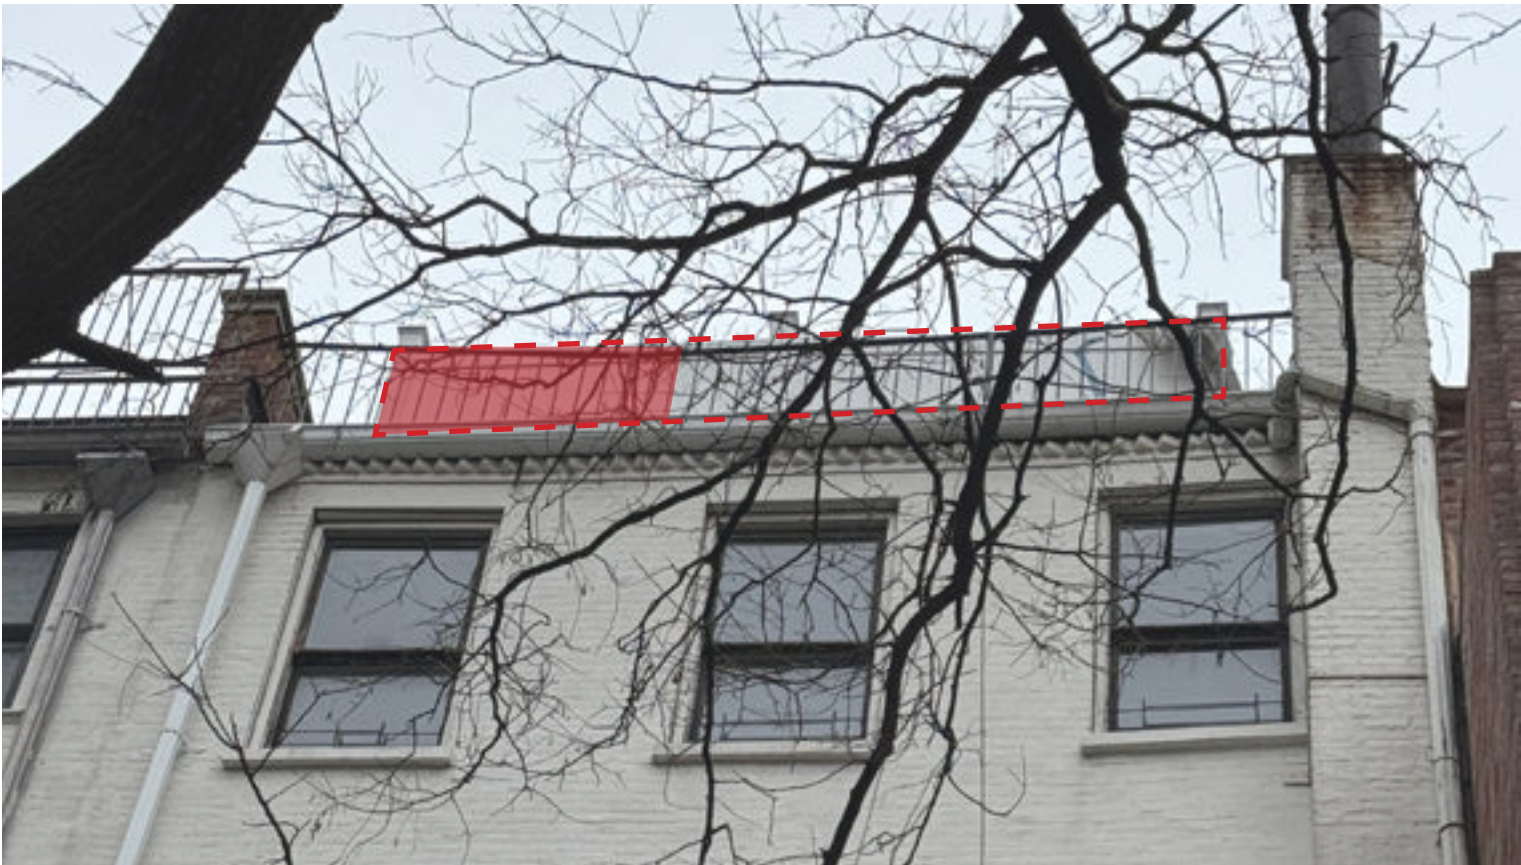
VIEW A - PHOTOS TAKEN 01.31.2025

EXISTING FENCE LOCATION BLOCKS ABILITY TO BUILD PROPOSED MECHANICAL SCREENING, CURRENT FENCE IS 23" FORWARD OF PROPOSED MECHANICAL FENCE, CURRENT FENCE IS 6' TALL

THIS MECHANICAL FENCING IS THE ONLY PORTION OF THE ROOF EXTENSION VISIBLE.
