Select Bus Service on 86th Street

Manhattan Community Board 8 | February 4, 2014

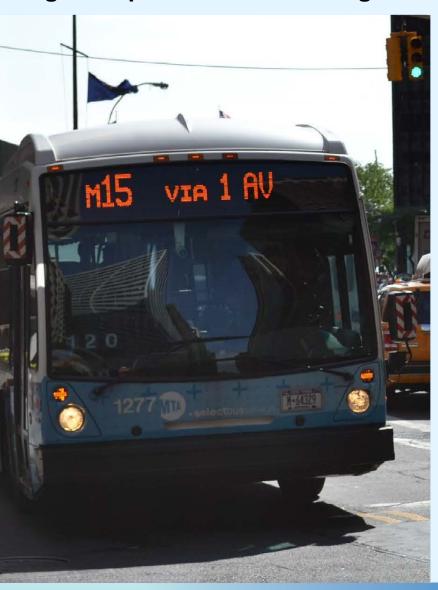
Signal Improvements and Targeted Bus Lanes

No dedicated bus lanes proposed for East 86th St – queue jumps being considered for 84th St exiting Central Park

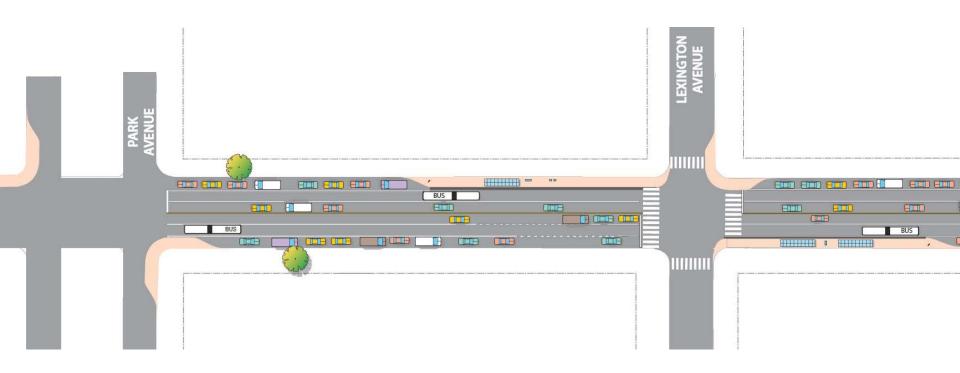
East 86th Street Pedestrian Improvements

Neckdowns

Park Av: NW and SE corners

Lexington Av: NE corner

Bus Bulbs

Lexington Av: NW corner

Lexington Av: SE corner

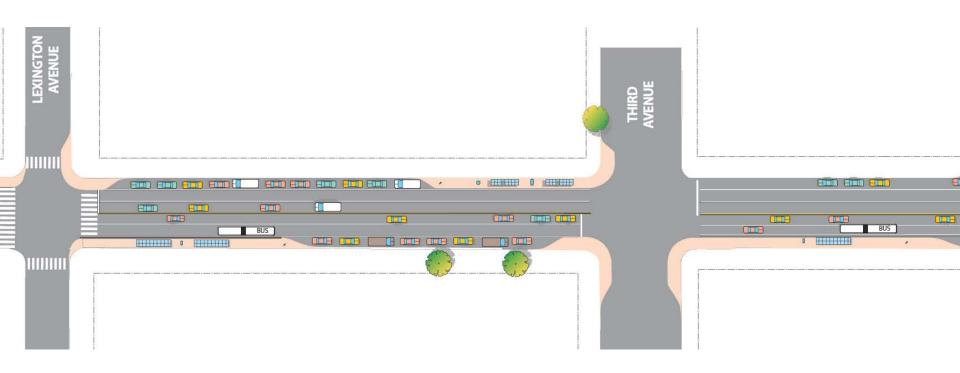
East 86th Street Pedestrian Improvements

Neckdowns

Park Av: NW and SE corners

Lexington Av: NE corner

Bus Bulbs

Lexington Av: NW corner

Lexington Av: SE corner

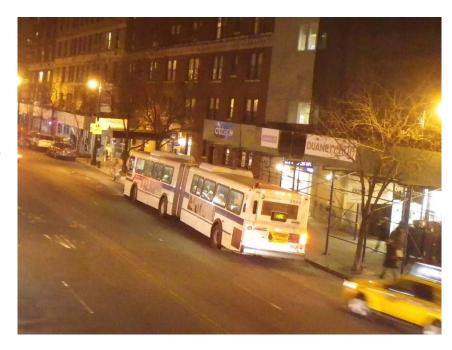
East 86th Street Traffic Analysis

M86: 12 buses per peak hour

Typical SBS loading time at a busy stop: 30 seconds

Buses loading at bus bulbs 10% of the time at peak hour

DOT collected traffic volumes that indicate maneuvering around loading buses will not have significant impact

Traffic movement on East 86th St is not adversely affected by proposed bus bulbs since motorists are typically able to clear the upcoming intersection in the same signal cycle
