**Northwell**  
Health®

**115 E 75th St Renovation**

December 17, 2018

**ennead** architects

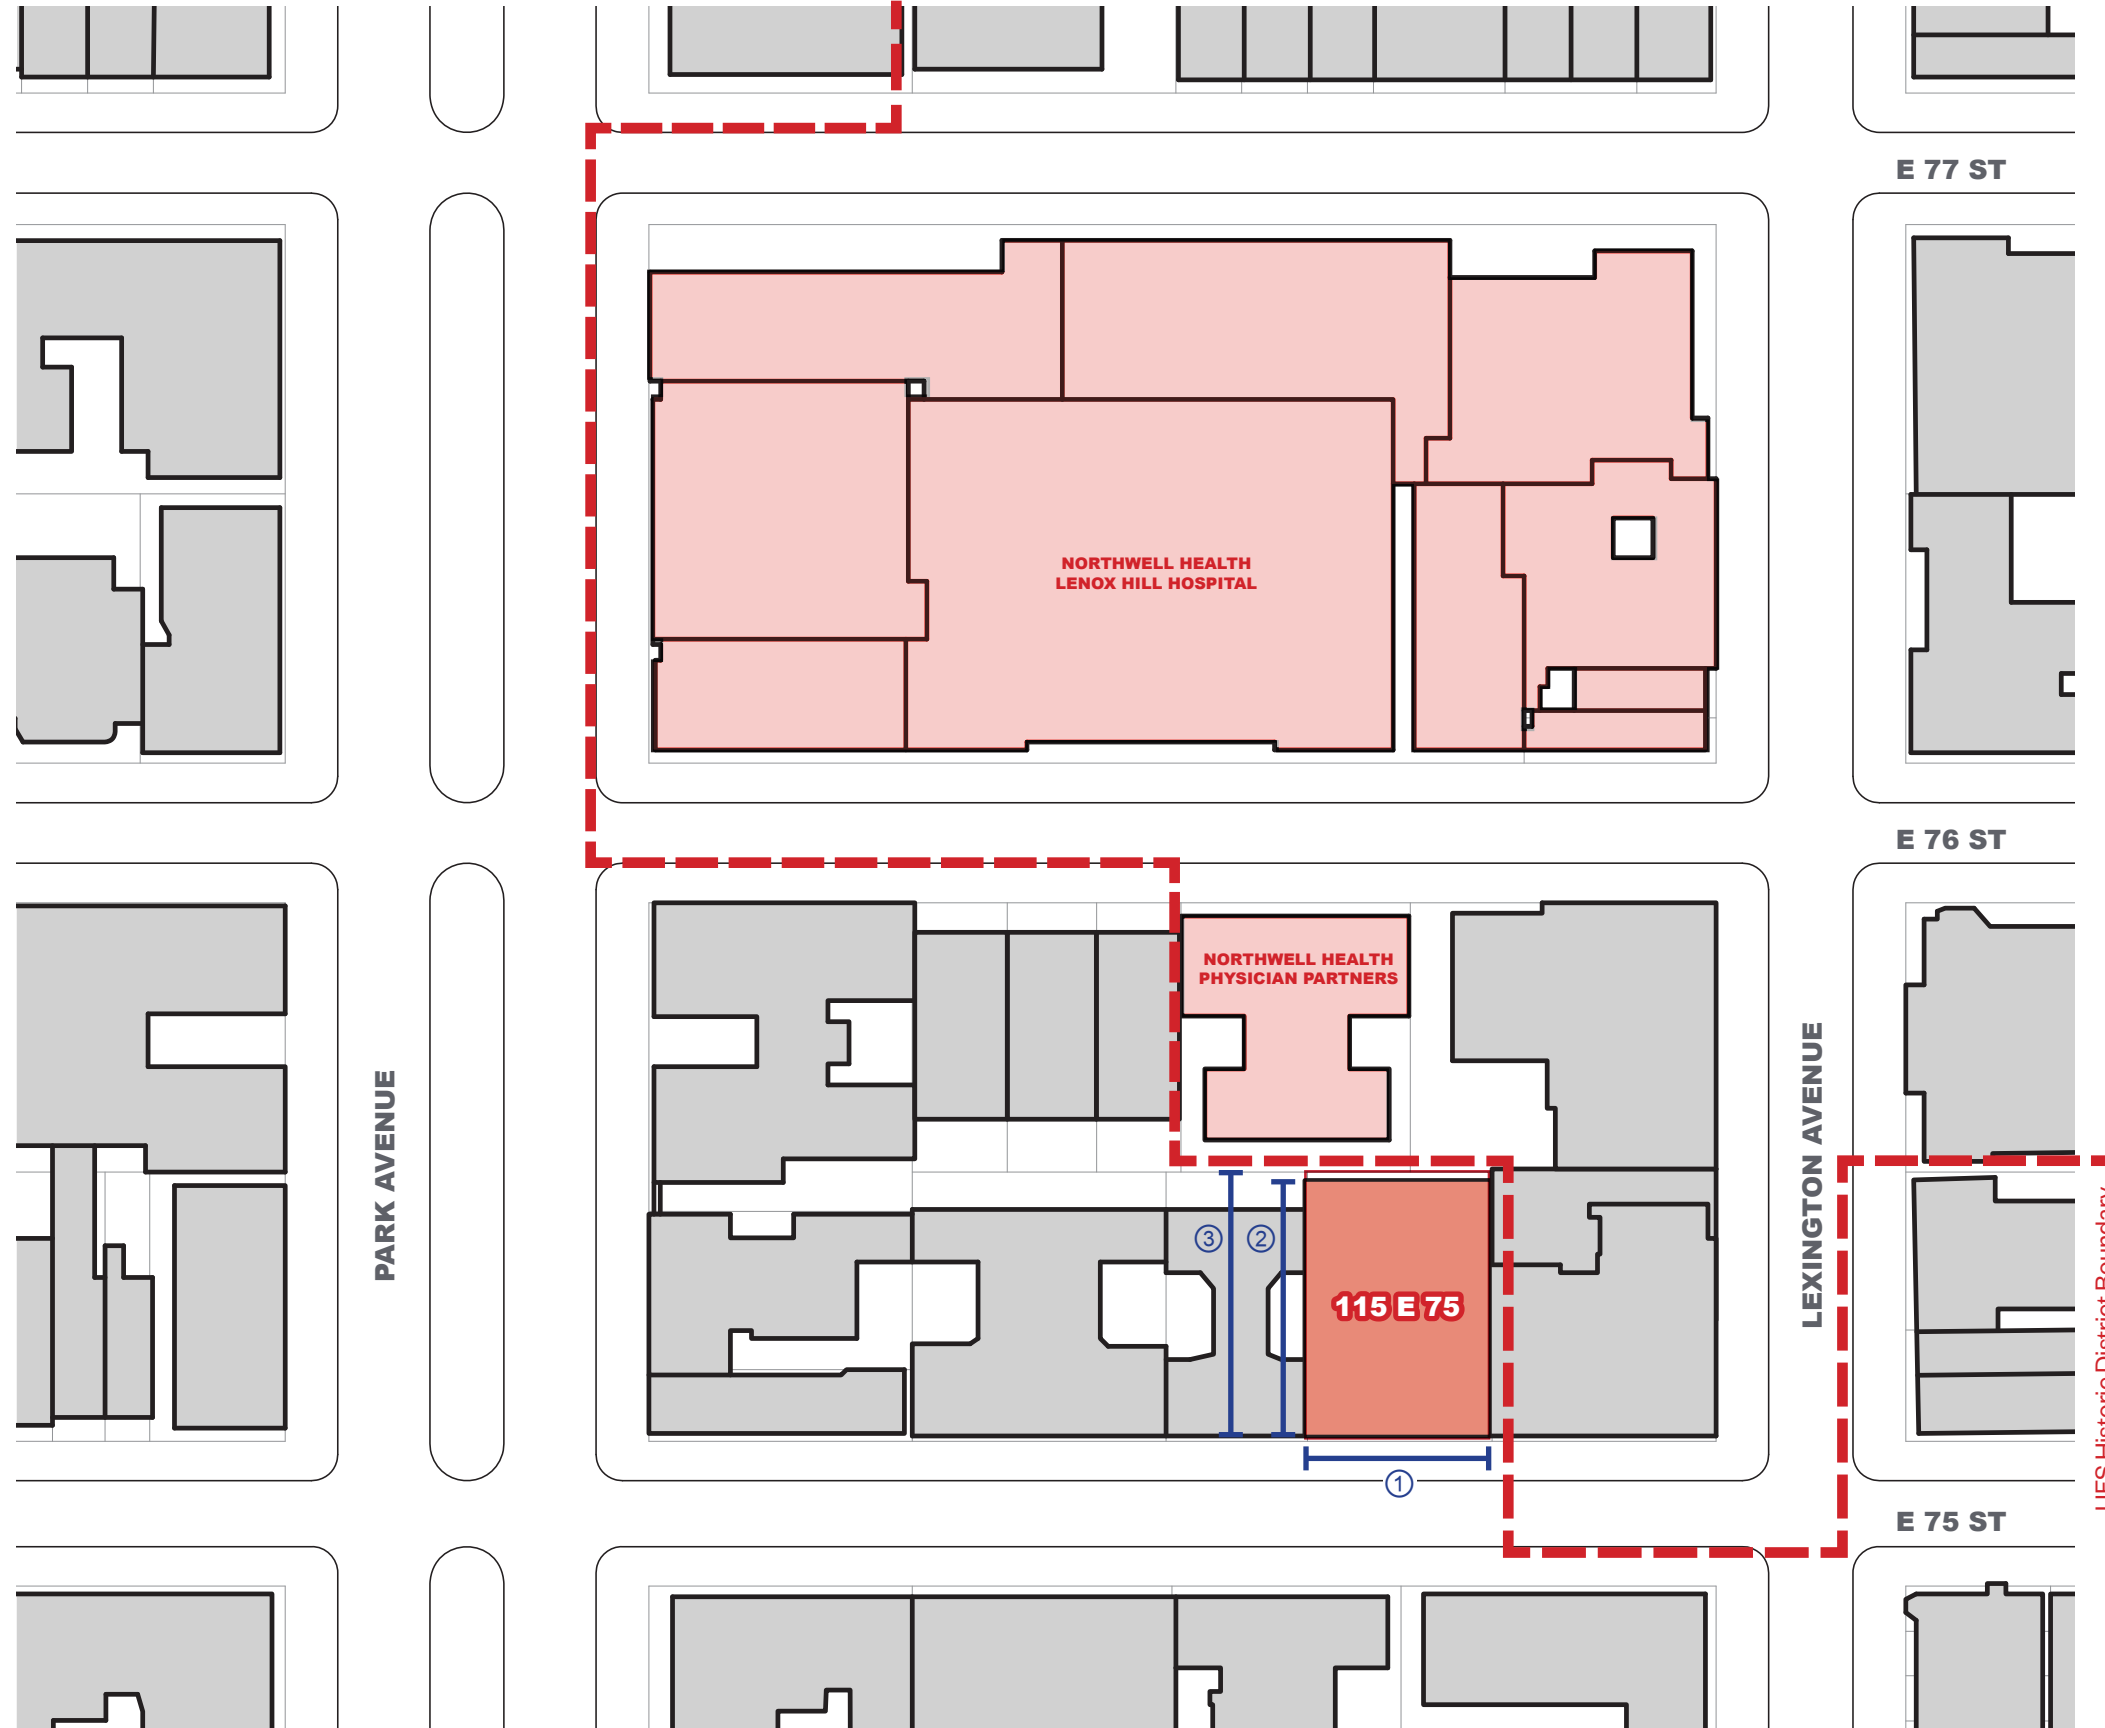
- ① Building/Lot: 70' - 0"
- ② Building: 97' - 0"
- ③ Lot: 102' - 2"

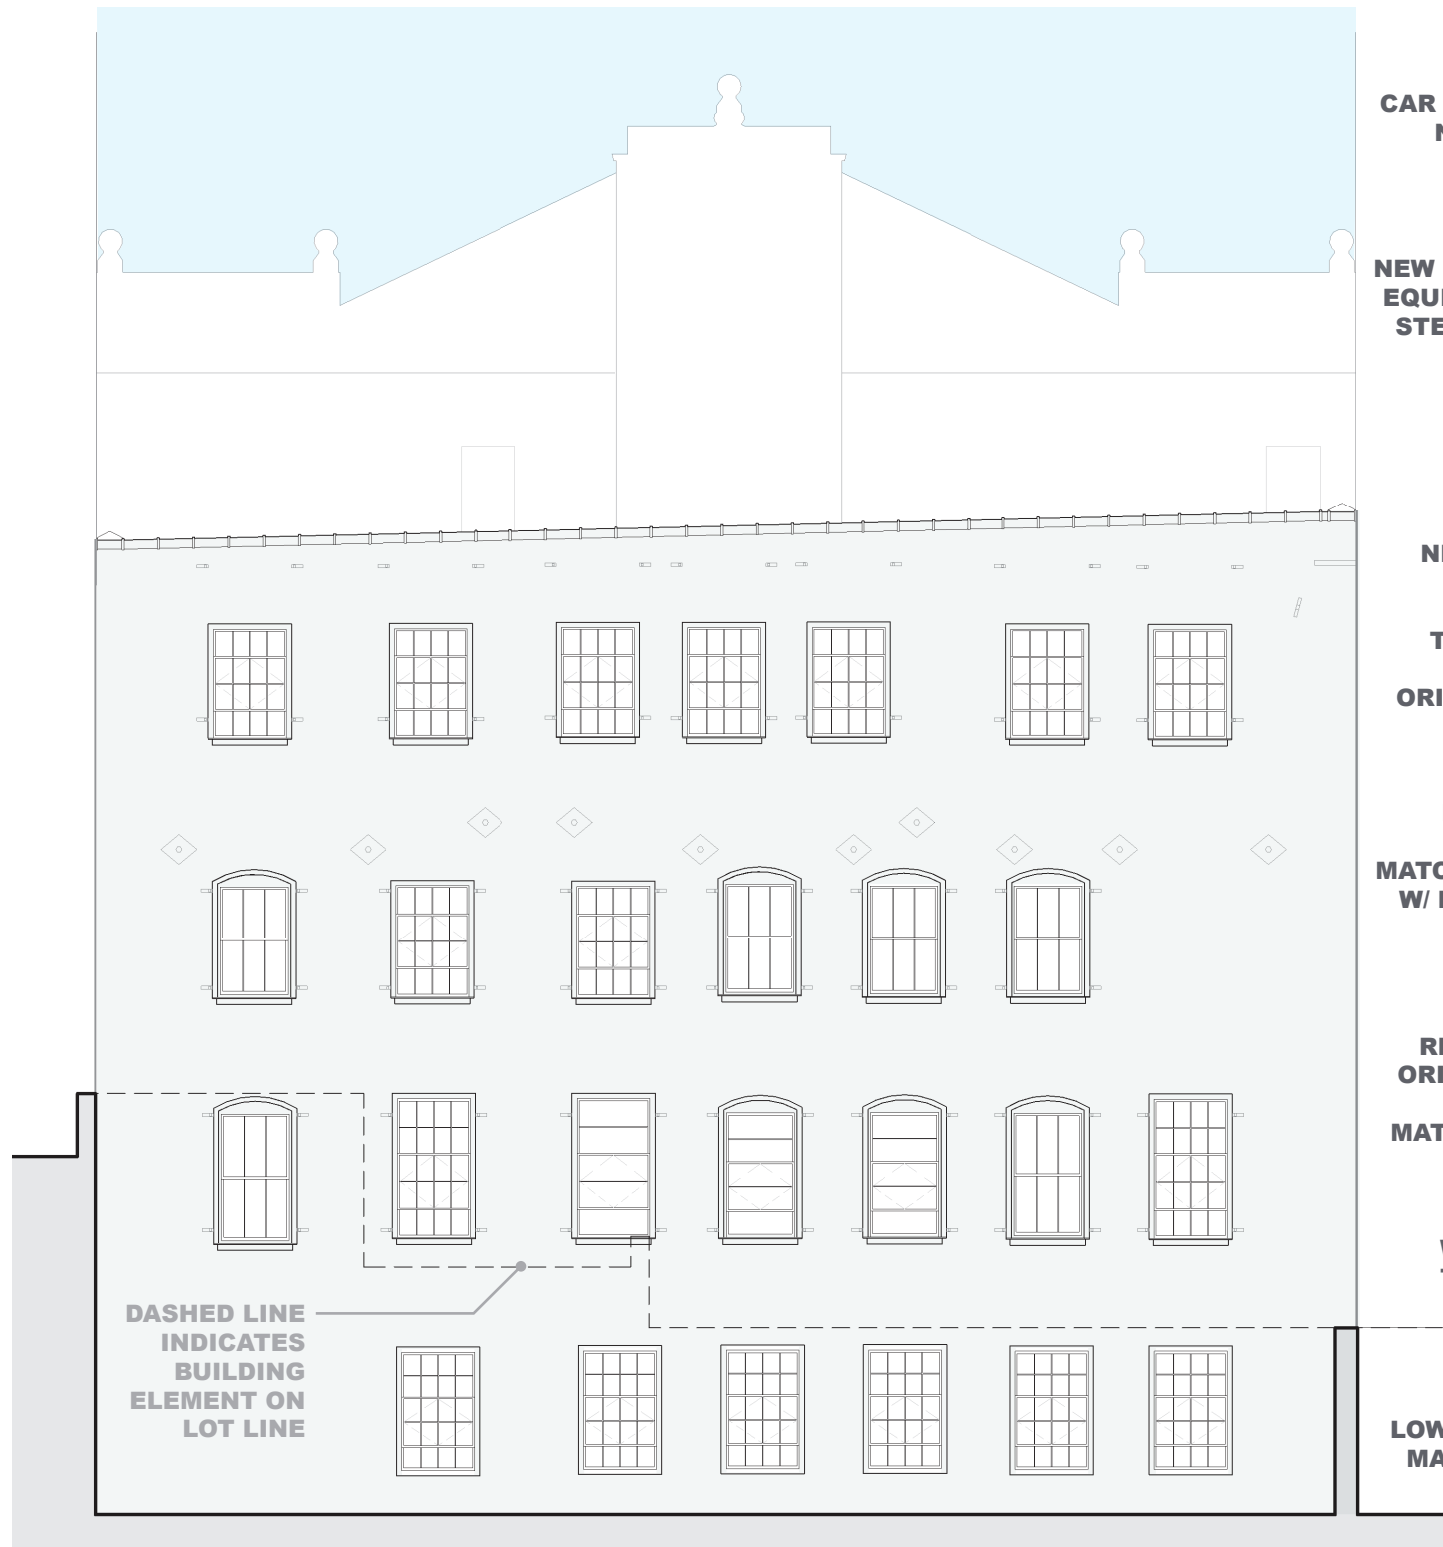
Existing

Various window types, including steel-framed center-pivot windows, and single-hung frames with metal or wood construction.

North Facade

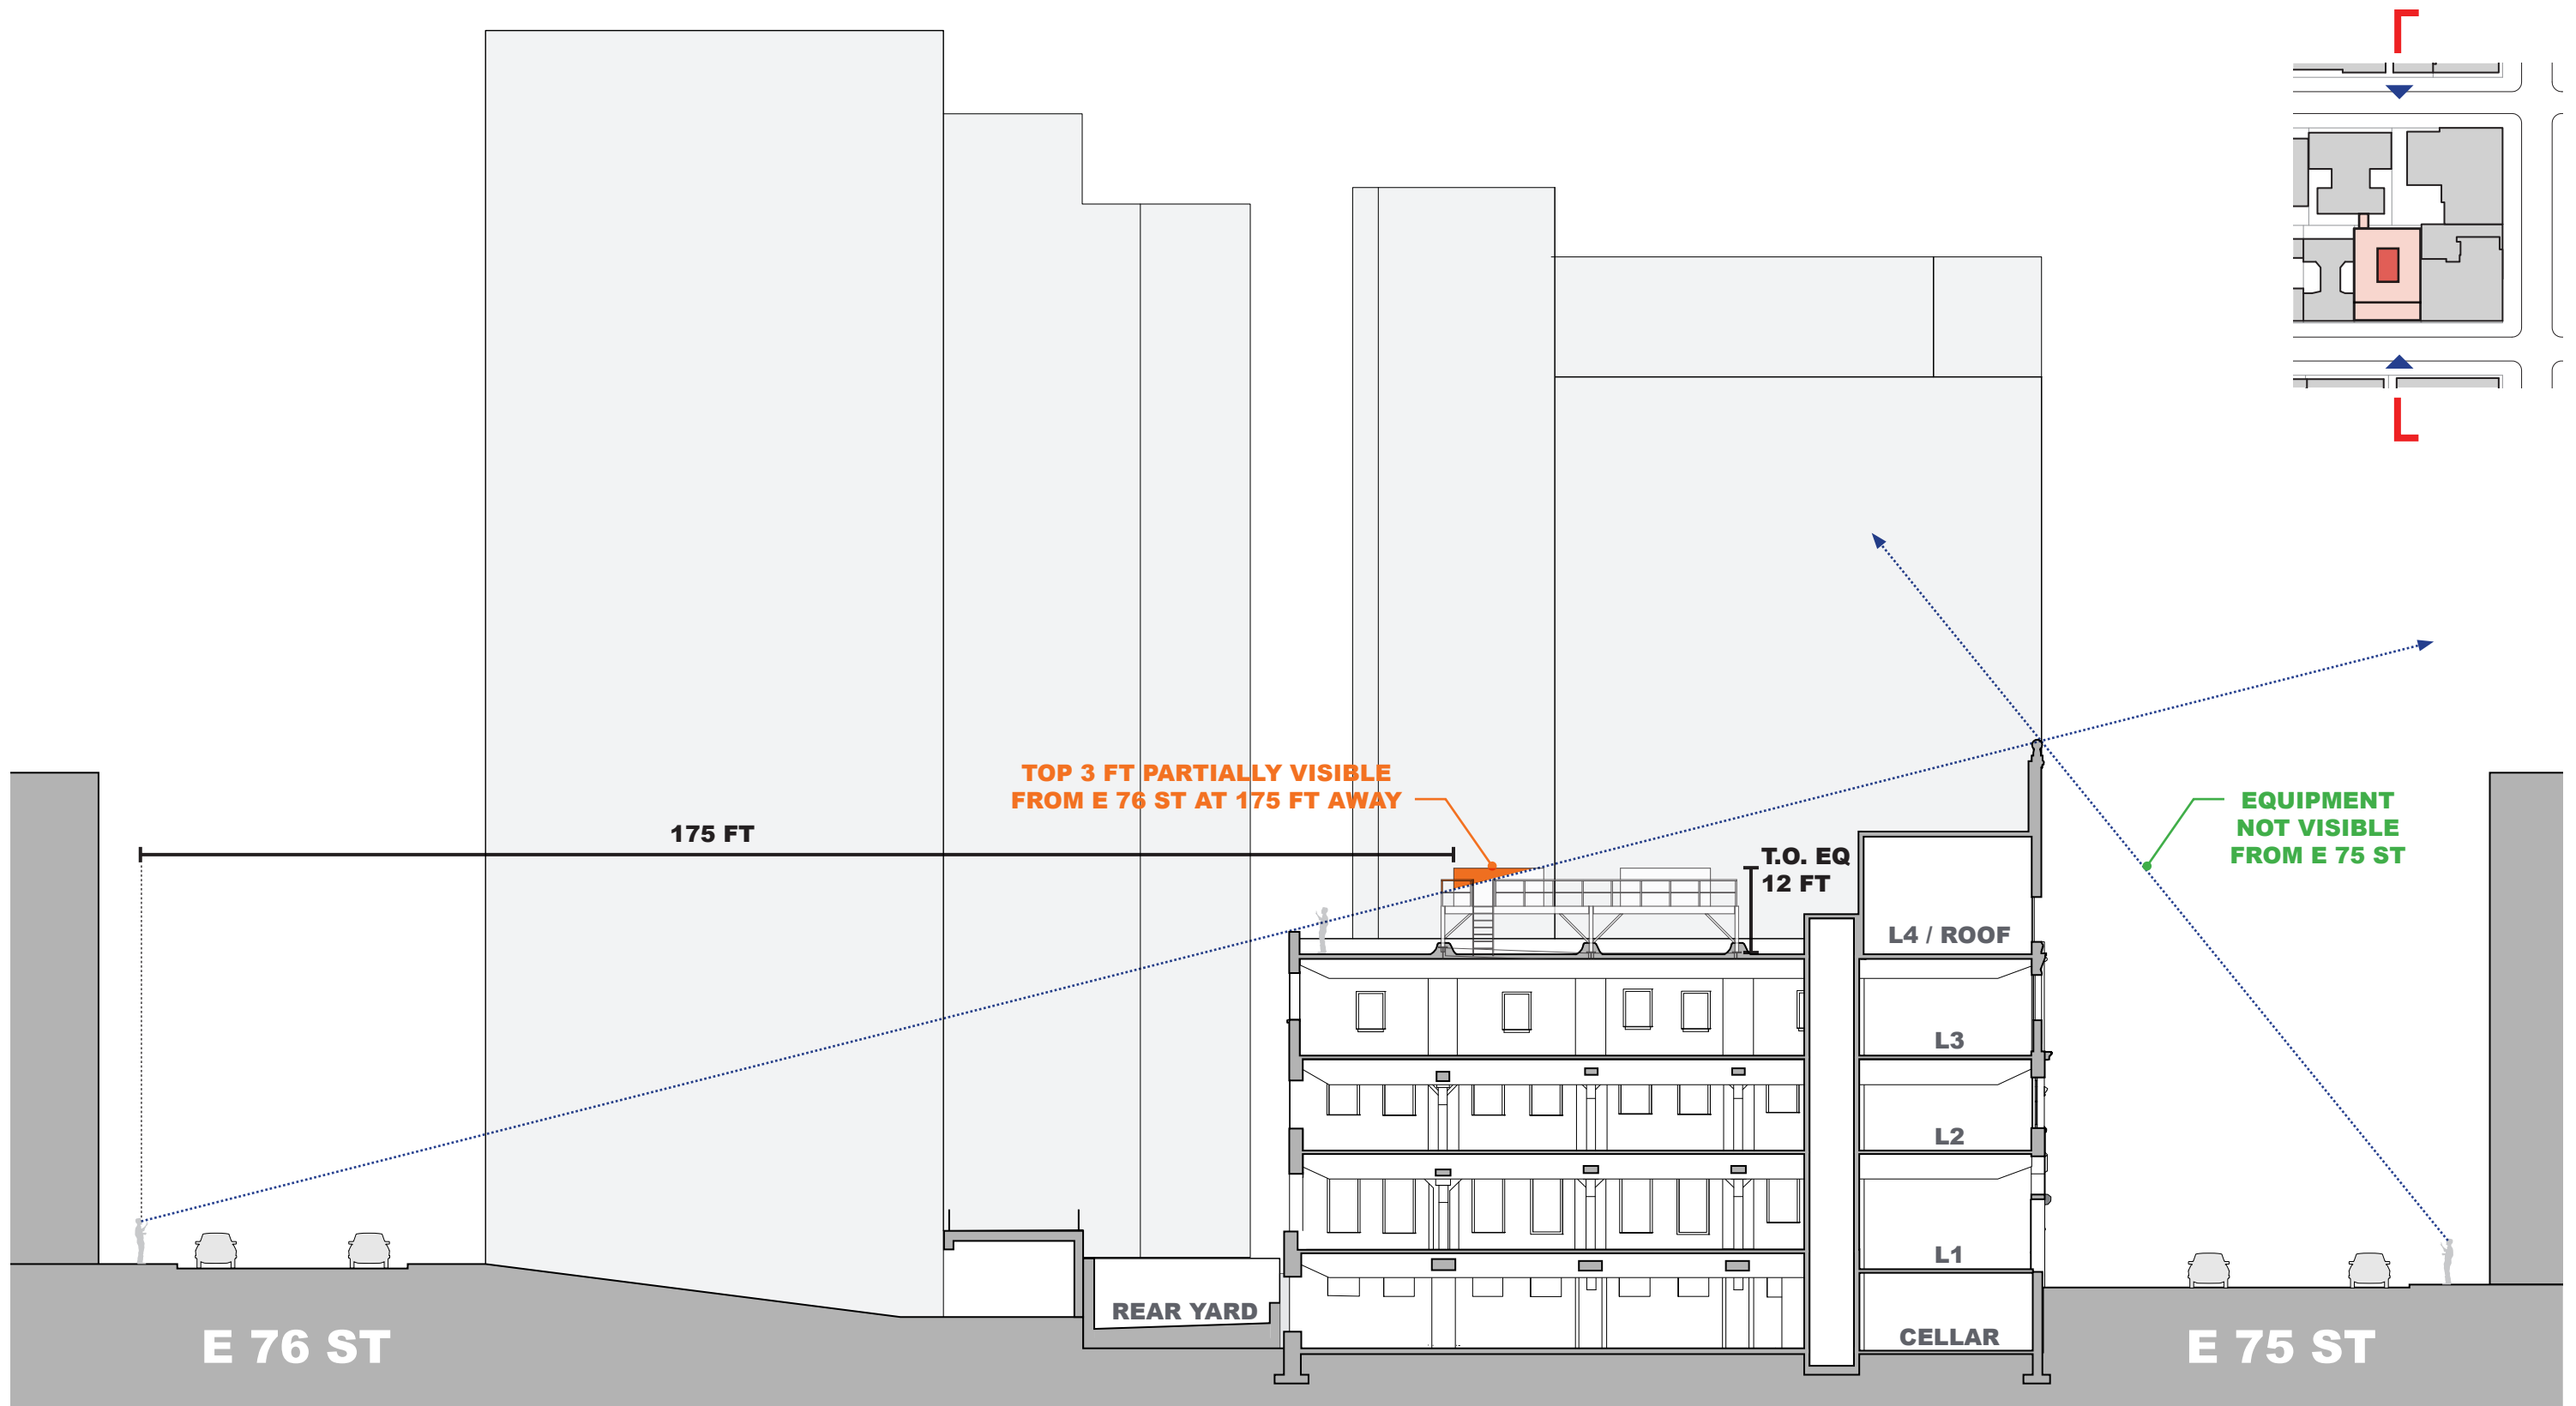
Proposed

Sightlines to Mechanical Equipment — 76 St 'gap'
