John Jay Park

Located on FDR Drive between East 76th and 78th Streets,
in the Borough of Manhattan.

Community Board 8 Meeting
January 10, 2019
Tyler Parlato, NYC Parks

John Jay Park | Project Location

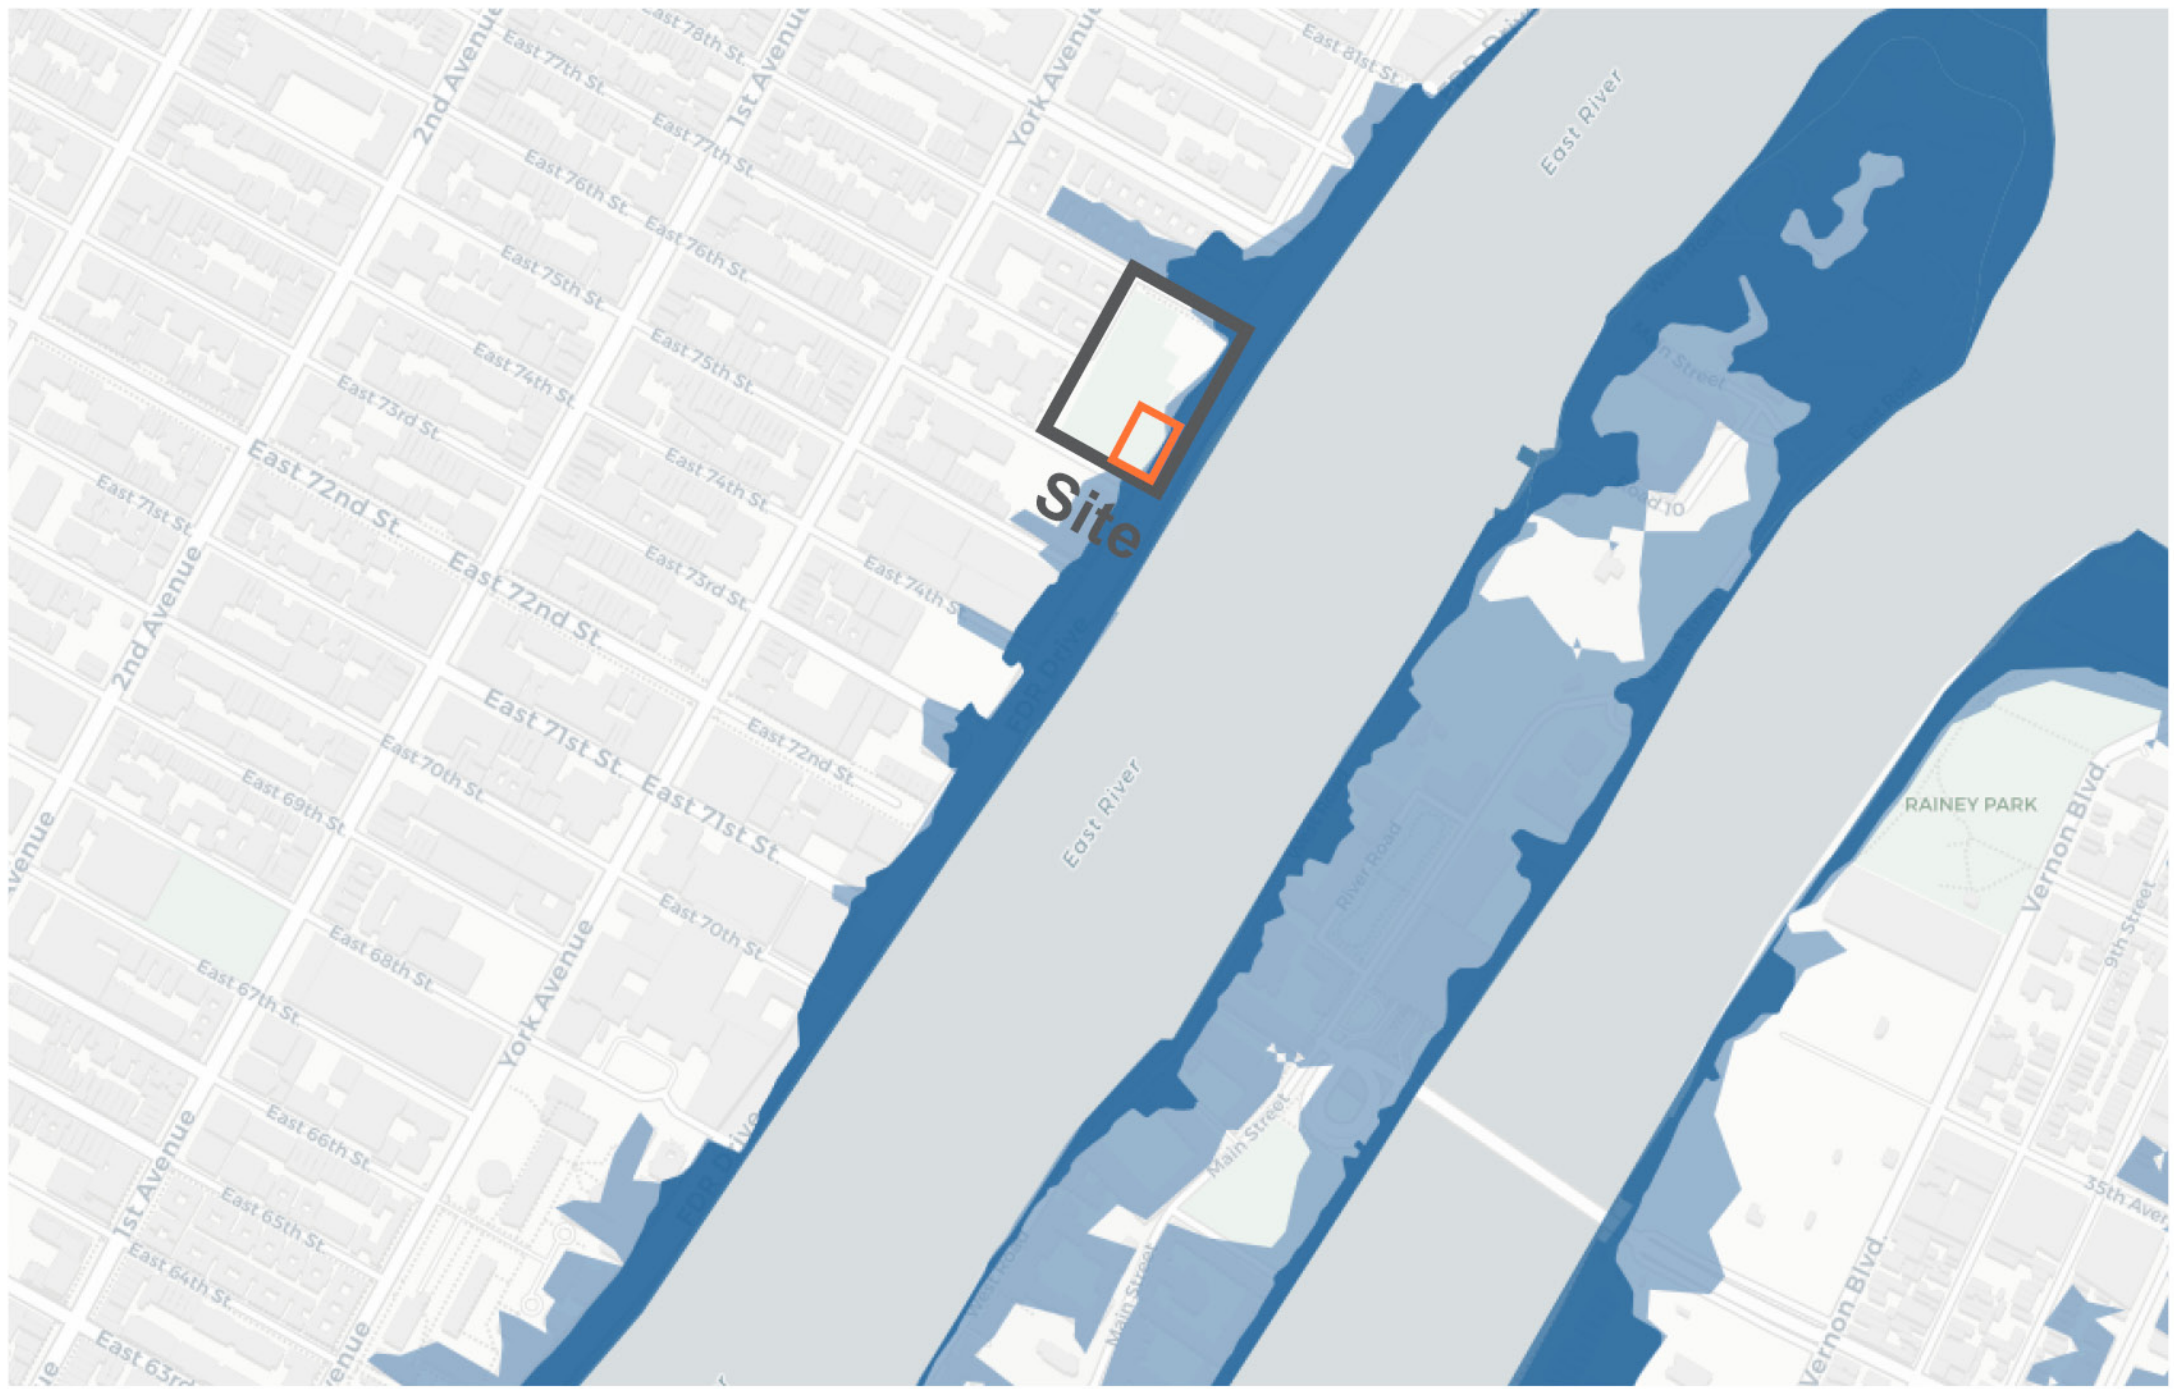
Flood Hazard Zones

2015 Preliminary 100-year Floodplain

1% Annual Chance Floodplain (100 Year Floodplain) The area that has a 1% chance of flooding in any given year.

2050s Projected 100-year Floodplain

The potential areas that could be impacted by the 100-Year flood in the 2050s based on projections of the high-estimate 90th percentile sea level rise scenario (NYC Panel on Climate Change (NPCC) 2015 data).

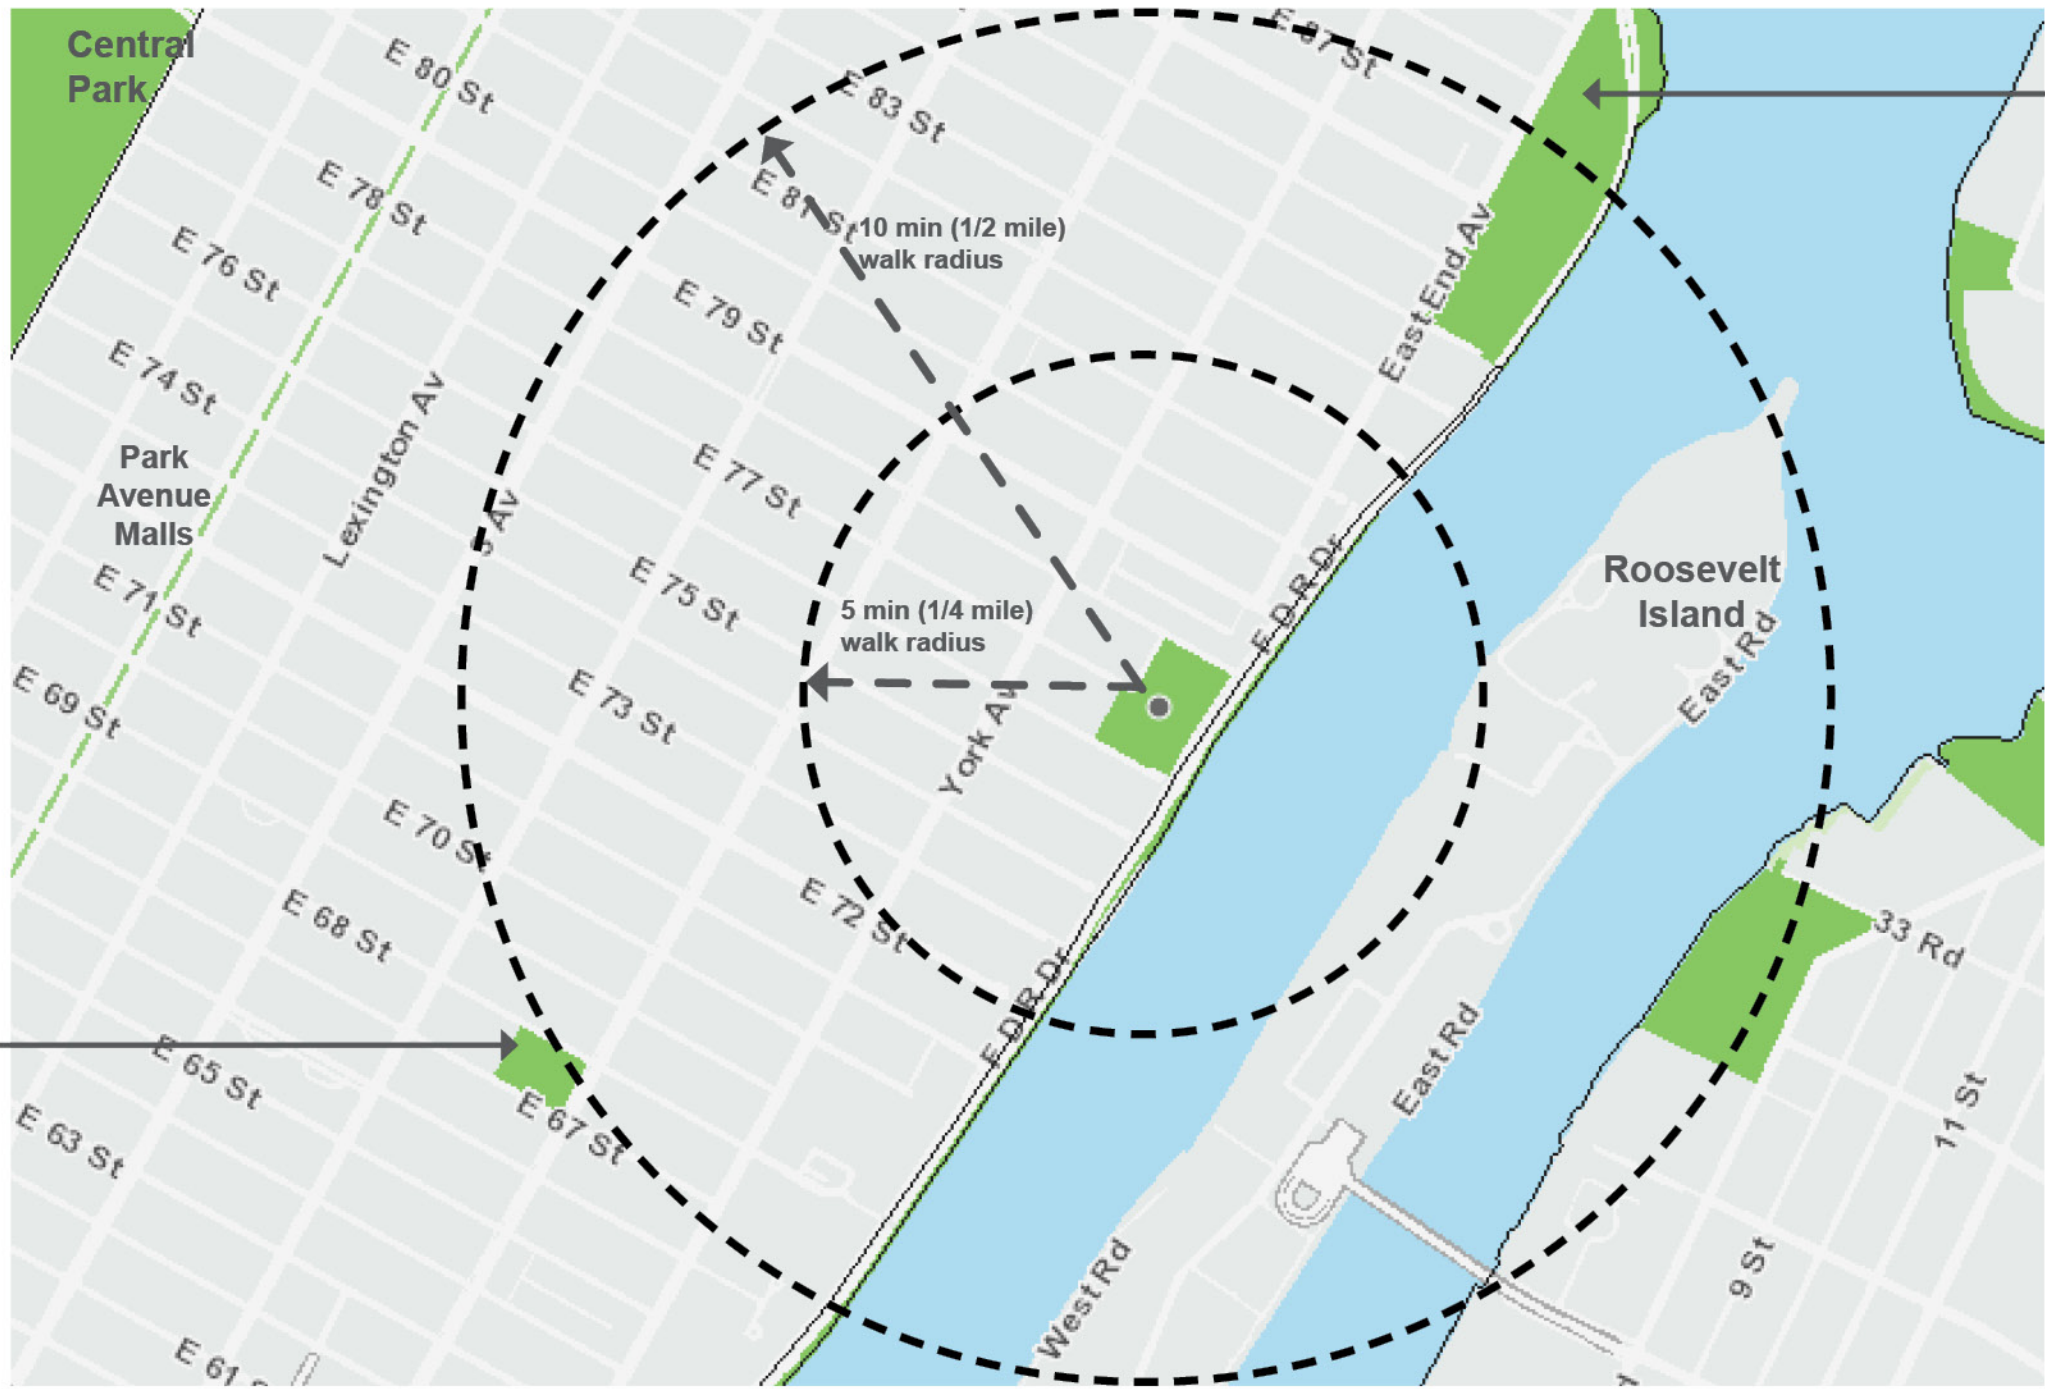
John Jay Park | Neighborhood Context

Carl Schurz Park
 Comfort Station
 Basketball
 Play Equipment
 Spray Shower
 Roller Hockey
 Dog Run

St. Catherine's Park
 Comfort Station
 Handball
 Tennis
 Basketball
 Play Equipment

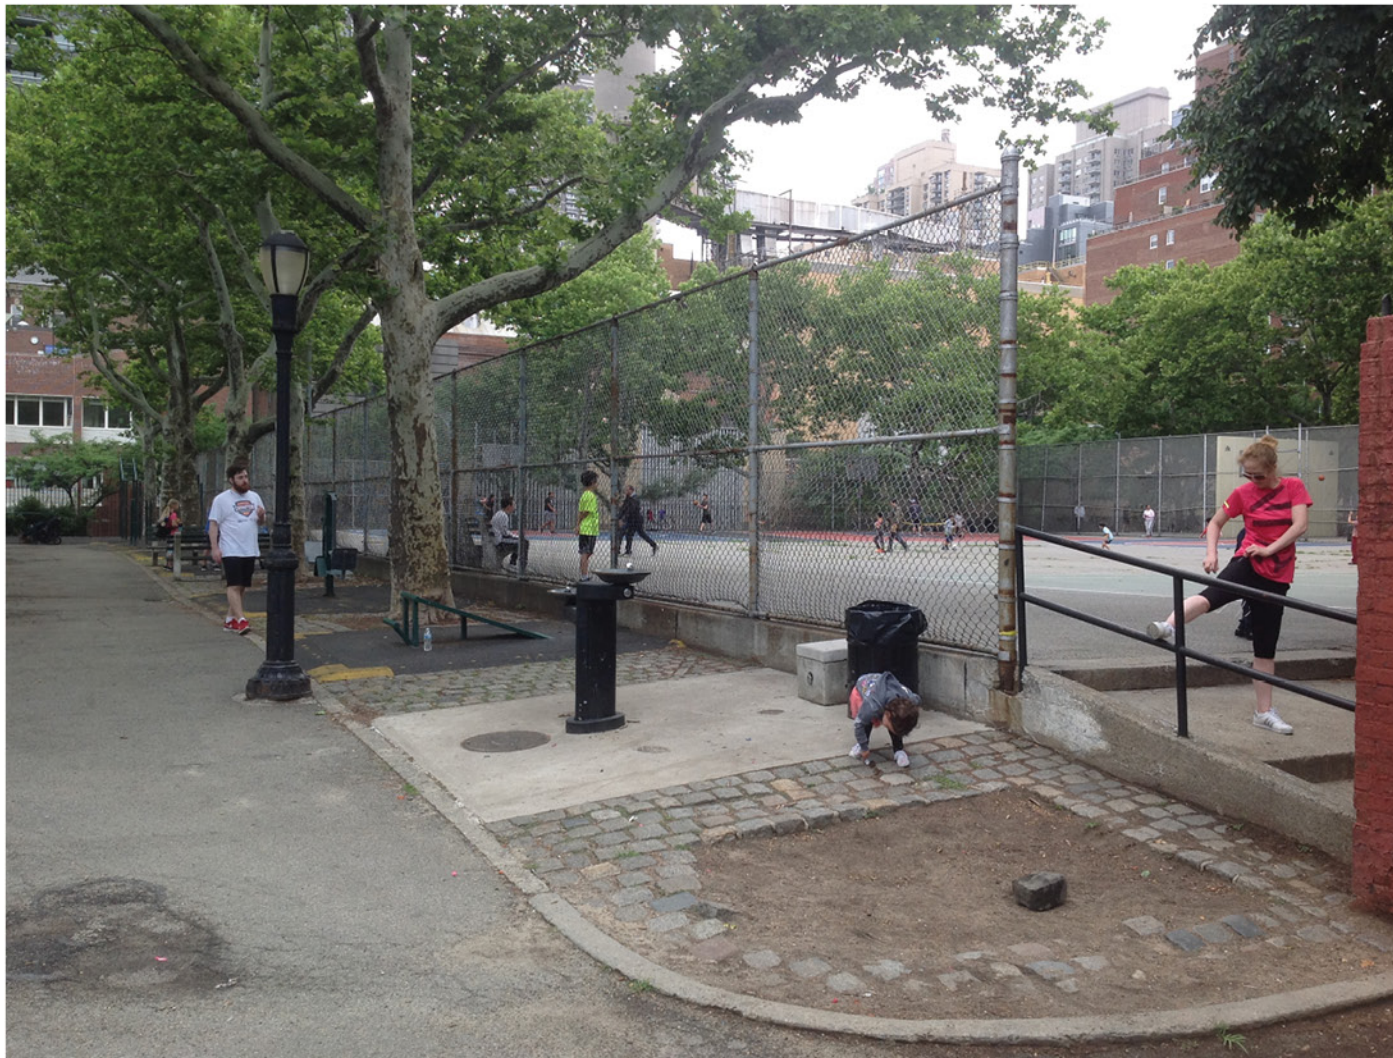
1 - View of Drinking Fountain looking South

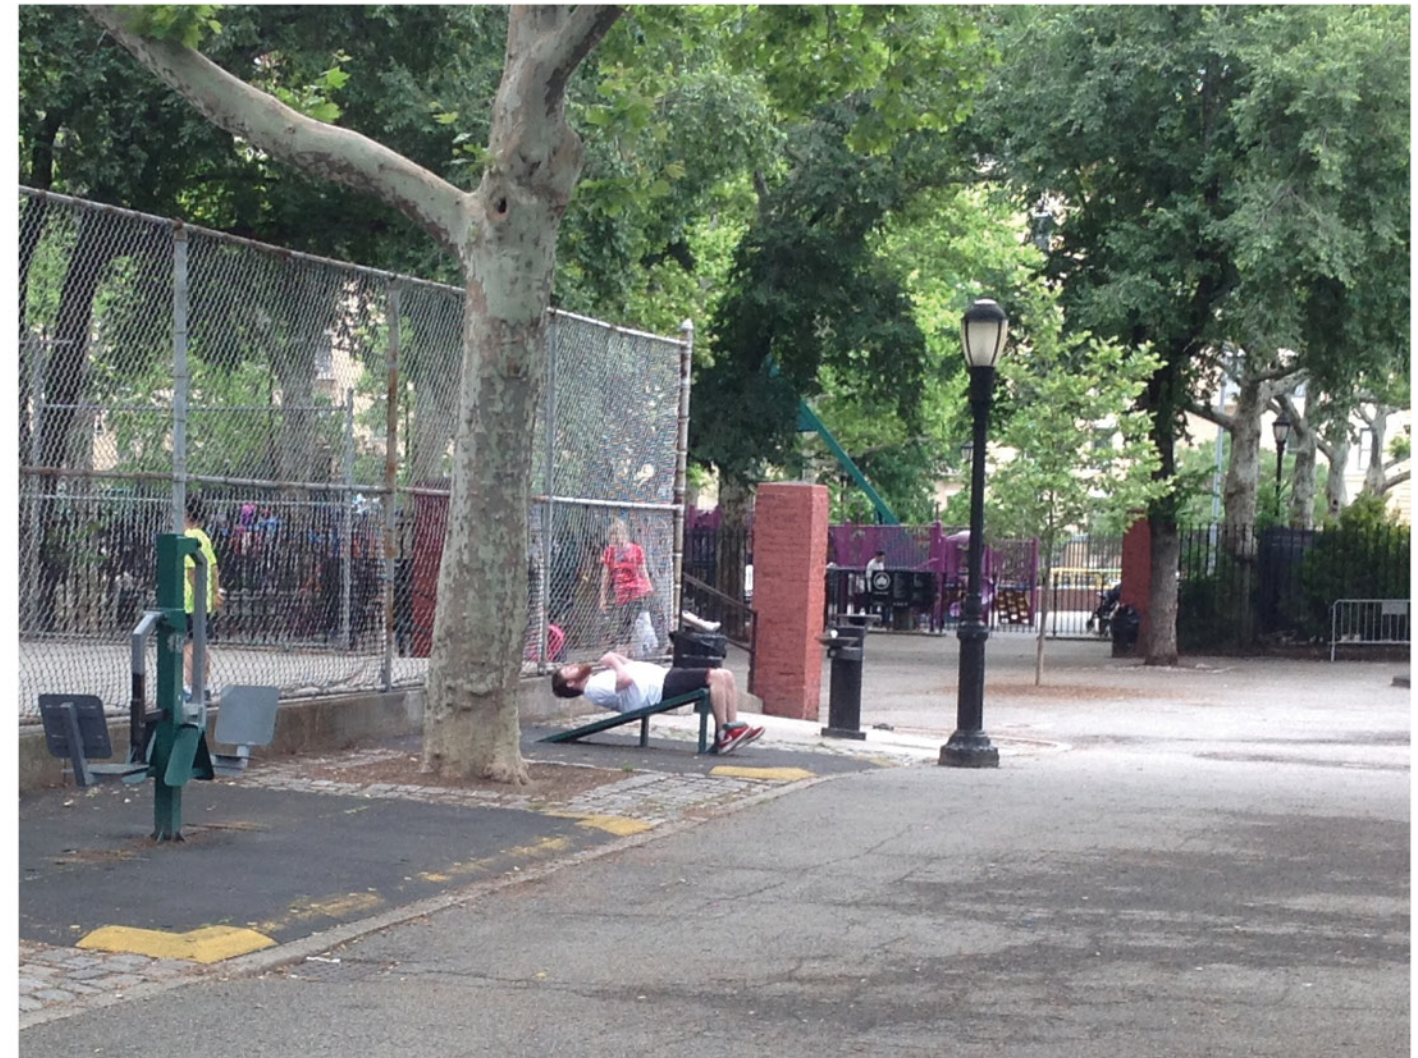
2 - View of Entrance and Fitness Equipment looking North

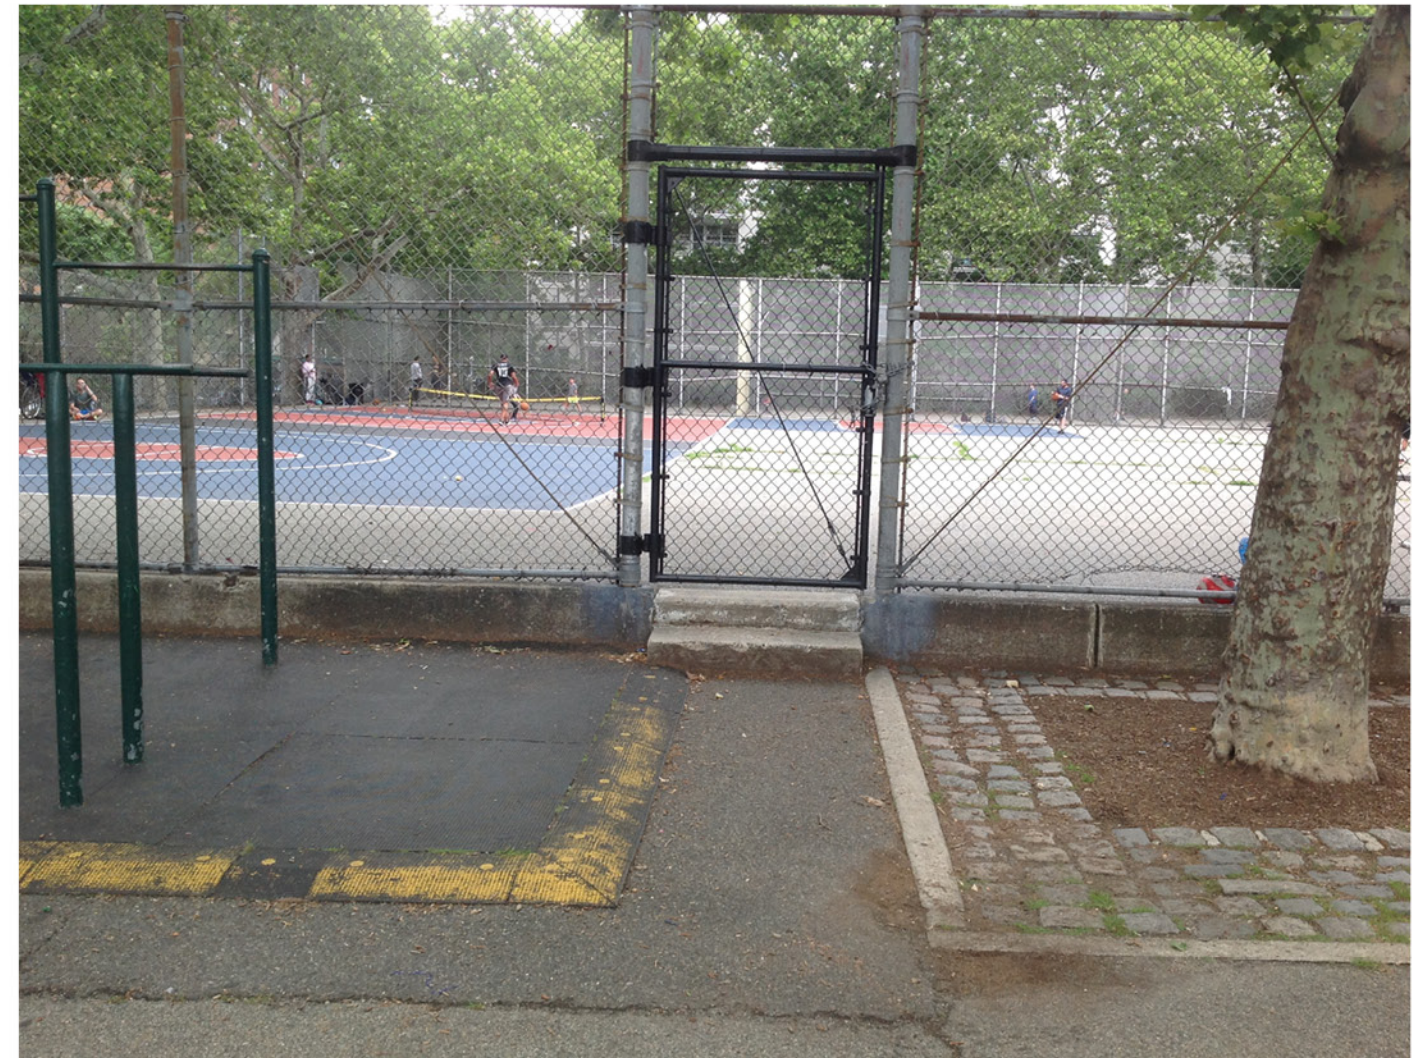
2 - View of Entrance to MPPA looking West

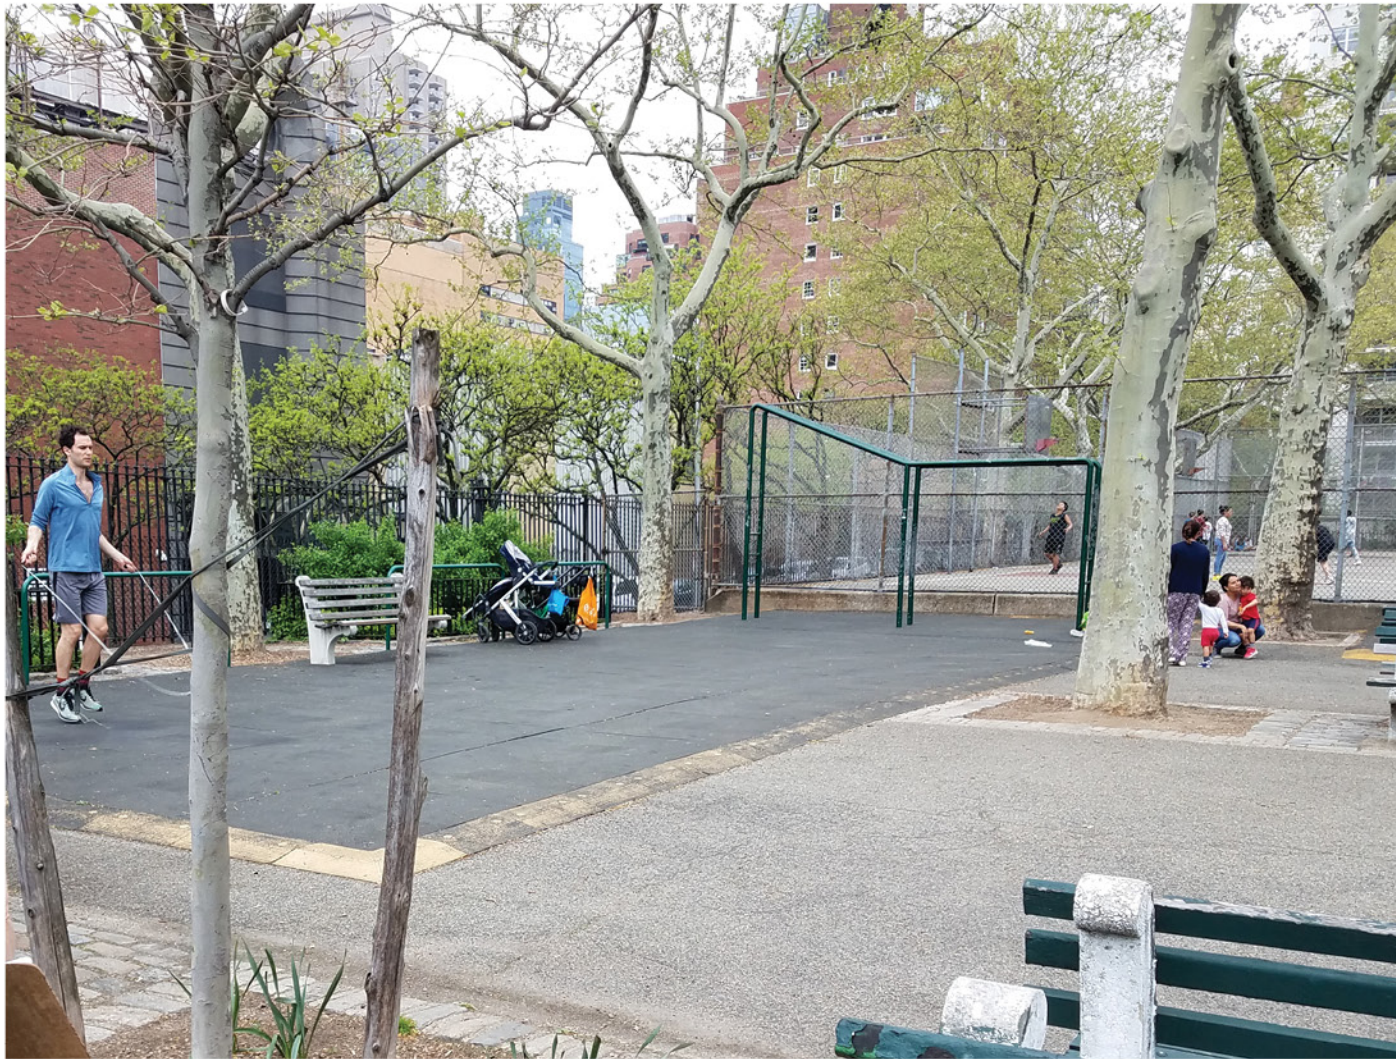
1 - View of Fitness Equipment and Yoga Area looking West

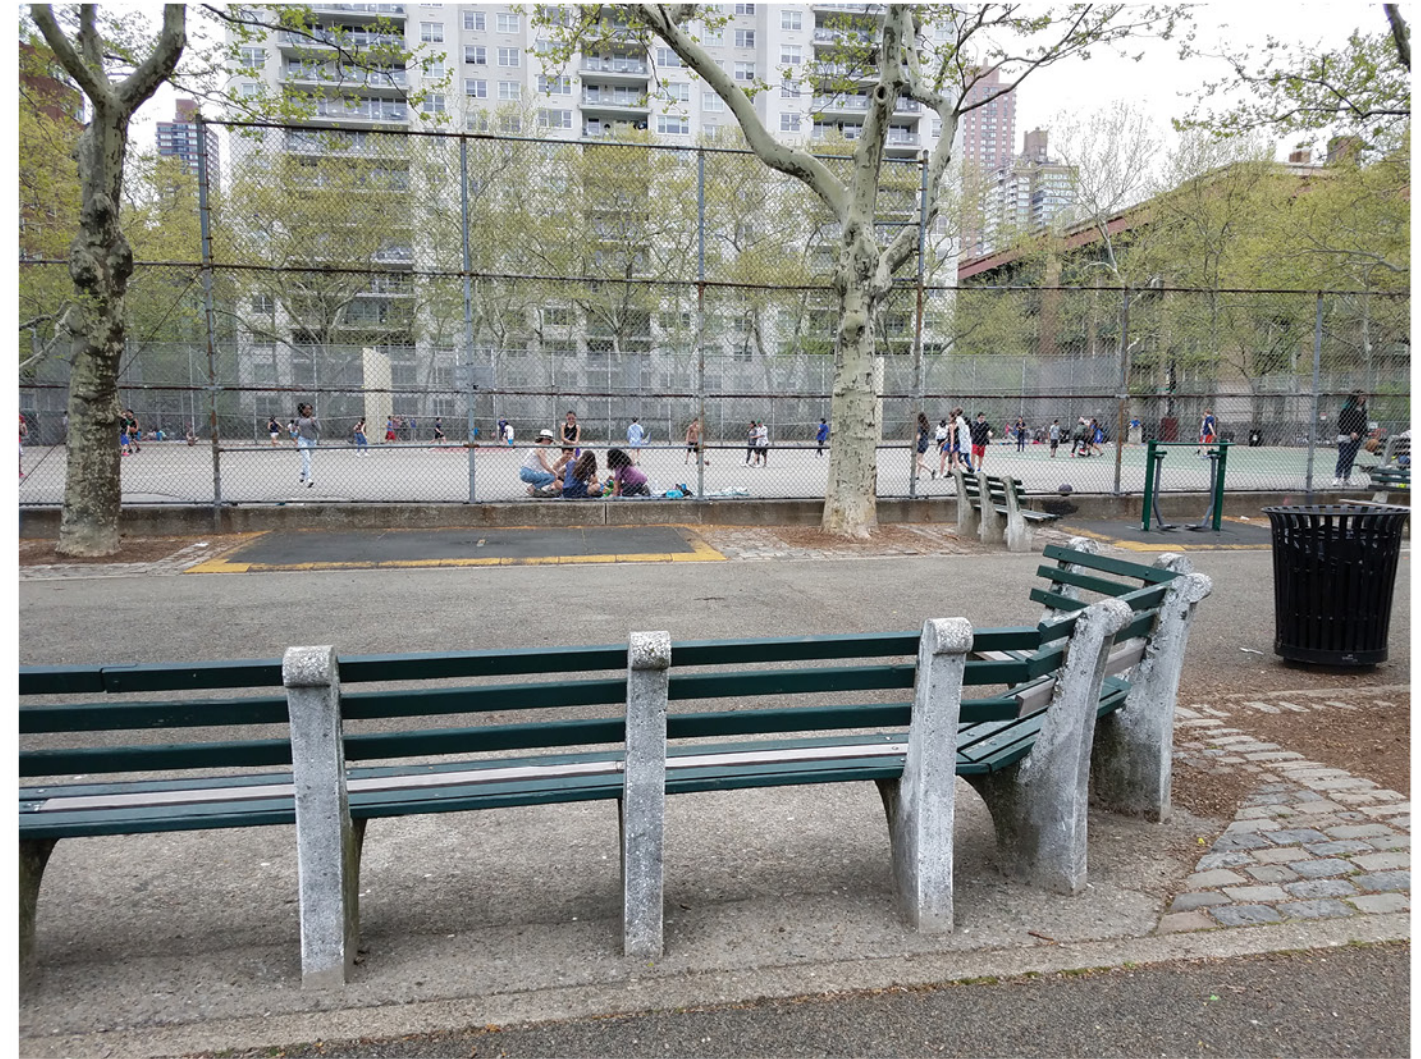
2 - View of Safety Surfacing with Fitness Equipment Removed
