# East River Esplanade

## CB8 Meeting

April 11, 2018

## E 88th - E 90th St

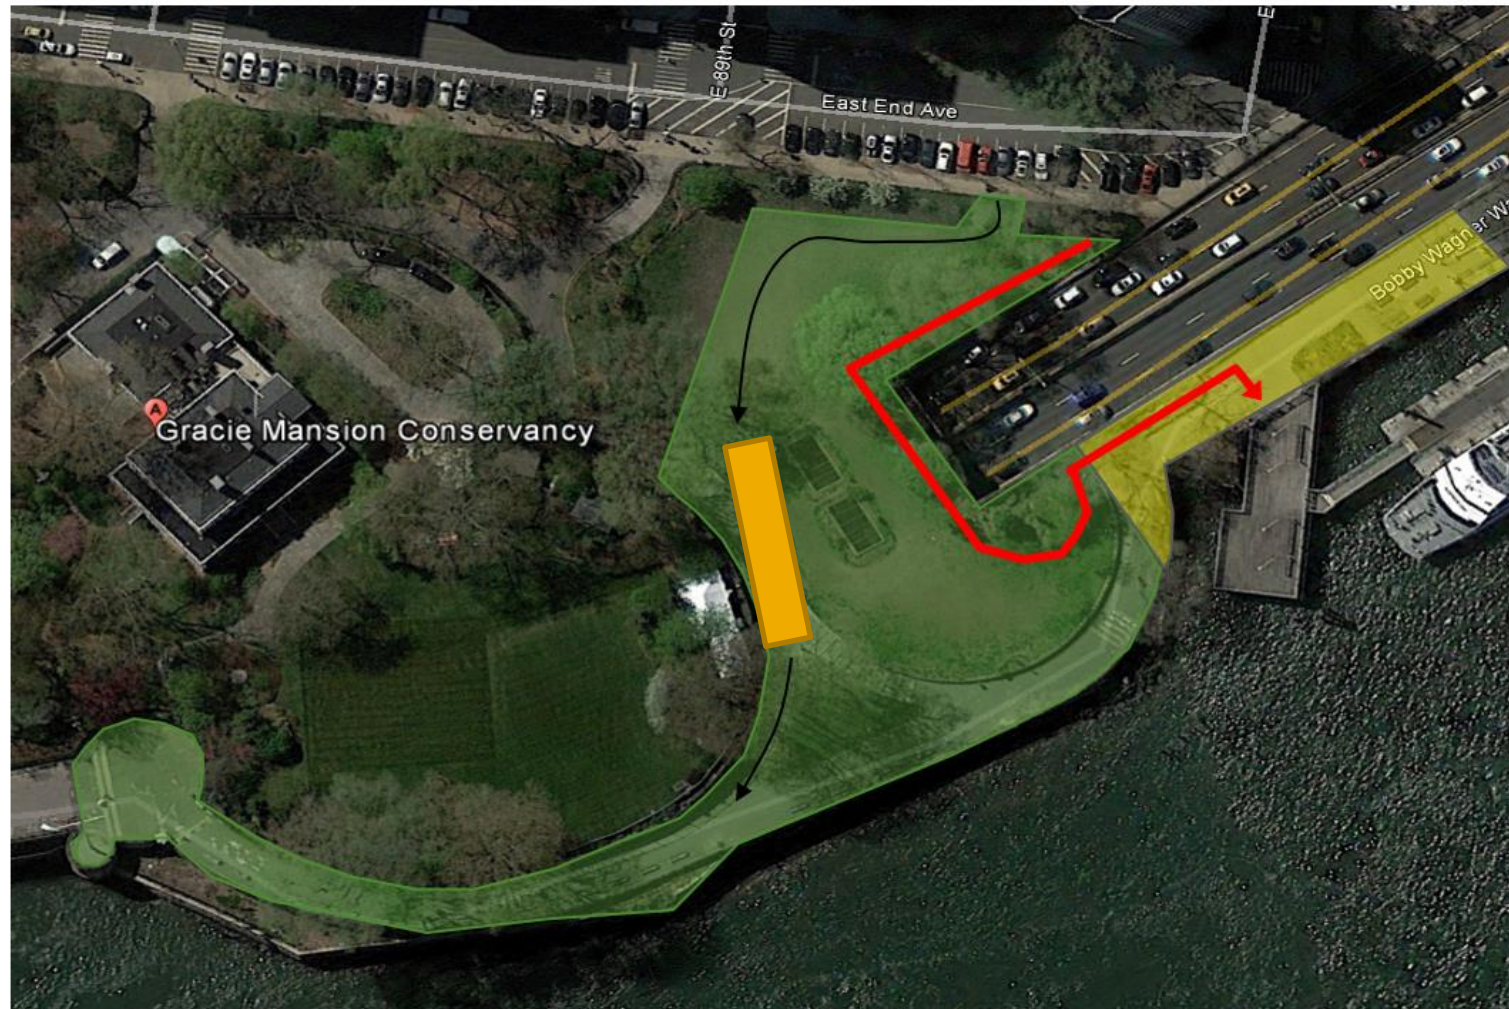
Open to Public

In Progress

→ Temporary Ferry Access

→ Construction Access

Temporary Bridge
