Carl Schurz Park Security Measures Construction

Located between East End Avenue and FDR Drive, in the borough of Manhattan

CB 8 Review Presentation November 7, 2019 NYC Parks, HDR, Thornton Tomasetti, Mathews Nielsen Landscape Architects

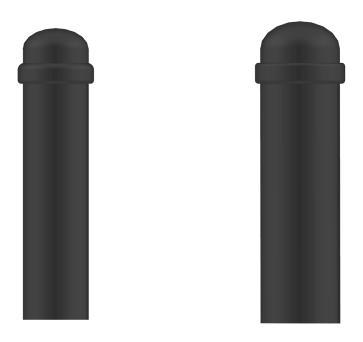
BLACK COATED METAL BOLLARD WITH ROUNDED TOP

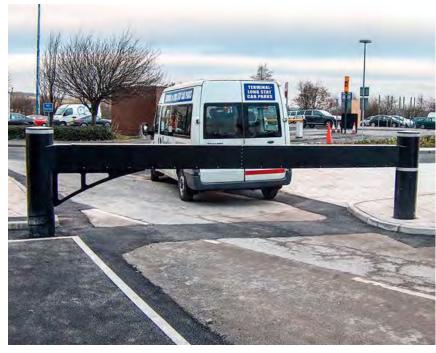
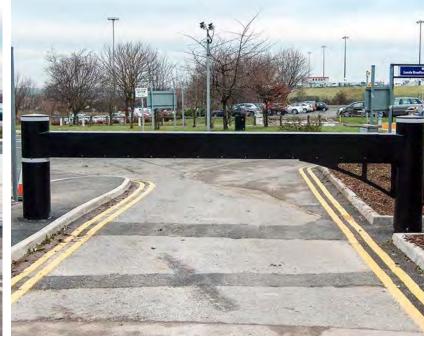
OPERABLE SWING GATE FOR VEHICULAR ENTRANCES

- SWING GATE OPENS 90 DEGREES EITHER OUTWARD OR INWARD AND DOES NOT SWING MORE THAN 180 DEGREES TOTAL
- MANUAL OPERATION WITH LOCKING PIN THAT IS ENCASED BY ANTI-TAMPER LOCKING MECHANISM; RESISTANT TO ATTACK FROM HAND AND BATTERY POWERED TOOLS
- IMPACT TESTED TO INTERNATIONAL IWA 14-1 SPECIFICATION FOR VEHICLES TRAVELLING AT 50 MPH
- CAN SPAN ENTRANCES UP TO 30'

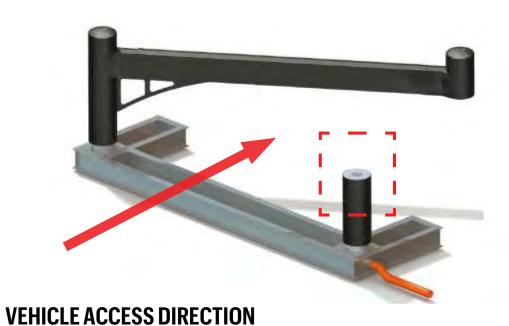
TYPICALLY, SWING GATE OPENS INWARD (TOWARD PROTECTED AREA), BUT IT IS POSSIBLE FOR GATE TO MOVE IN EITHER DIRECTION.

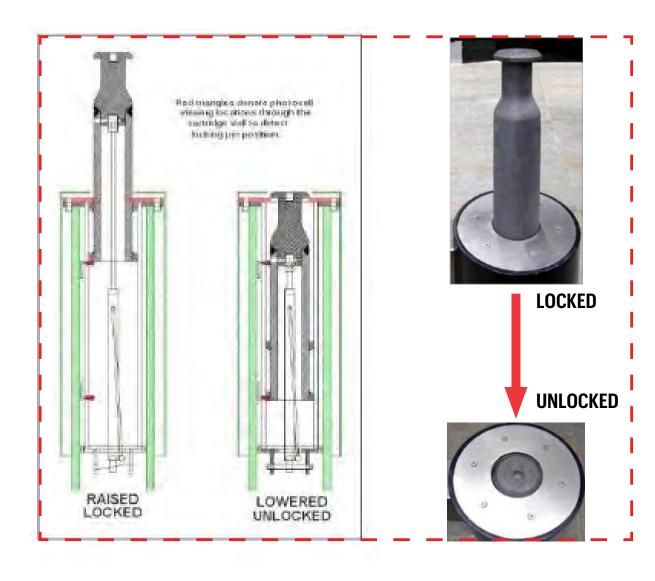
MANUAL LOCKING PIN IS NOT DRIVEN INTO THE GROUND, SO THERE IS LITTLE RISK OF DEBRIS PREVENTING THE PIN FROM FUNCTIONING. LOCKING PIN IS OPERATED BY HAND CRANK/PUMP. HAND CRANK/PUMP IS IN A SECURE LOCKED BOX AND IS ONLY ACCESSIBLE TO THOSE WHO HAVE A KEY. GATE CAN BE OPERATED BY ONE PERSON WITH THE USE OF A LATCH POST.

GATE LATCH POST PREVENTS SWING ARM FROM DAMAGING SURROUNDING STRUCTURES AND/OR VEHICLES PROCEEDING THROUGH GATE.

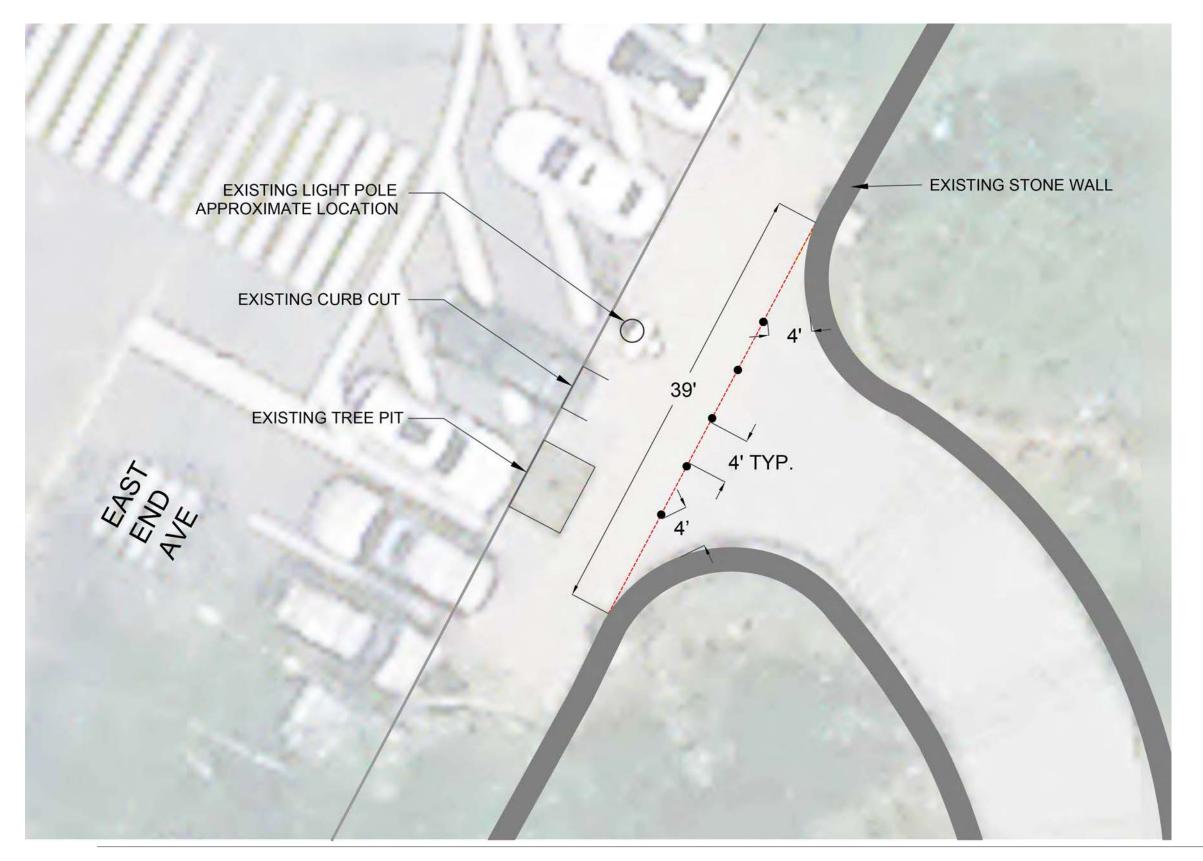
LOCATION1[Low Risk]

8.75" Diameter Fixed Bollard

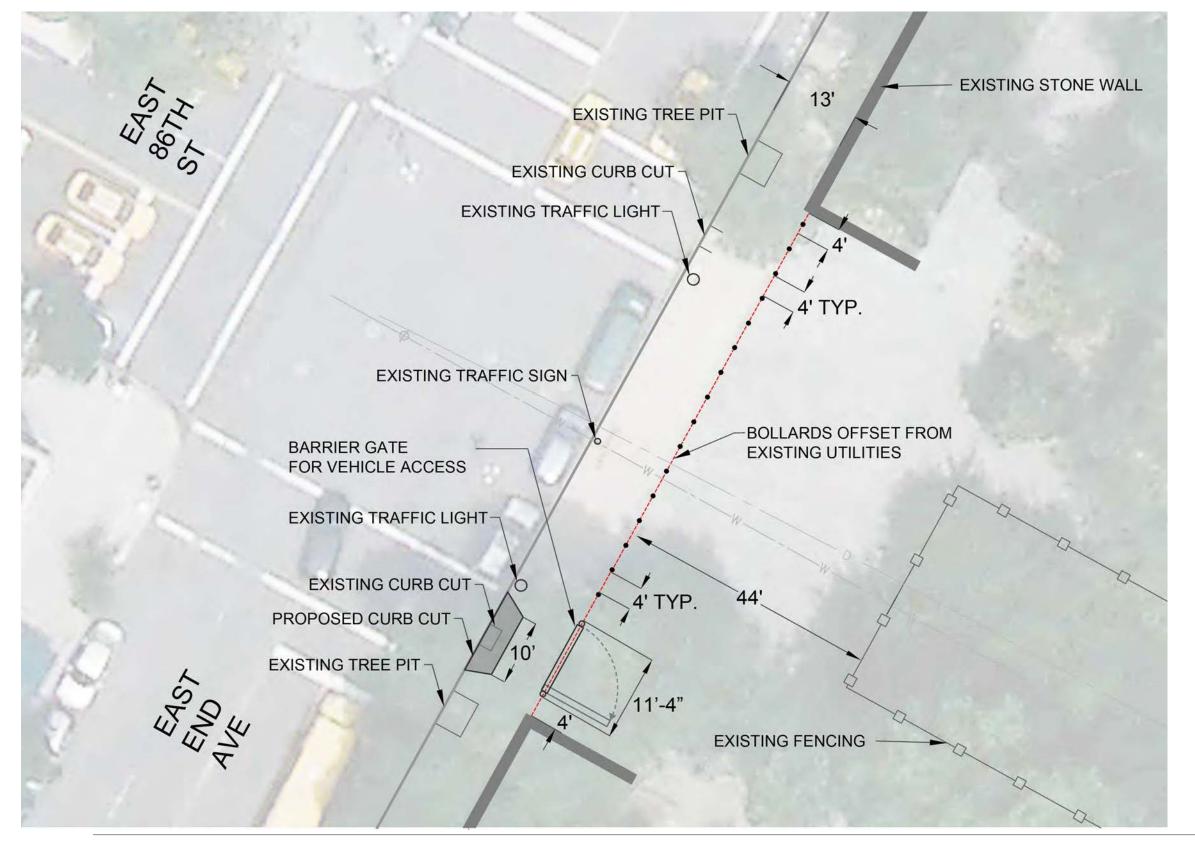
LOCATION 4 [High Risk]

10.75" Diameter Fixed Bollard

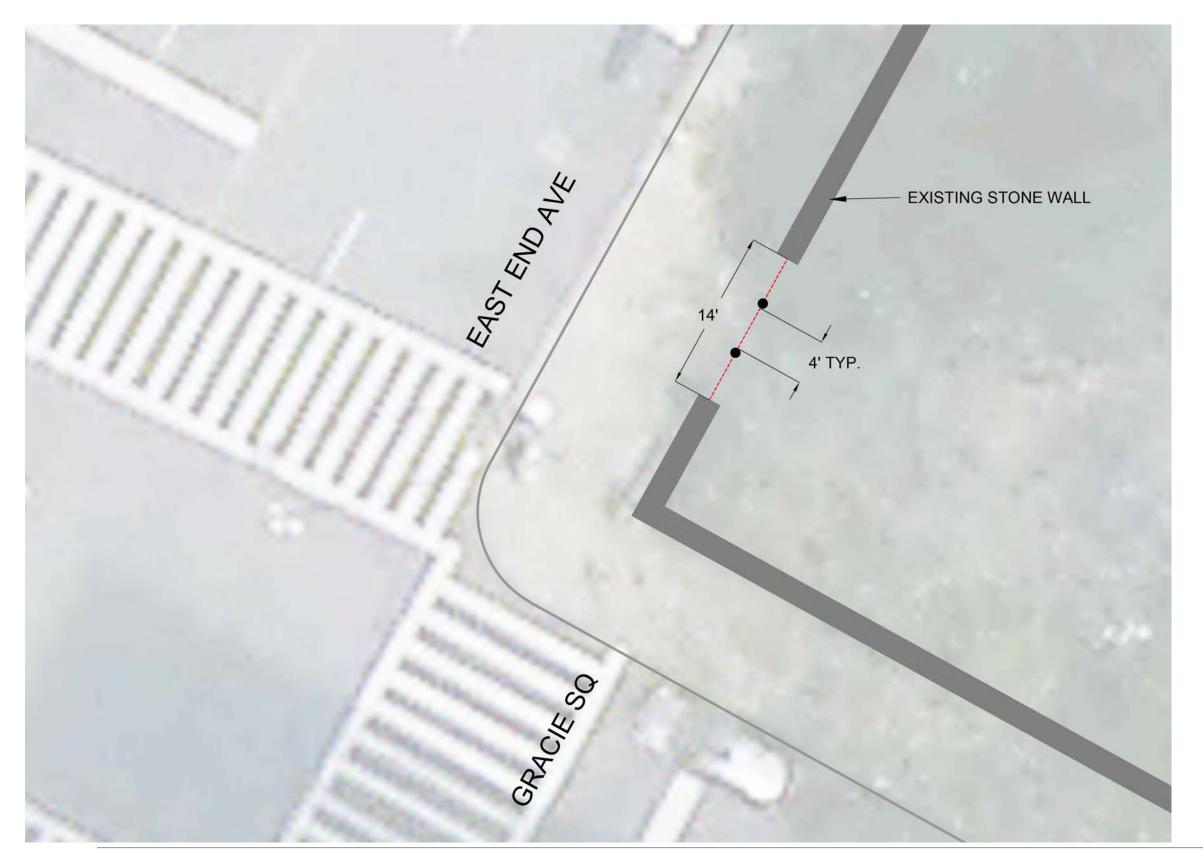
LOCATION 5 [Low Risk]

8.75" Diameter Fixed Bollard

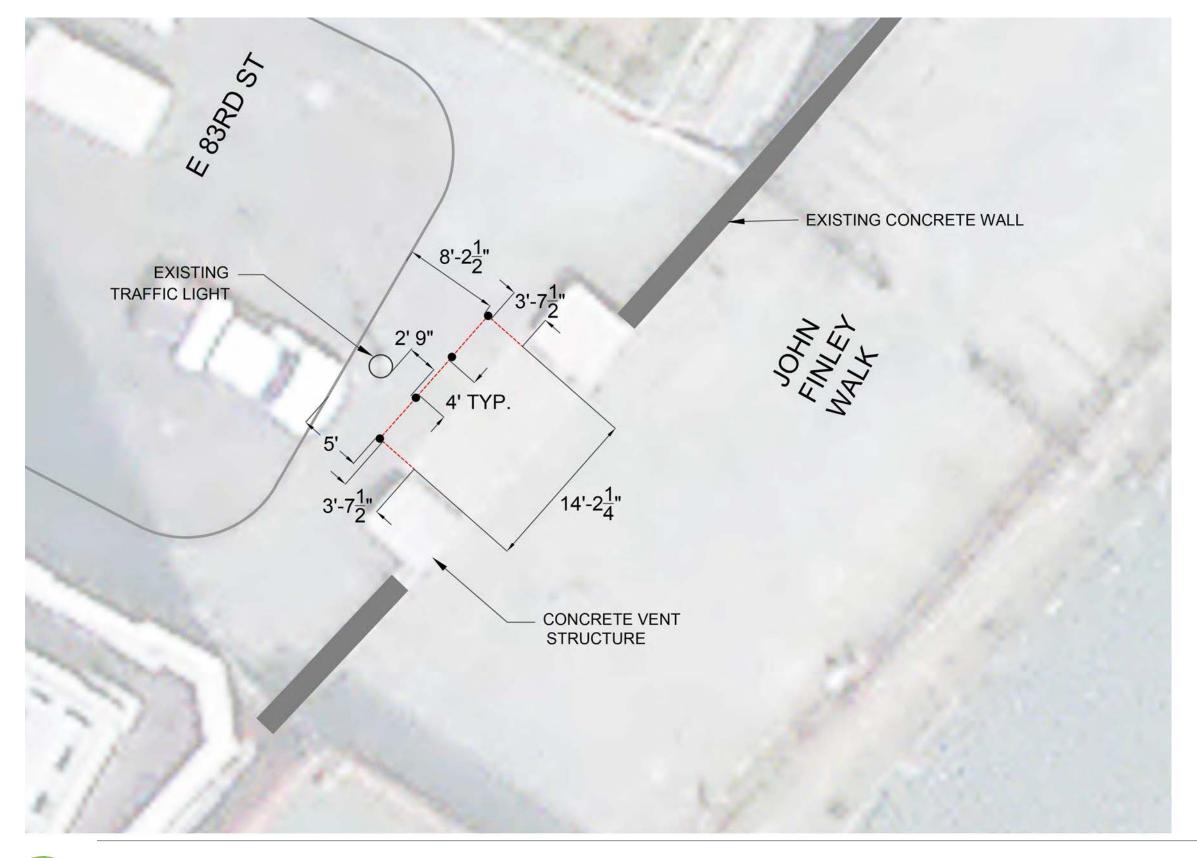
LOCATION 7 [Low Risk]

8.75" Diameter Fixed Bollard
