Saint Catherine's Park Safety Surface Replacement

Located on First Avenue between East 67th and east 68th Streets,
in the Borough of Manhattan

Community Review 8 Review
June 9, 2020
Christopher M. Crowley, RLA

- Replace deteriorated safety surface and asphalt base
- Install a new tot swing to meet current code
- Replace deteriorated spray shower pavement if funding allows

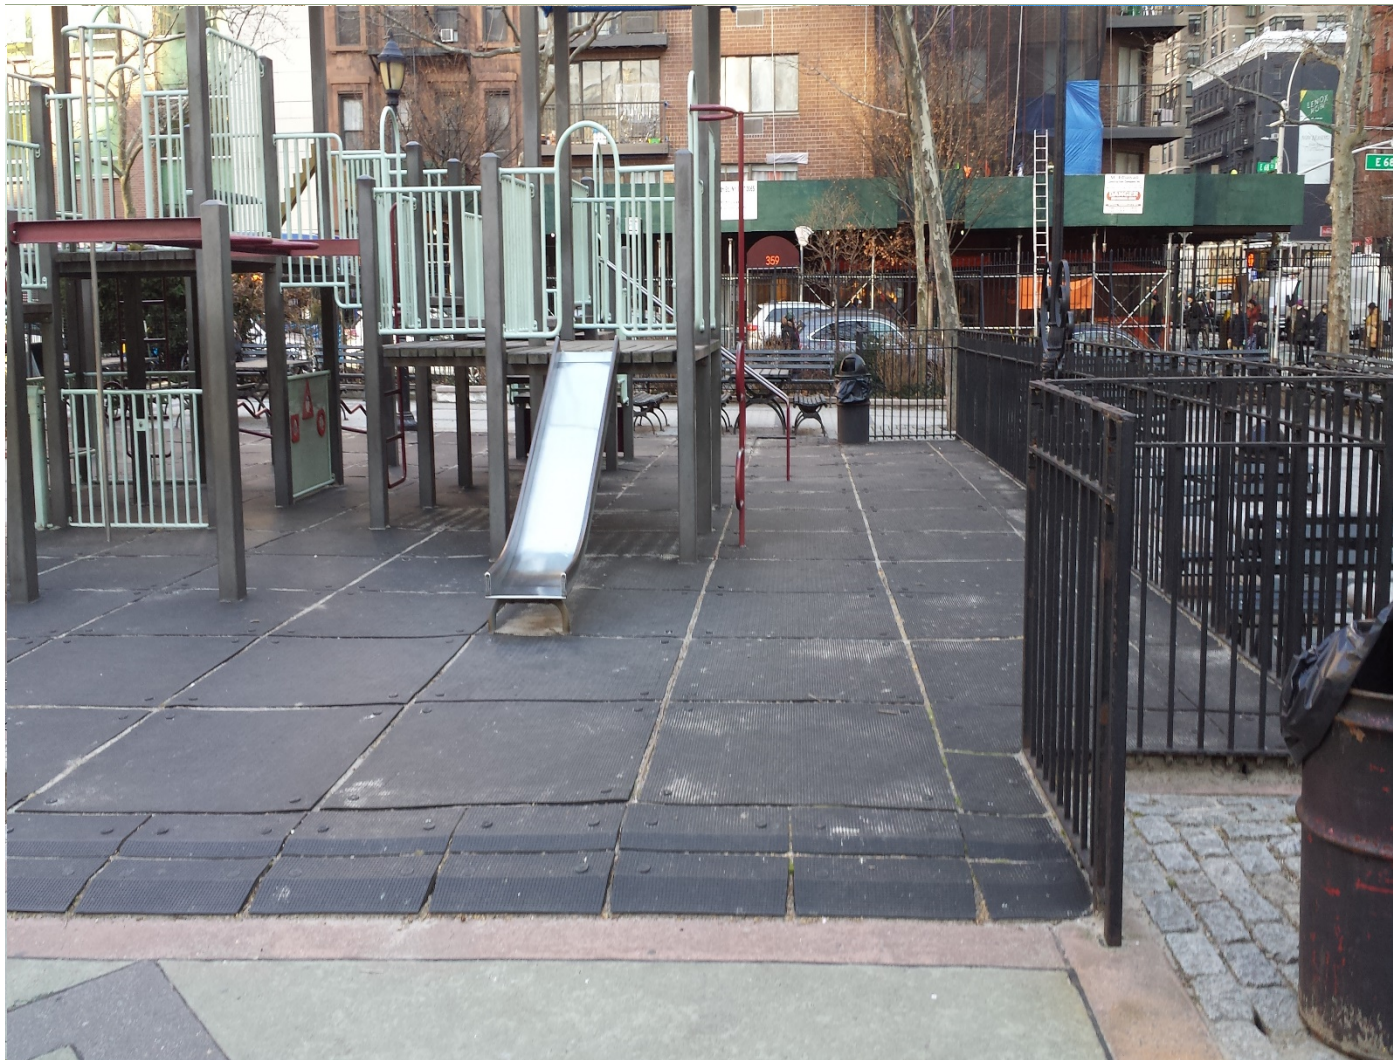
1) 5-12 Year-Old Play Area, Looking North

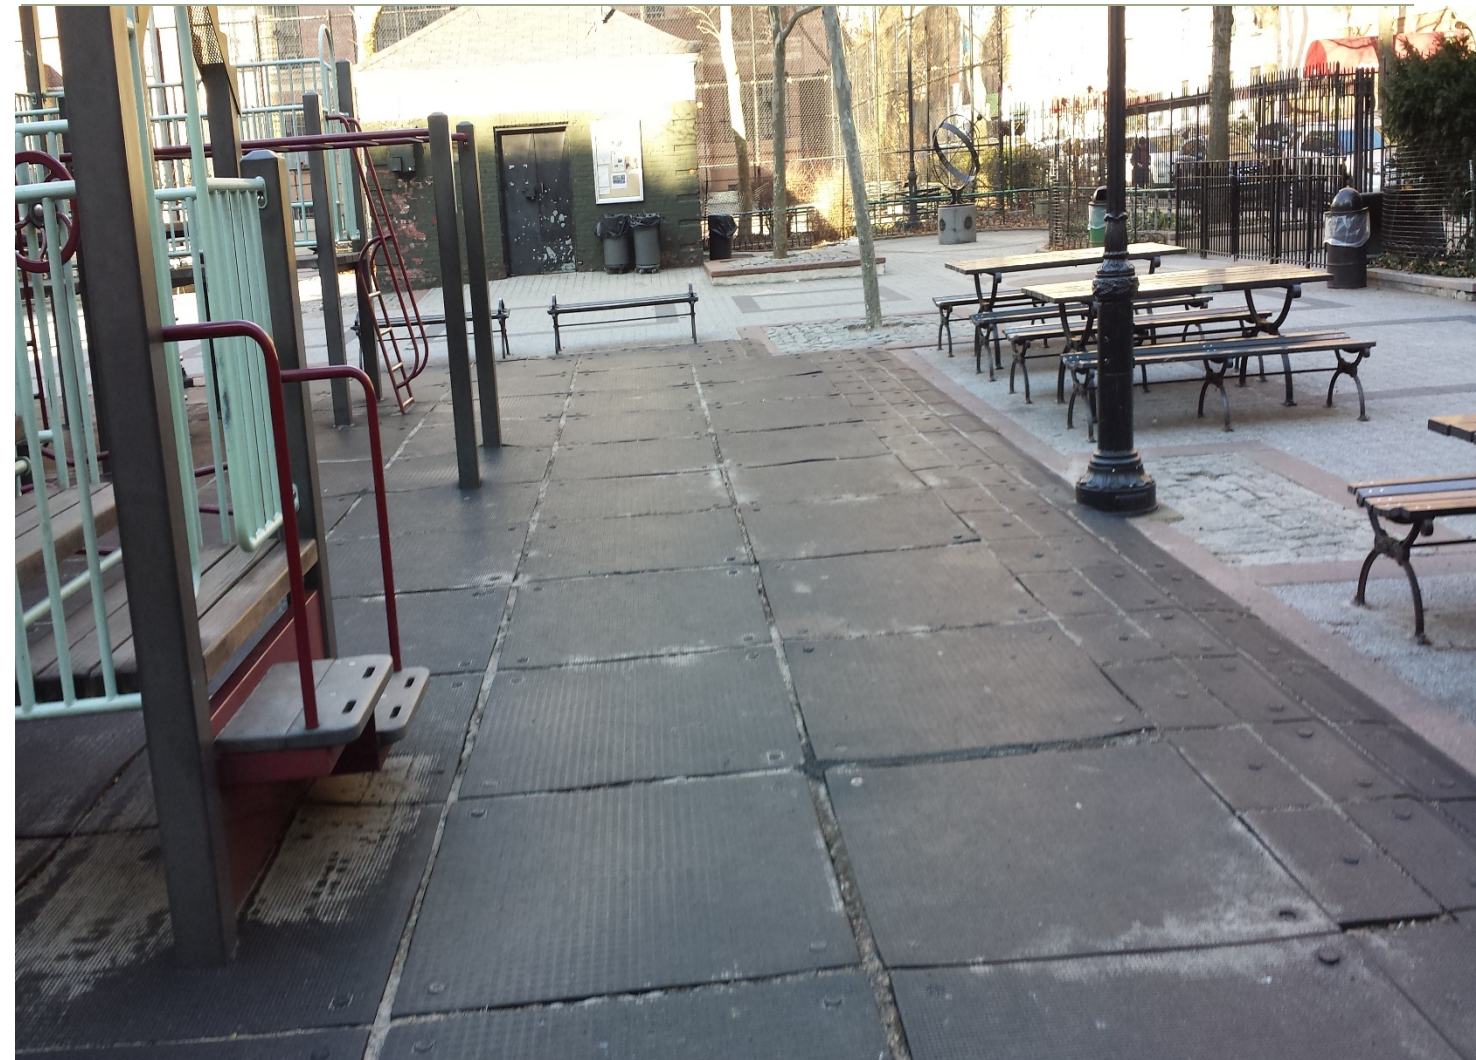
2) 5-12 Year-Old Play Area, Looking West

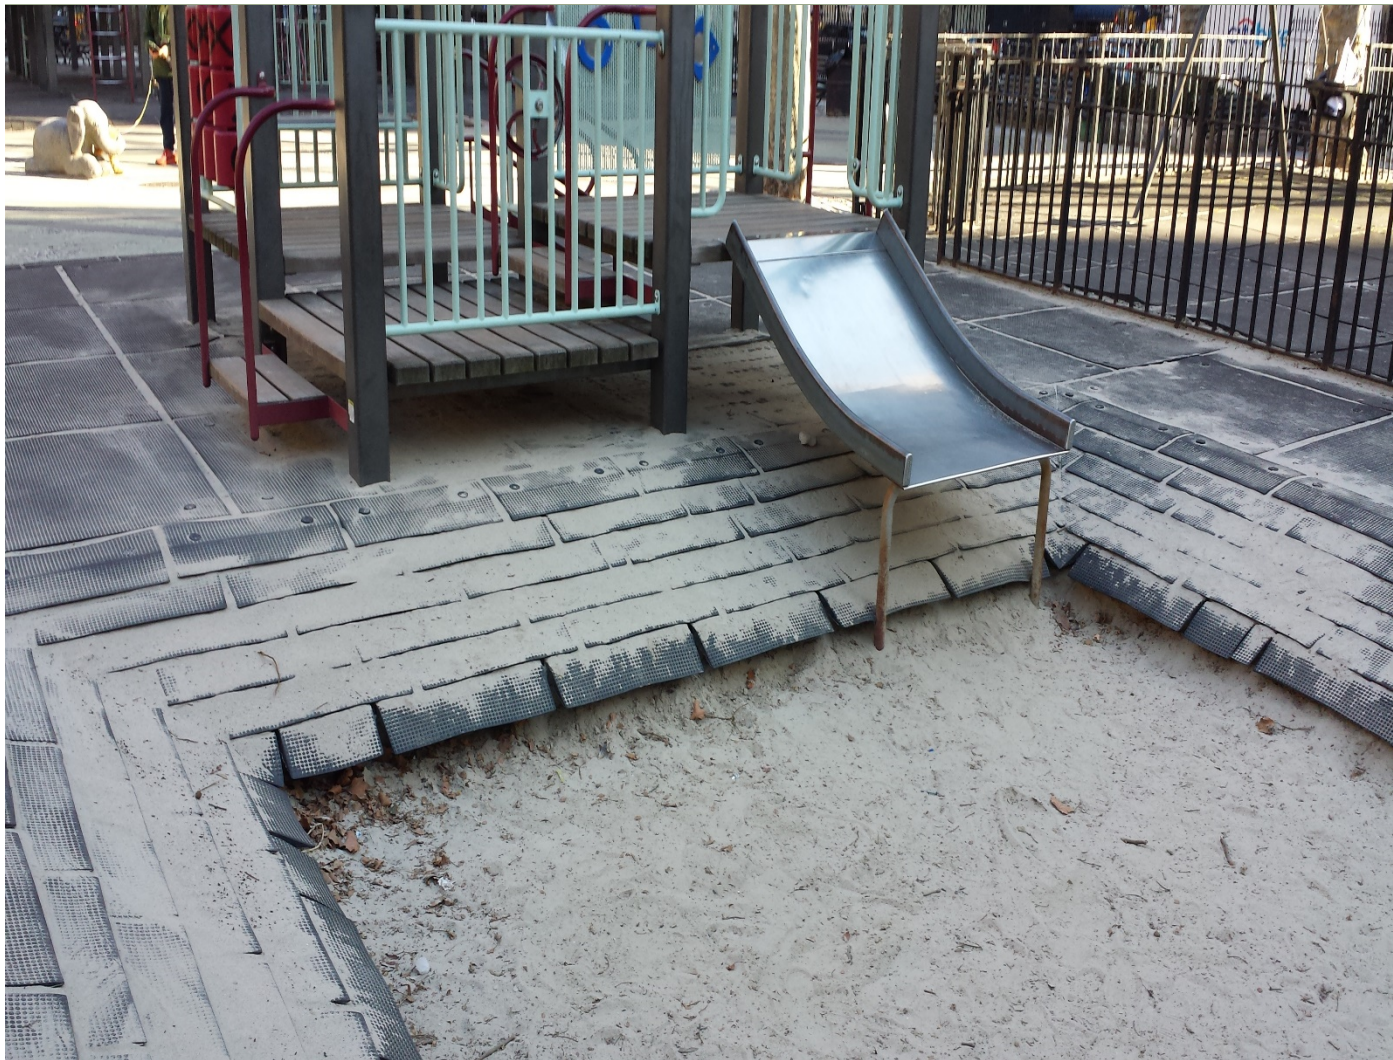
1) 2-5 Year-Old Play Area, Looking North

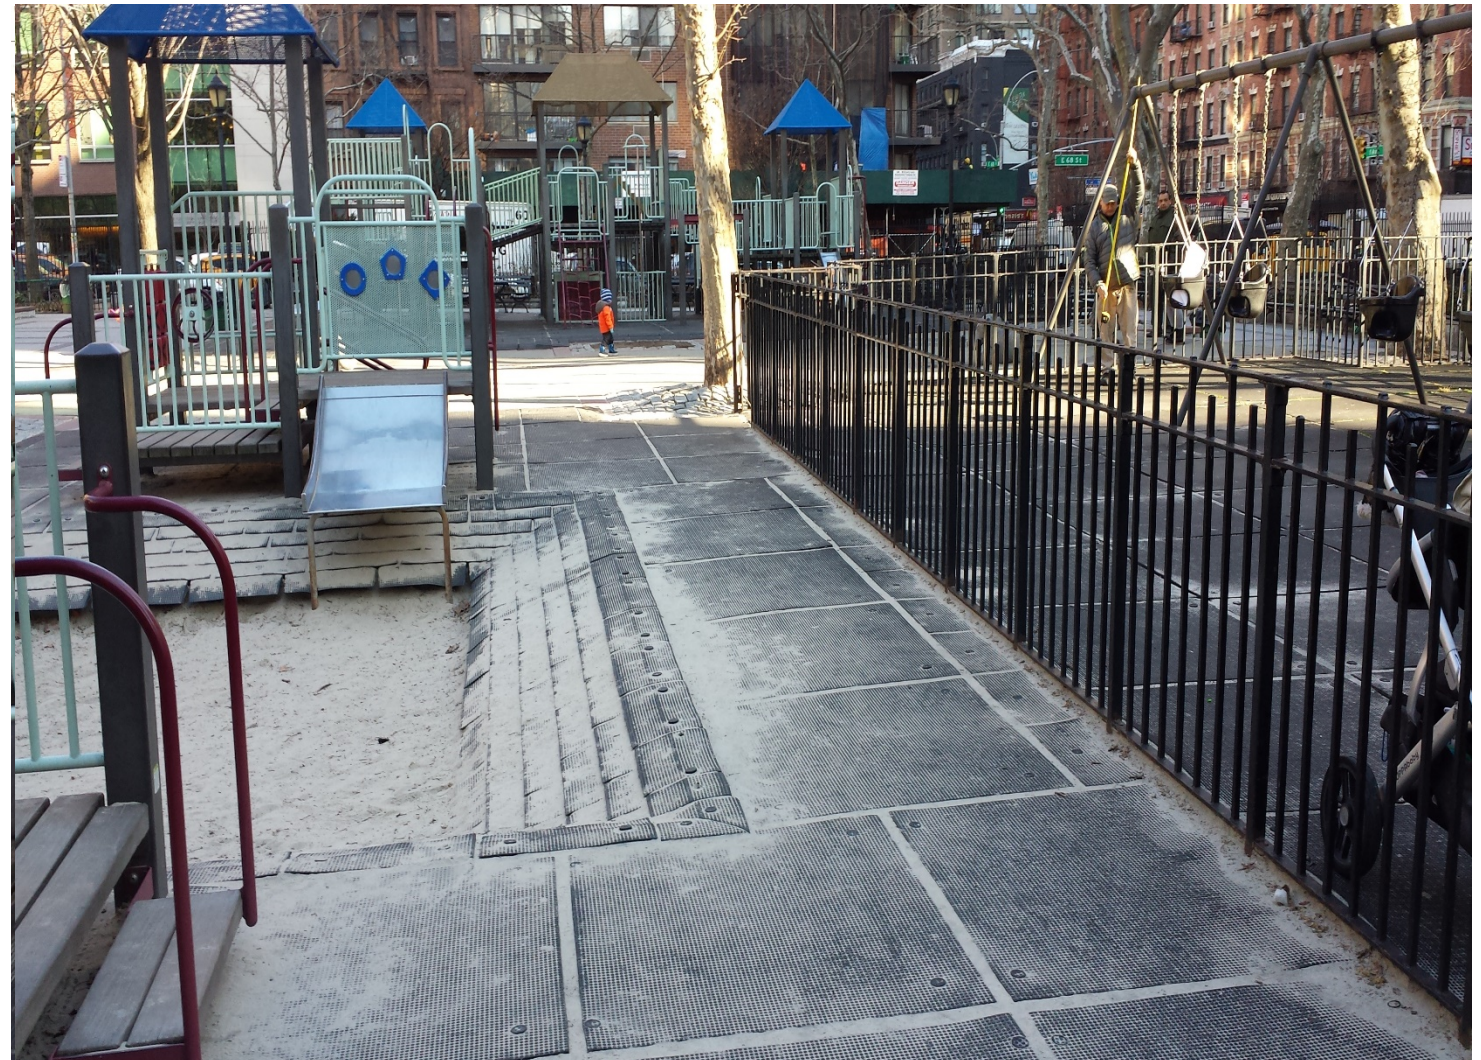
2) 2-5 Year-Old Play Area Looking West

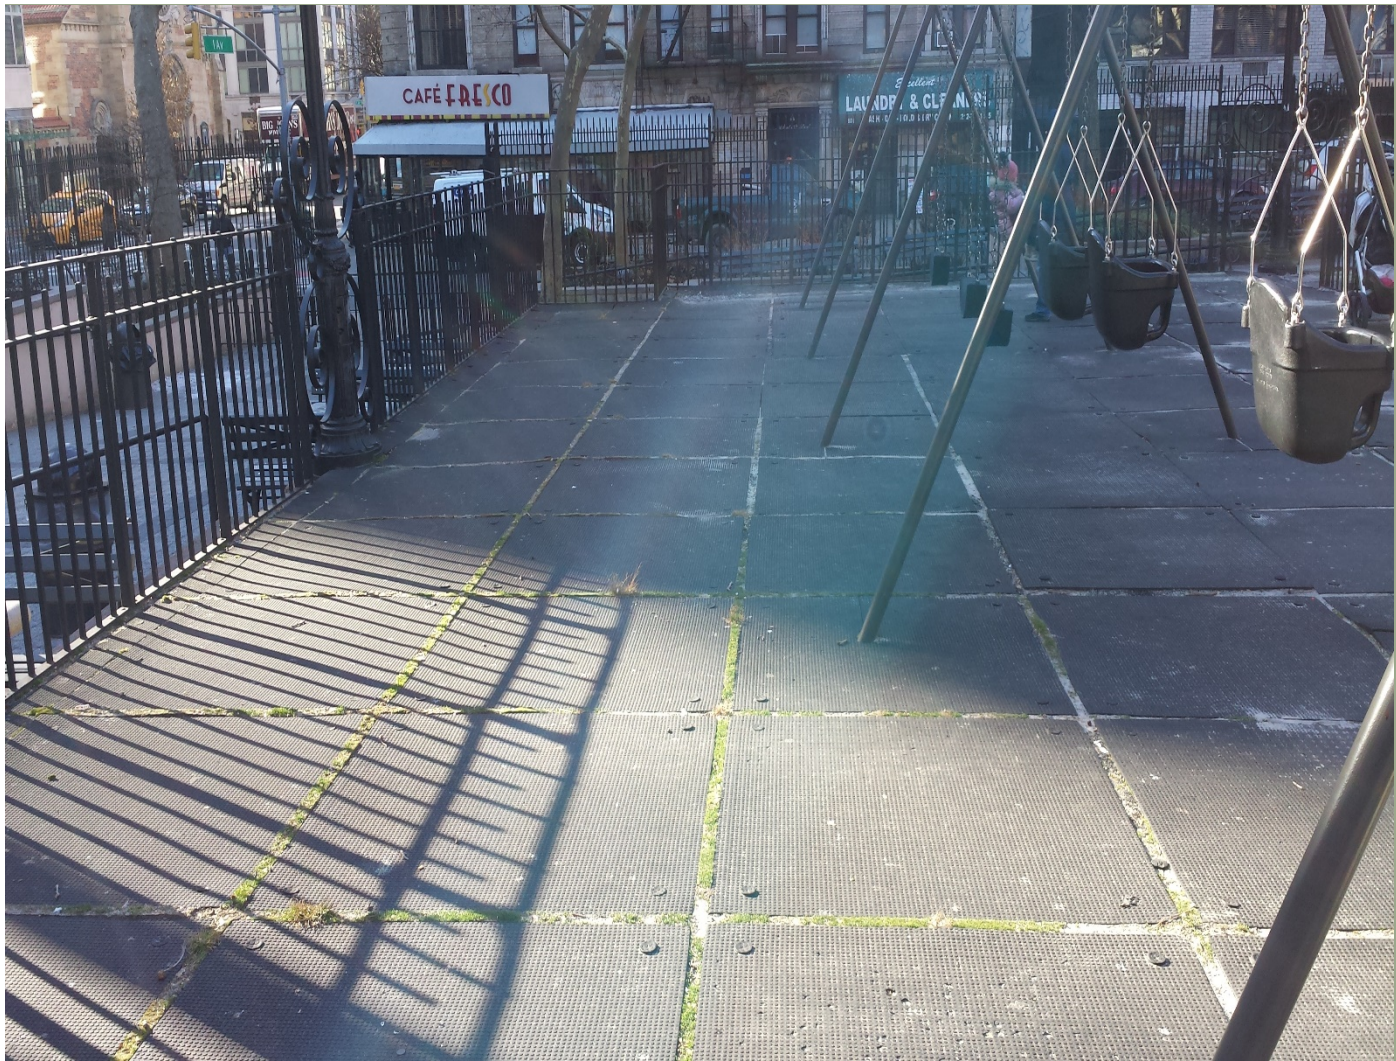
1) Tot Swing

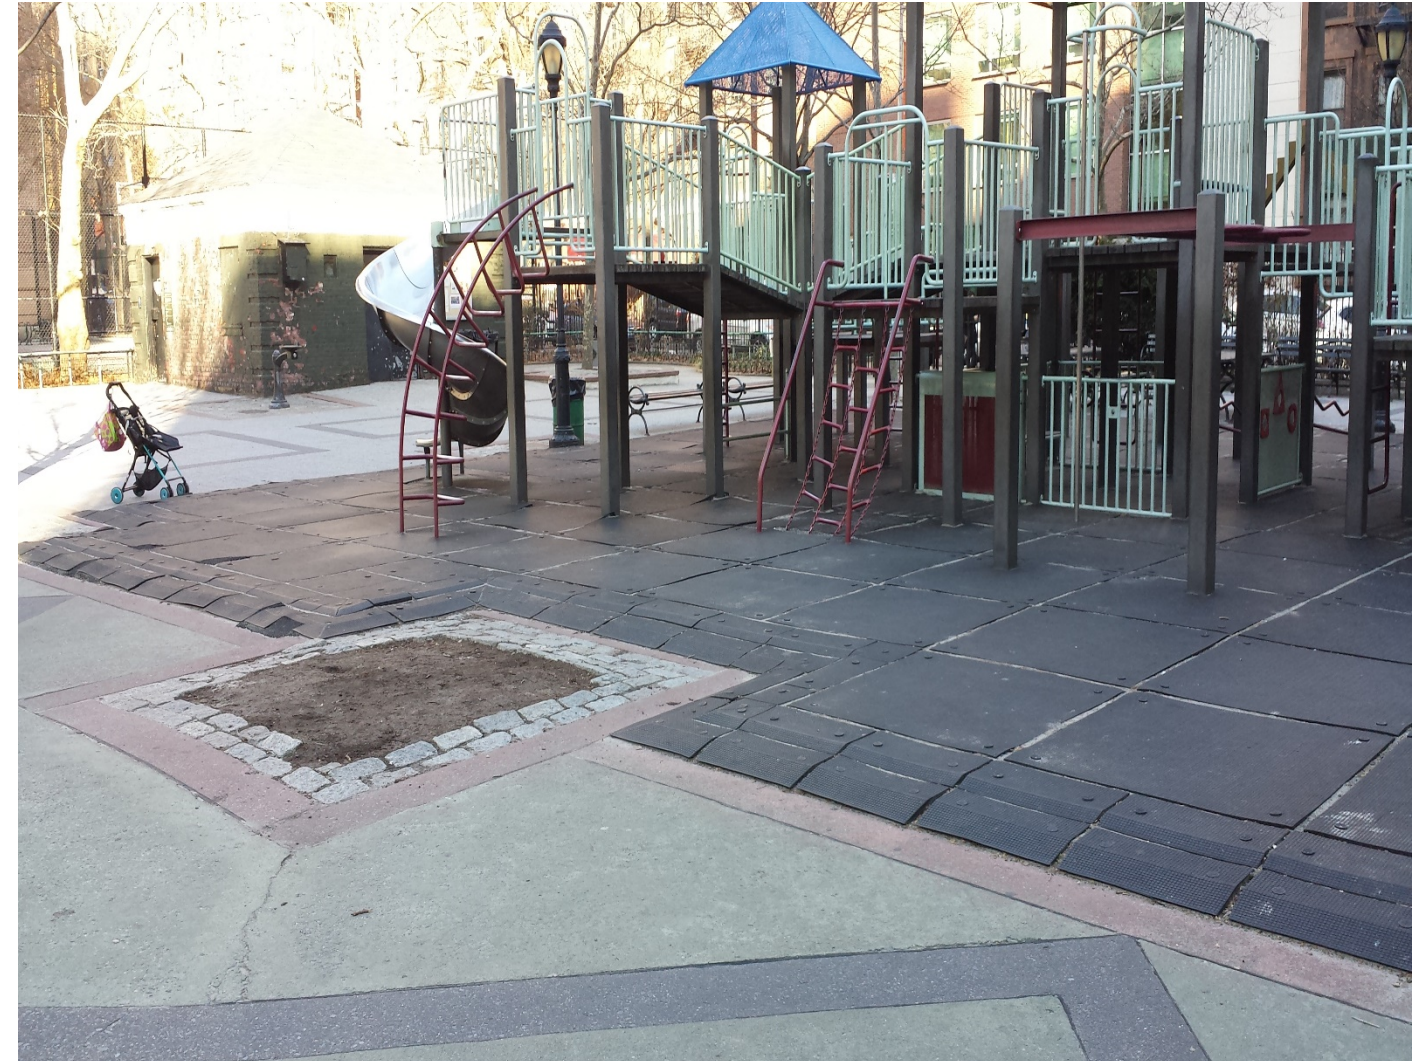
2) Tree Pit in Spray Area

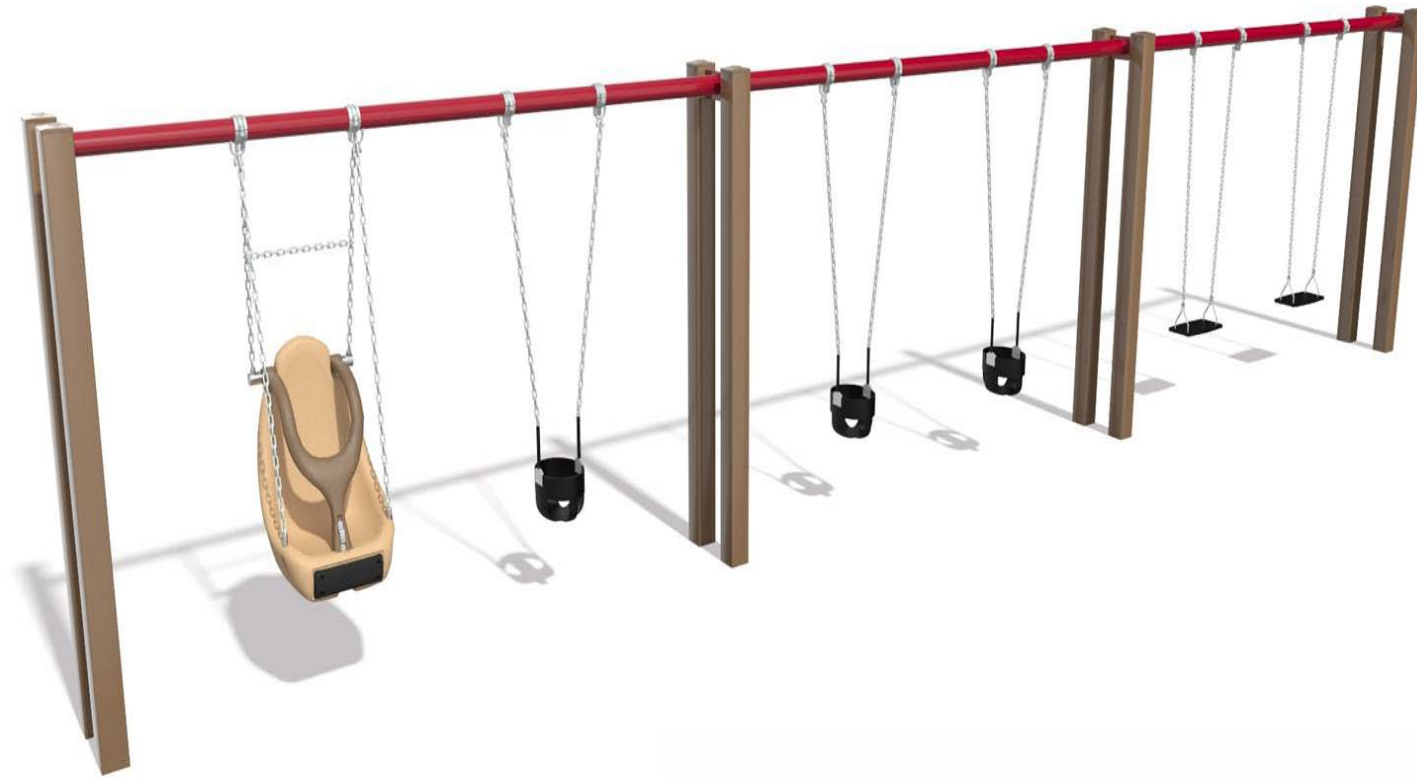
7'-0" Swing Conforming to Existing Play Units
