PROPOSING WORK

15 EAST 91 STREET AP. #4A
MANHATTAN, N.Y., 10128

RENOVATION OF APT. #4A.
RESTORATION OF PREEXISTING
EXTERIOR TERRACE.

Expanded Carnegie Hill Historic District | LP-1834

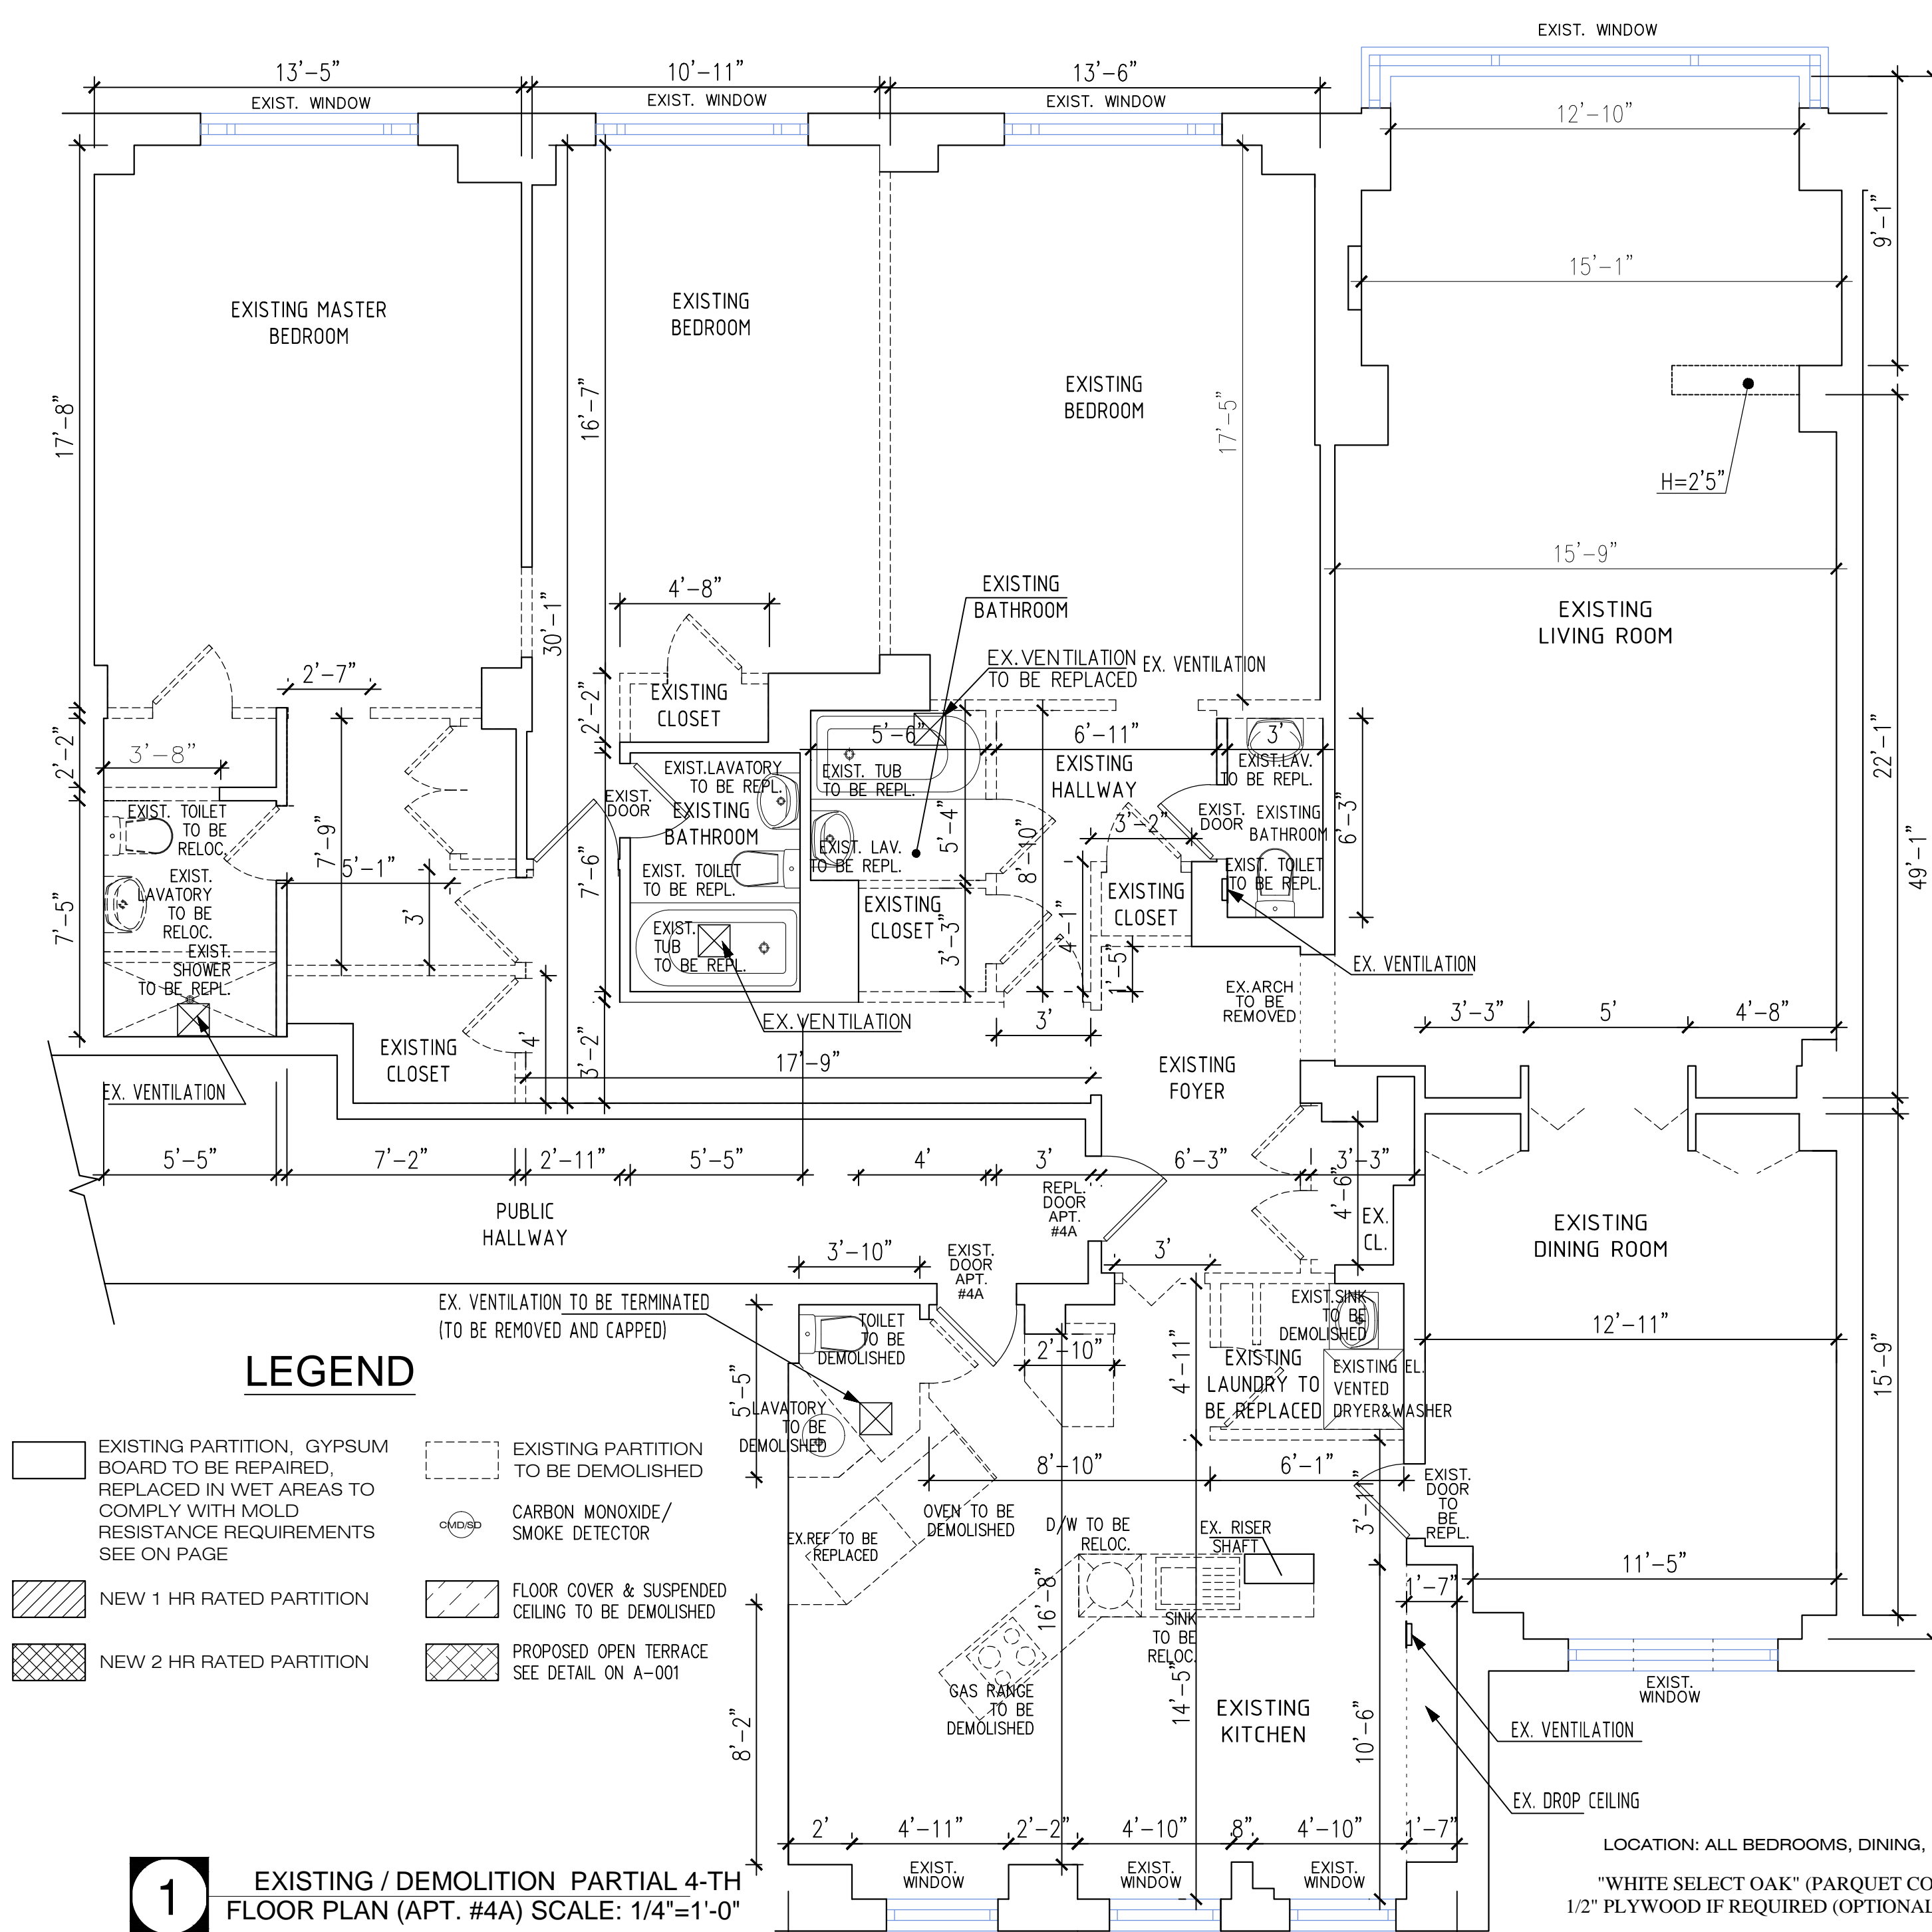
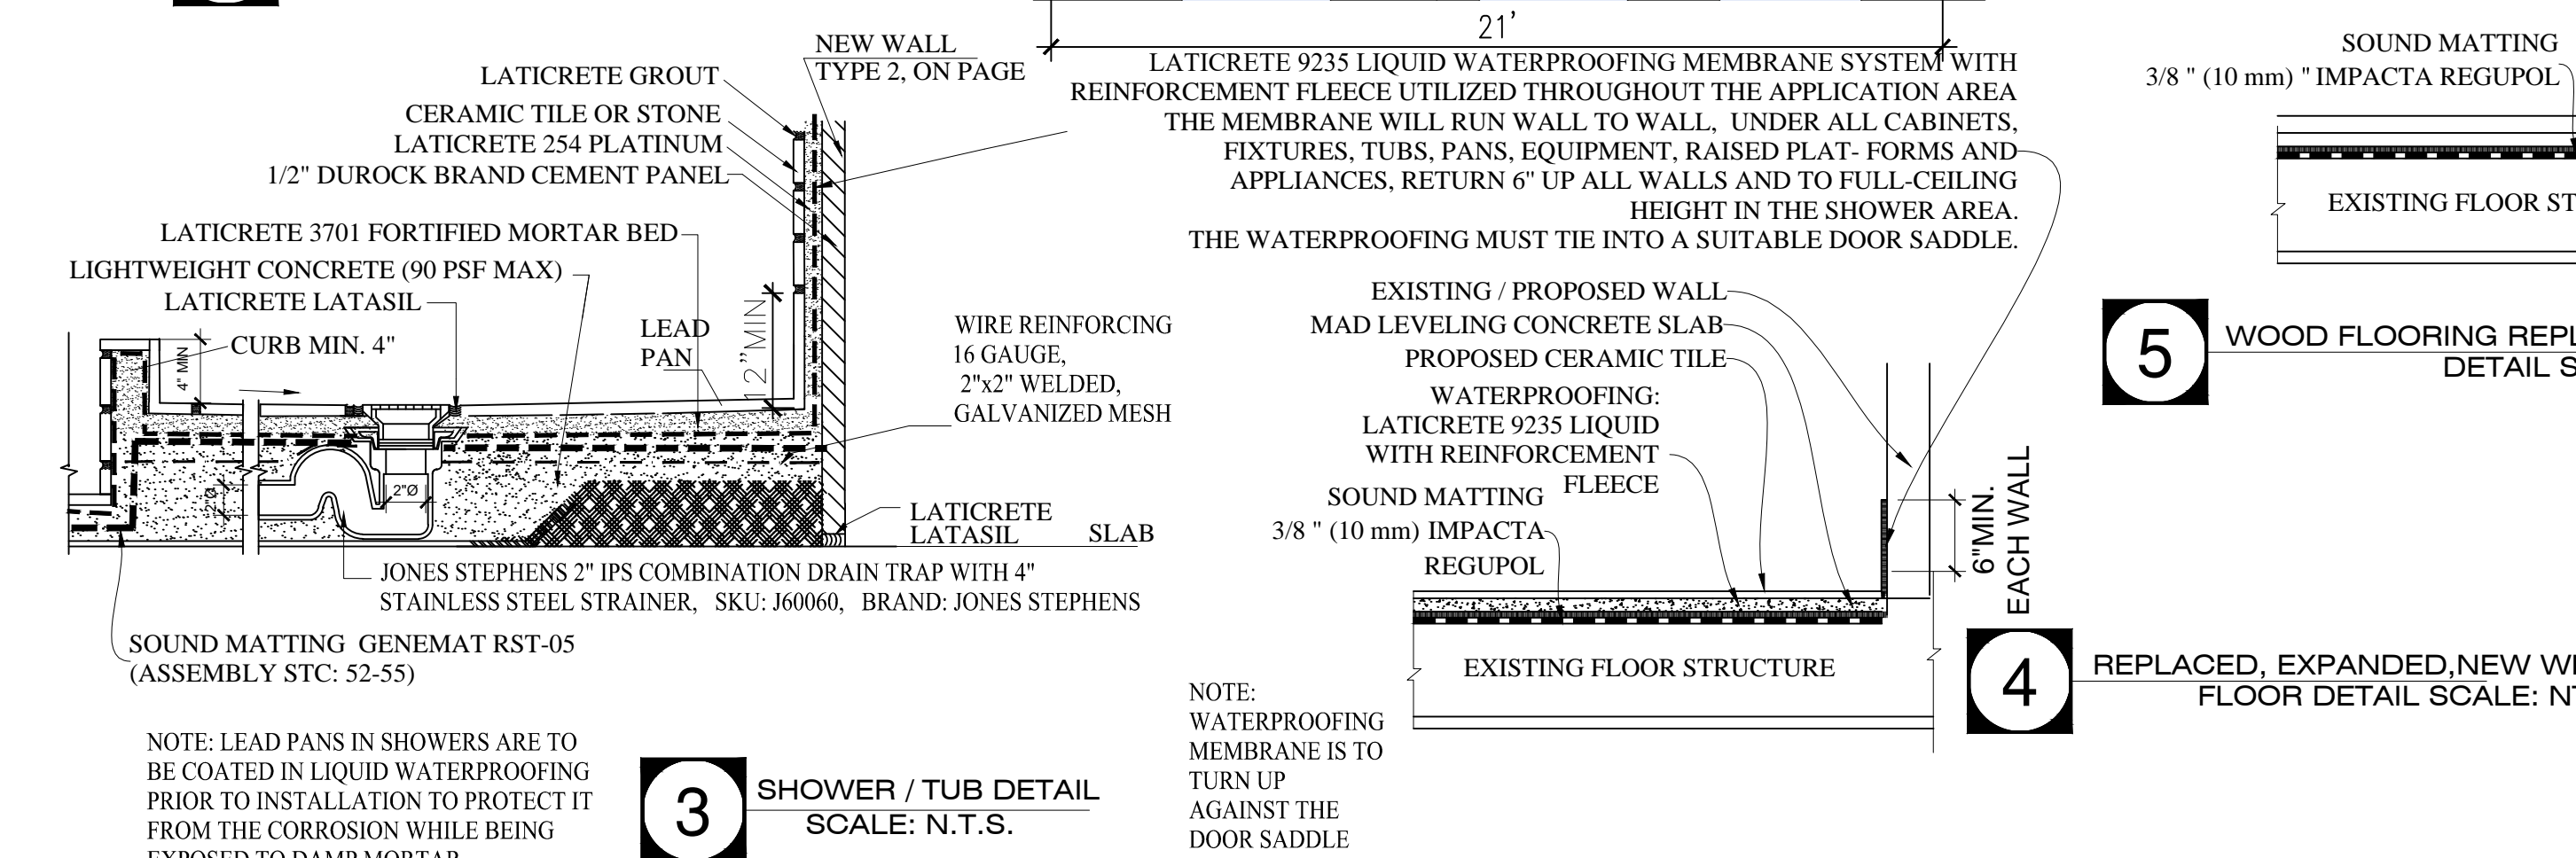
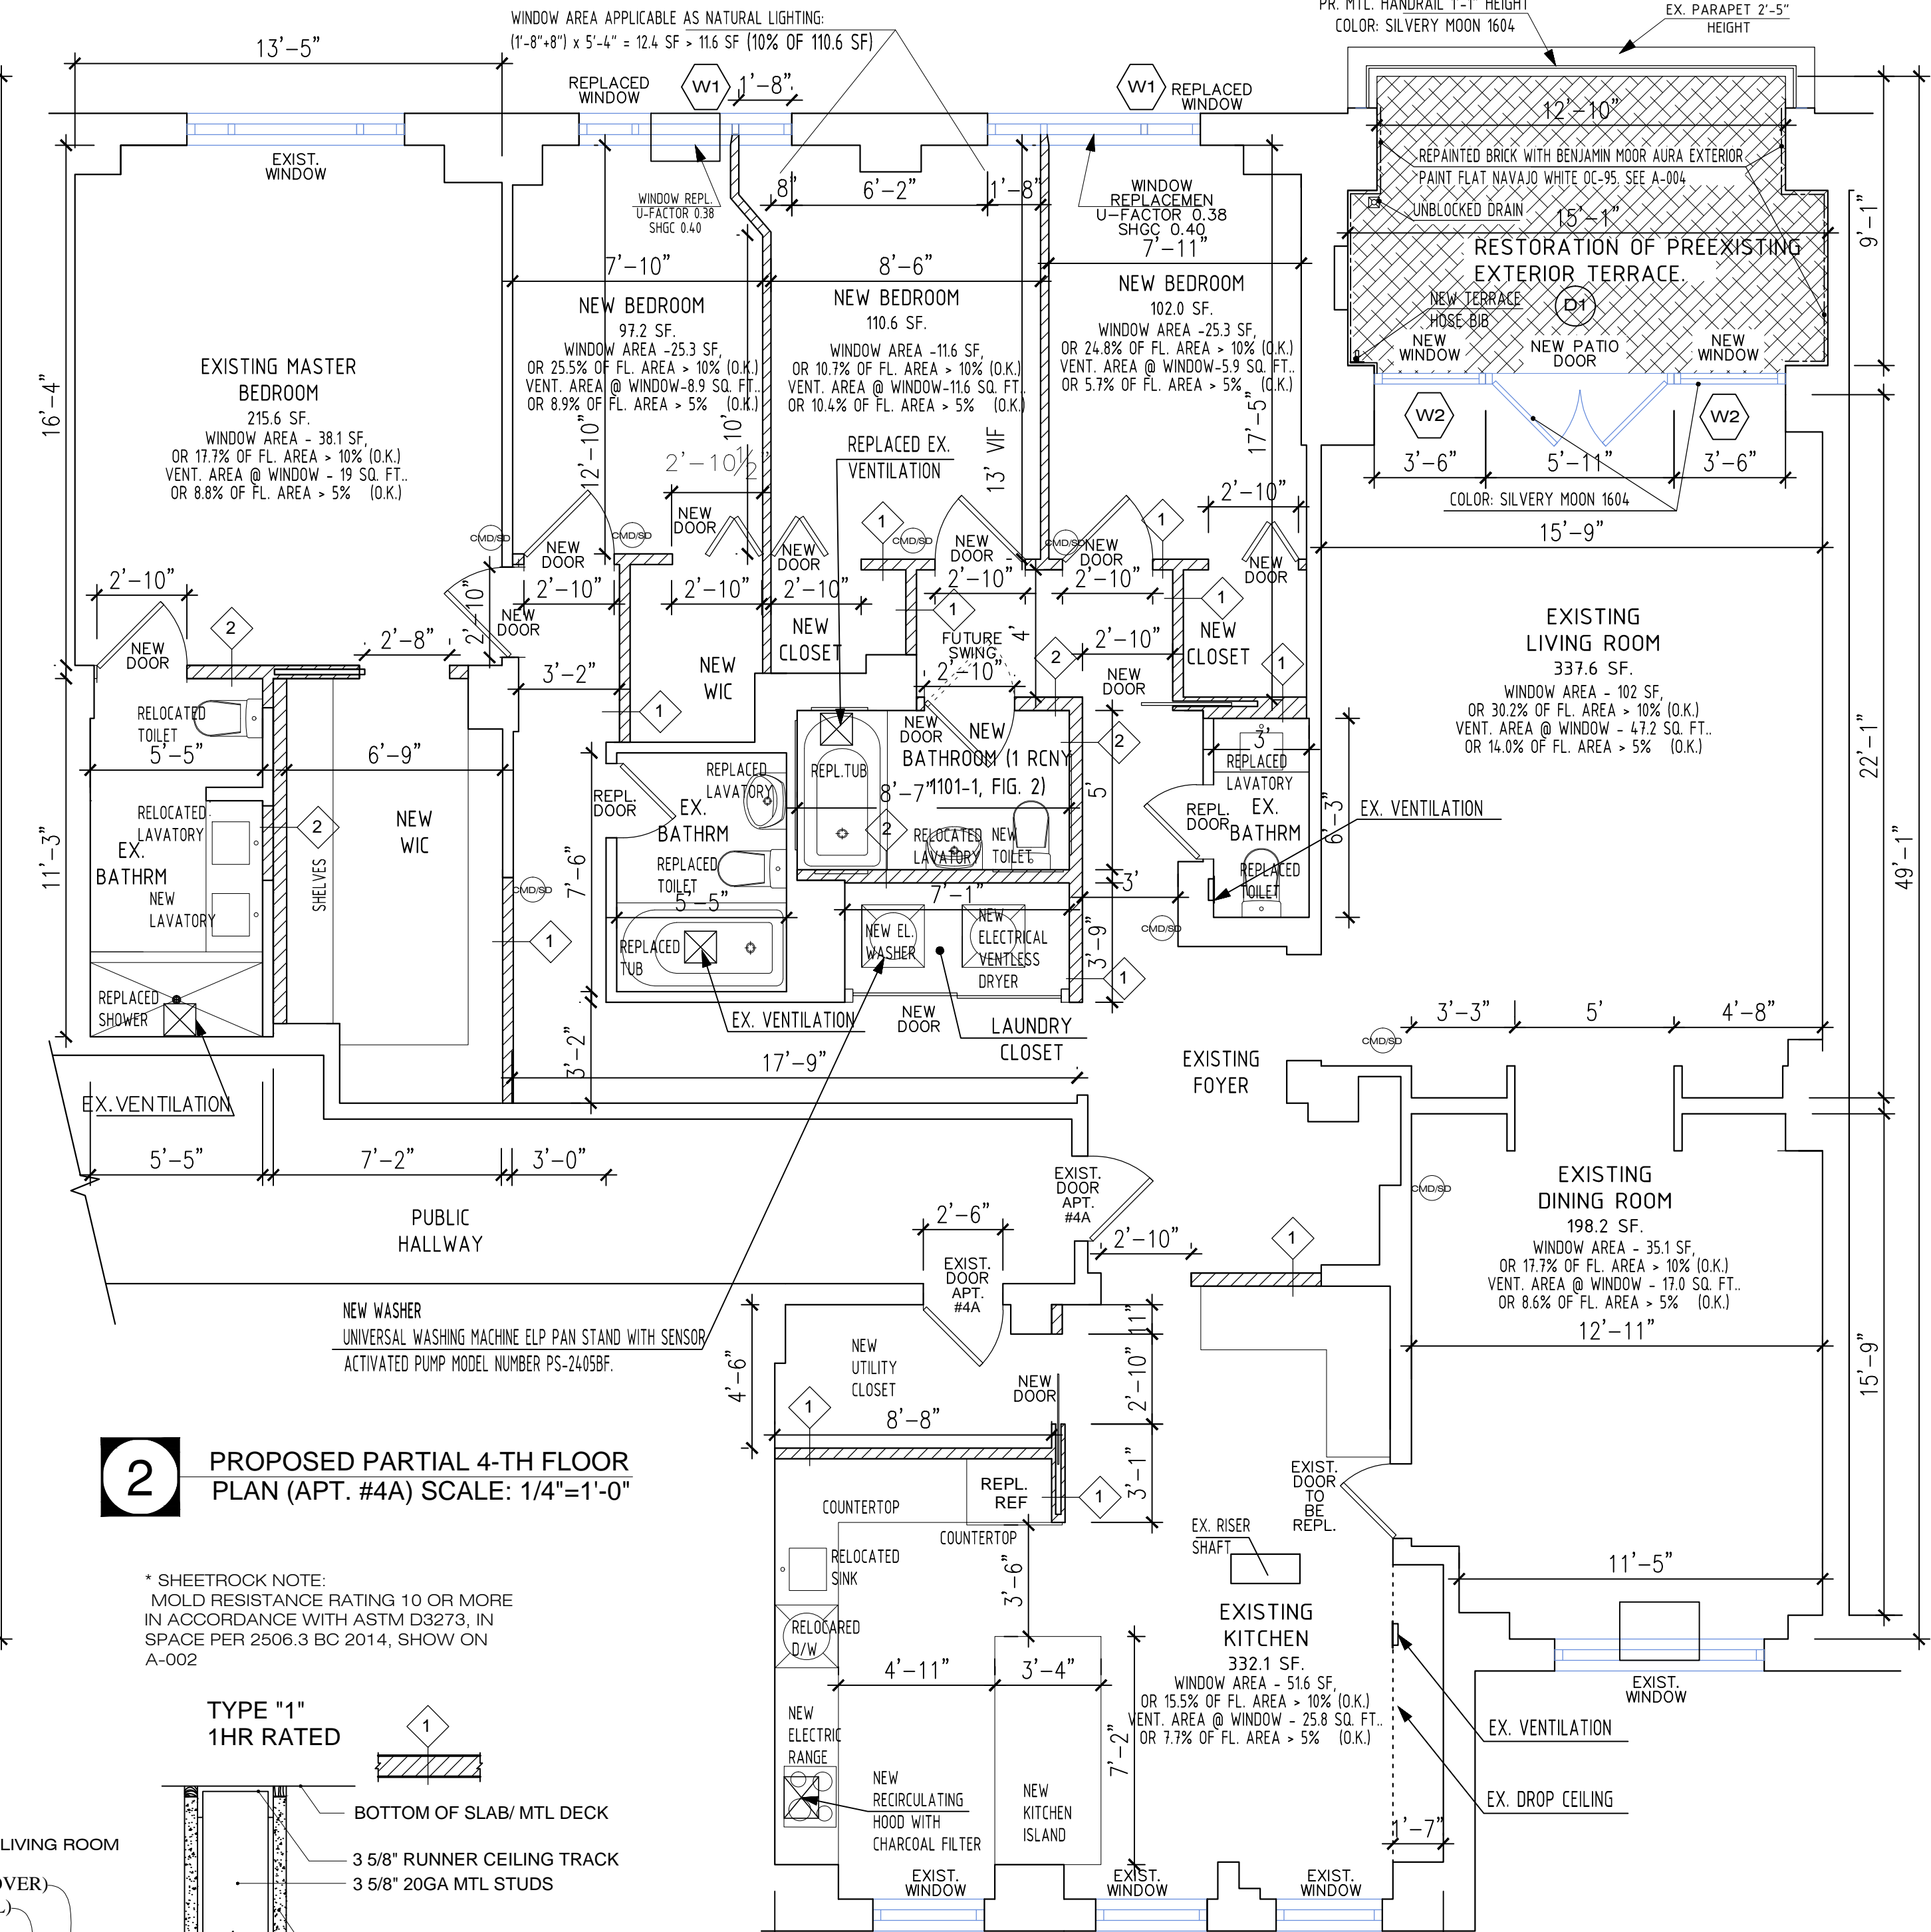
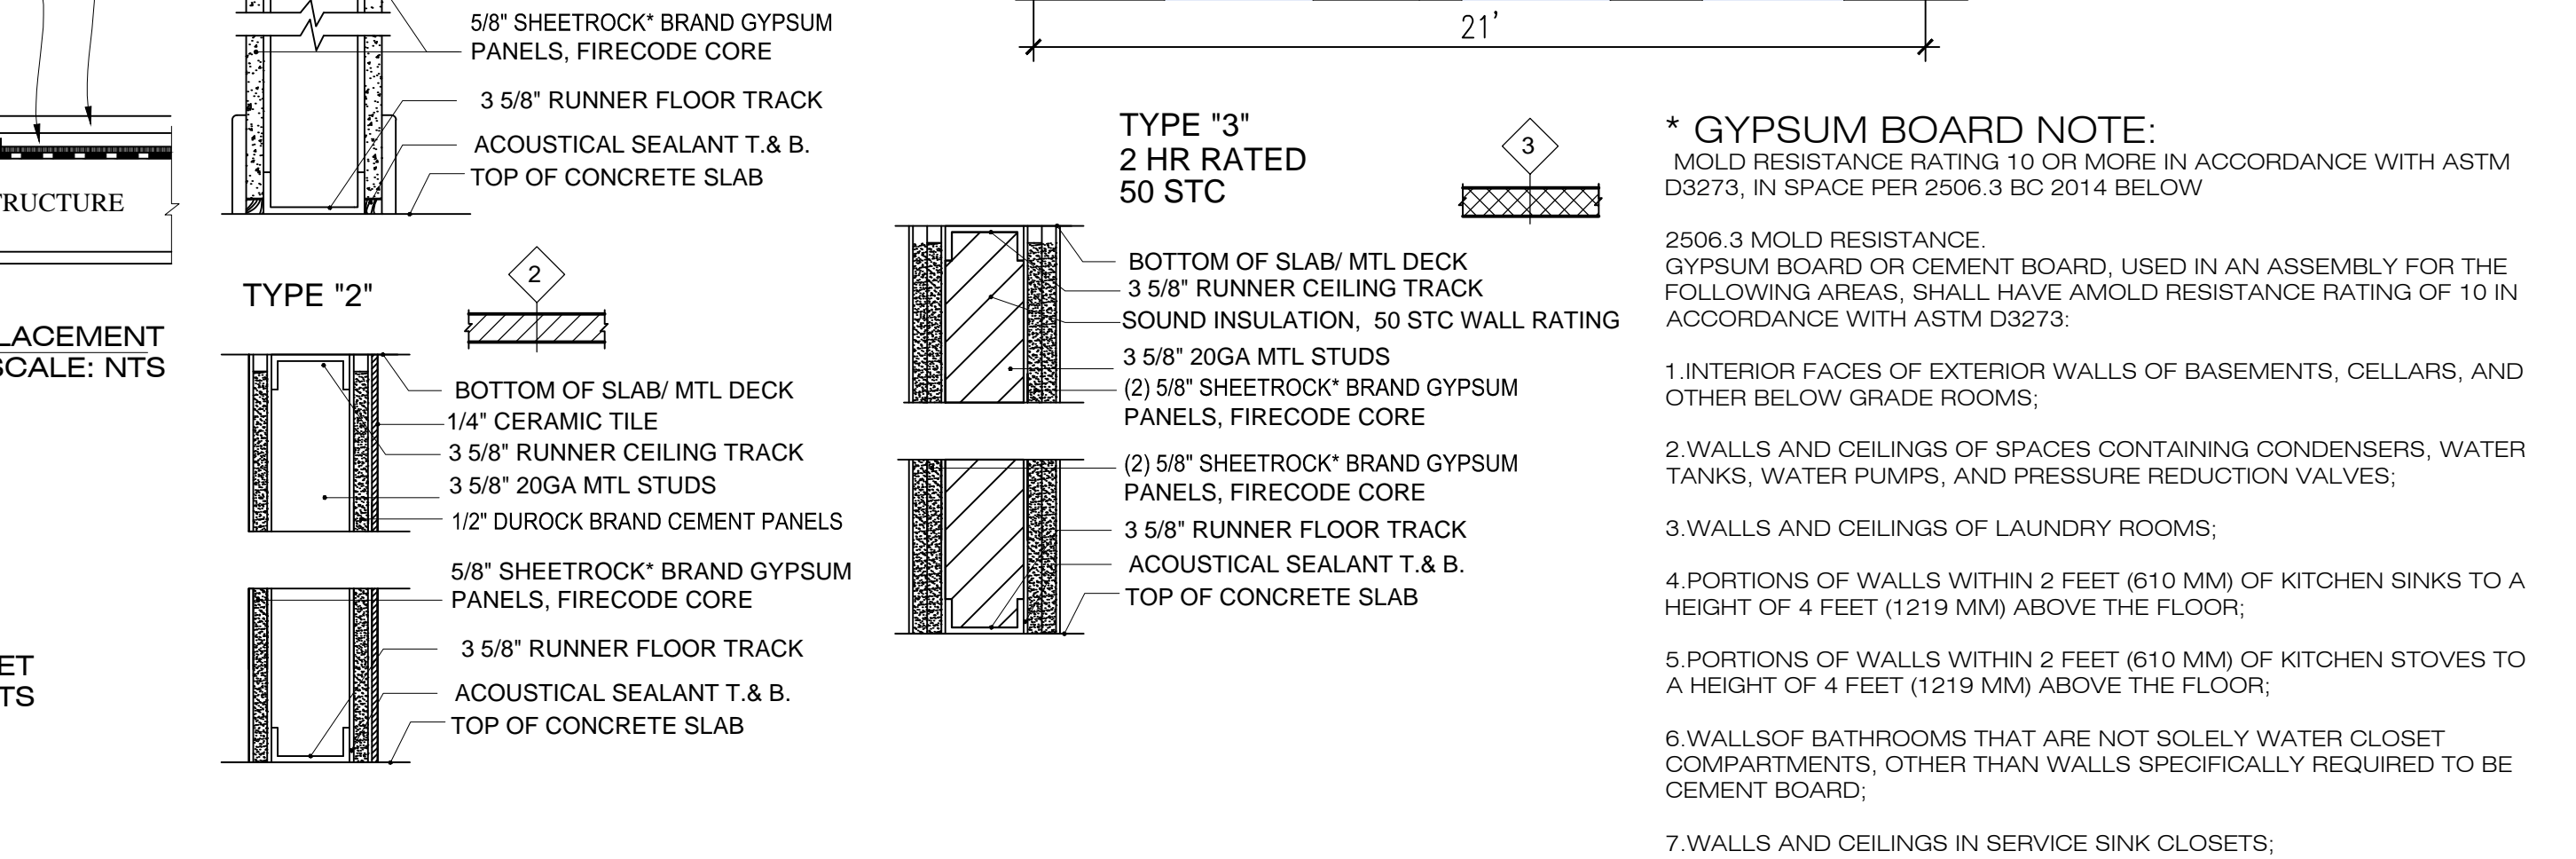
EXISTING & PROPOSED APARTMENT PLANS

STRUCTURE NOTE:

NO CUTTING OR CHANNELING OF BUILDING STRUCTURE SHOULD BE PERMITTED FOR ANY WORK OF ALTERATION.

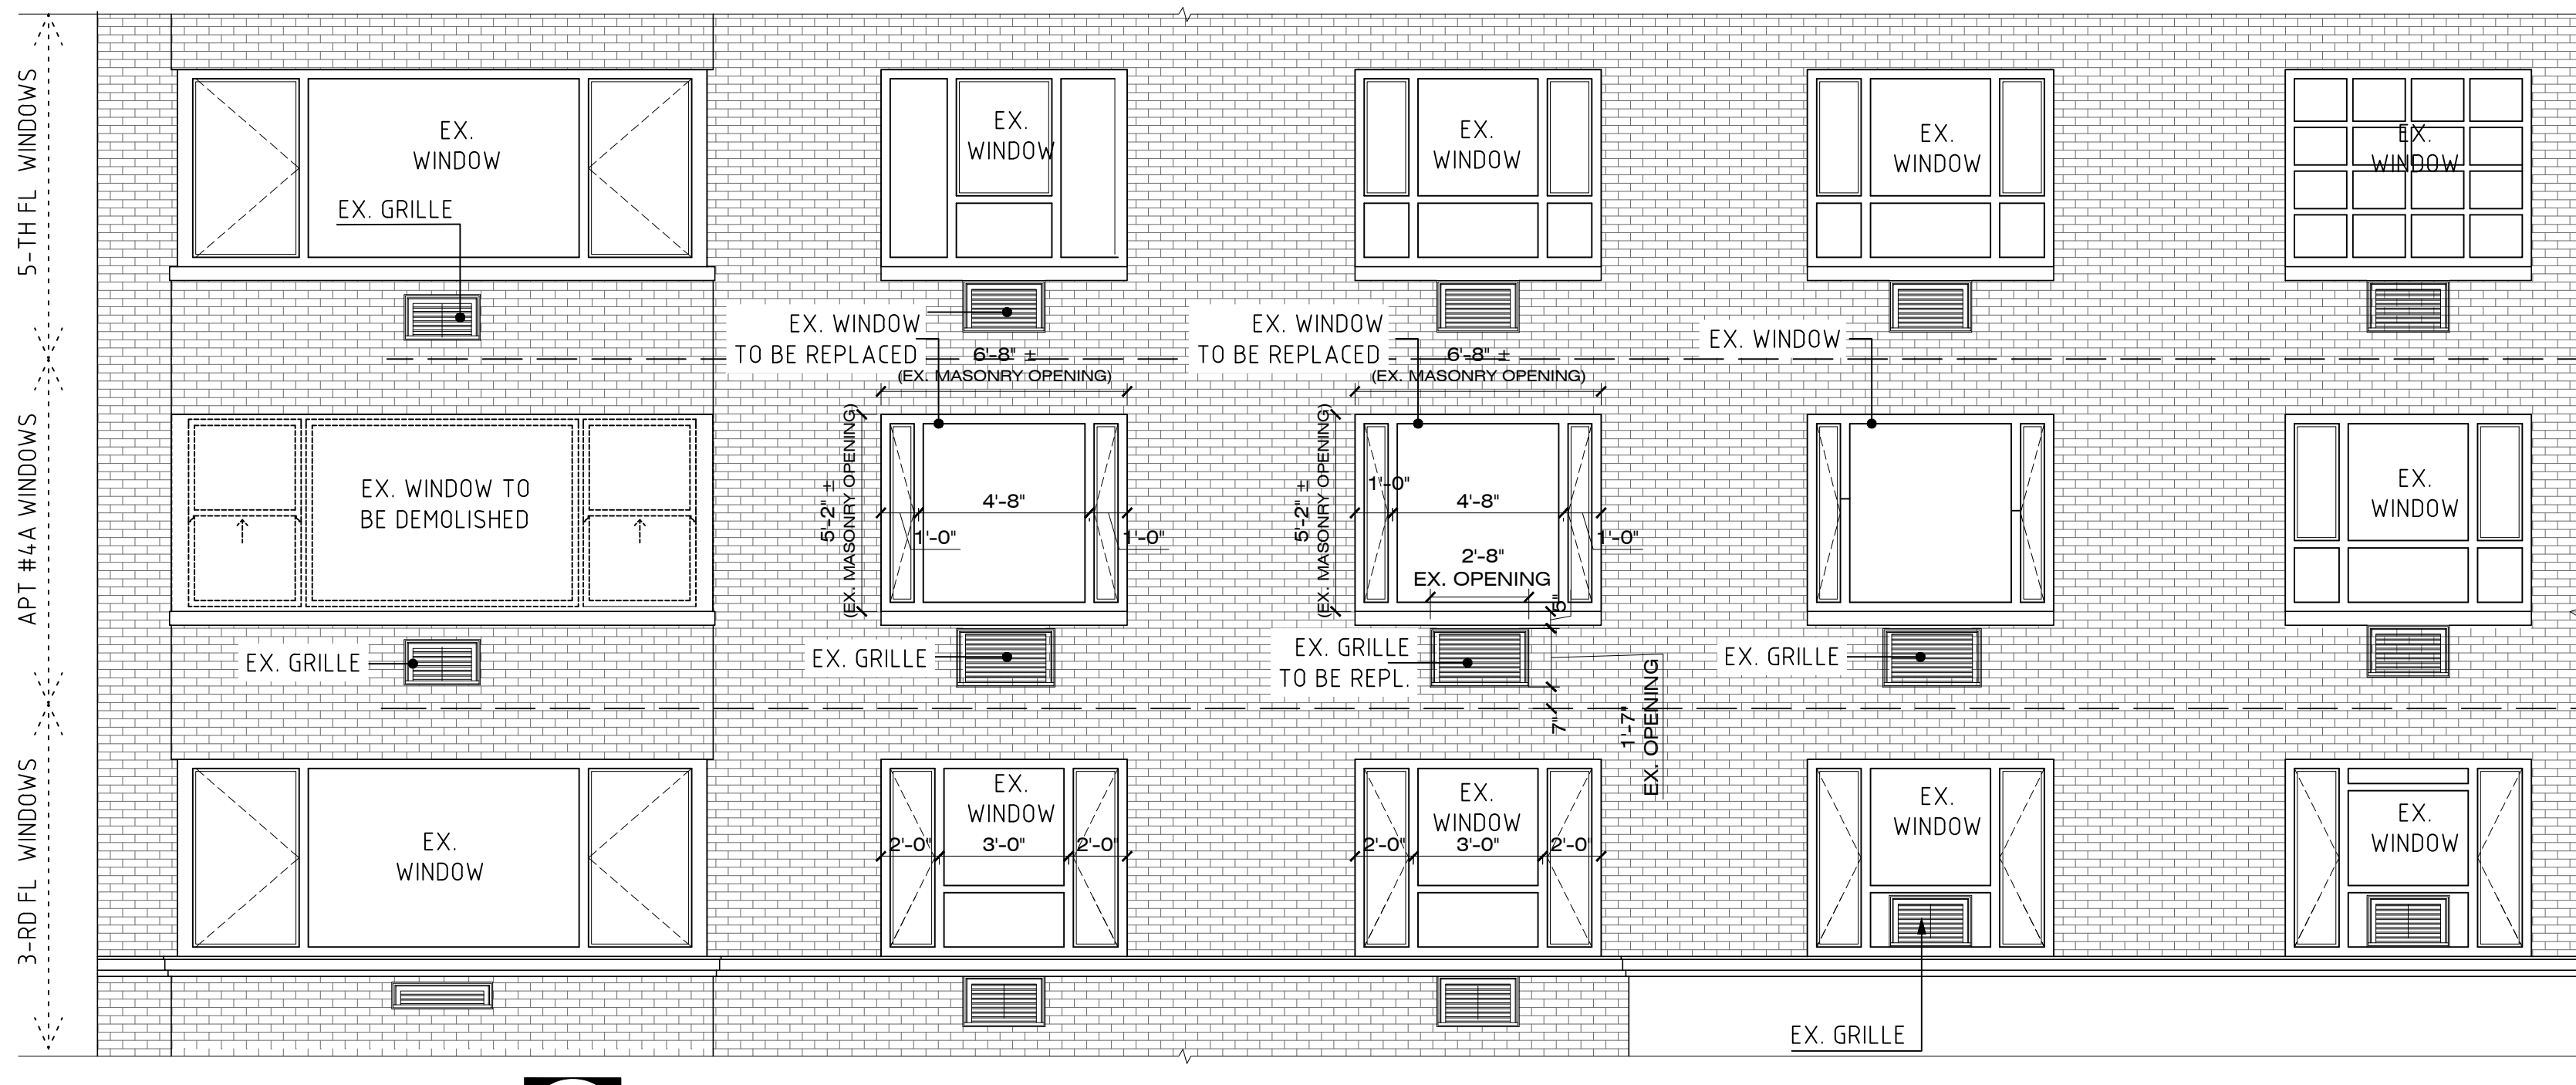
1 EXISTING EXTERIOR ELEVATION
(EAST 91 ST.) SCALE: 3/16"=1'-0"

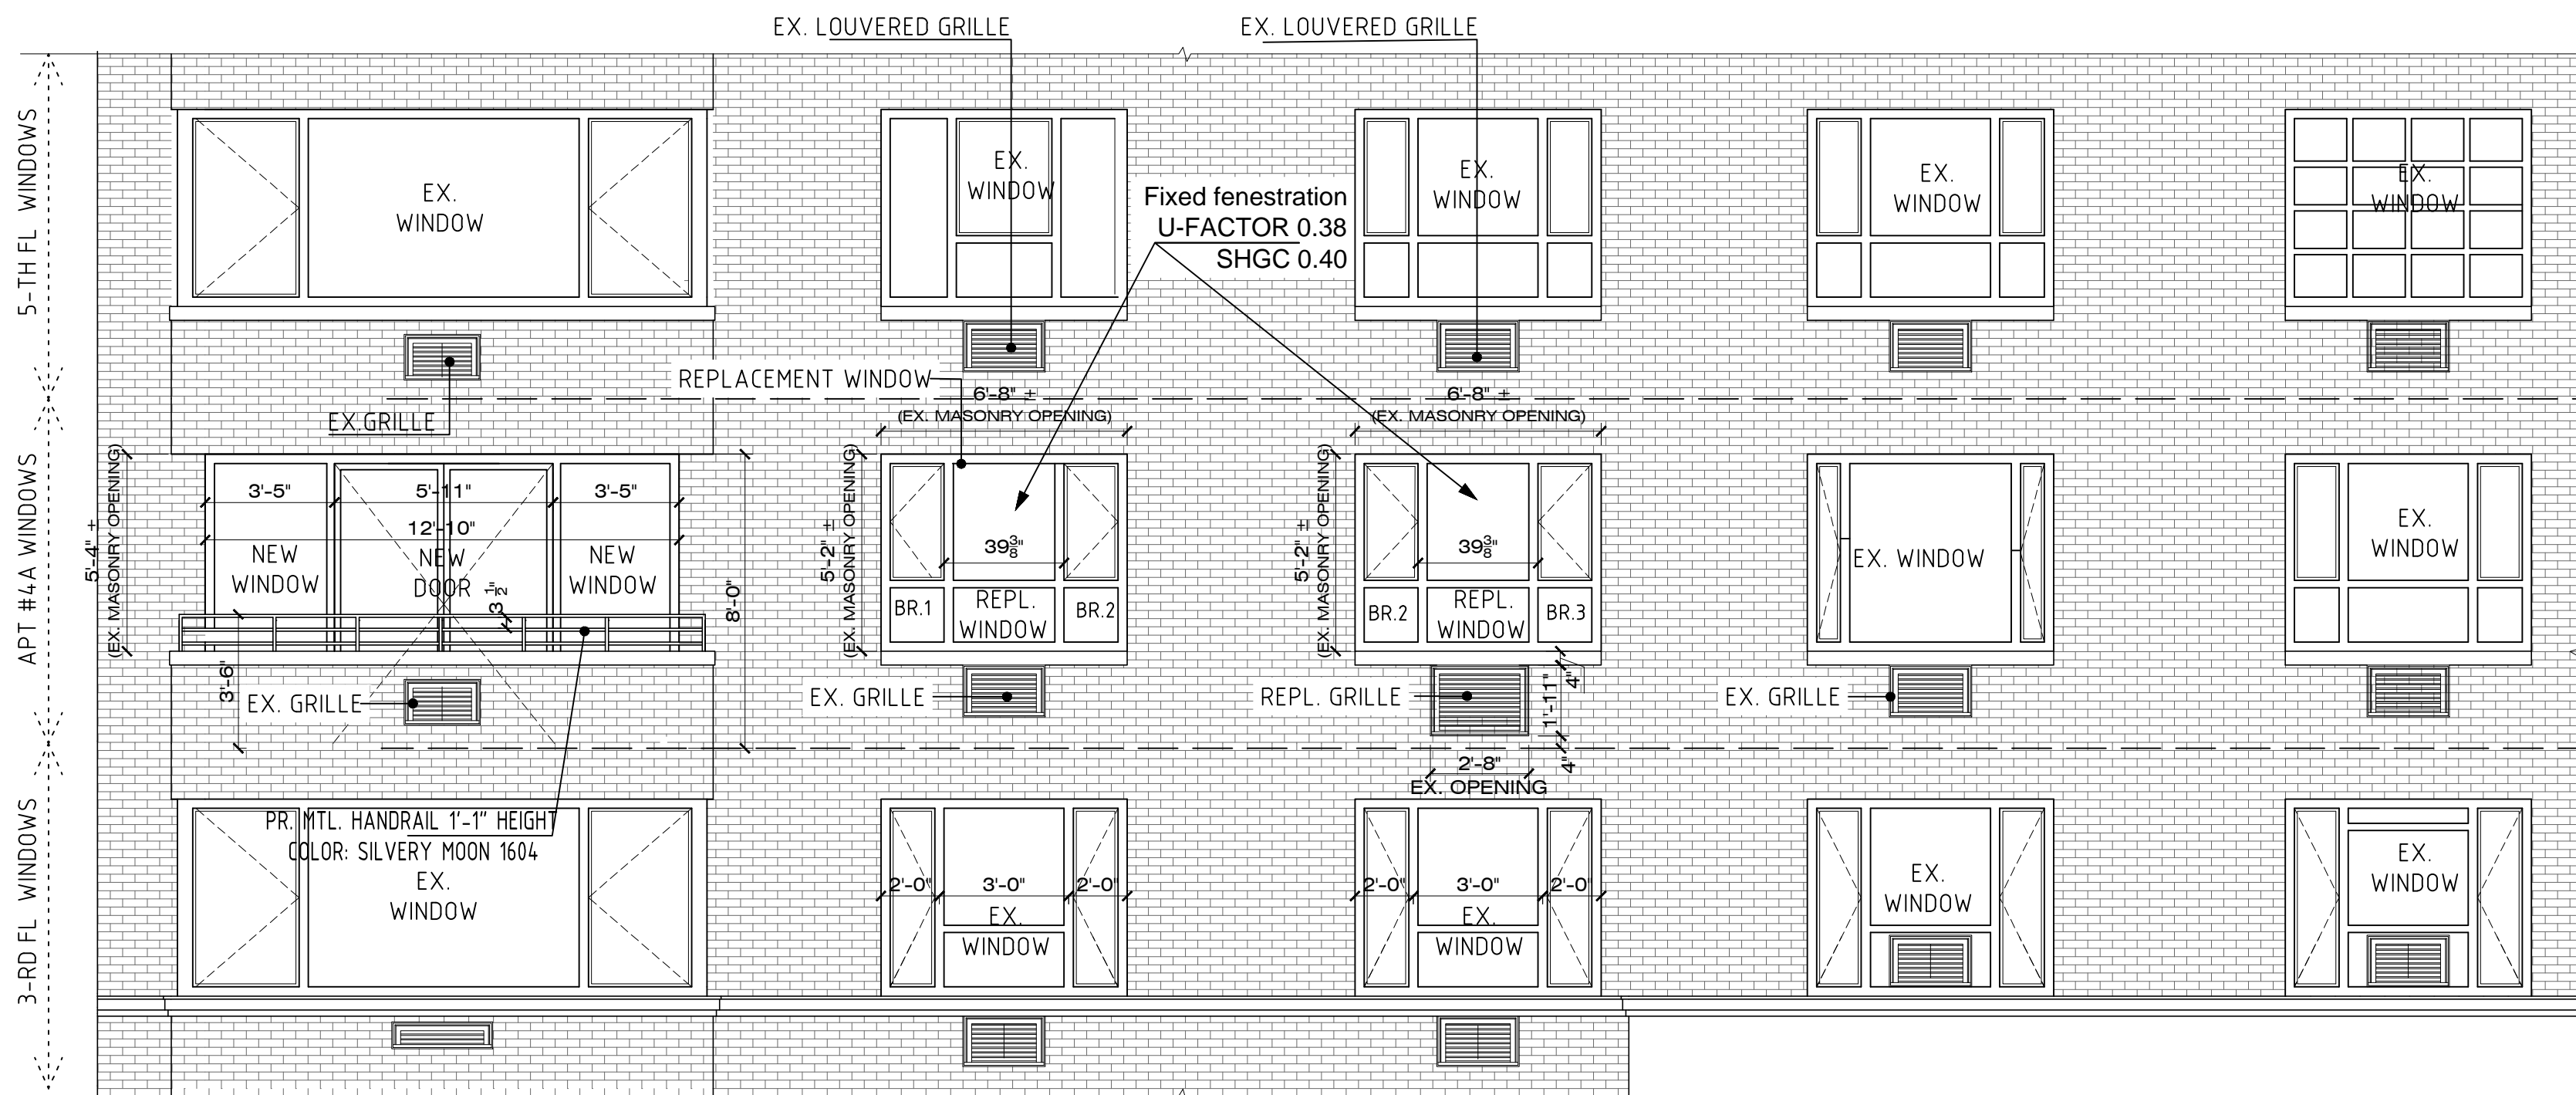
2 PROPOSED EXTERIOR ELEVATION
(EAST 91 ST.) SCALE: 3/16"=1'-0"

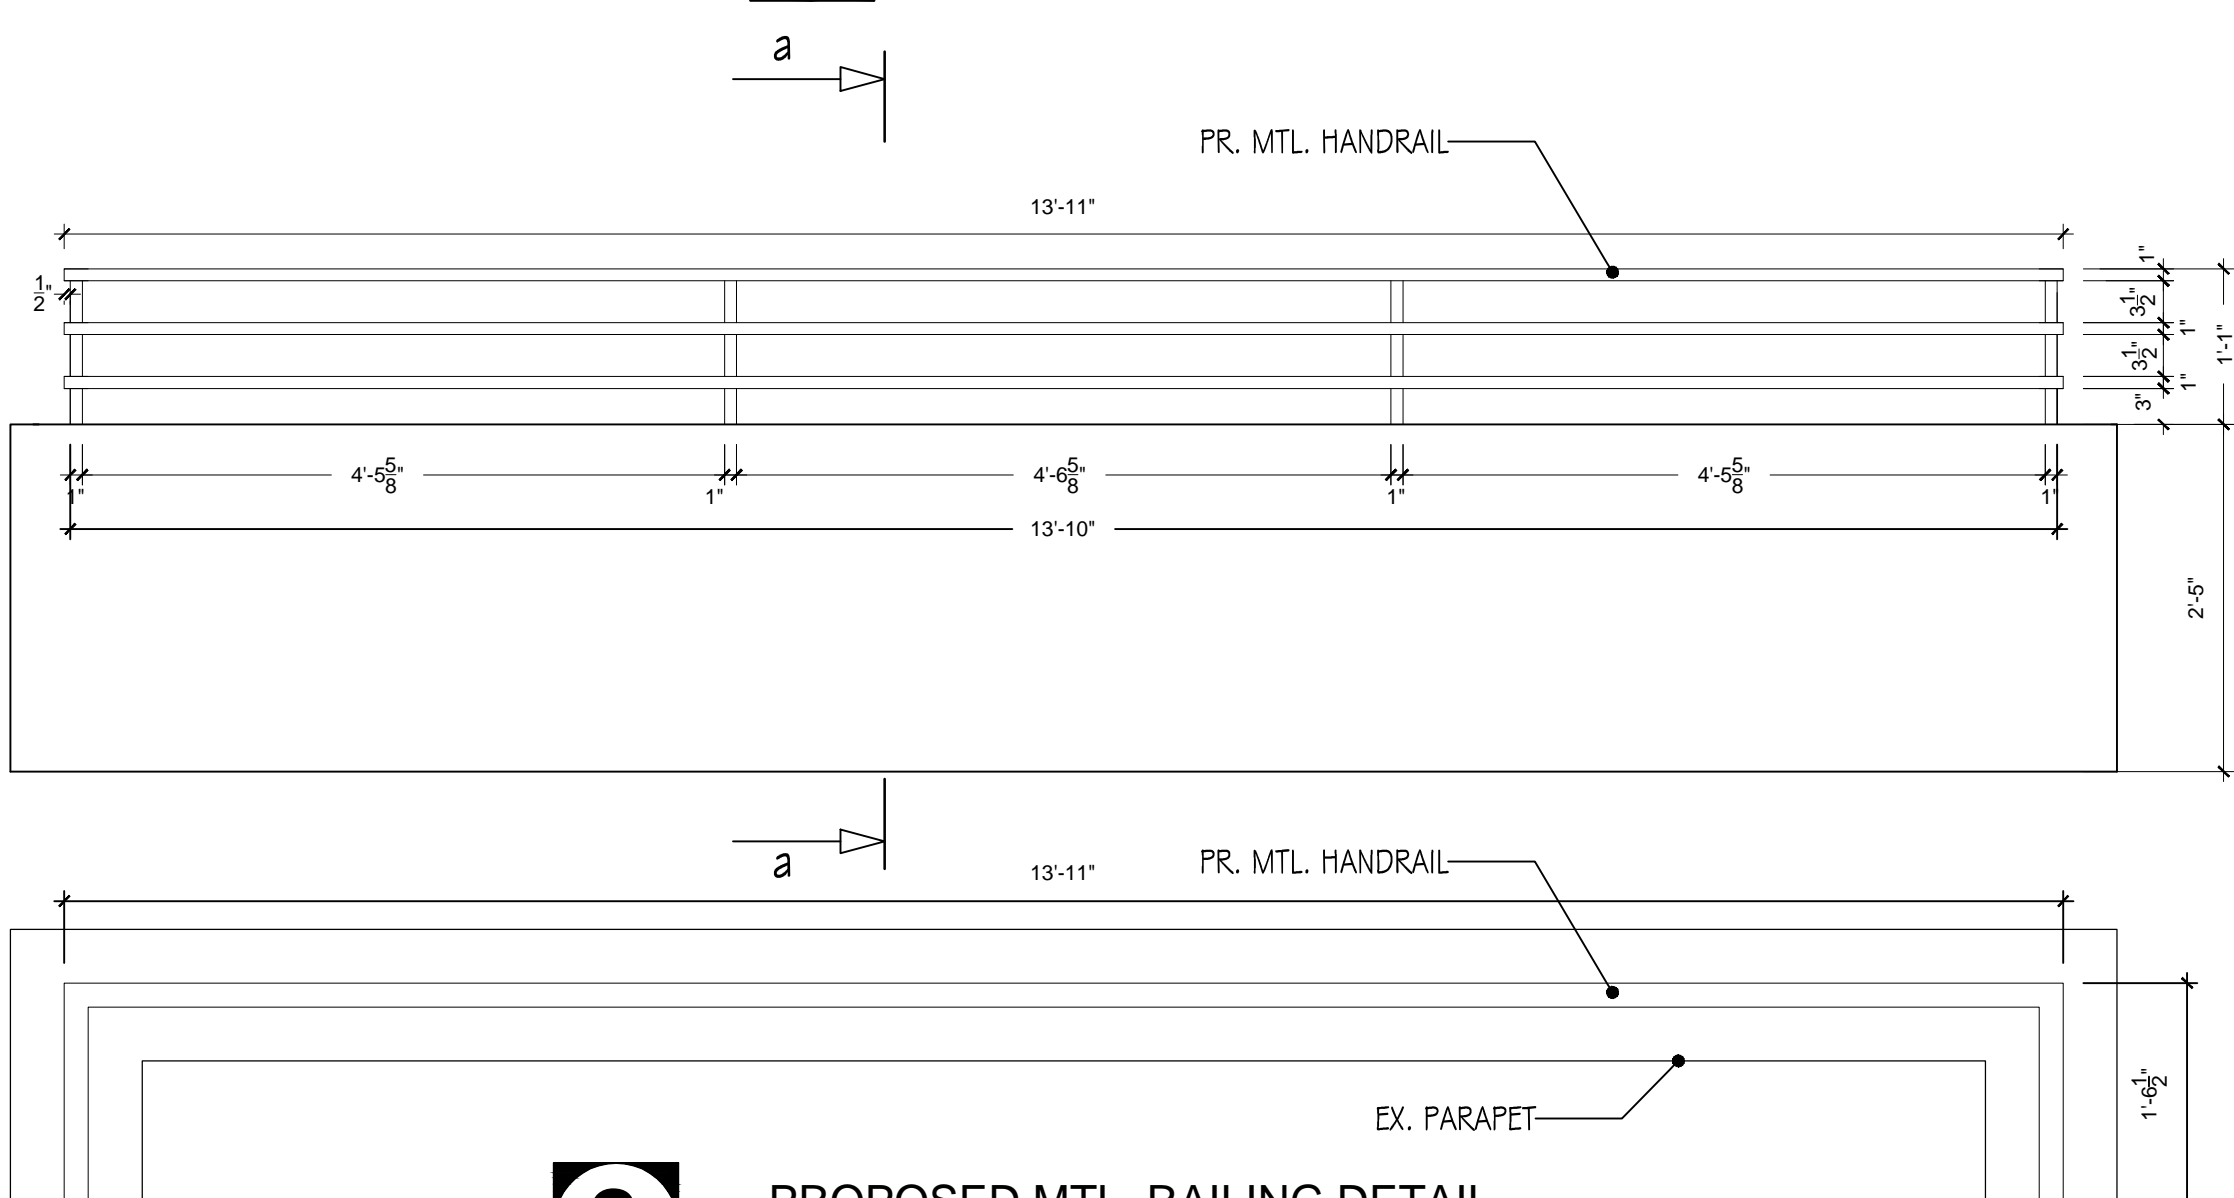
3 PROPOSED MTL. RAILING DETAIL
SCALE: 3/4"=1'-0"
