PROPOSING WORK

15 EAST 91 STREET AP. #4A
MANHATTAN, N.Y., 10128

RENOVATION OF APT. #4A.
RESTORATION OF PREEXISTING
EXTERIOR TERRACE.

Expanded Carnegie Hill Historic District | LP-1834

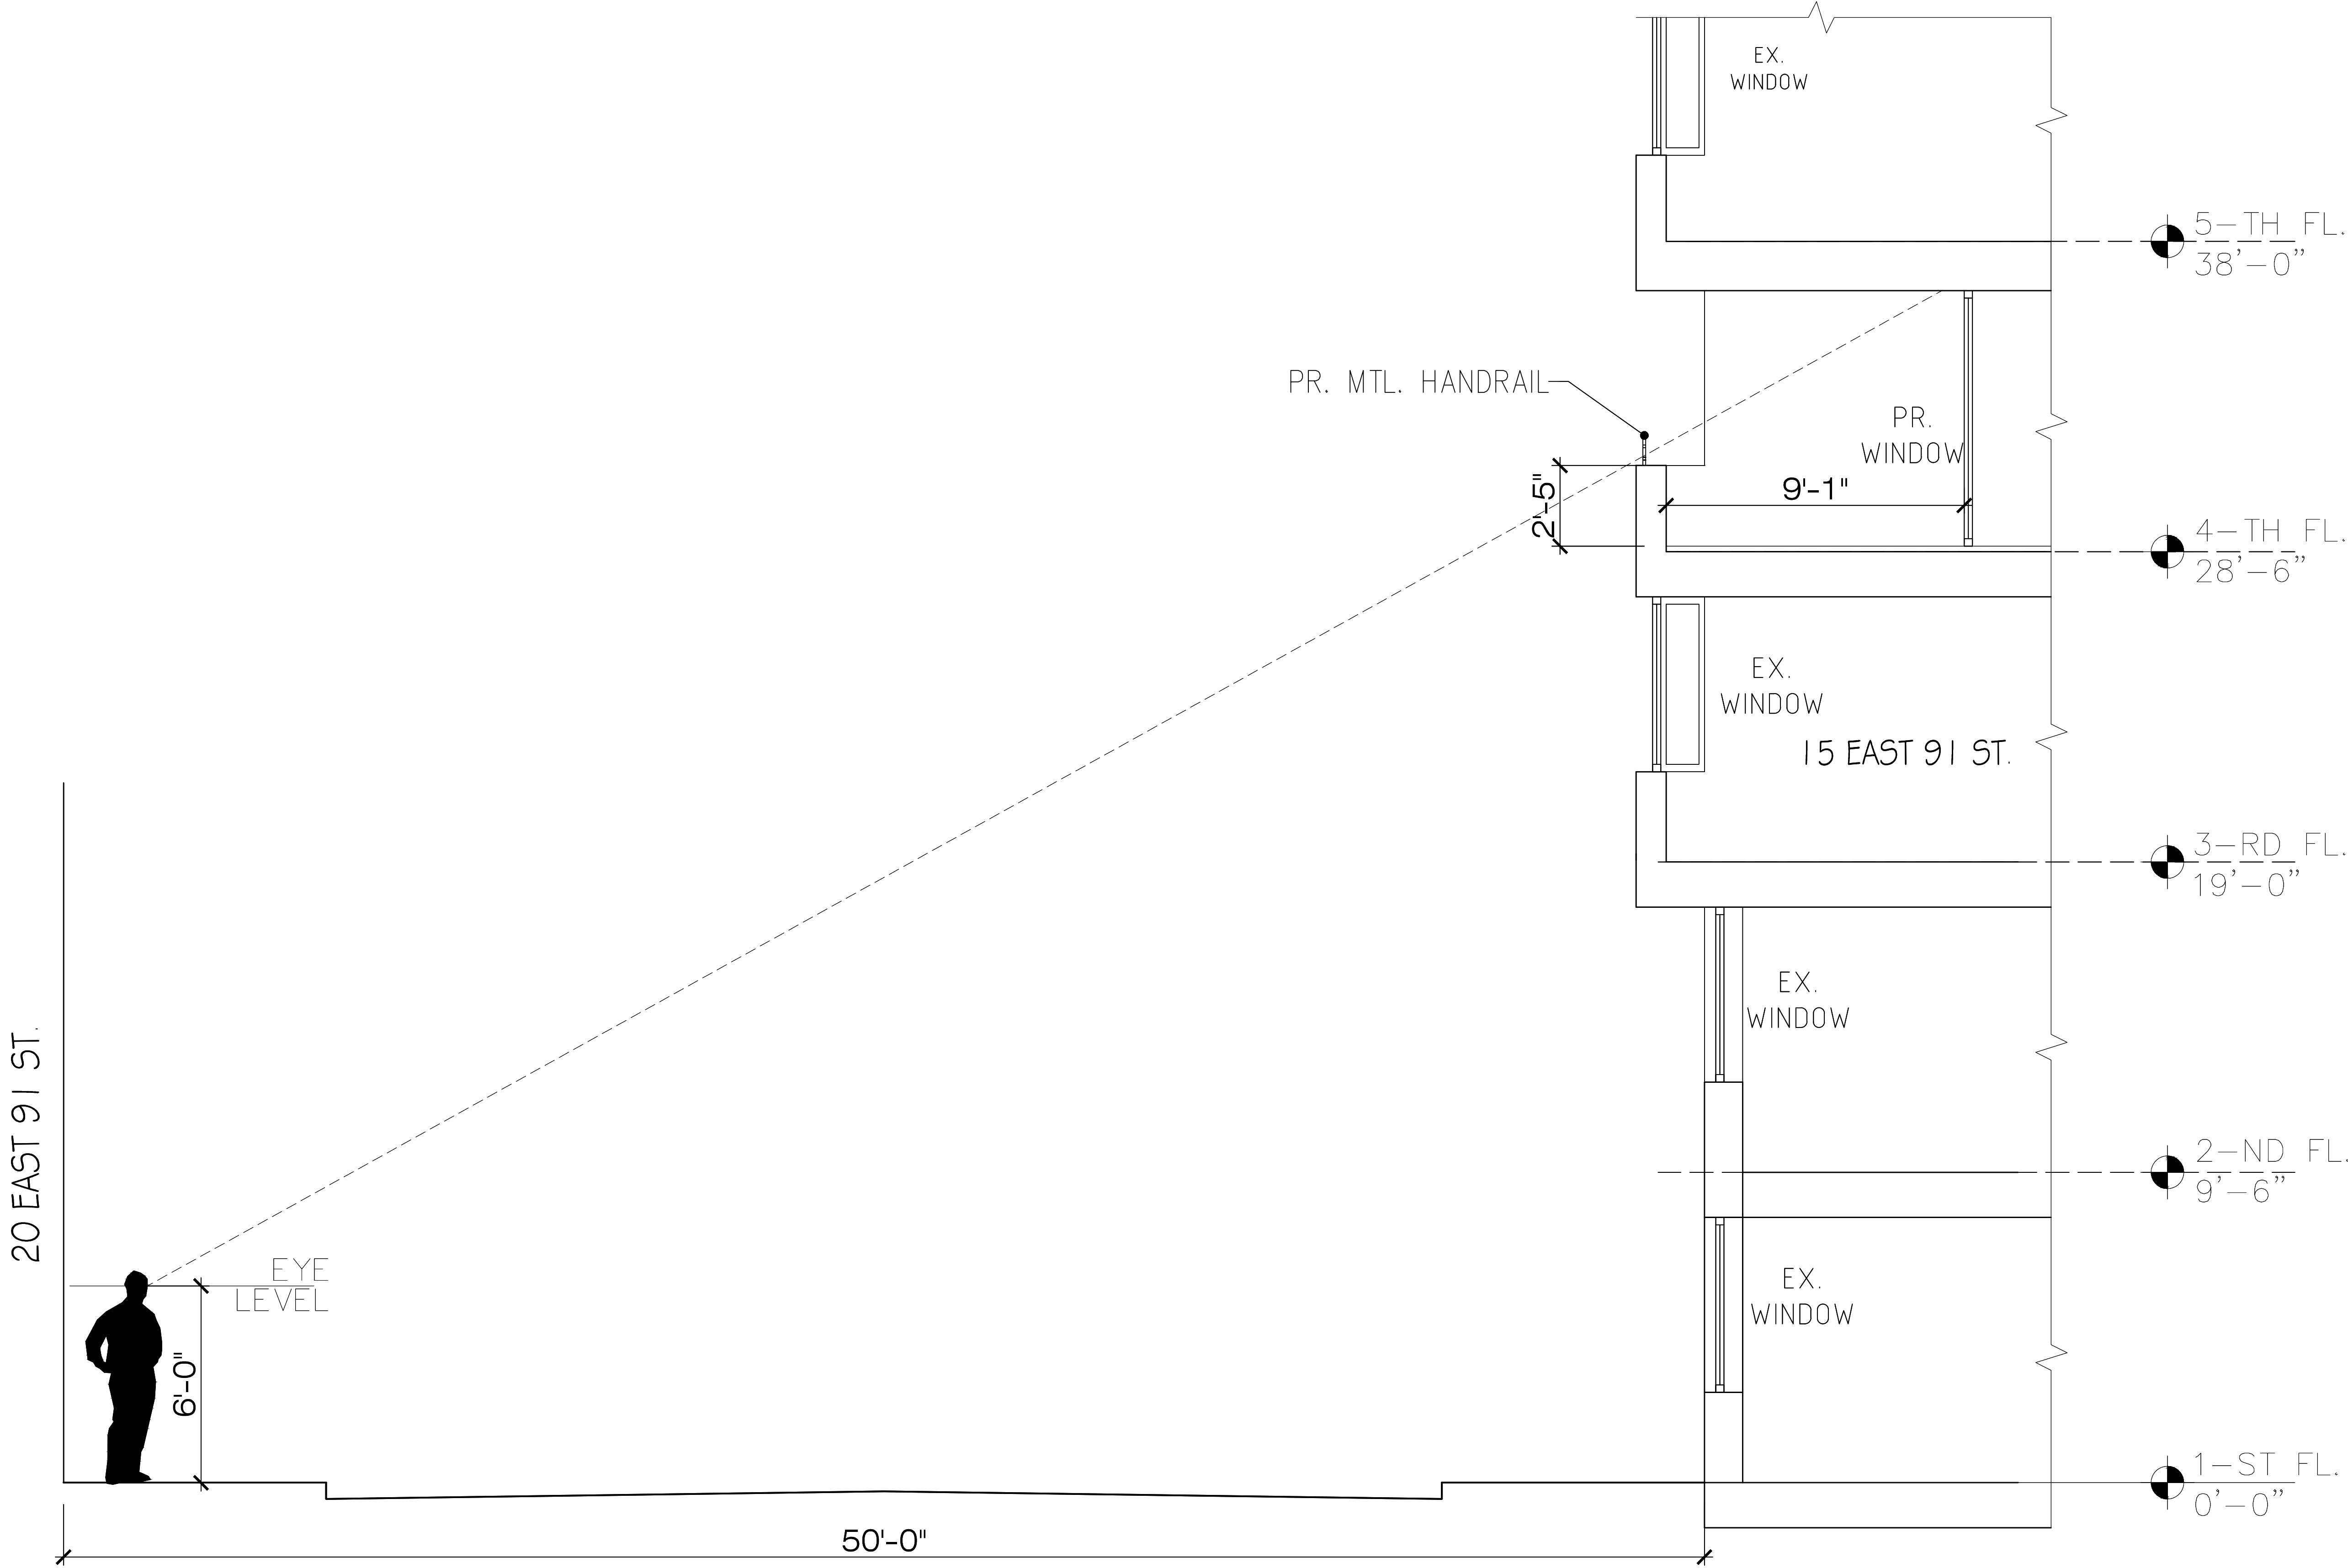
1

PROPOSED SECTION
(EAST 91 ST.) SCALE: 3/16"=1'-0"

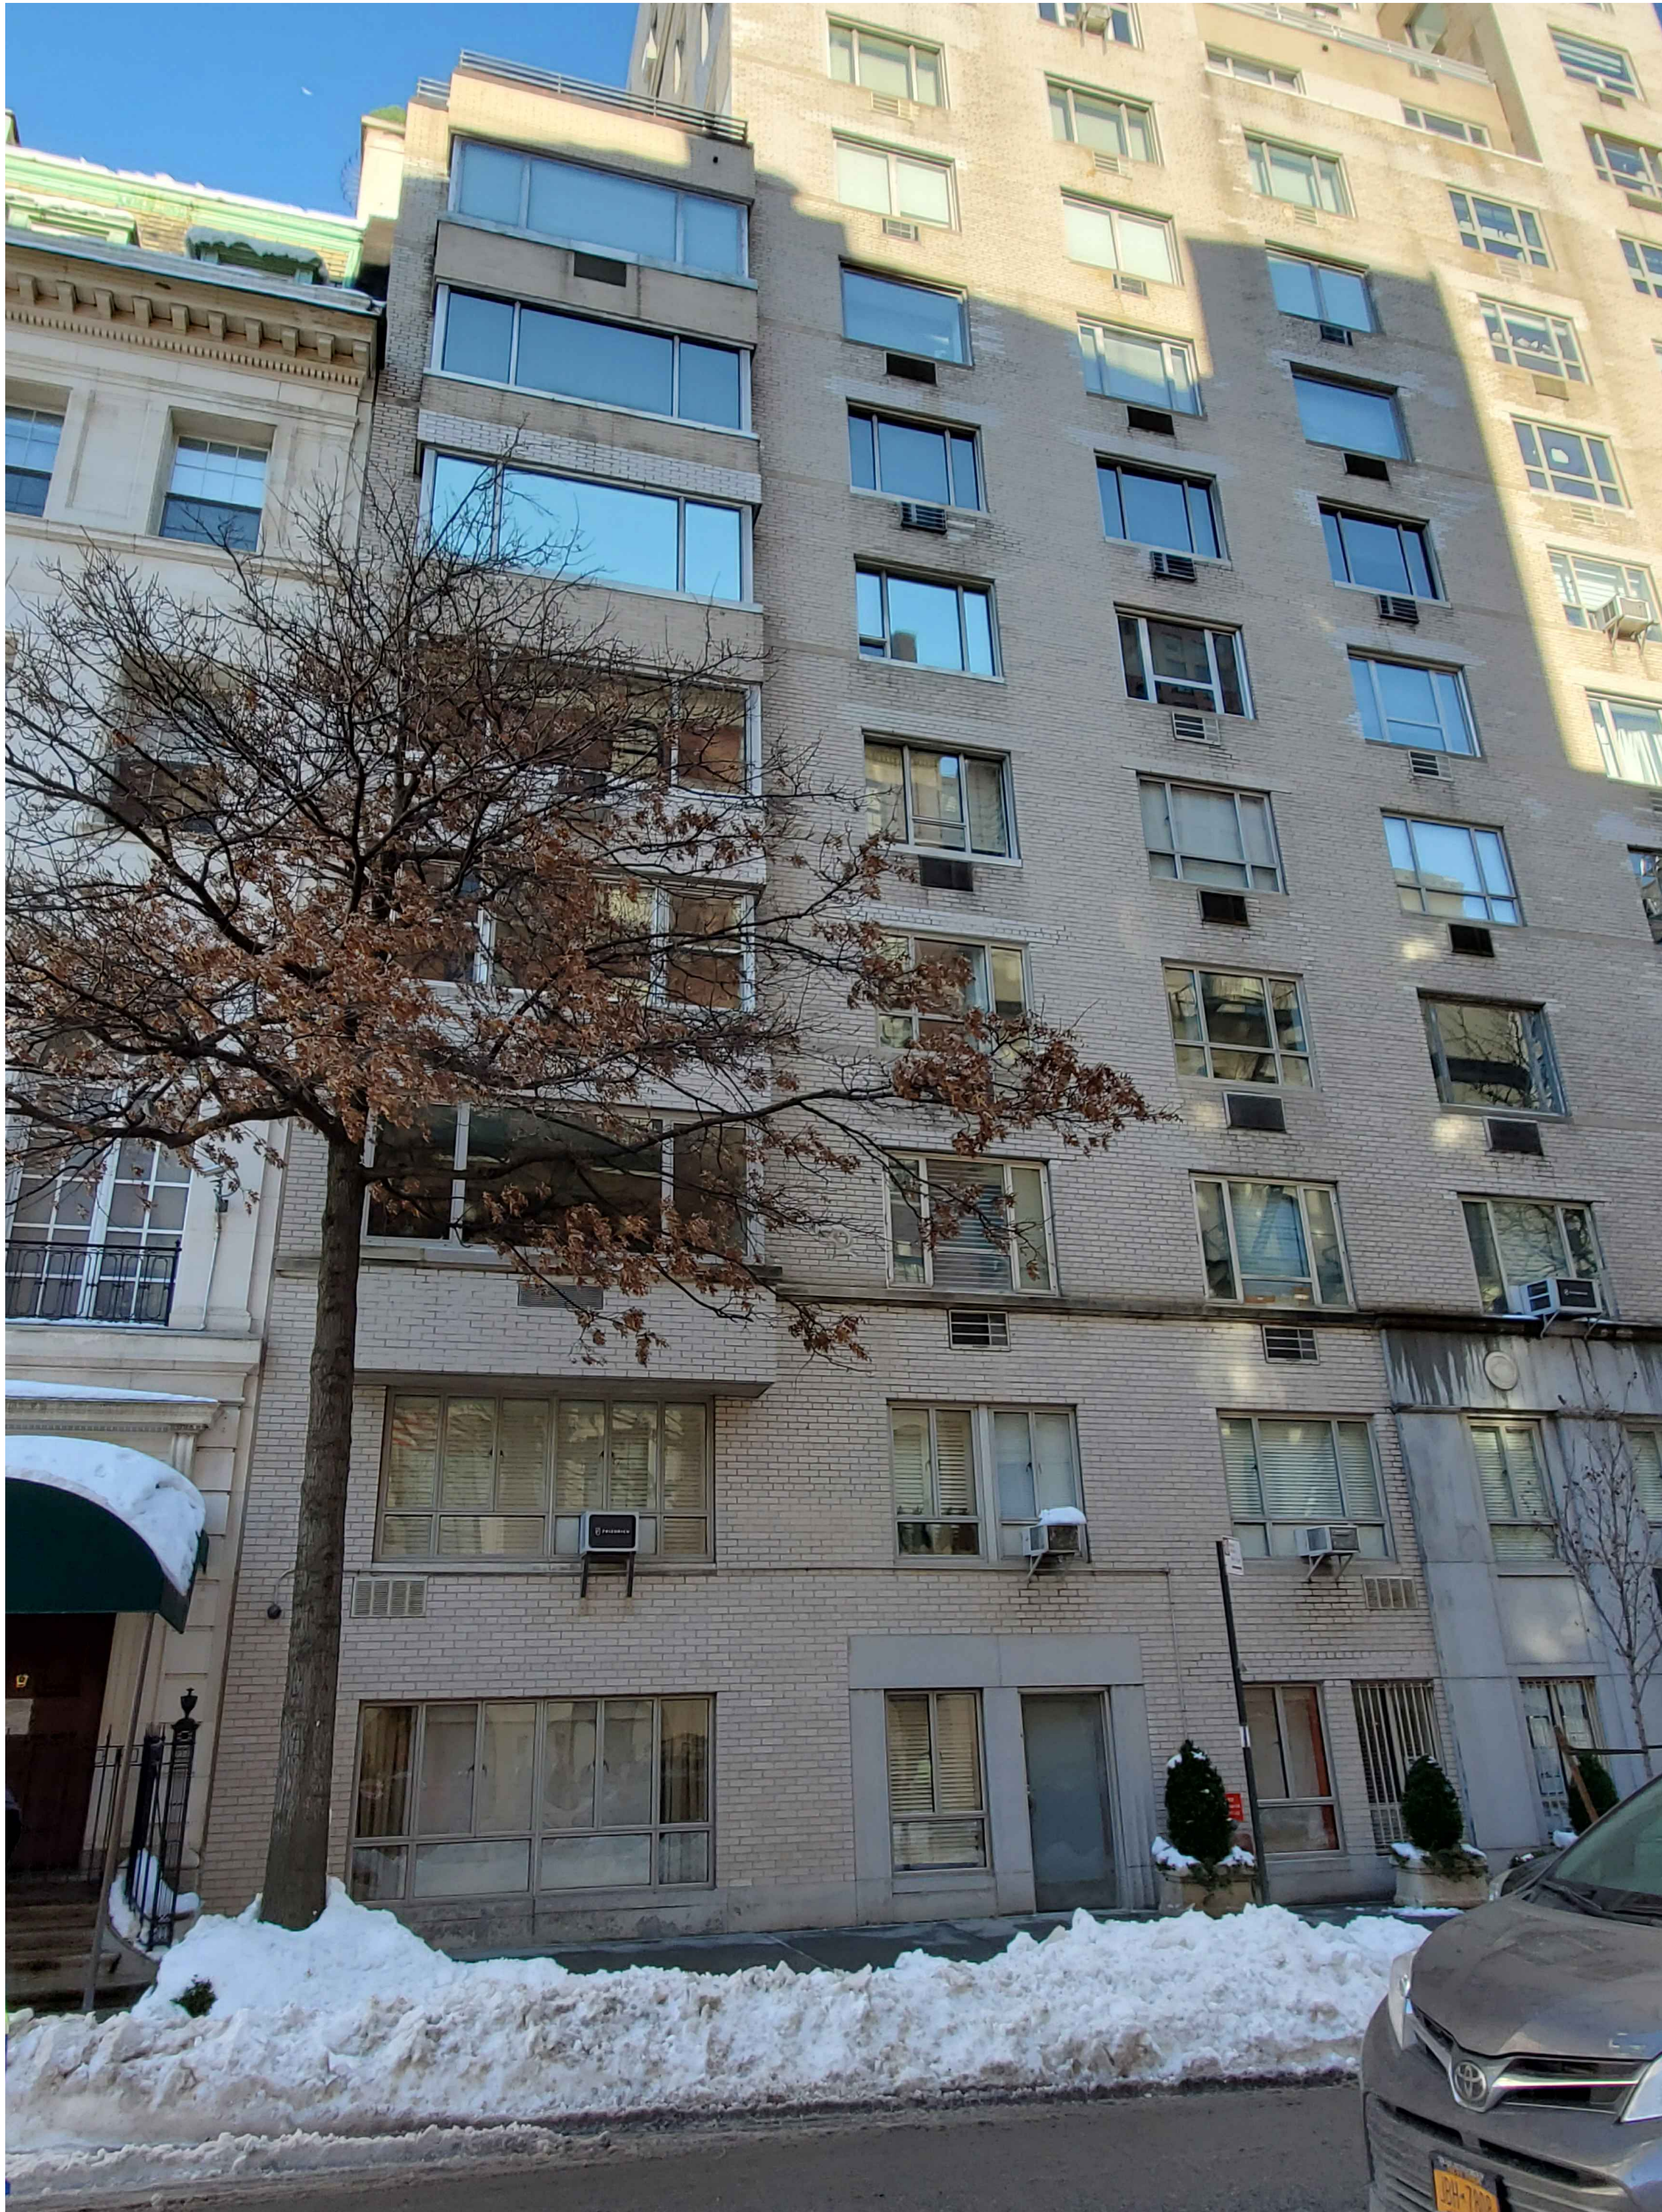
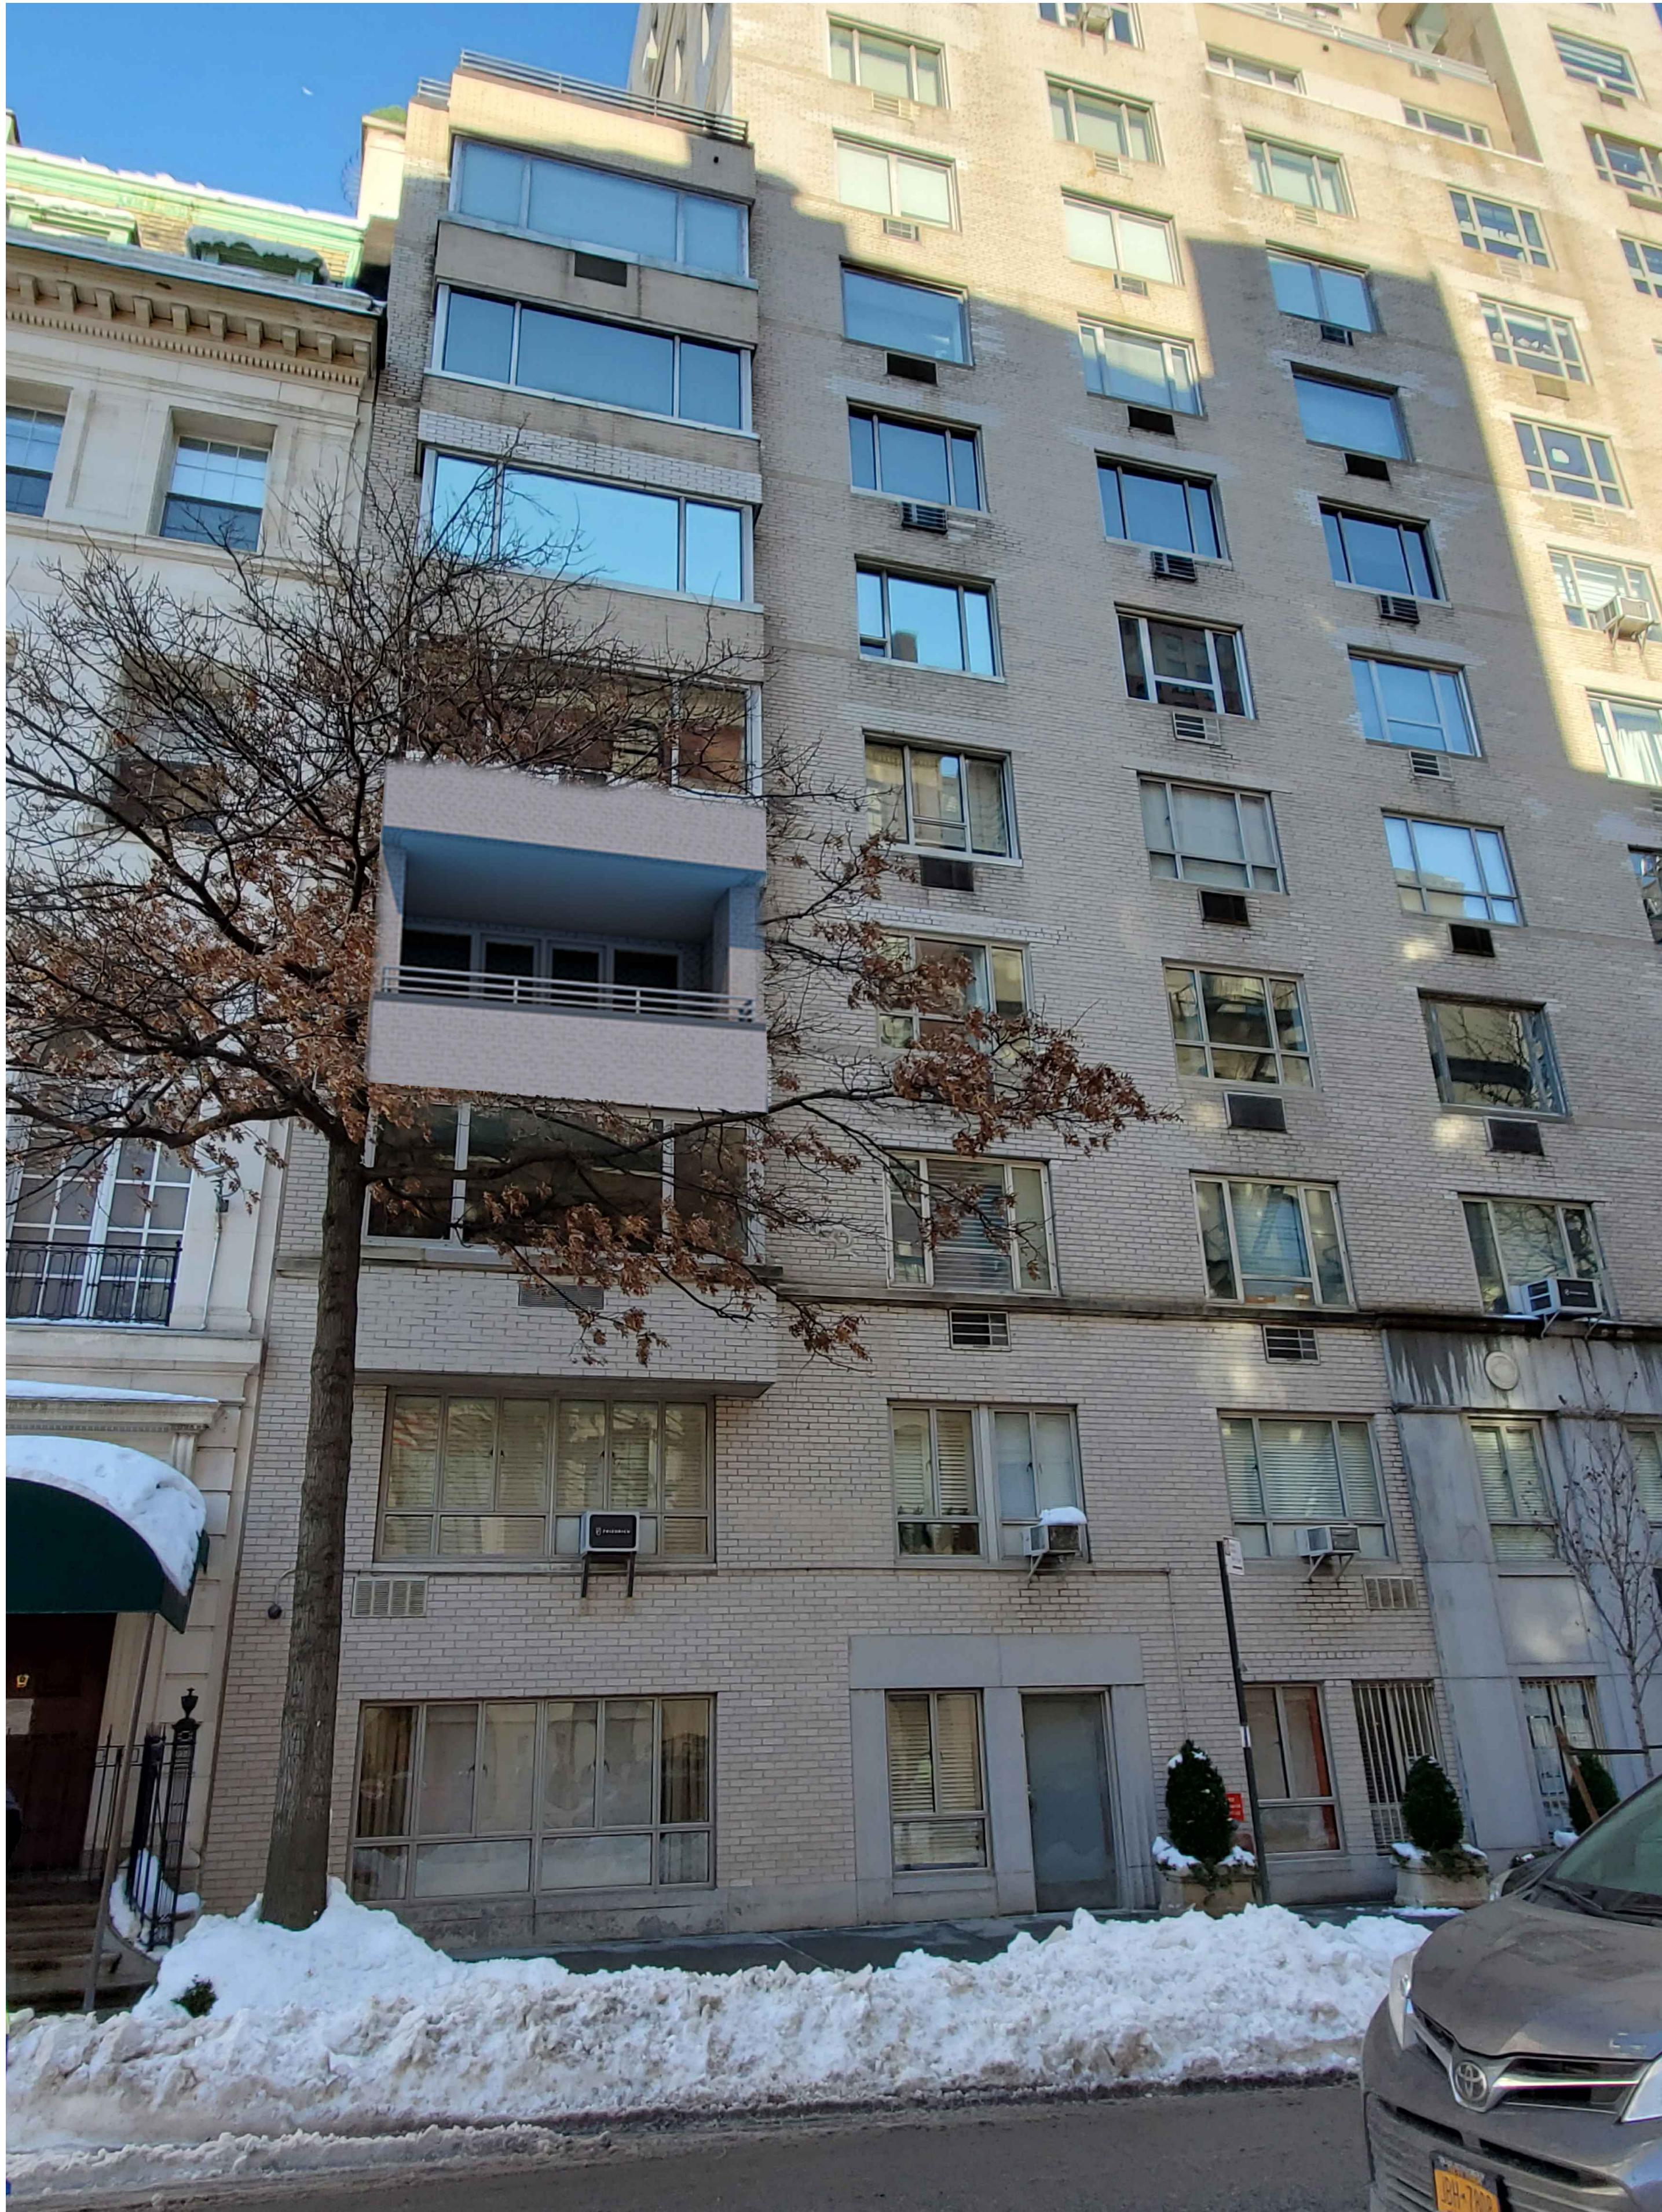
EXISTING PHOTO AND
RENDERING IN
PROPOSED CONDITION

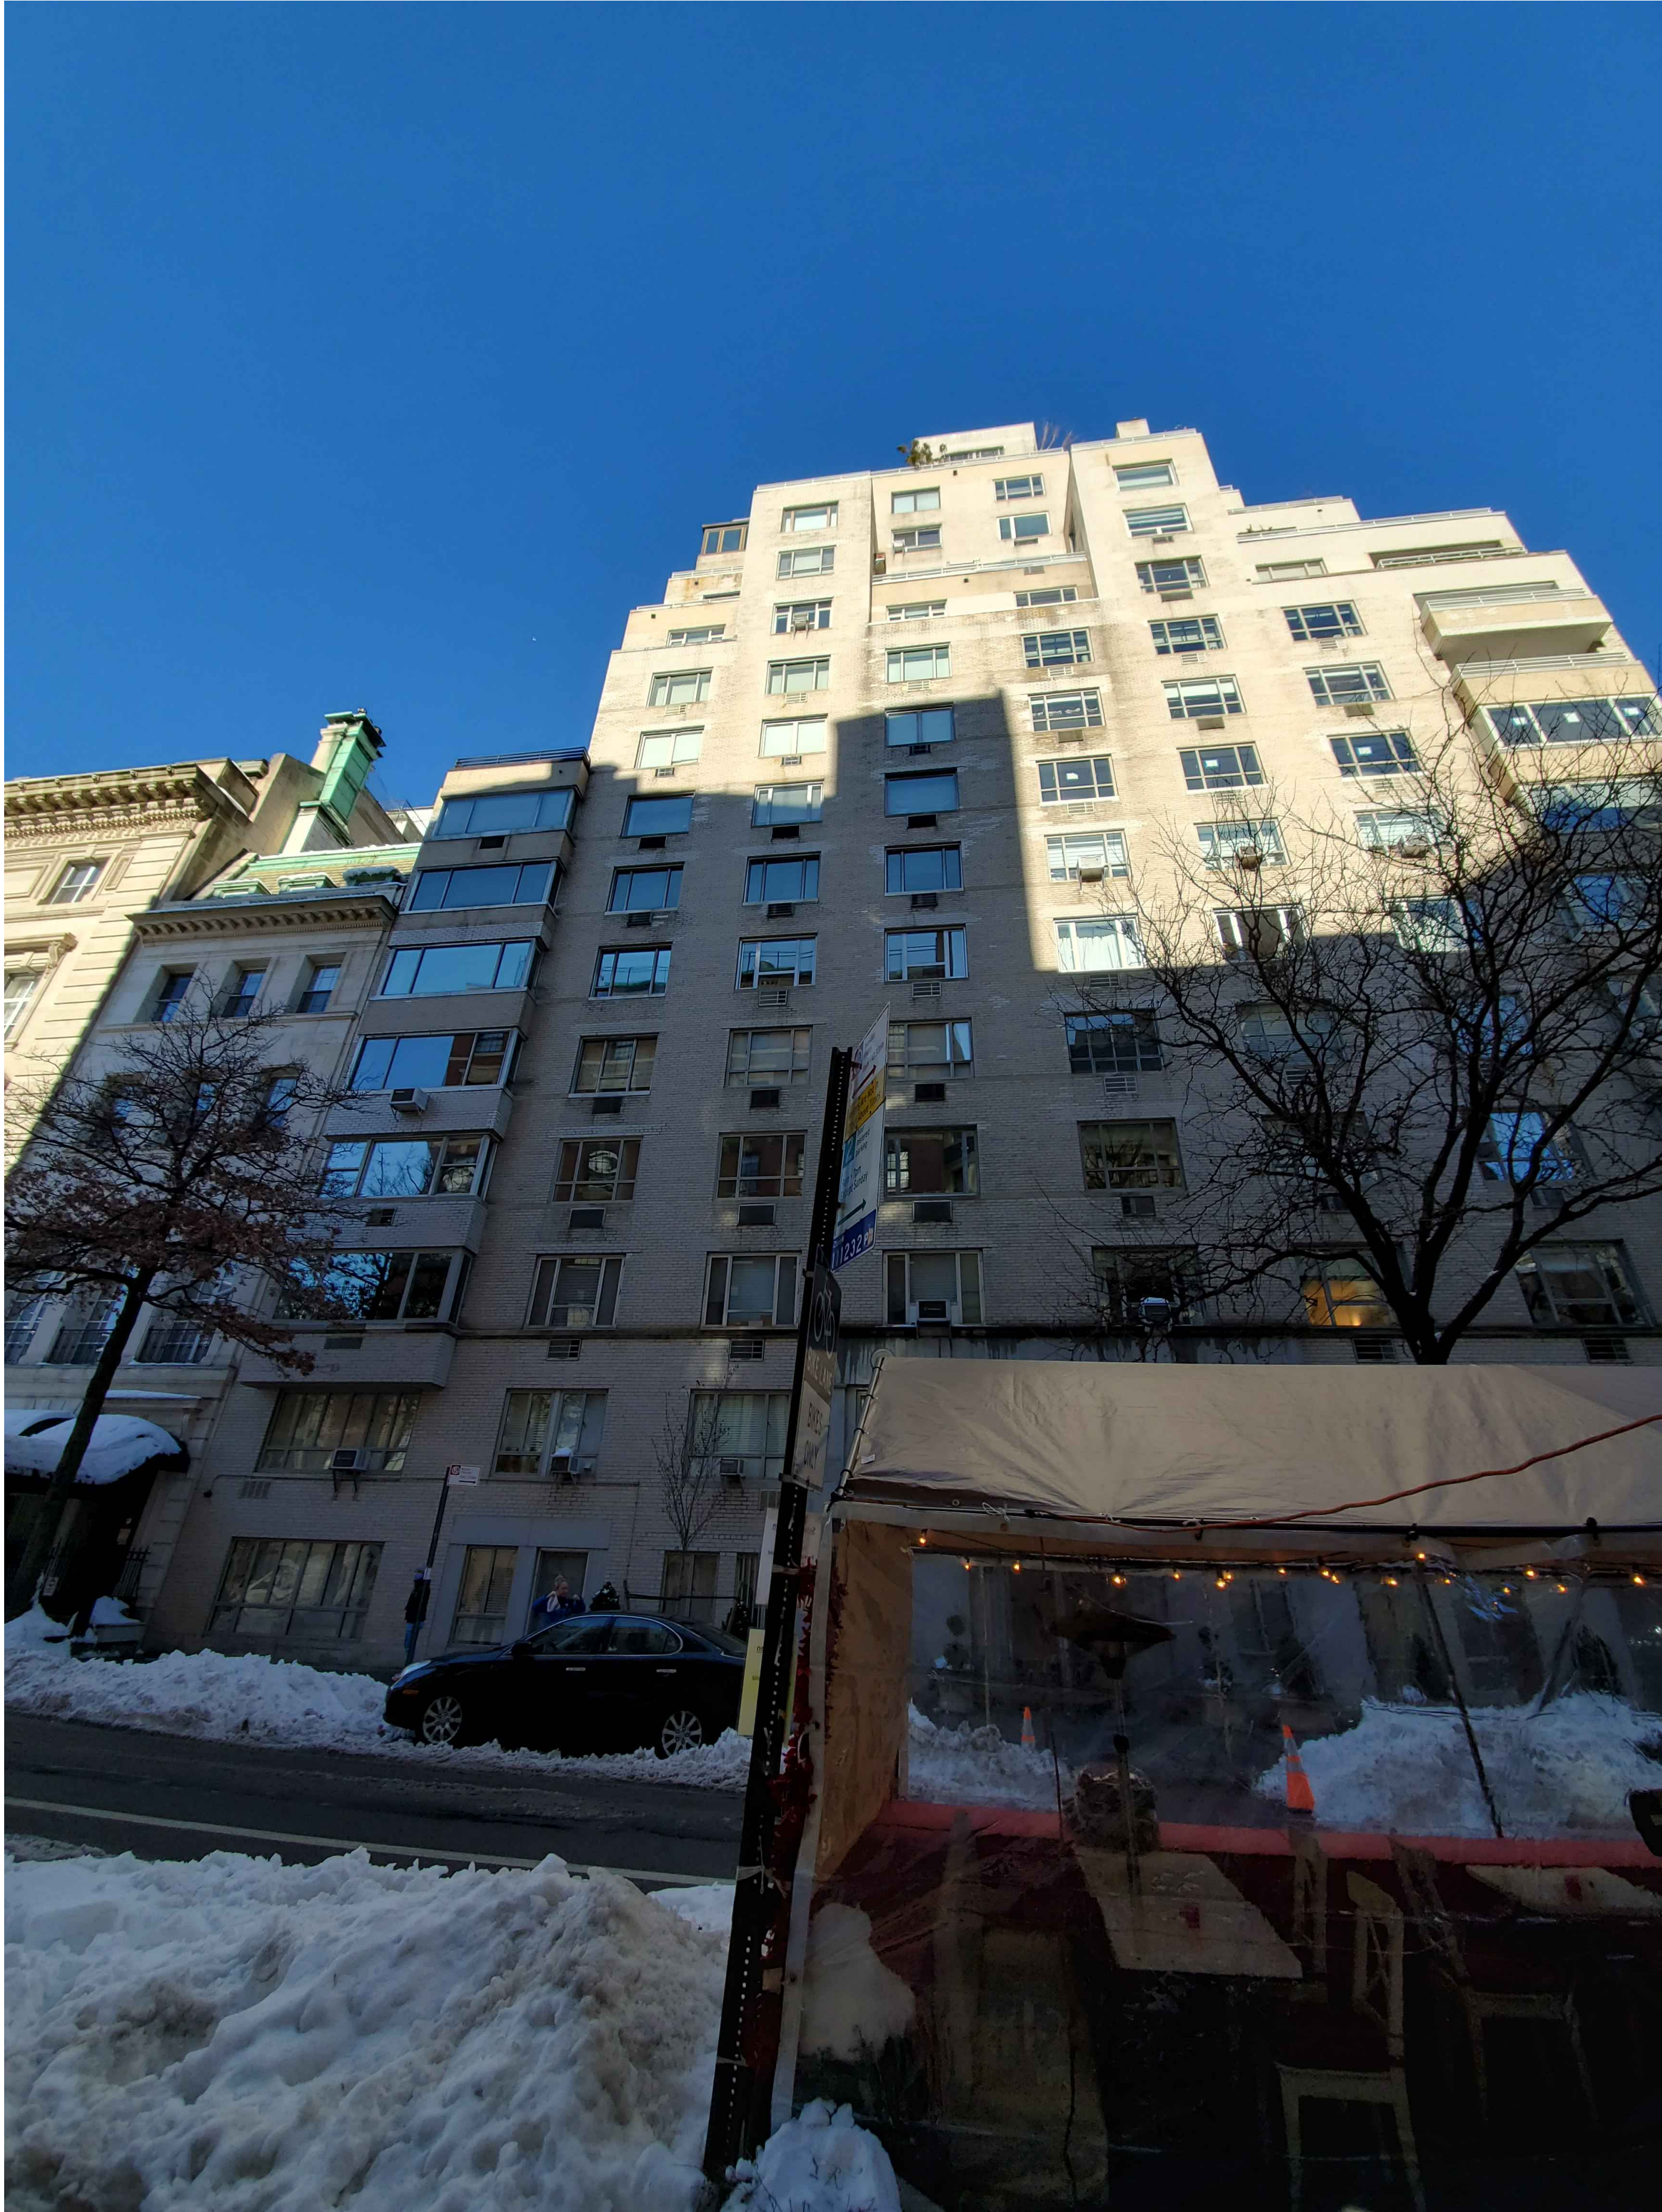
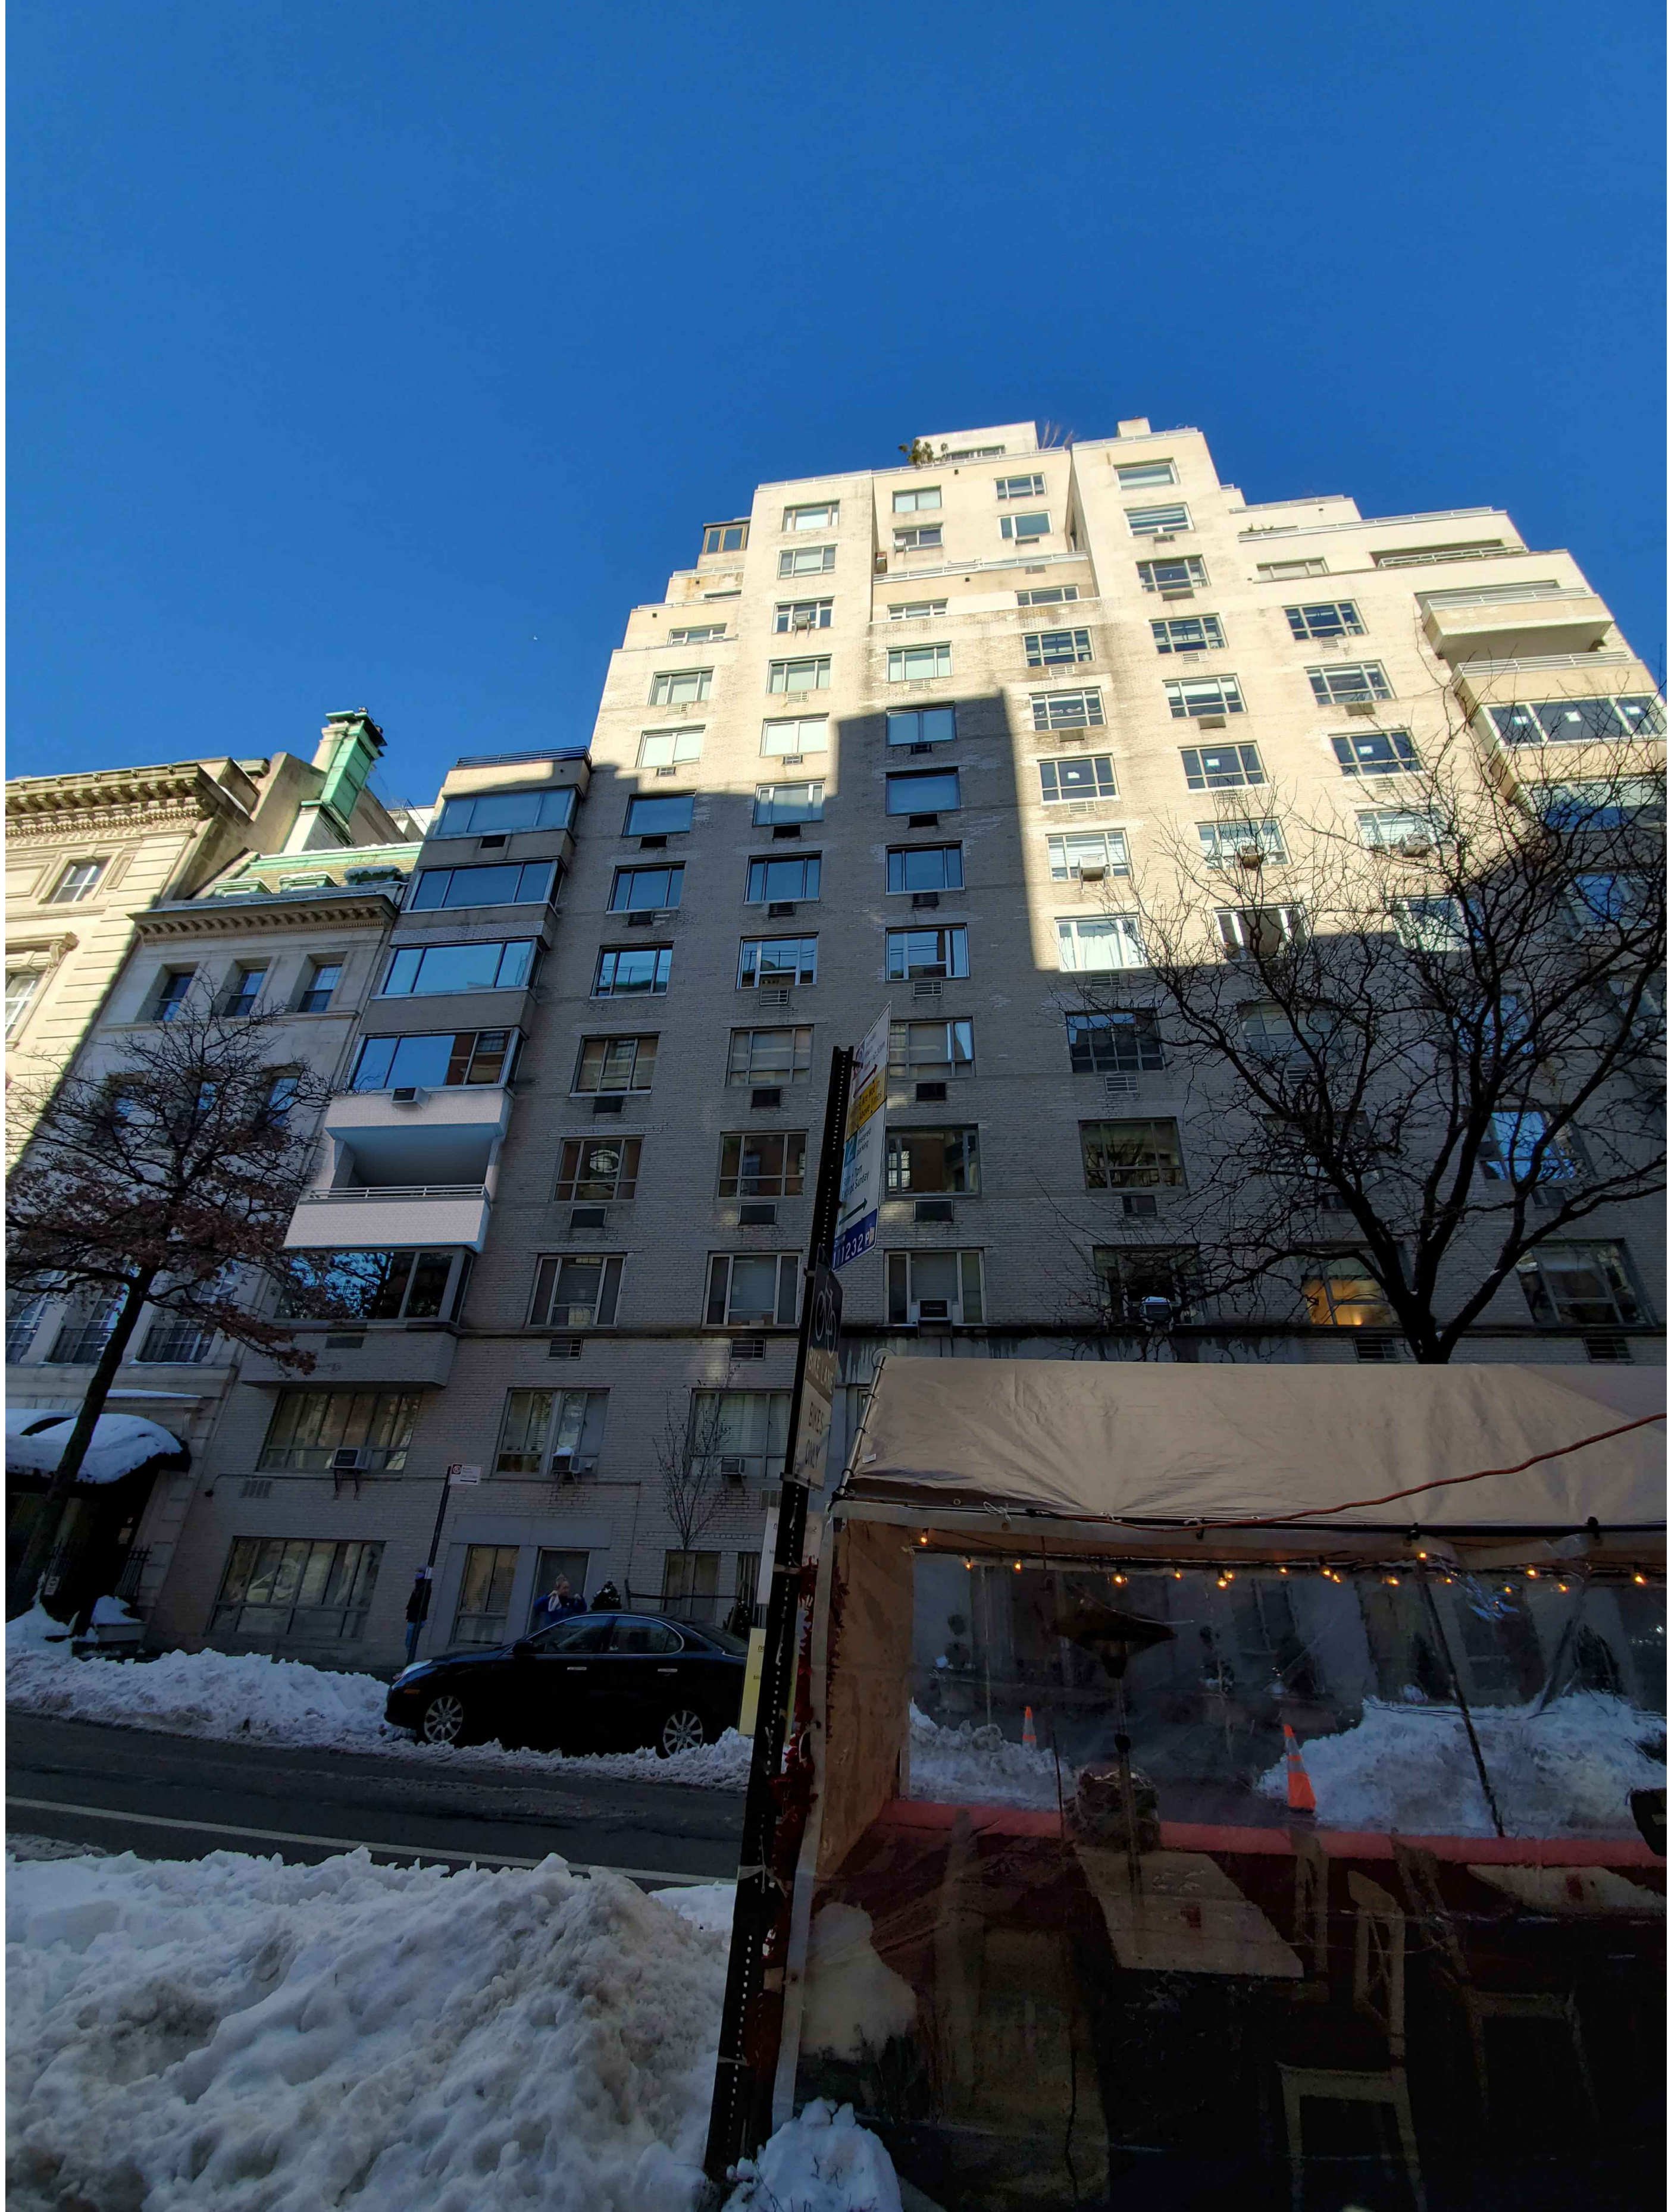
EXISTING PHOTO AND
RENDERING IN
PROPOSED CONDITION

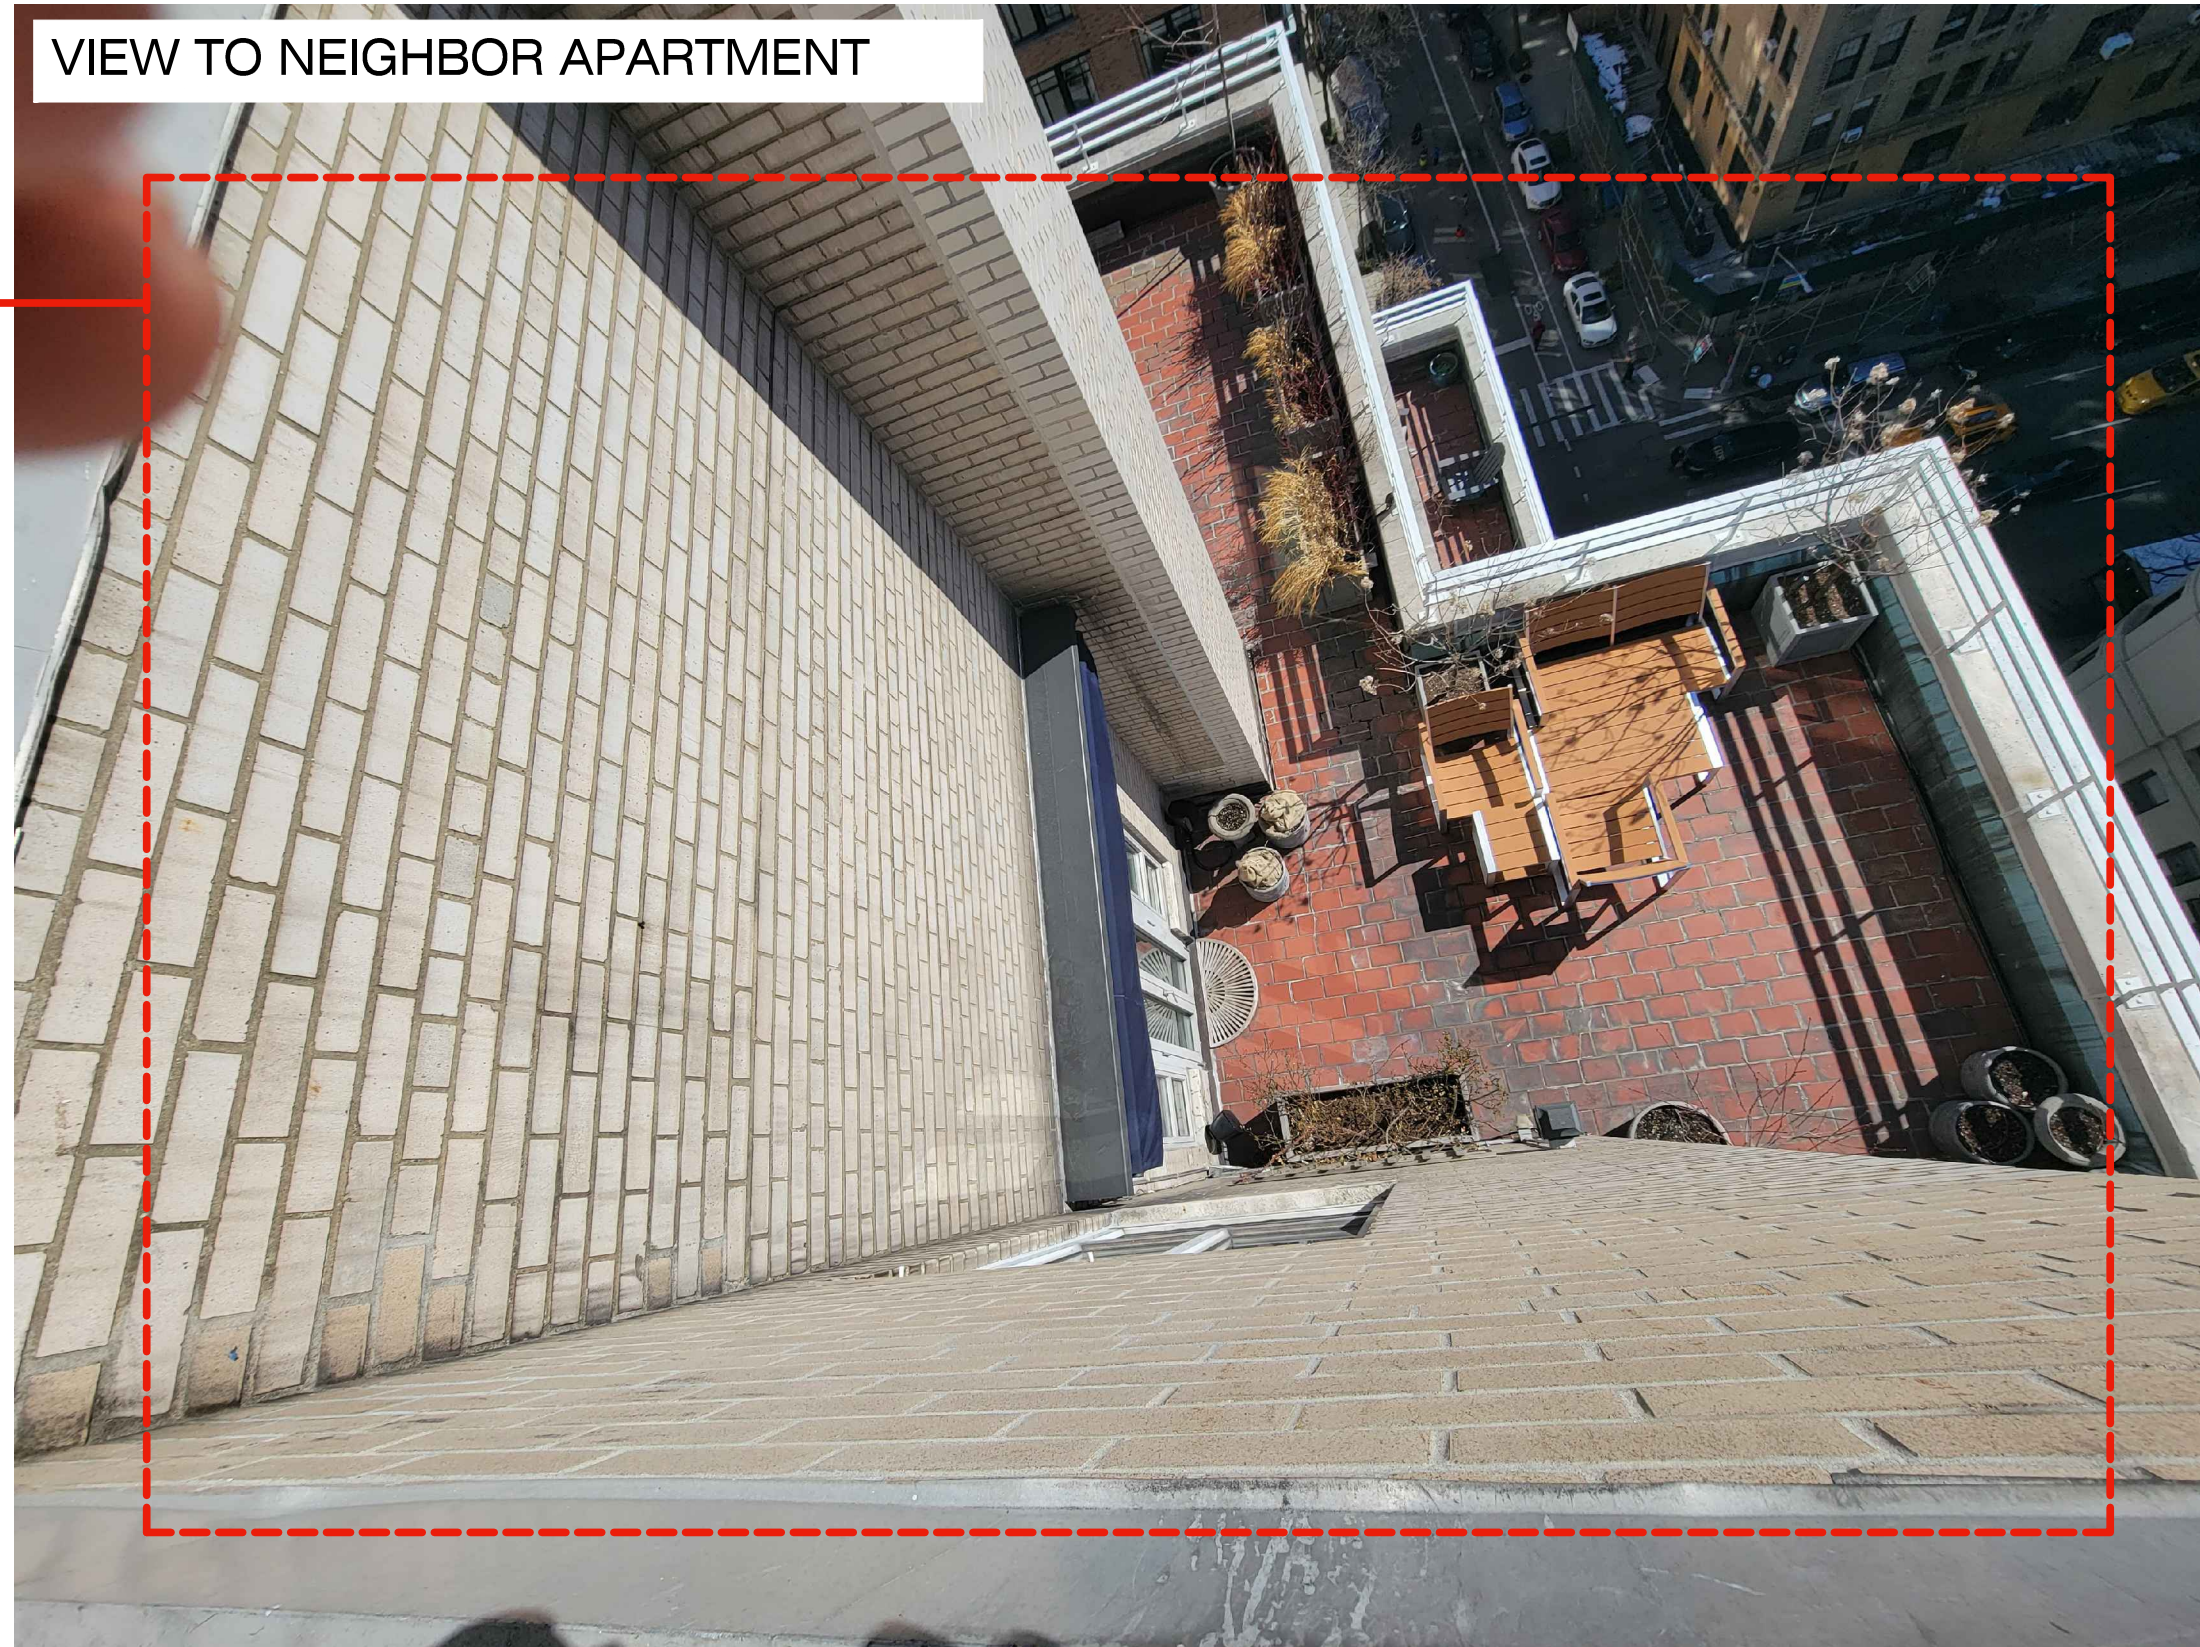
EXISTING PHOTO AND
ORIGINAL RAILINGS
