Individual Landmark LP-0427:

John S. and Catherine C. Rogers House

53 East 79th Street, Manhattan

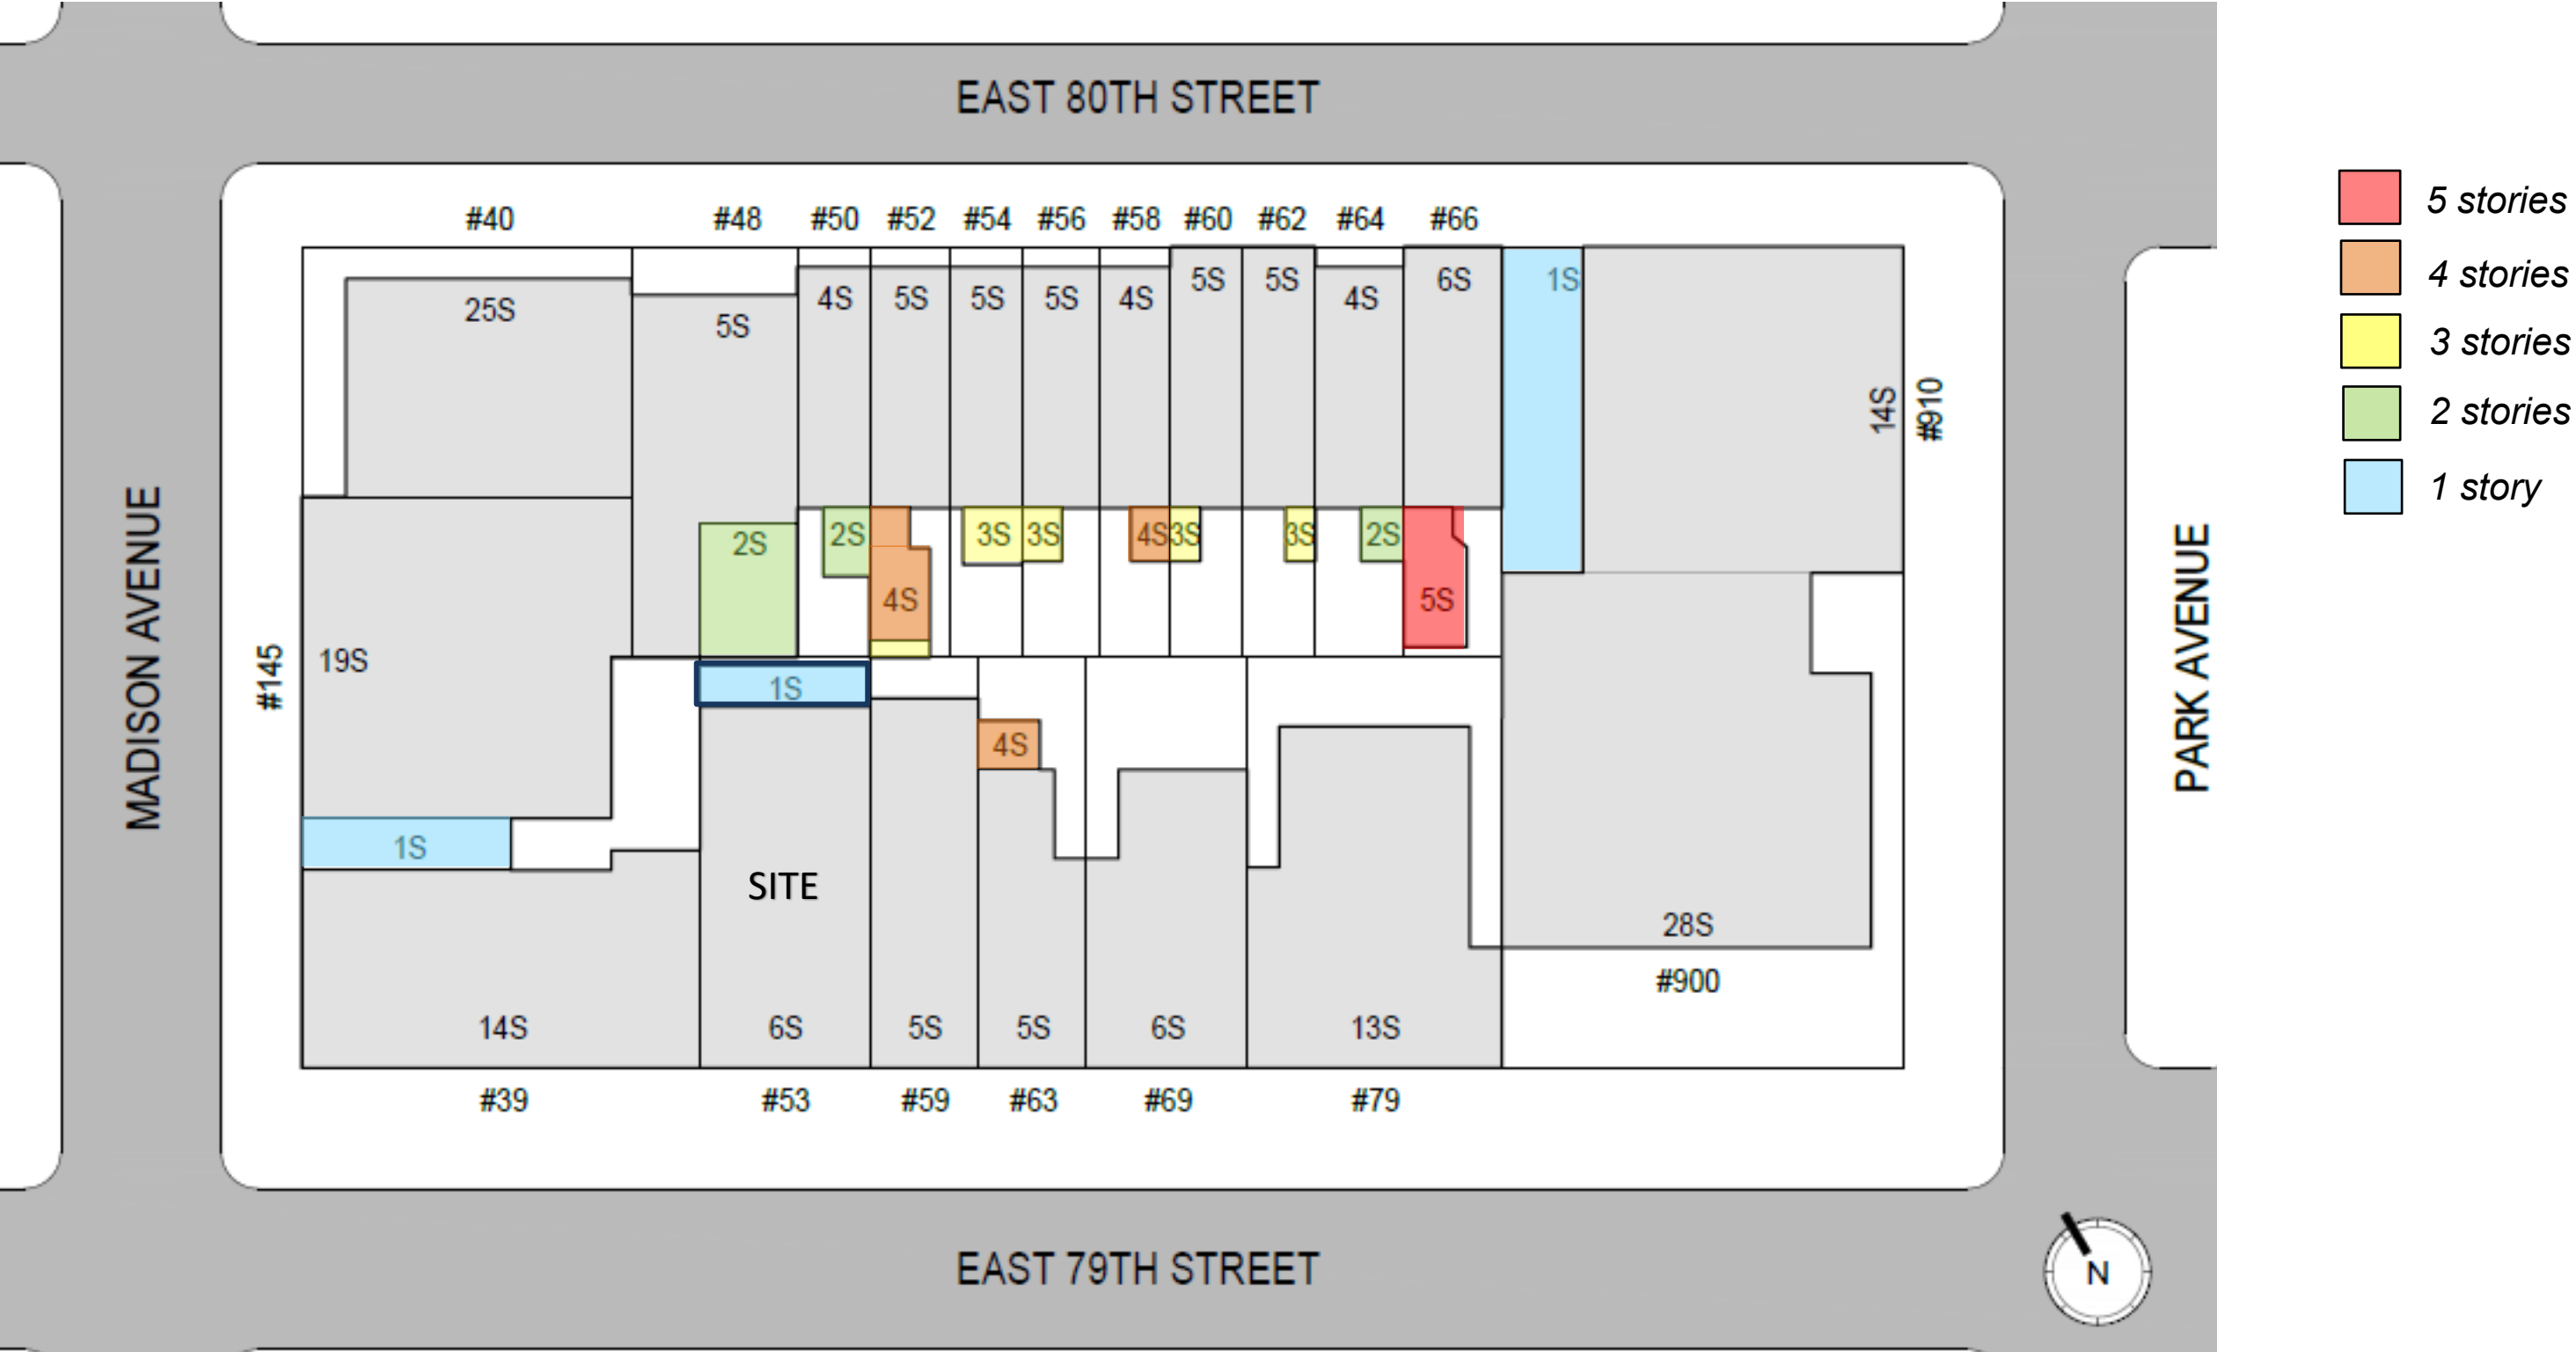
Plan of block with neighboring rear yard buildings highlighted

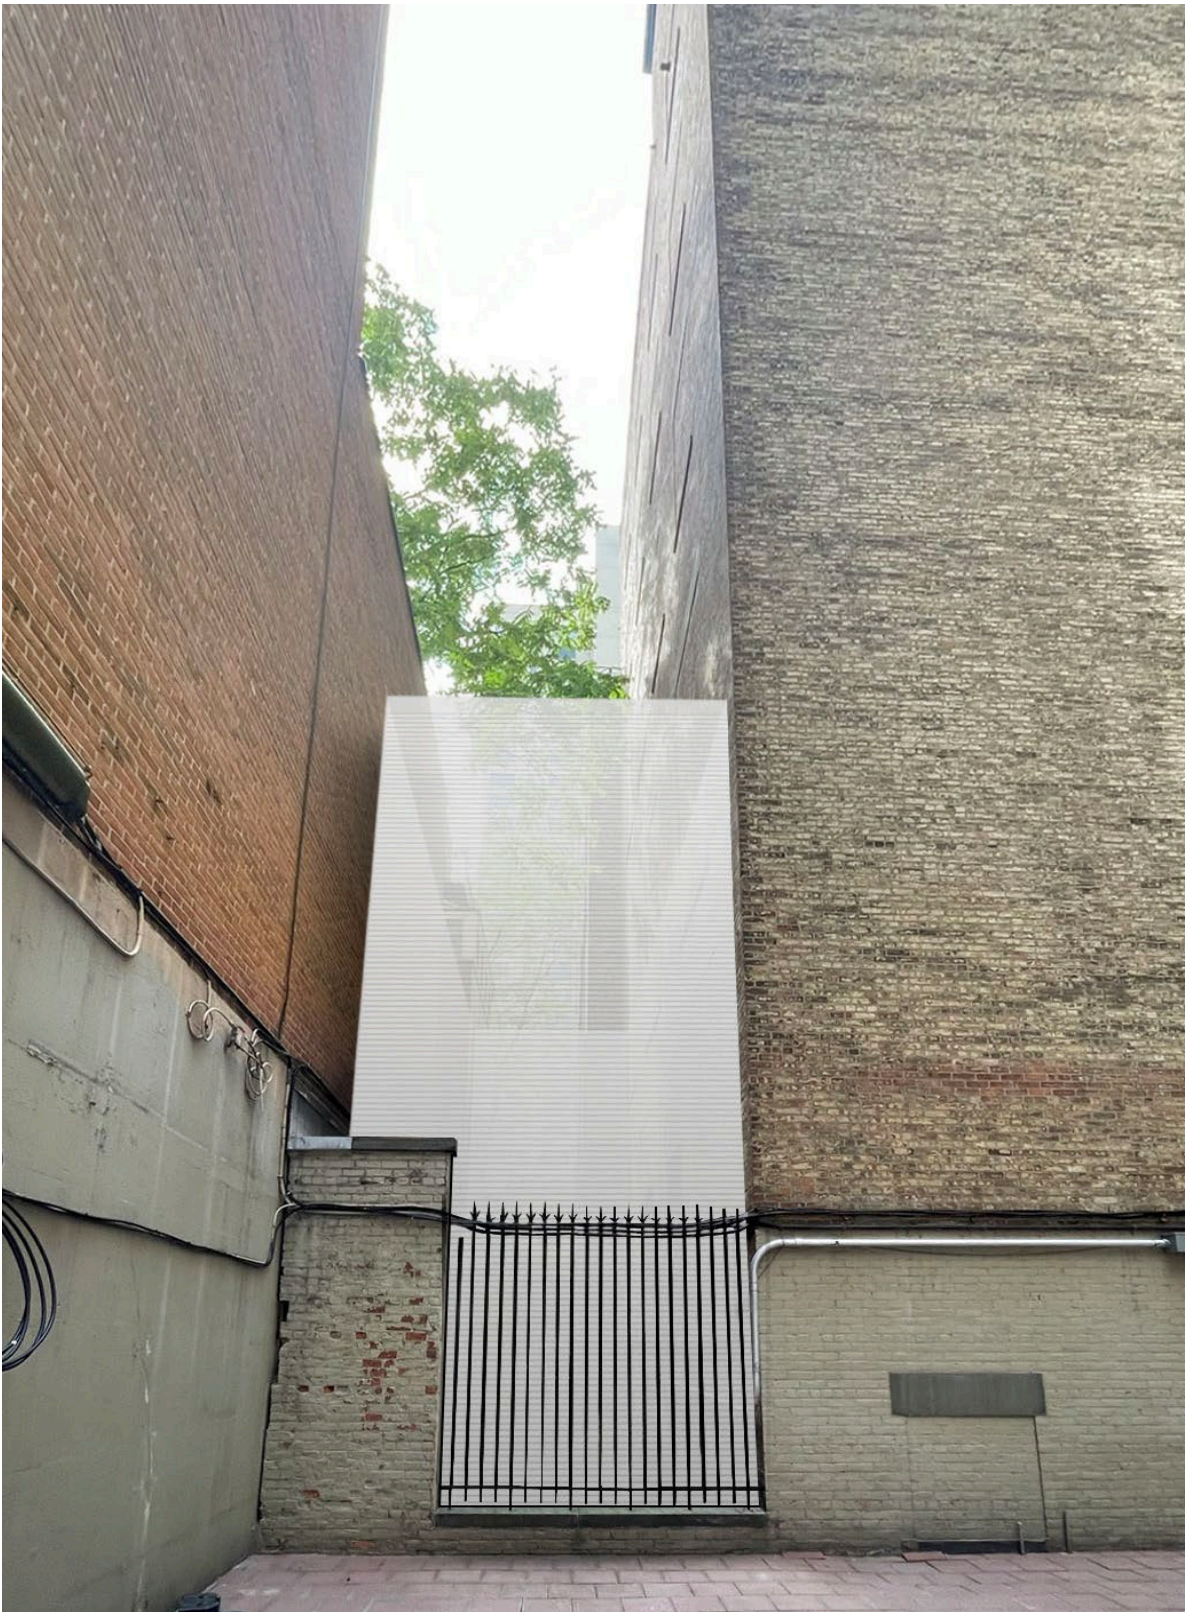
With Proposed Addition

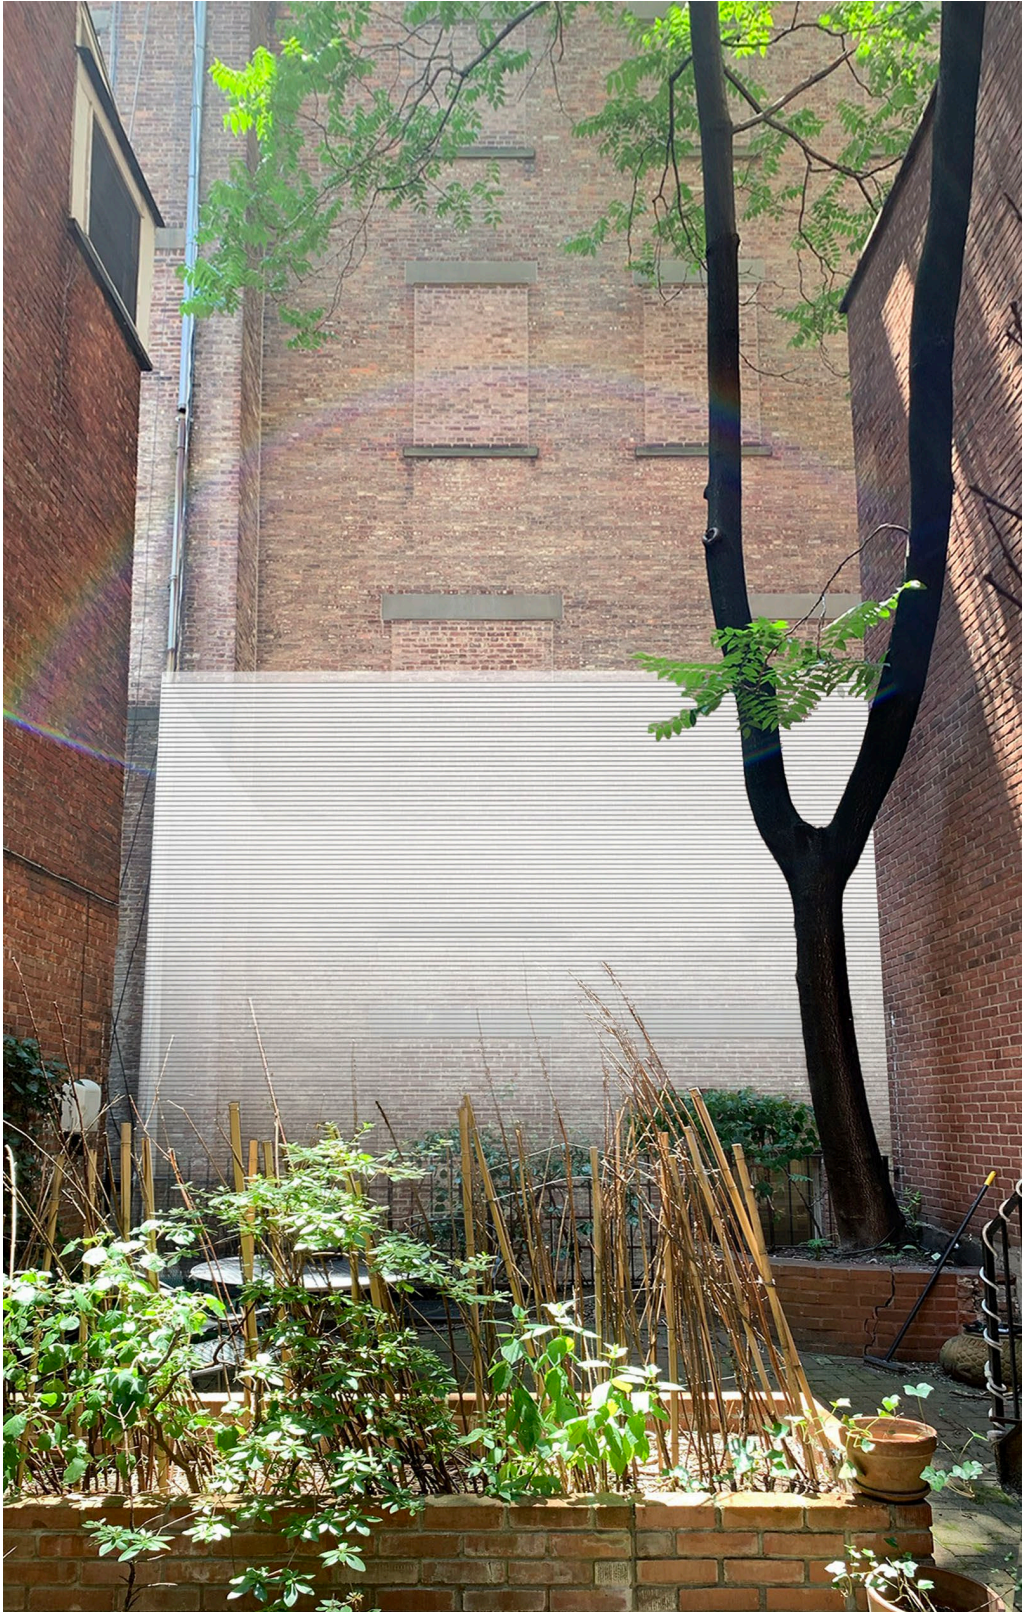
With Proposed Addition

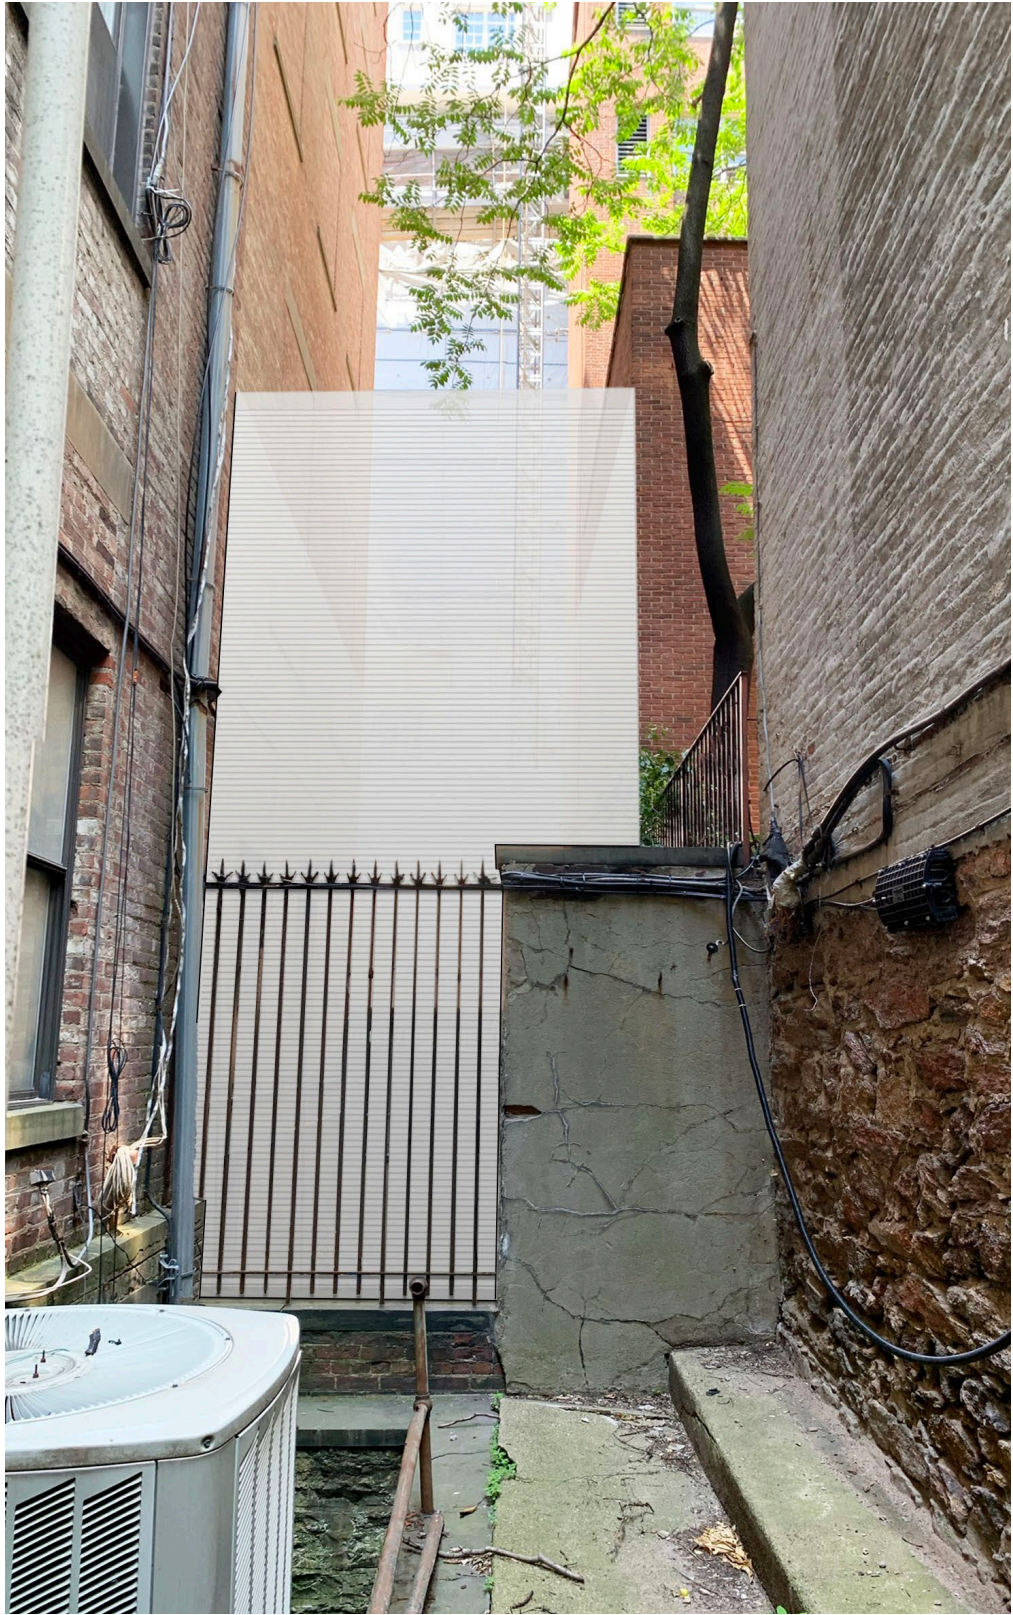
With Proposed Addition

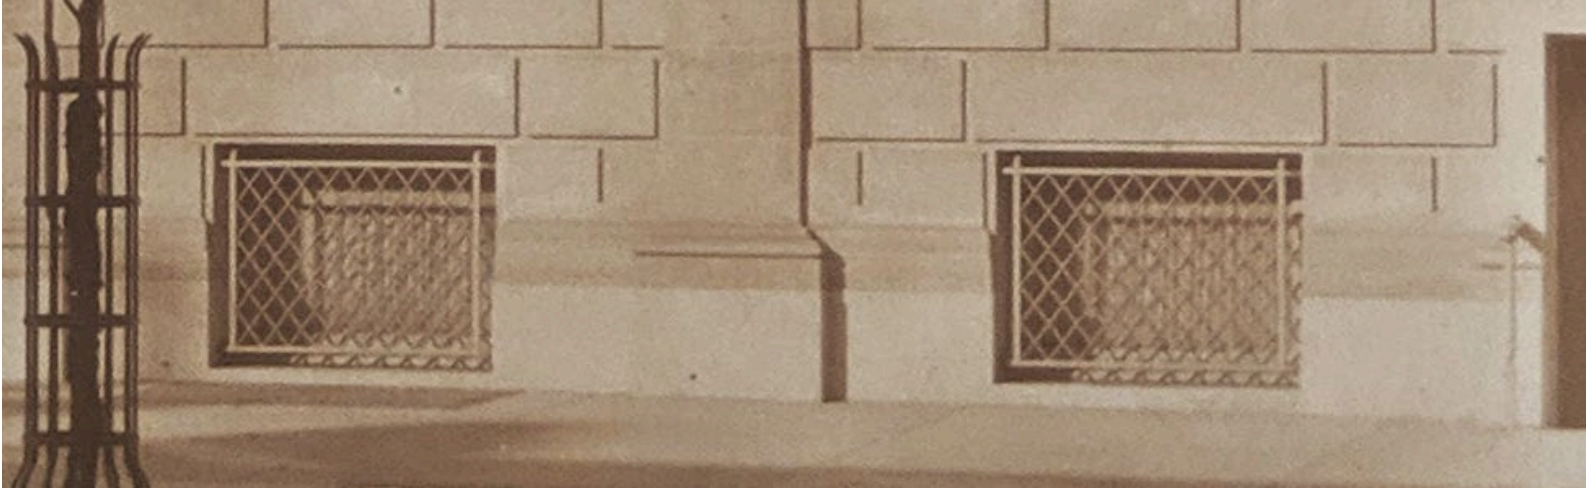
Enlarged view of original windows at sidewalk (1917)

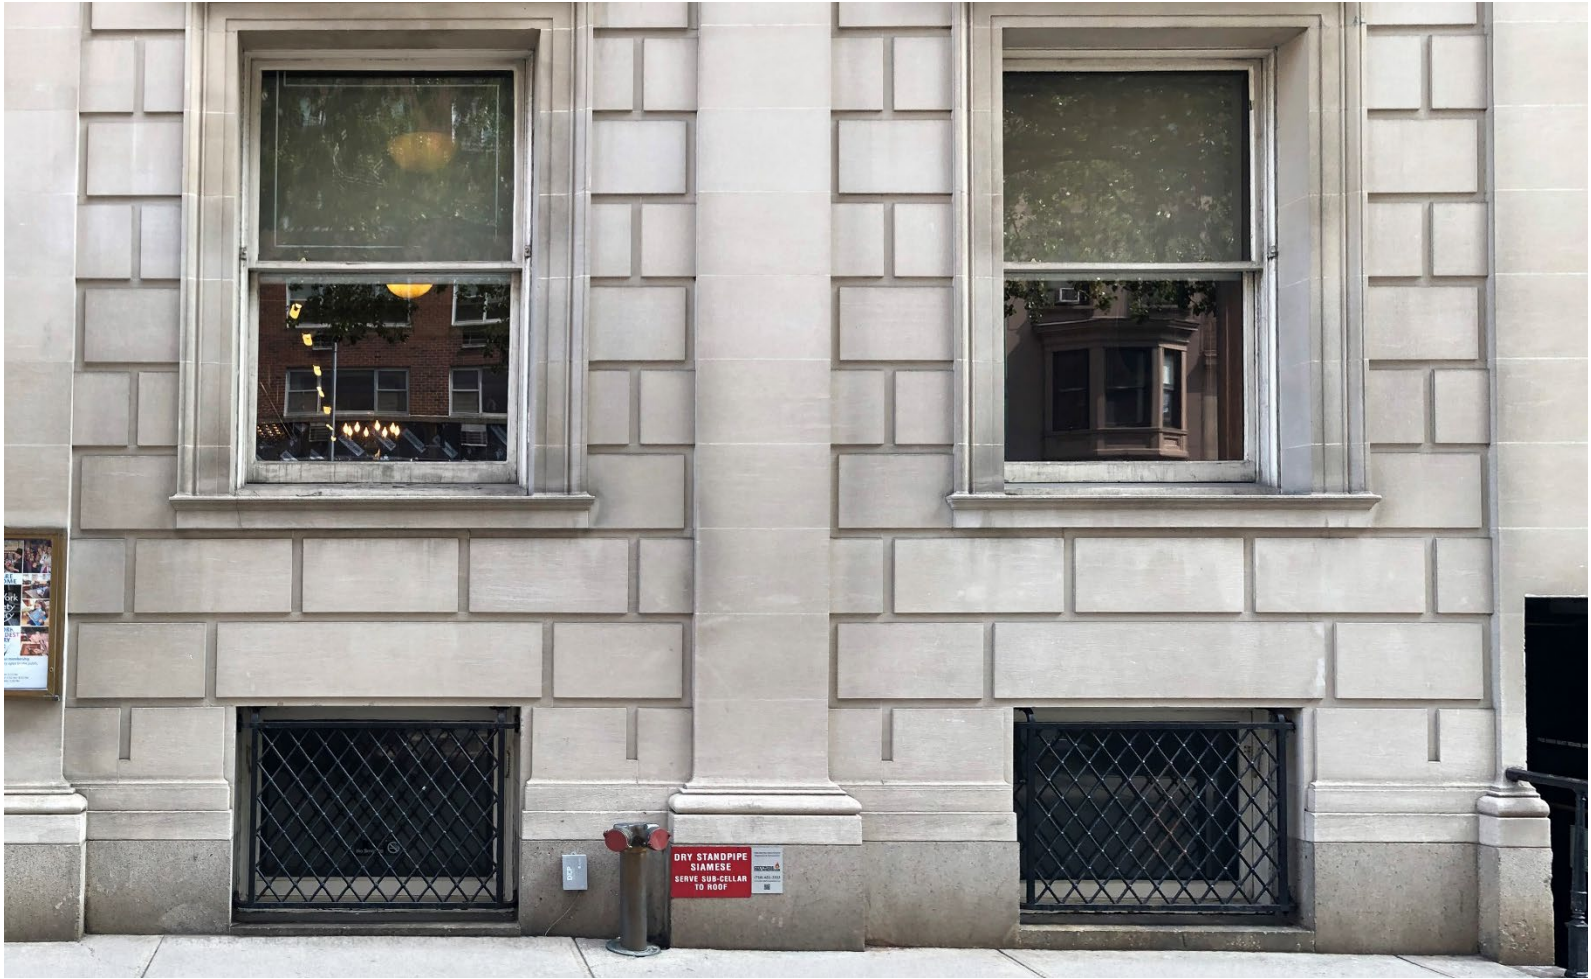
Current view of windows at sidewalk, to be replaced with operable hopper windows to match existing as closely as possible; Existing grilles to remain
