Revised Proposal

Persian Jewish Center of New York City

Proposal to include a Synagogue - 177-179 East 73rd Street

NARATIVE OF CONDITIONS ASSESSEMENT REPORT

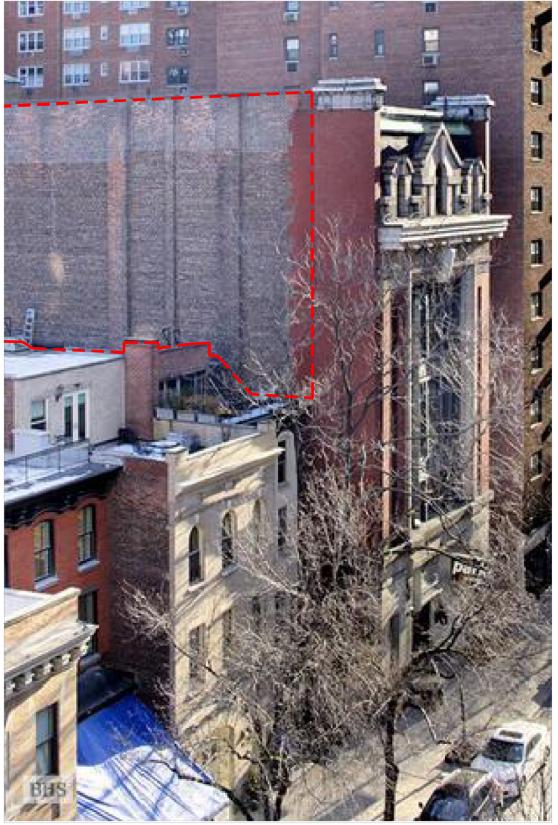
PROPOSED CONDITION OF WEST FACADE

PROPOSED REMOVAL AND REPLACEMENT OF EXISTING BRICK FACADE

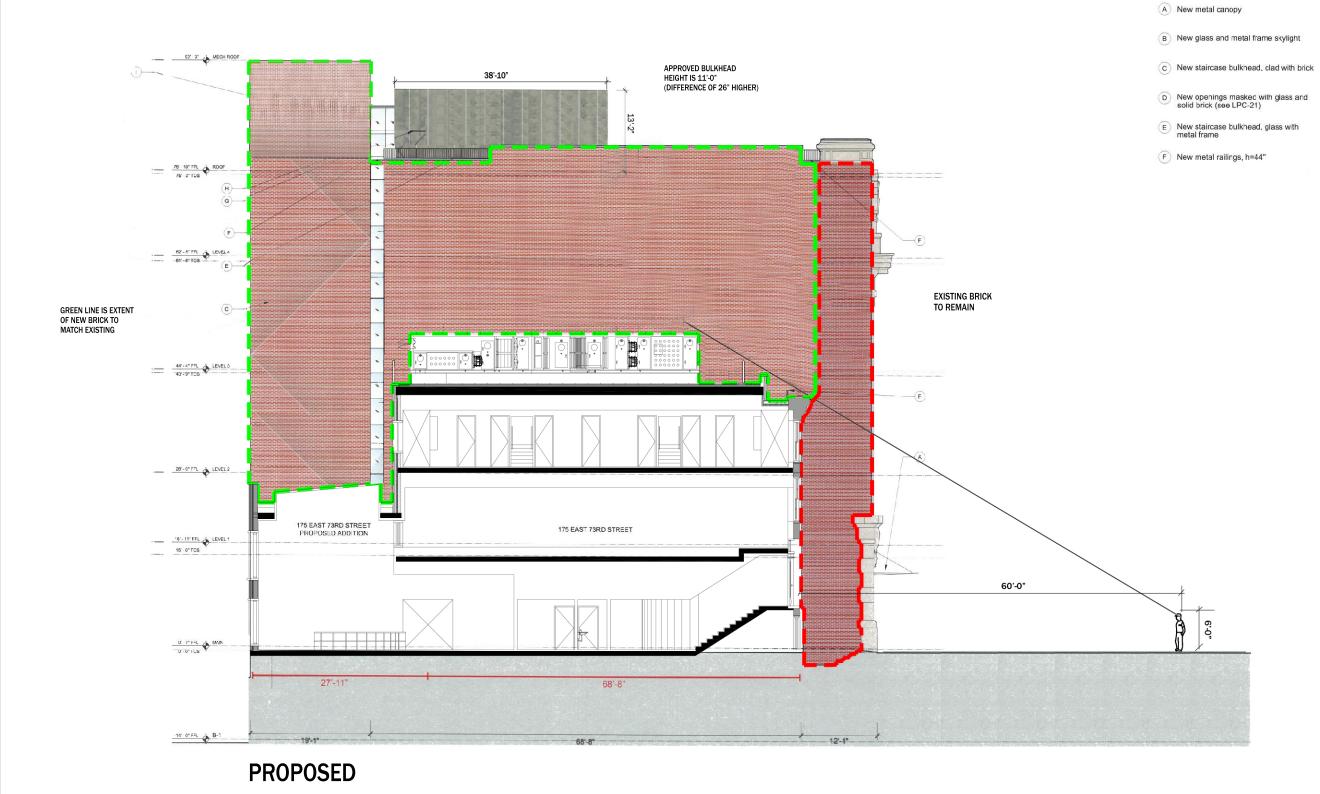
PROPOSED ELEVATION OF WEST FACADE

New mechanical room, clad with

H New door to mechanical room, clad with weathered copper to match mechanical room cladding

weathered copper

New elevator core, clad with corrugated metal to match existing core

J Patch, repair, and fill existing or new anchor fastener at masonry or stone, use repai mortar color to match adjacent similar material
