Presentation to the Manhattan Community Board 8

10 East 76th Street Upper East Side Historic District

12 June 2023

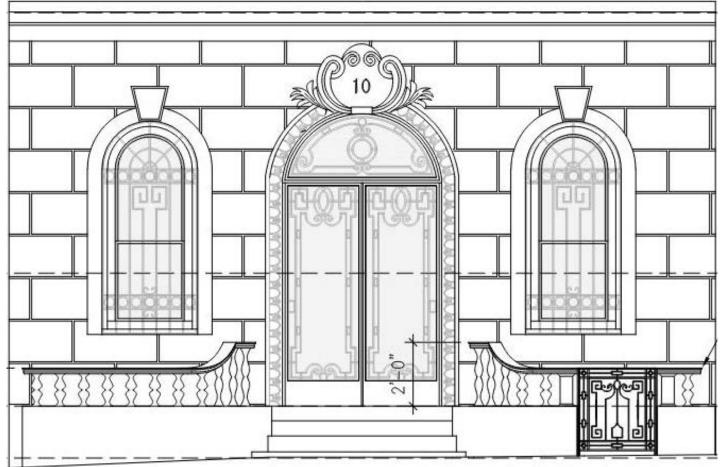
10 East 76th Street Upper East Side Historic District Proposed Entry Balustrade, Railing, & Gate

Proposed Balustrade and Gate to Match Historical from 1910 but in Cast Stone, not Bronze

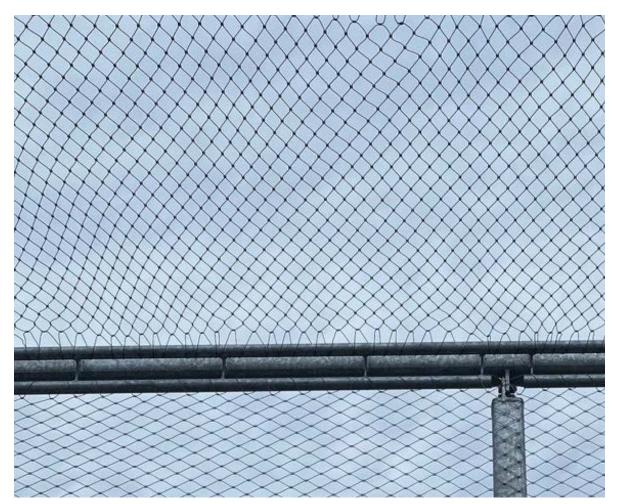
Mesh on Painted Steel Tubes

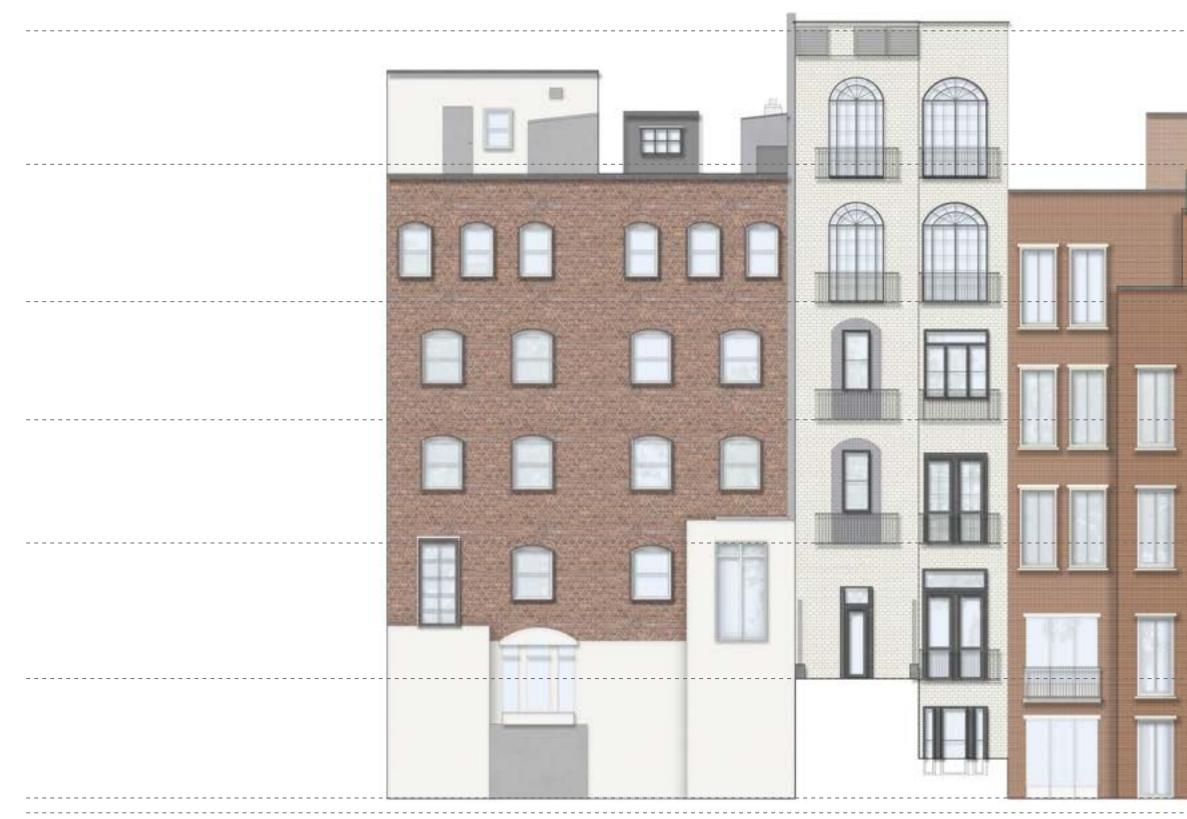
Existing Rear Elevation

_	 	 	 	Roof EL: +79'-9"
	 	 	 	Sixth Floor EL: +65'-8"
	 	 	 	Fifth Floor EL: +51'-7"
	 	 	 	Fourth Floor EL: +39'-5"
	 	 	 	Third Floor EL: +26'-6"
	 	 	 	Second Floor EL: +12'-4"
	 	 	 	First Floor EL: +0'-0" Sidewalk EL: -1'-7 1/2"
				38

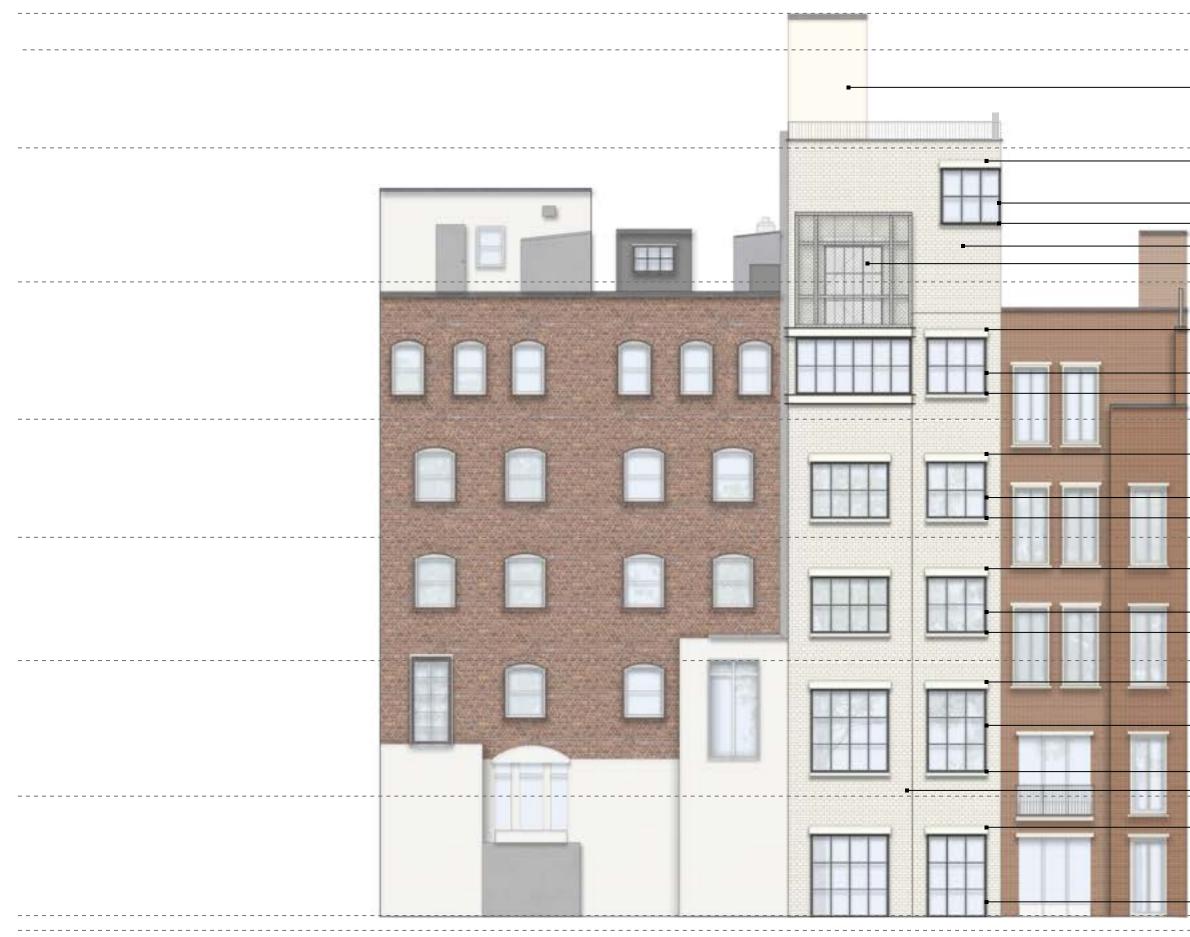
Proposed Rear Elevation

Elevator Bulkhead EL: +93'-11 1/2"
		Stair Bulkhead EL: +89'-9"
	New Elevator & Stair Bulkhead	
		Roof
	New Lintels (Typ.)	EL: +79'-9"
	New Steel Windows in New Openings (Typ.)

-	New Sills (Typ.)	
	Repaint Existing Brick Facade	
	New Steel & Glass Doors In New Openings (Typ.)	Sixth Floor
		EL: +65'-8"
	New Lintels (Typ.)	
	New Steel Windows in New Openings (Typ.)	
	New Sills (Typ.)	
		Fifth Floor
		EL: +51'-7"
	New Lintels (Typ.)	
	New Steel Windows	
	in New Openings (Typ.)	
	New Sills (Typ.)	Fourth Floor
		EL: +39'-5"
	New Lintels (Typ.)	
	New Steel Windows in New Openings (Typ.)	
	New Sills (Typ.)	
		Third Floor EL: +26'-6"
	New Lintels (Typ.)	EL: +20-0
	New Steel Windows in New Openings (Typ.)	
	New Sills (Typ.) New Infill Masonry &	Second Floor
	New Infill Masonry & Mortar to Match Existing	EL: +12'-4"
	New Lintels (Typ.)	
	New Steel & Glass Doors	First Floor
	in New Openings (Typ.)	EL: +0'-0"
		Ciderrally
		Sidewalk EL: -1'-7 1/2"
		,_
		20
		00
