MIDTOWN PRESERVATION

INTRODUCTION & INTENT

817 Fifth Avenue Condominium seeks approval for a *Window Master Plan* for windows at the West Façade fronting Fifth Avenue and the North Façade fronting East 63rd Street of the building located at 817 Fifth Avenue, New York, NY. The building was designated as part of the Upper East Side Historic District designated in 1981. It is 14-stories with a slender footprint relative to other buildings along the Avenue. The abutting adjacent property just south is a newly constructed building completed in 2021. Across the street is Central Park, a scenic landmark designated in 1974, which has continued to evolve and grow over the decades into a forested retreat.

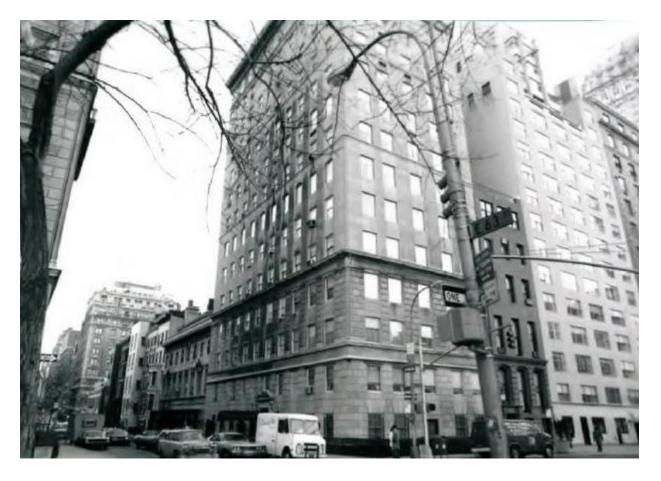
HISTORIC PHOTO, CIRCA 1975, prior to designation by the Landmarks Preservation Commission and prior to being placed on the National Register of Historic Places.

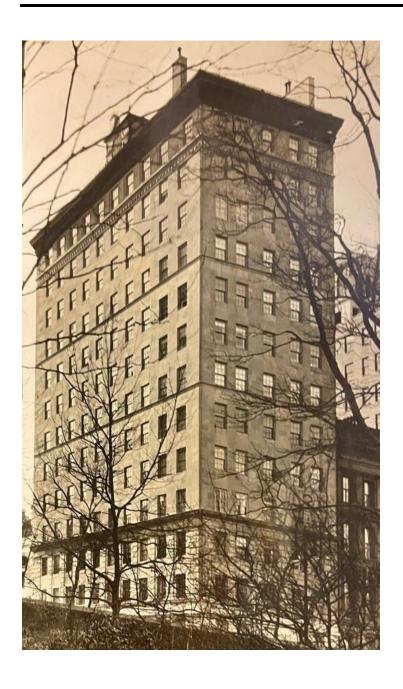
HISTORIC PHOTO, CIRCA 1946'S – FIFTH AVENUE & EAST 63RD STREET FAÇADES

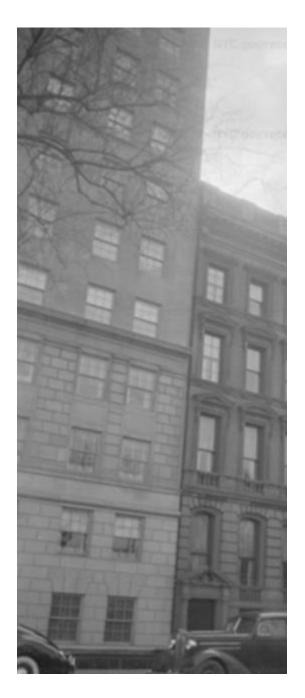
HISTORIC PHOTO, CIRCA 1940'S – FIFTH AVENUE FAÇADE

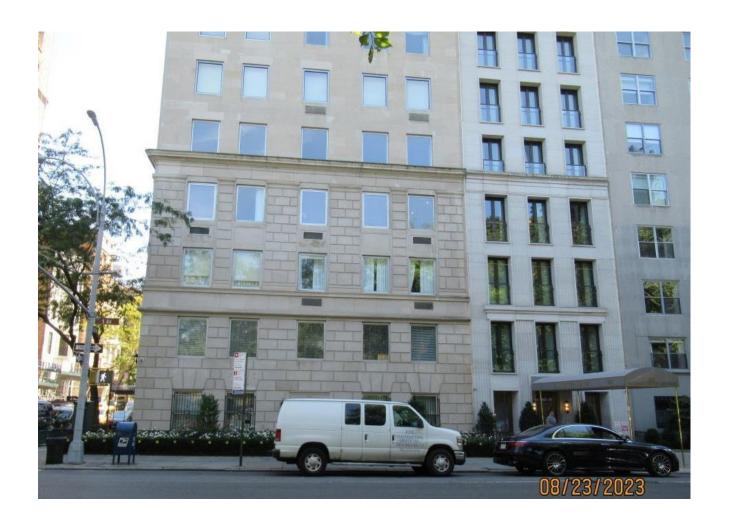
RECENT PHOTO – CLOSE-UP AT FIFTH AVENUE

Currently, all windows except for the Ground floor are single-lite. For consistency, the Owners wish to maintain this single lite window configuration at the Fifth Avenue façade. This will conserve their uninterrupted views of the park which they have appreciated for almost five decades. The single lite windows will be tilt & turn operation and have a simple, historic profiled brick mold with a light grey finish achieved using clear anodized aluminum that will not compete nor detract from the limestone façade.

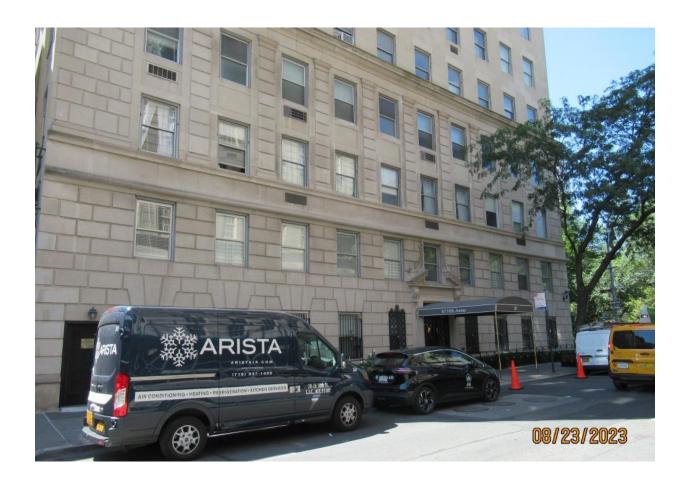
RECENT PHOTO - CLOSE-UP AT EAST 63RD STREET FACADE

Most of the windows at this wall are one-over-one double hung windows. The Owners wish to incorporate a one-over-one configuration into the Master Plan. These configurations have also existed for almost five decades. They will also have a simple, historic profiled brick mold with a light grey finish achieved using clear anodized aluminum that will not compete nor detract from the limestone façade.

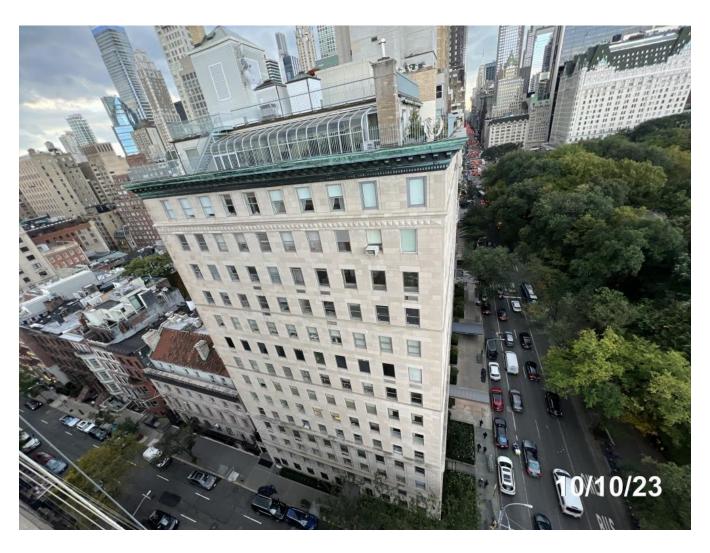
RECENT PHOTO OF BUILDING – East 63^{rd} Street Façade, taken from neighboring rooftop
