10 East 82nd Street

Landmarks Presentation
June 2025

SUK | design studio
ARCHITECTURE

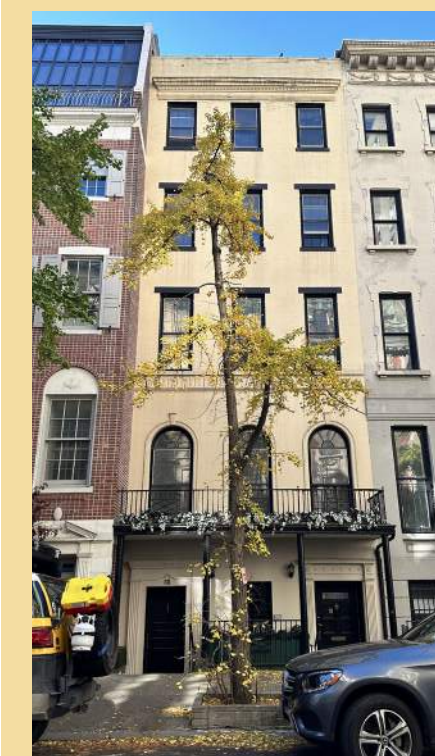
- current state**
- cornice has been repainted to match facade color
 - trim around parlor windows has been painted to match facade color
 - facade is cracking and paint is peeling off of brick

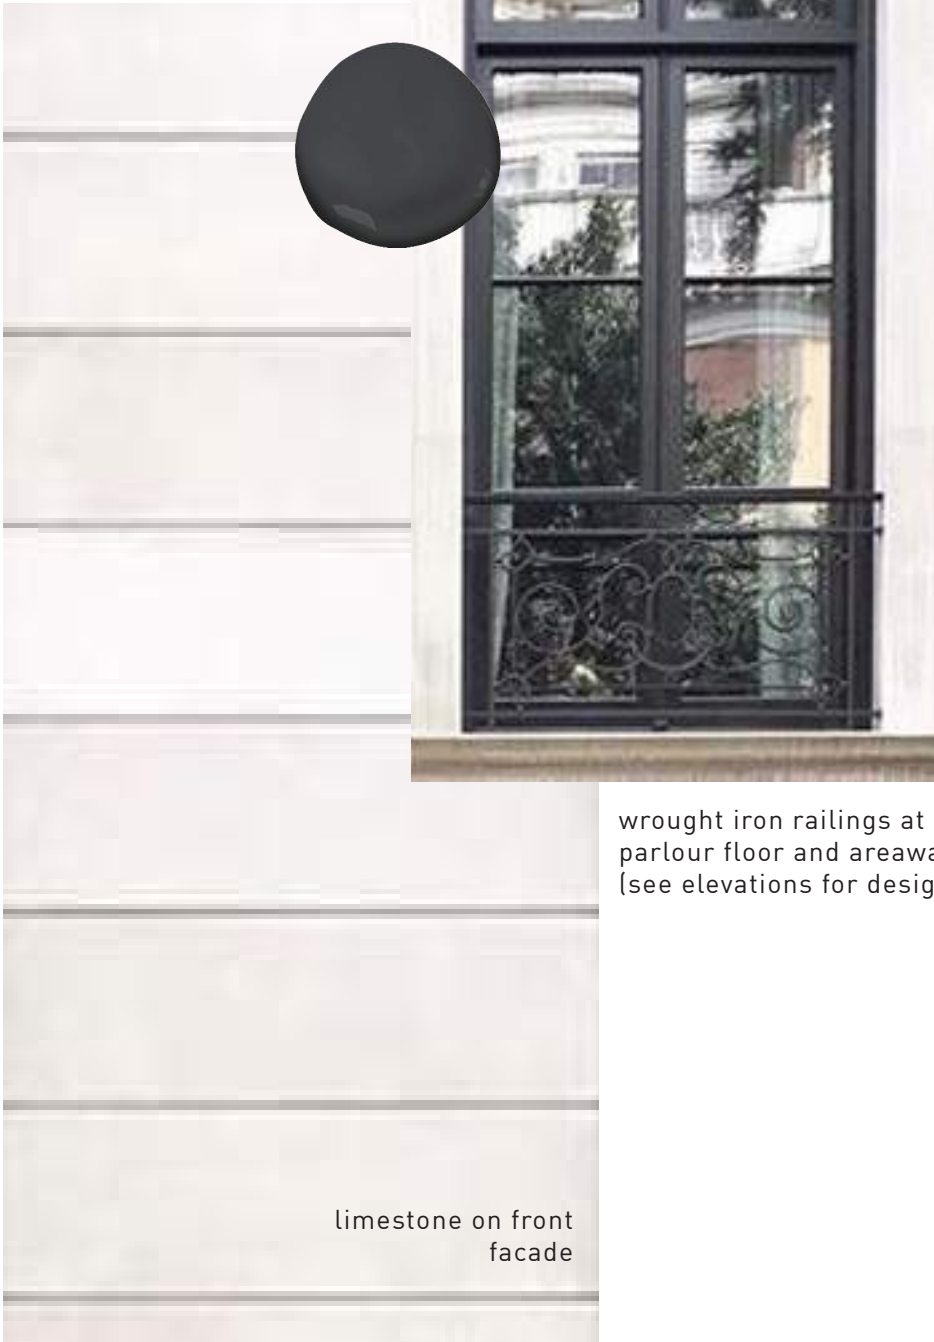
wrought iron railings at
parlour floor and areaway
(see elevations for design)
