# 673 MADISON AVENUE

**673 MADISON AVENUE - CORNICE LIGHTING  
PUBLIC HEARING JULY 13, 2026**

**PROPOSED FACADE LIGHTING SCHEME (OVERALL)**

**673 MADISON AVENUE - CORNICE LIGHTING**

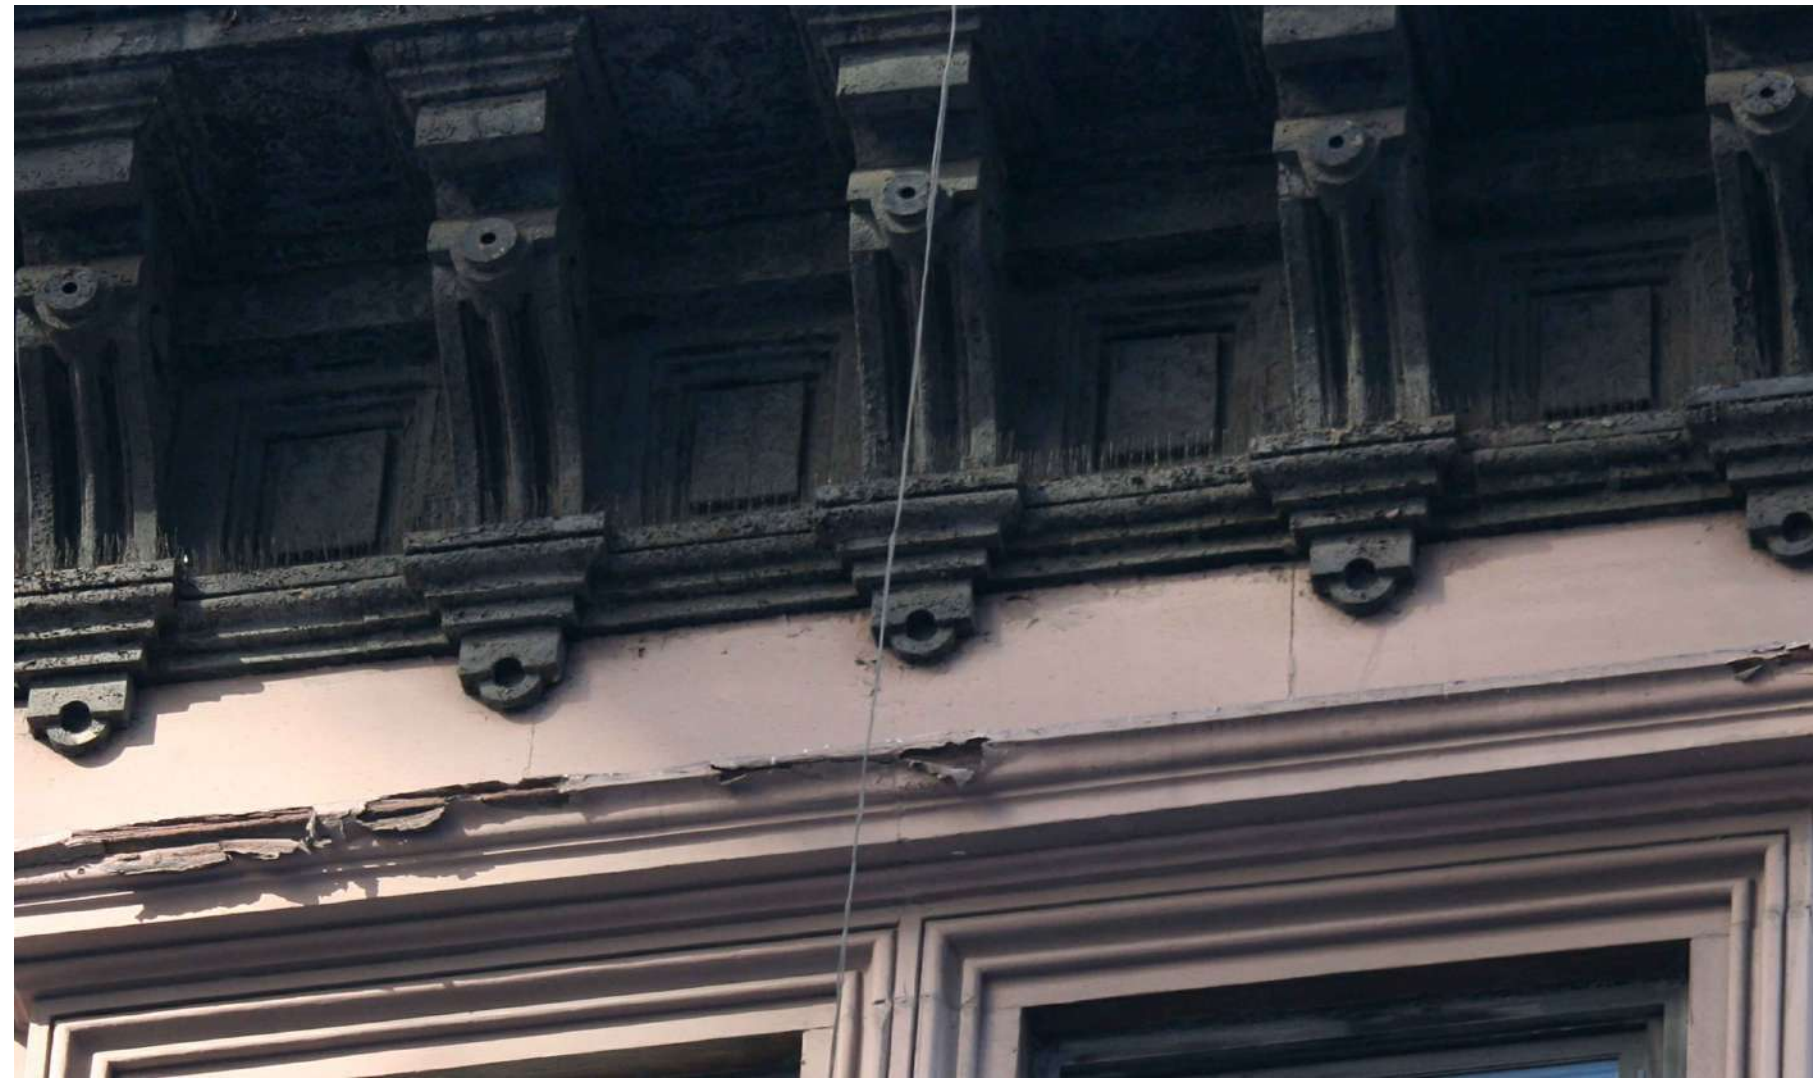
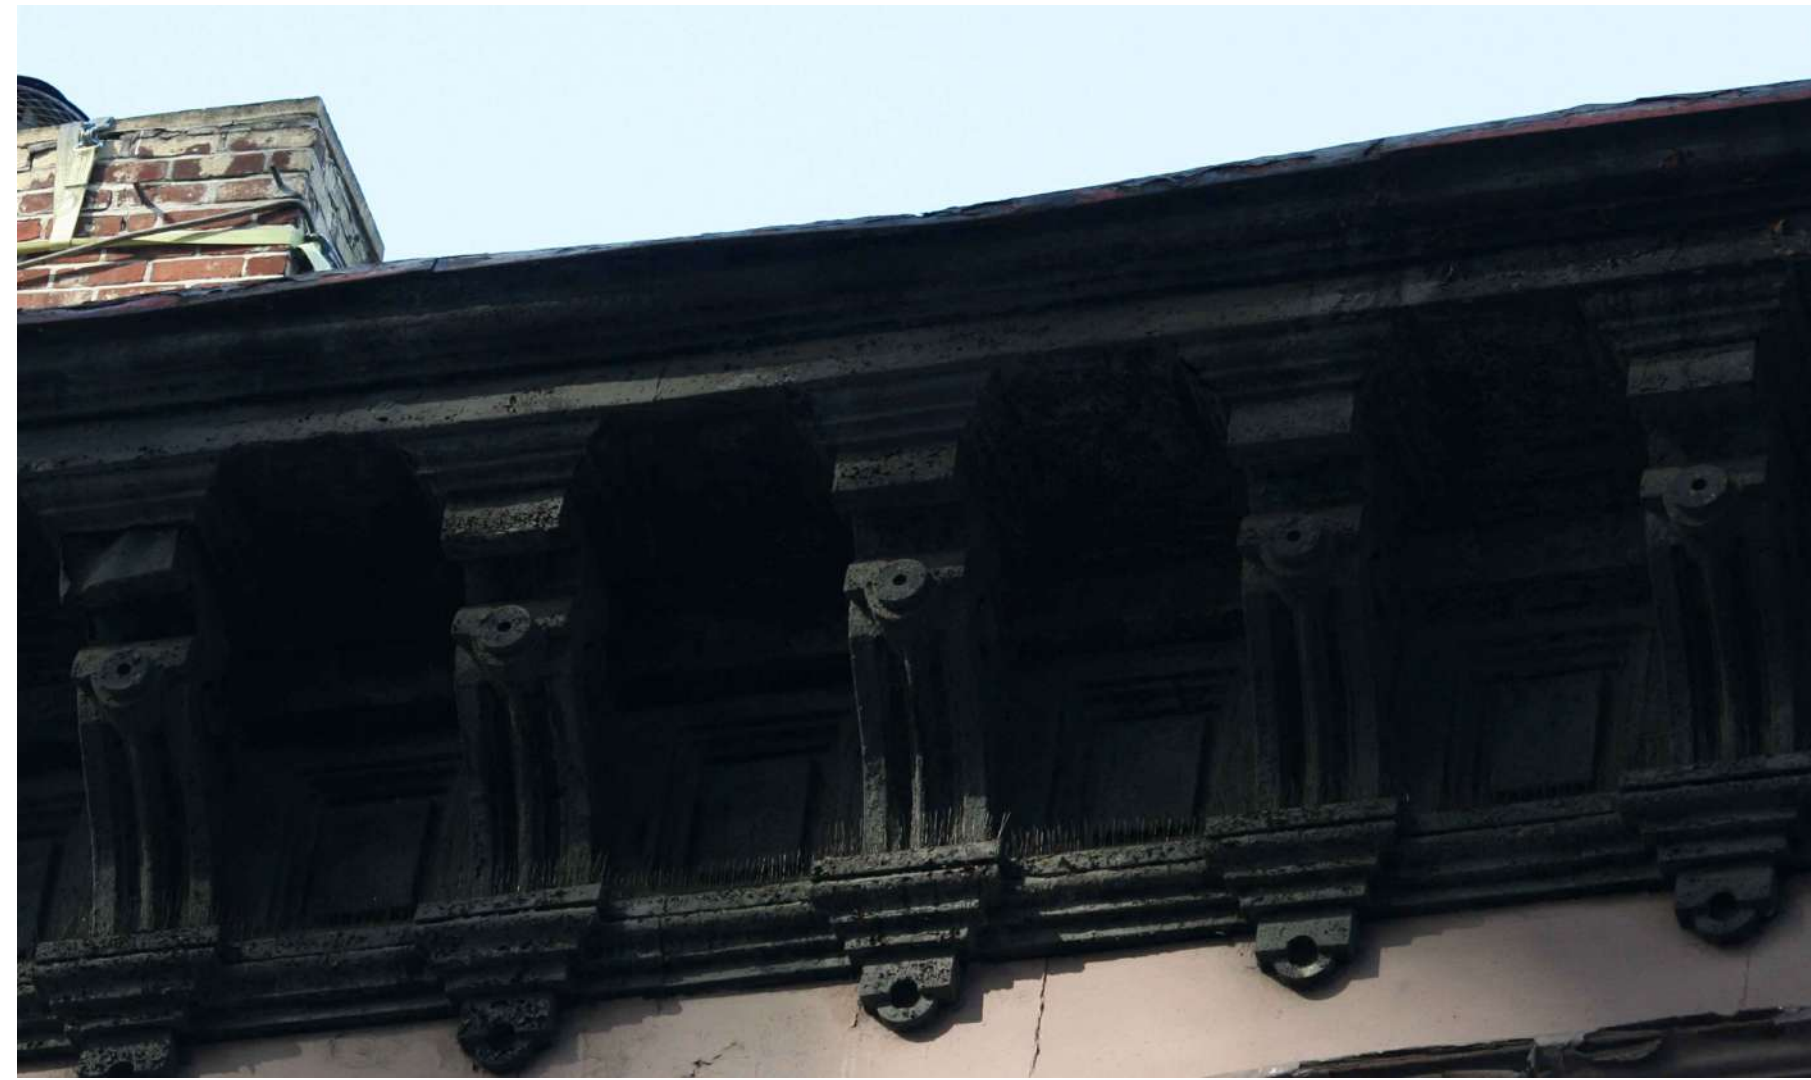
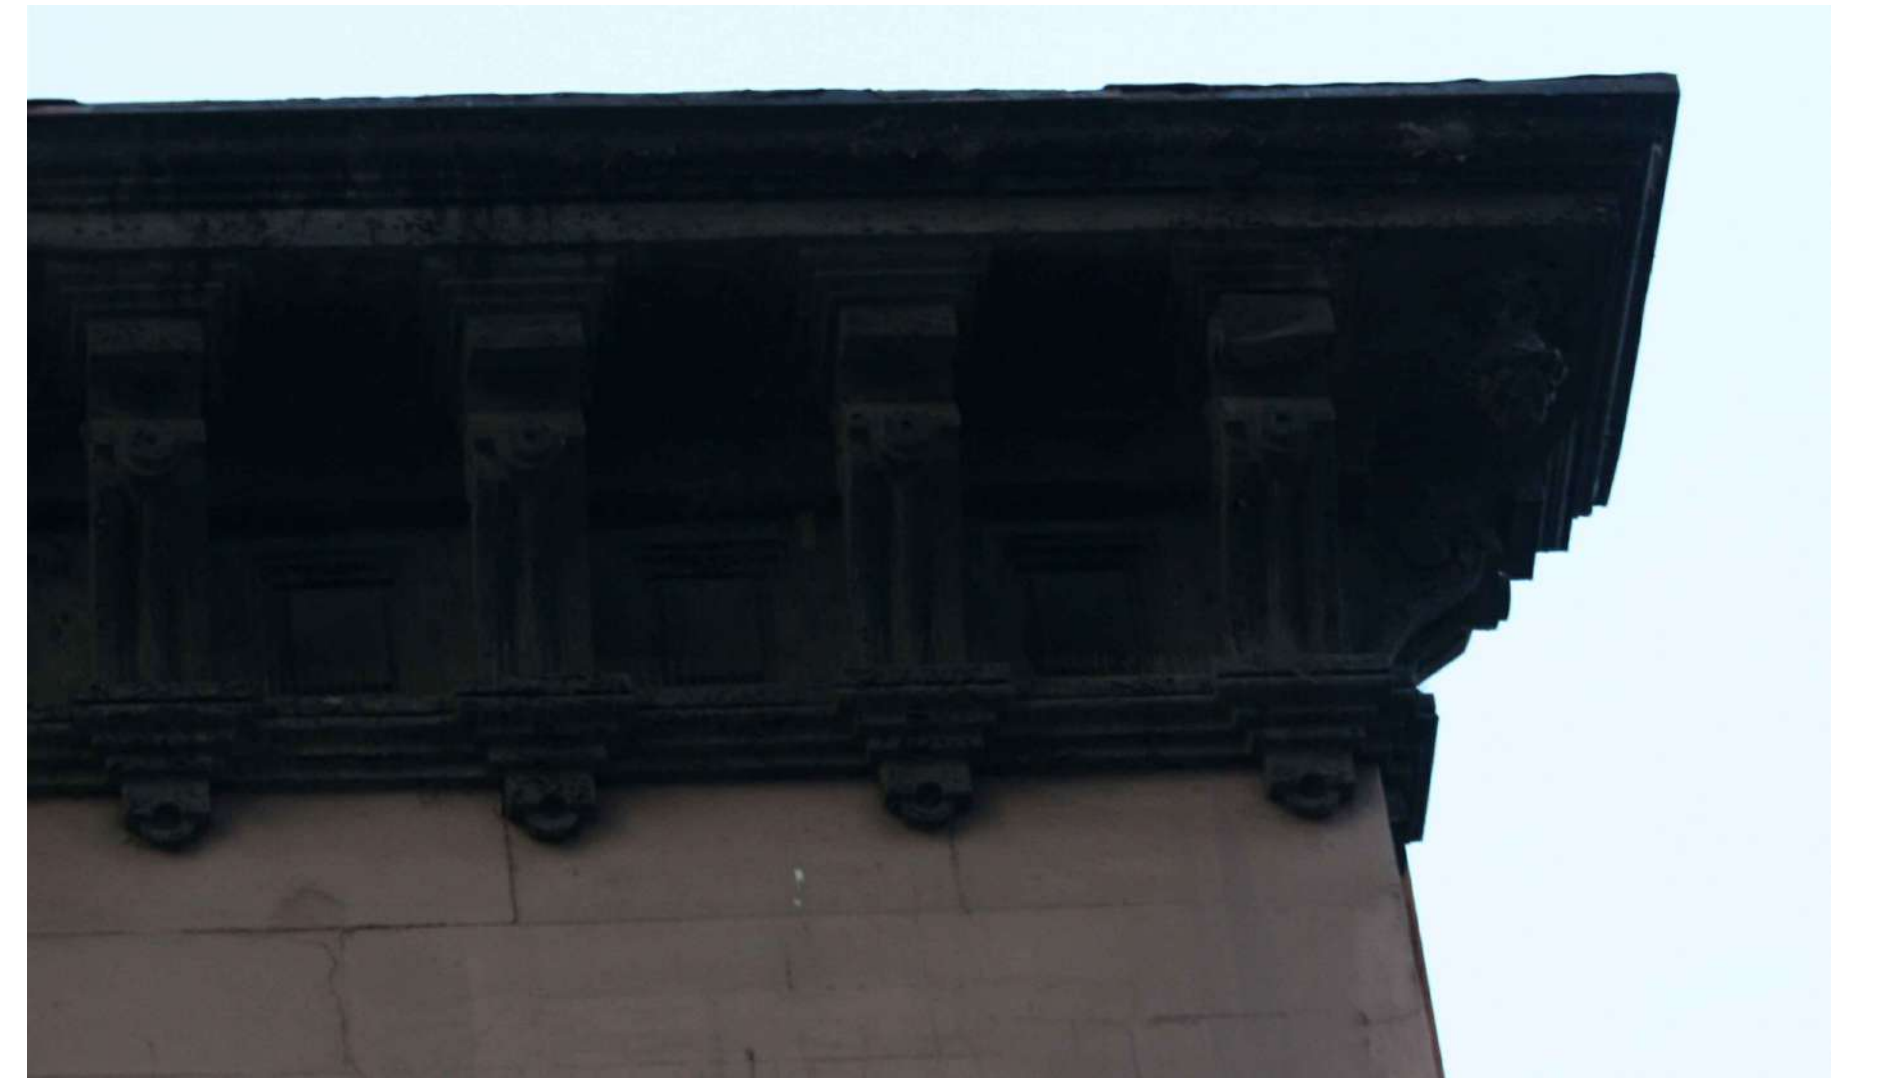
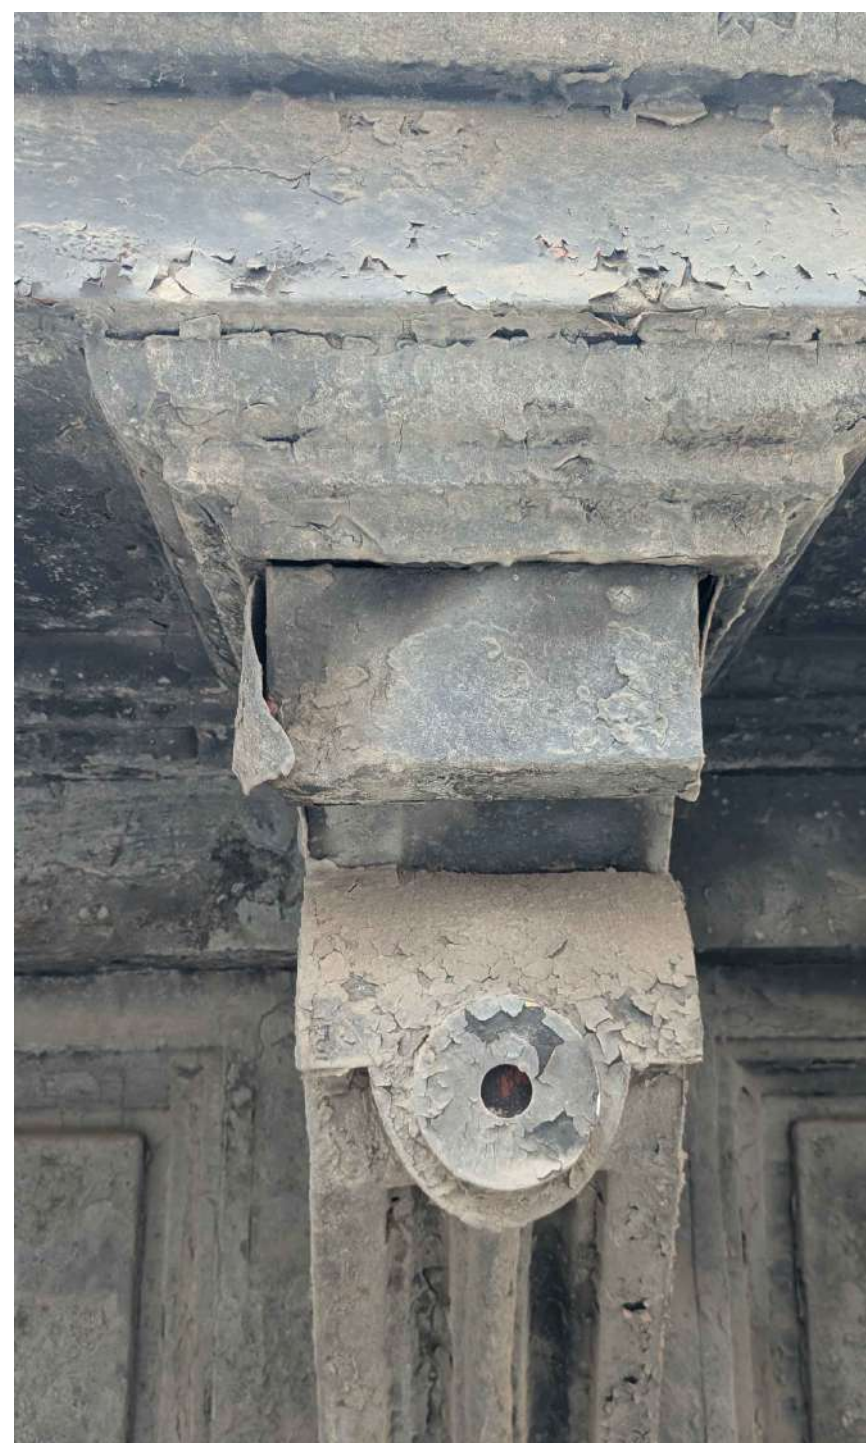
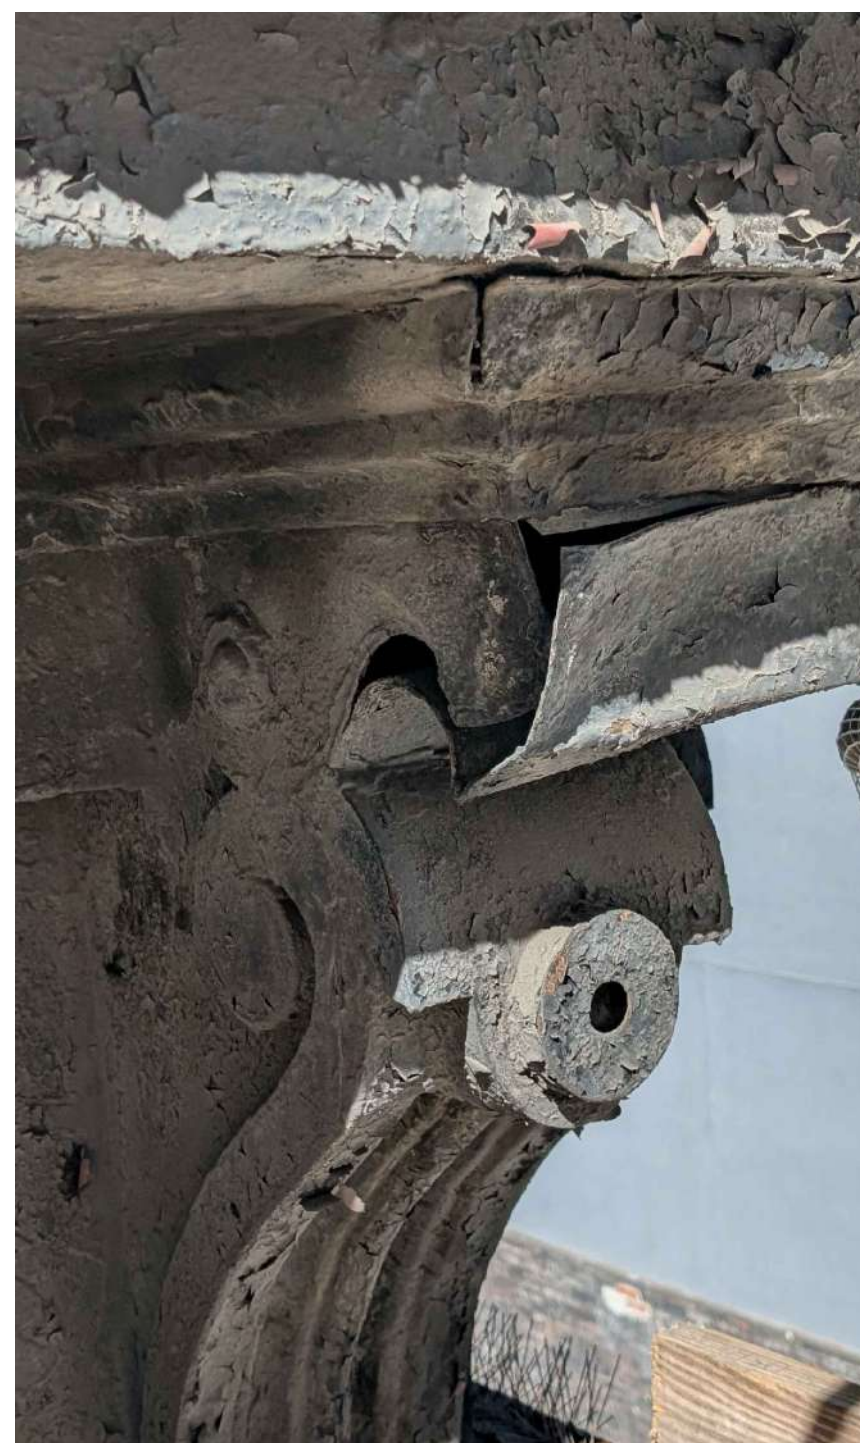
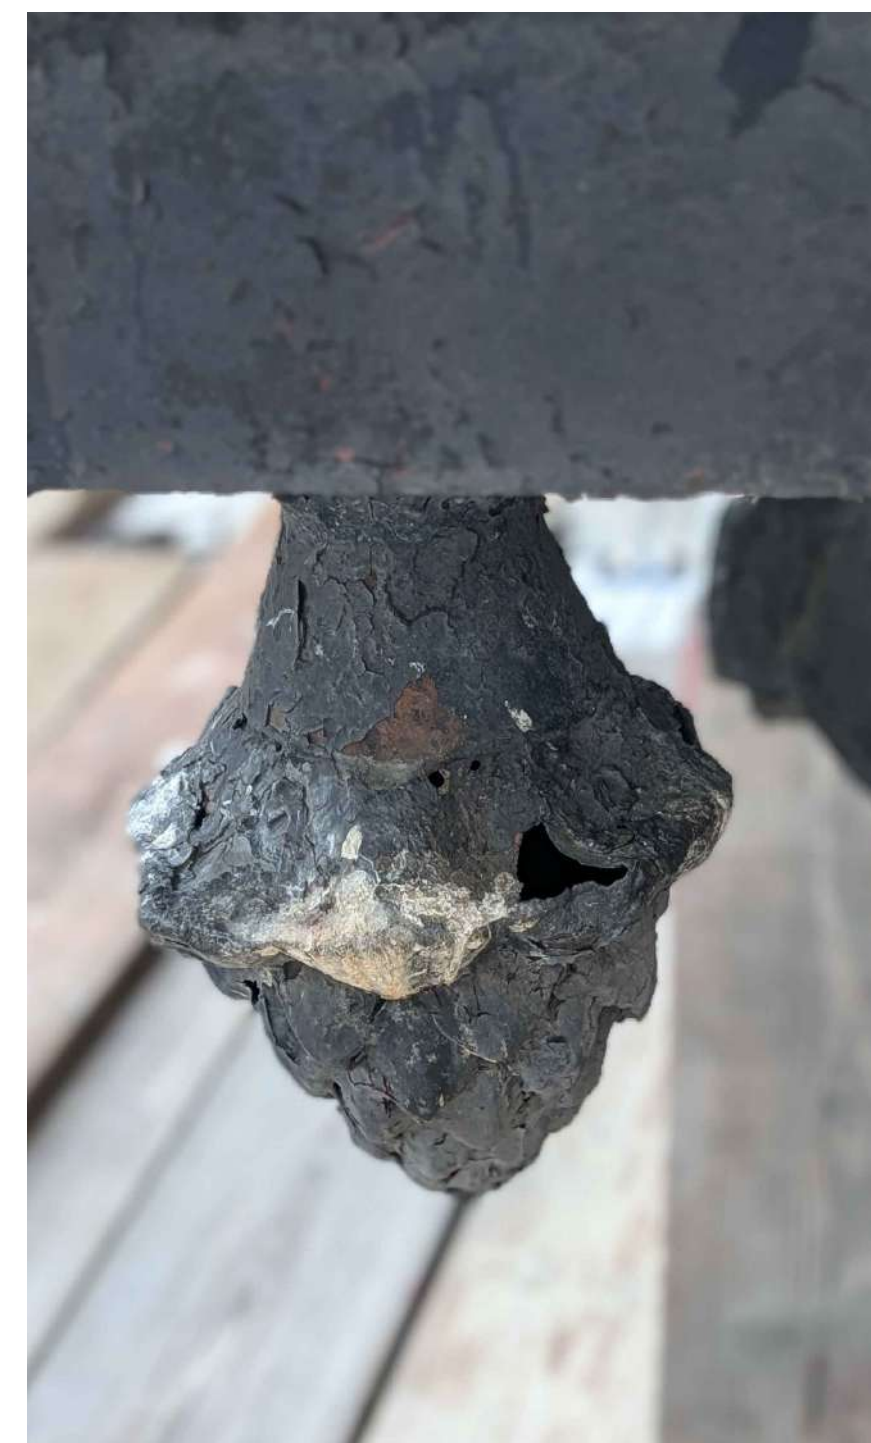
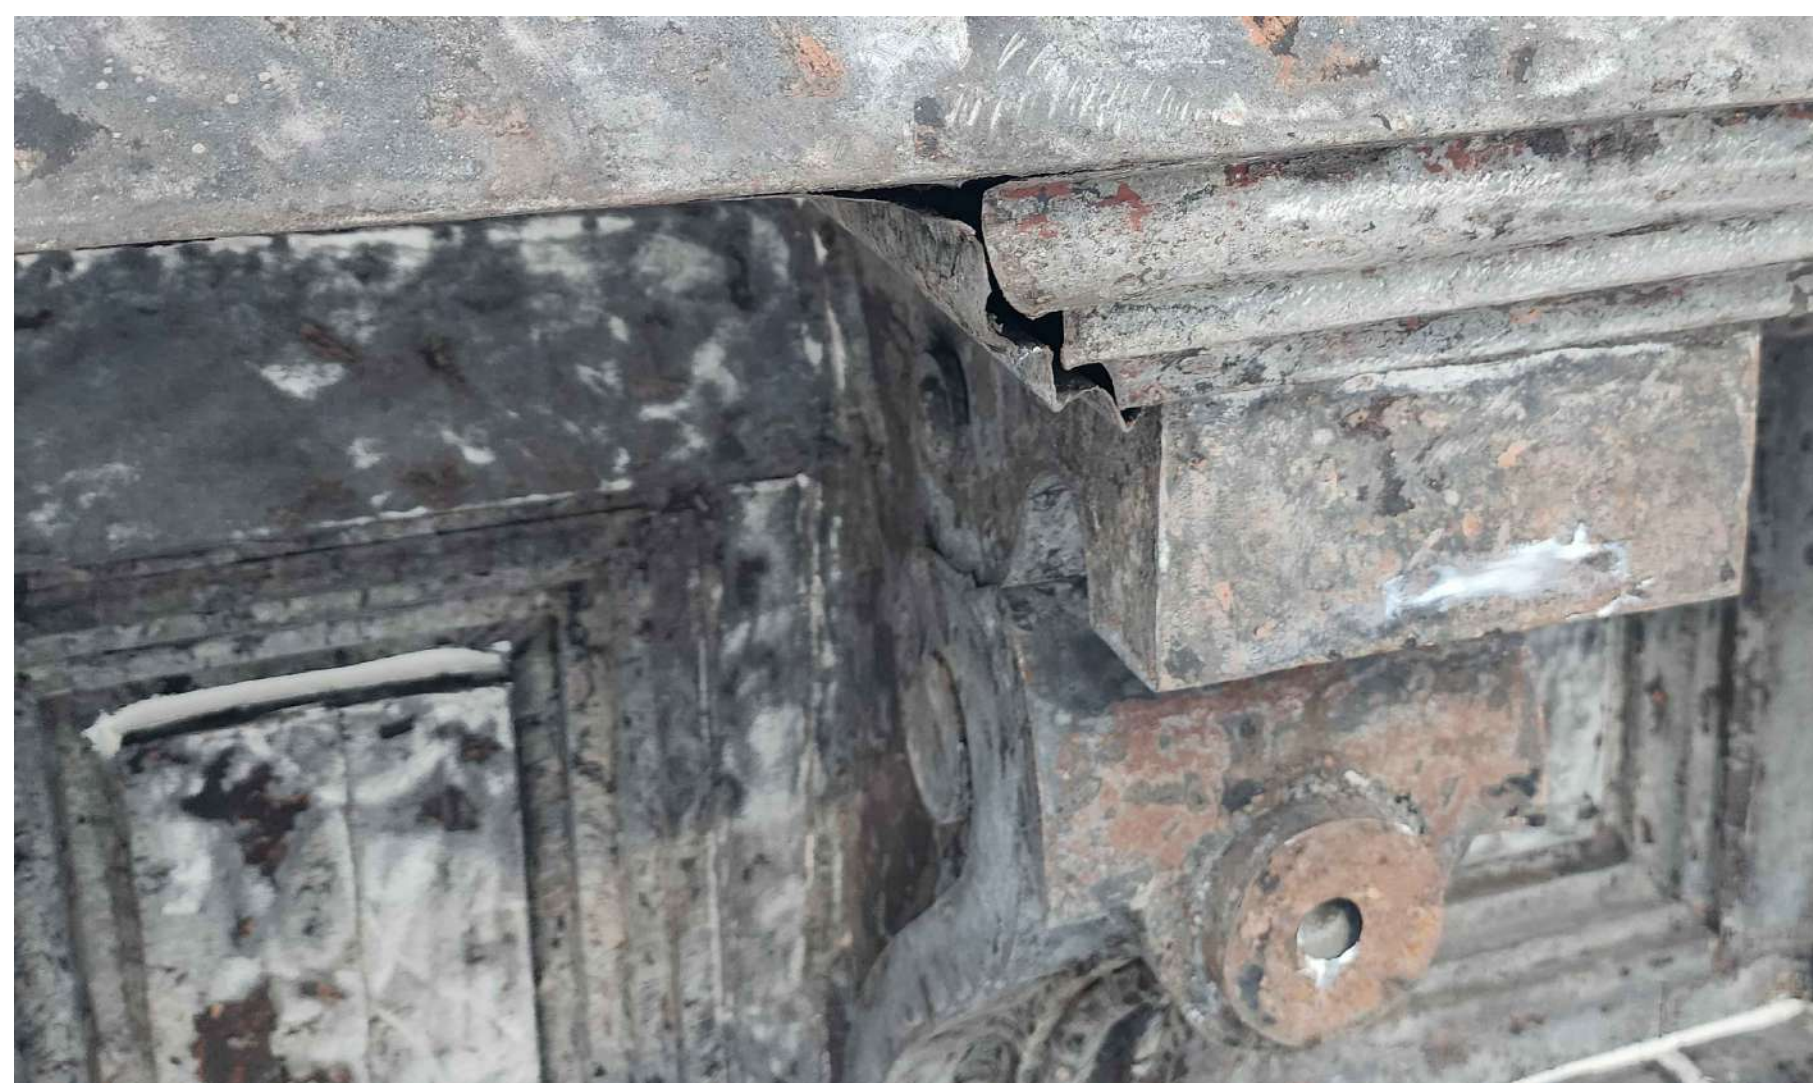
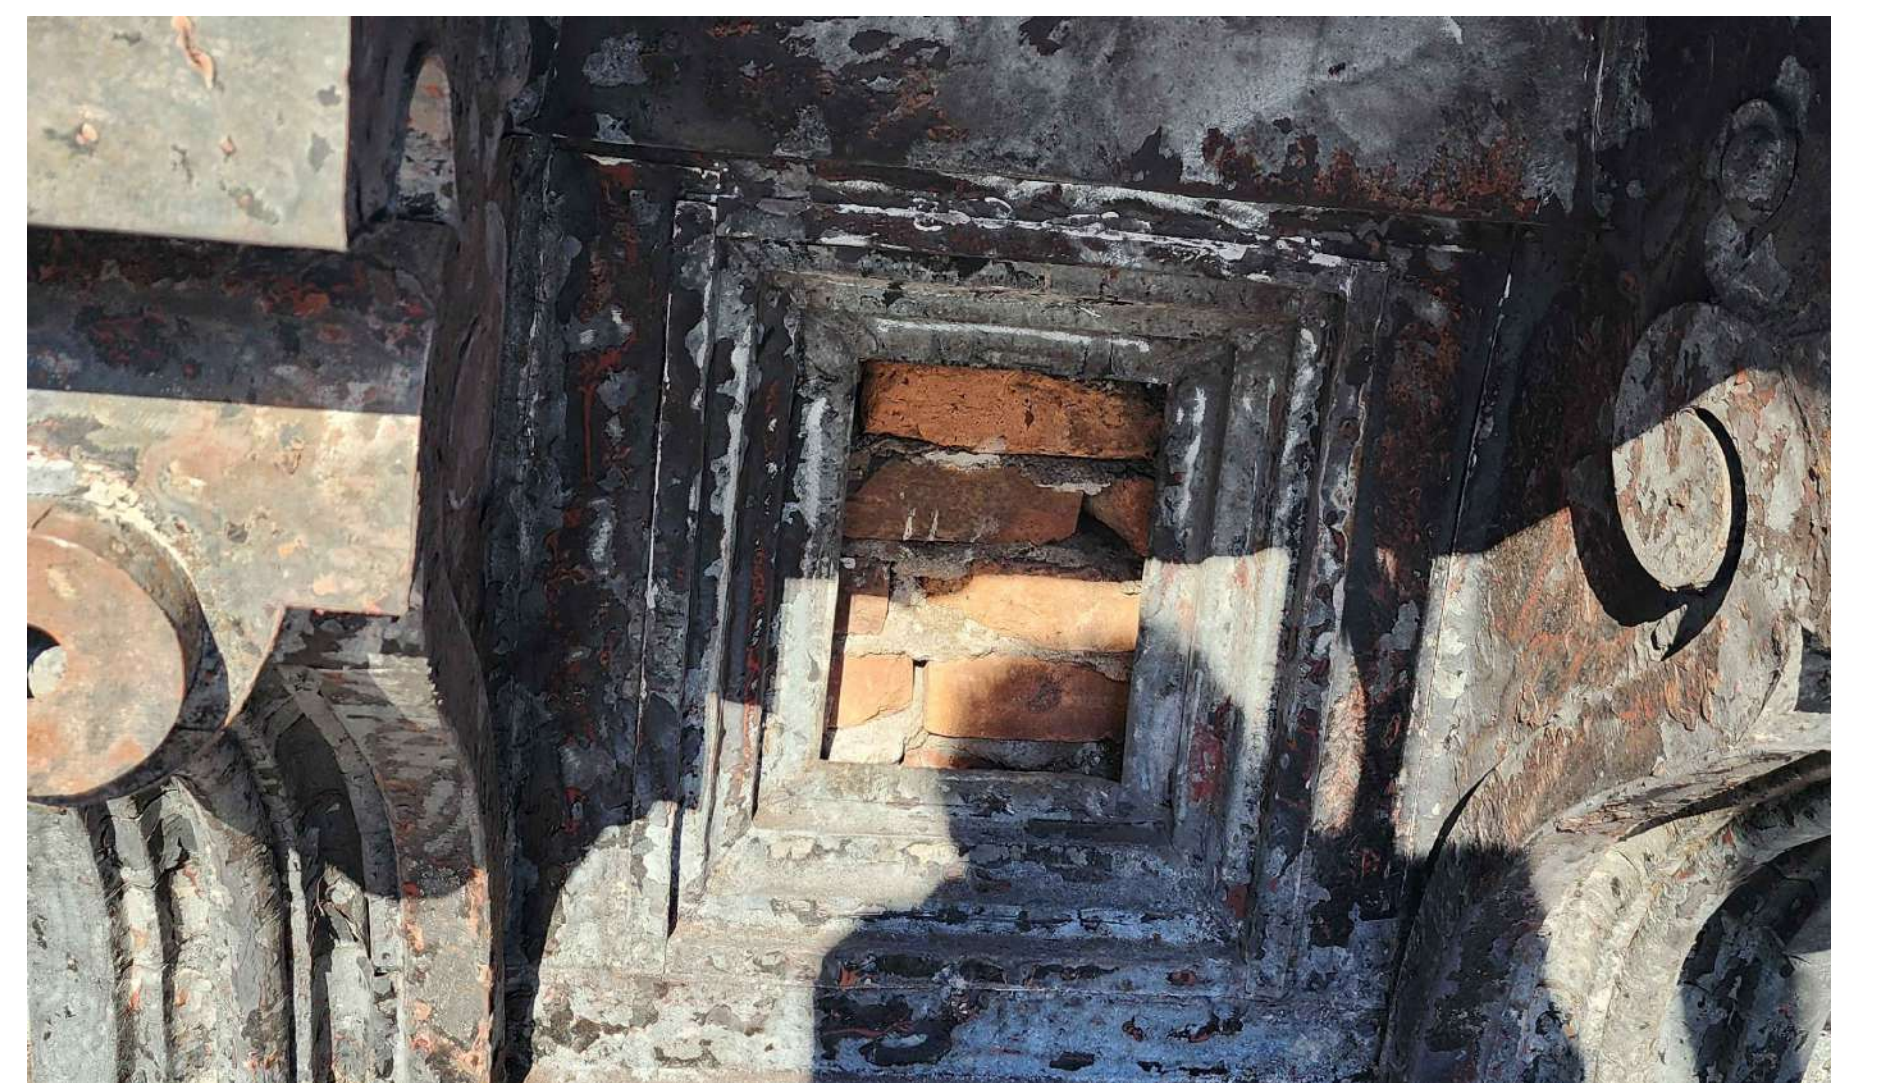
PHOTOS SHOWING  
PRE-RESTORATION CONDITIONS  
OF 673 MADISON AVE BUILDING  
TOP CORNICE
