# 673 MADISON AVENUE

**673 MADISON AVENUE - CORNICE LIGHTING  
PUBLIC HEARING JULY 13, 2026**

**PROPOSED FACADE LIGHTING SCHEME (OVERALL)**

**673 MADISON AVENUE - CORNICE LIGHTING**

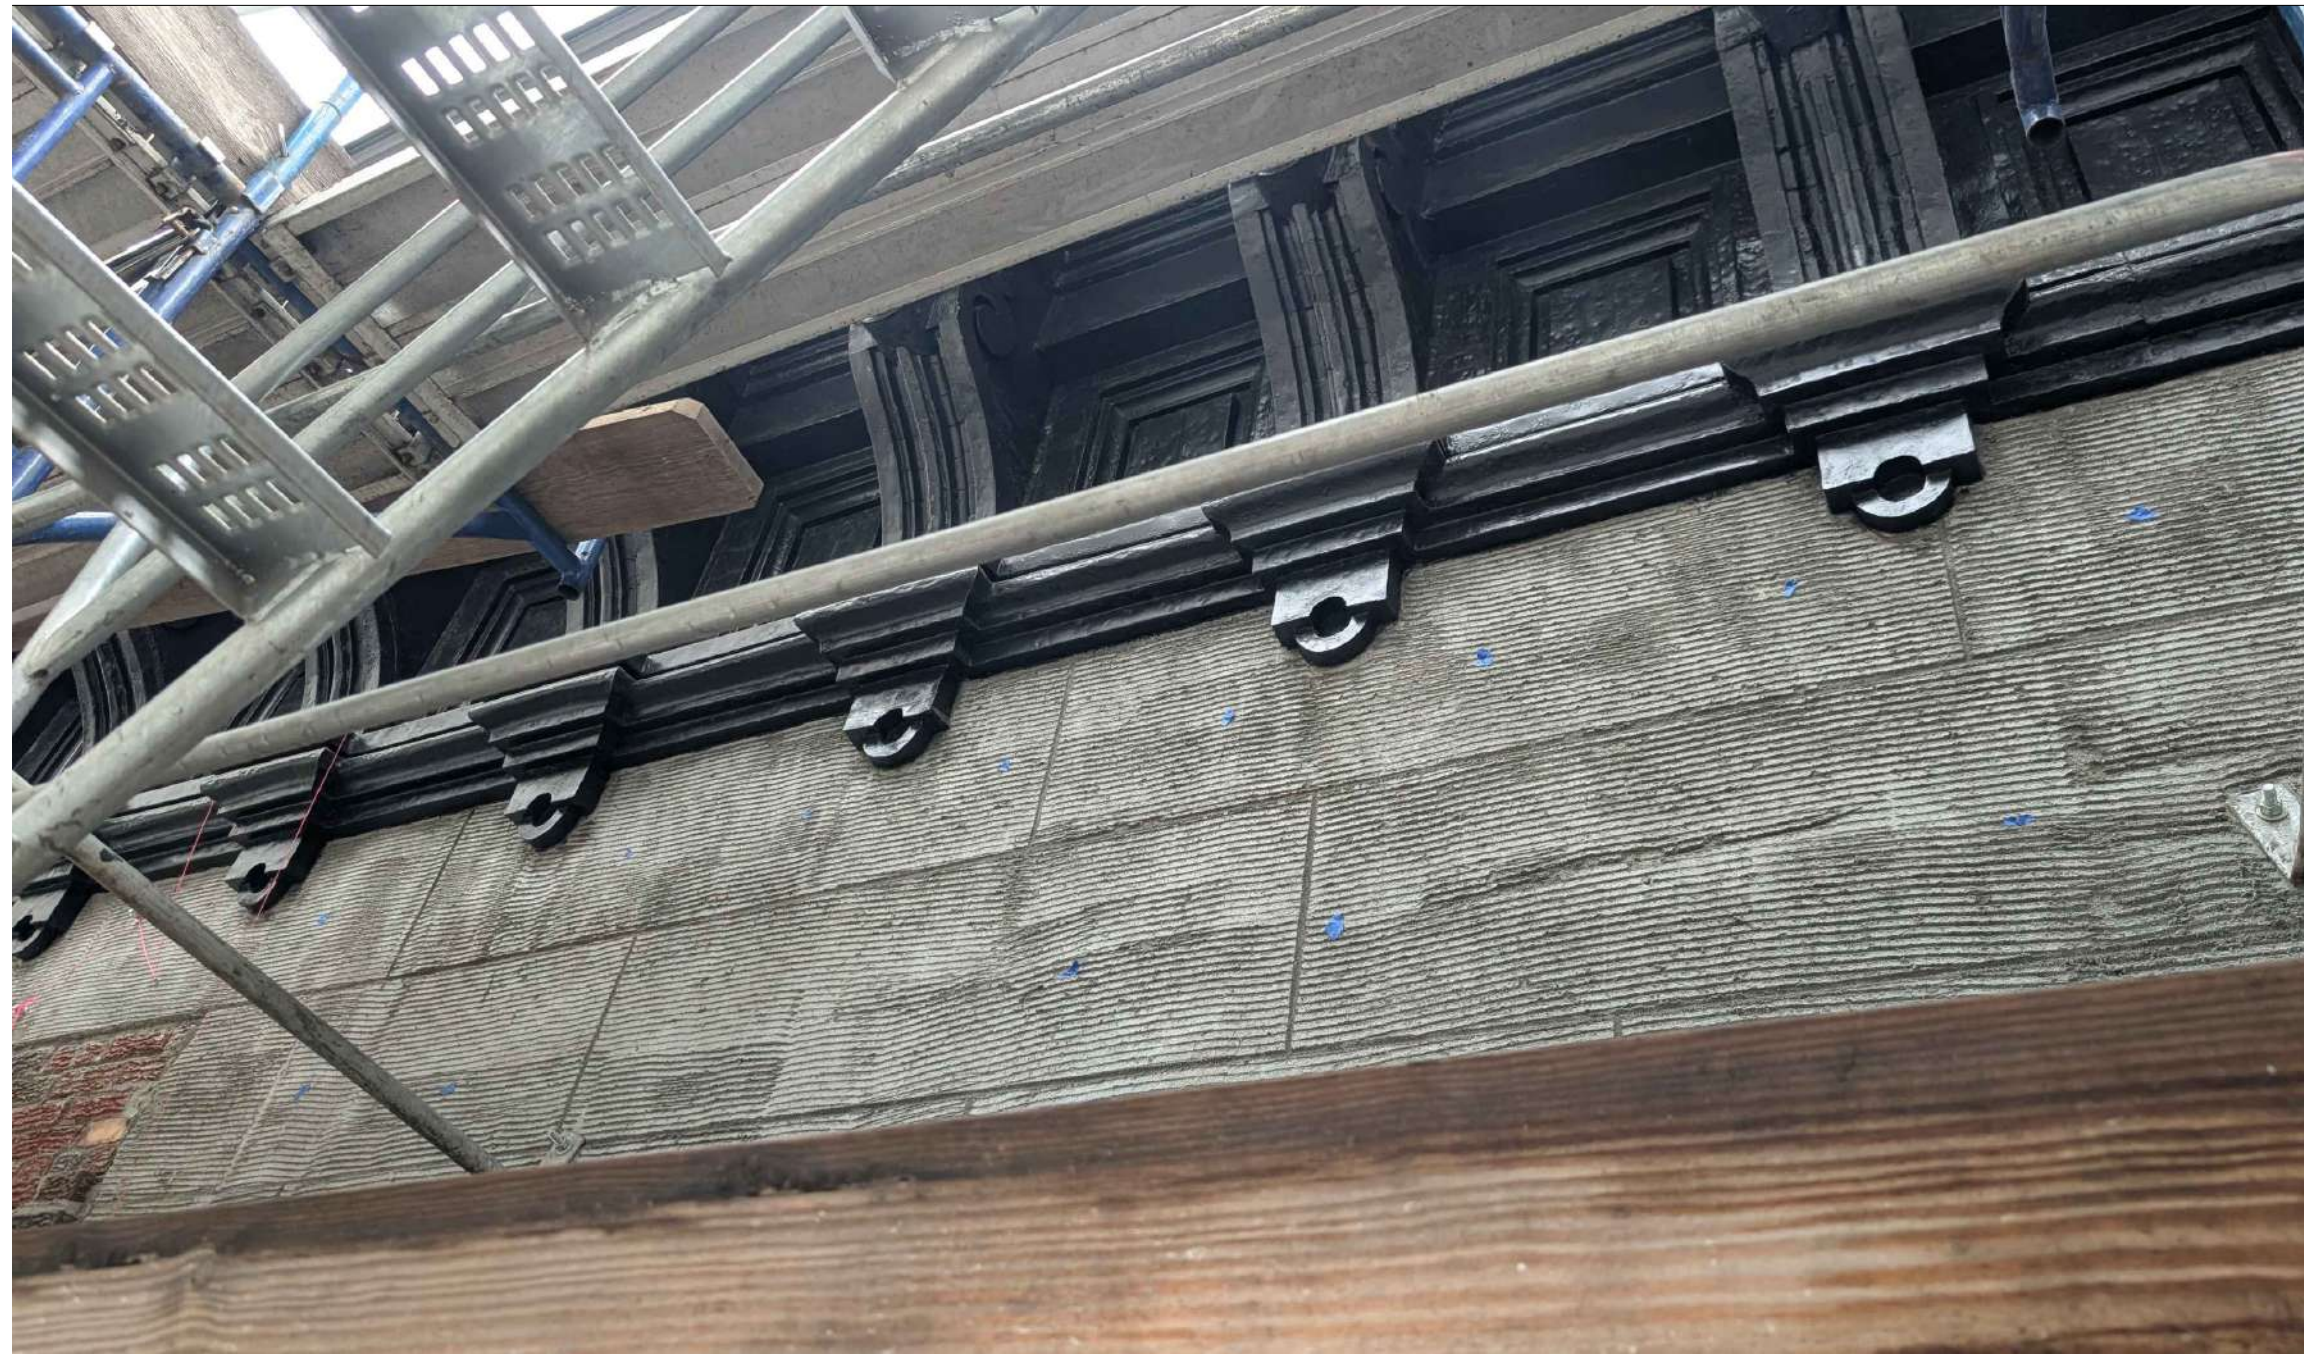
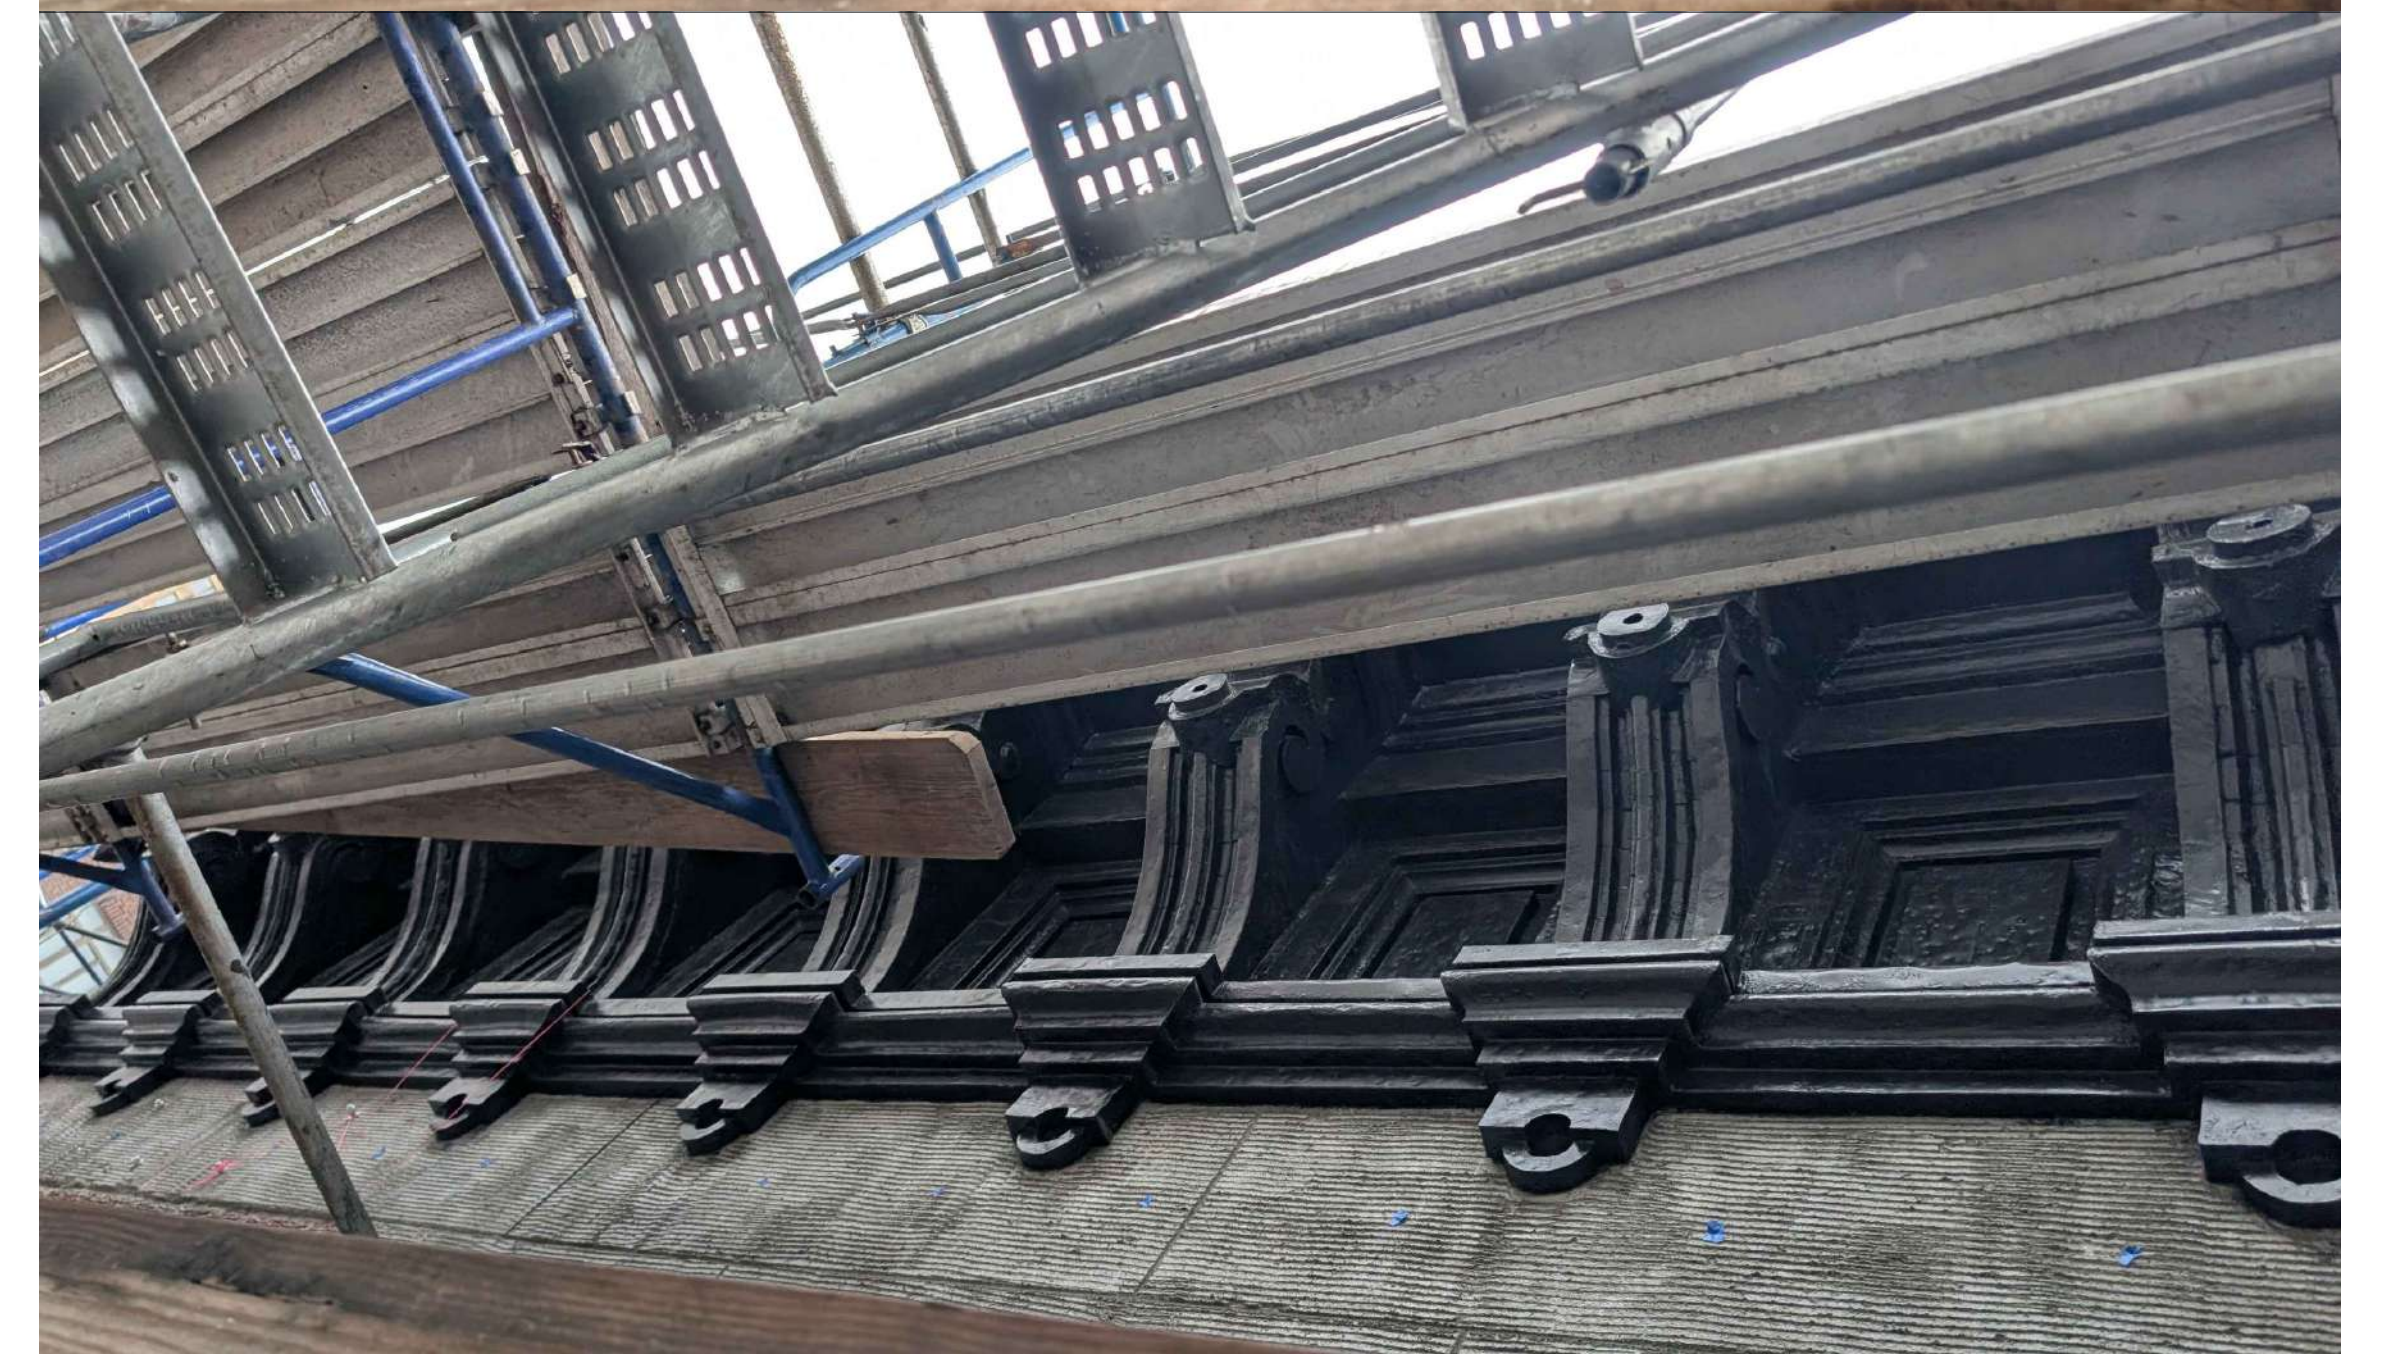
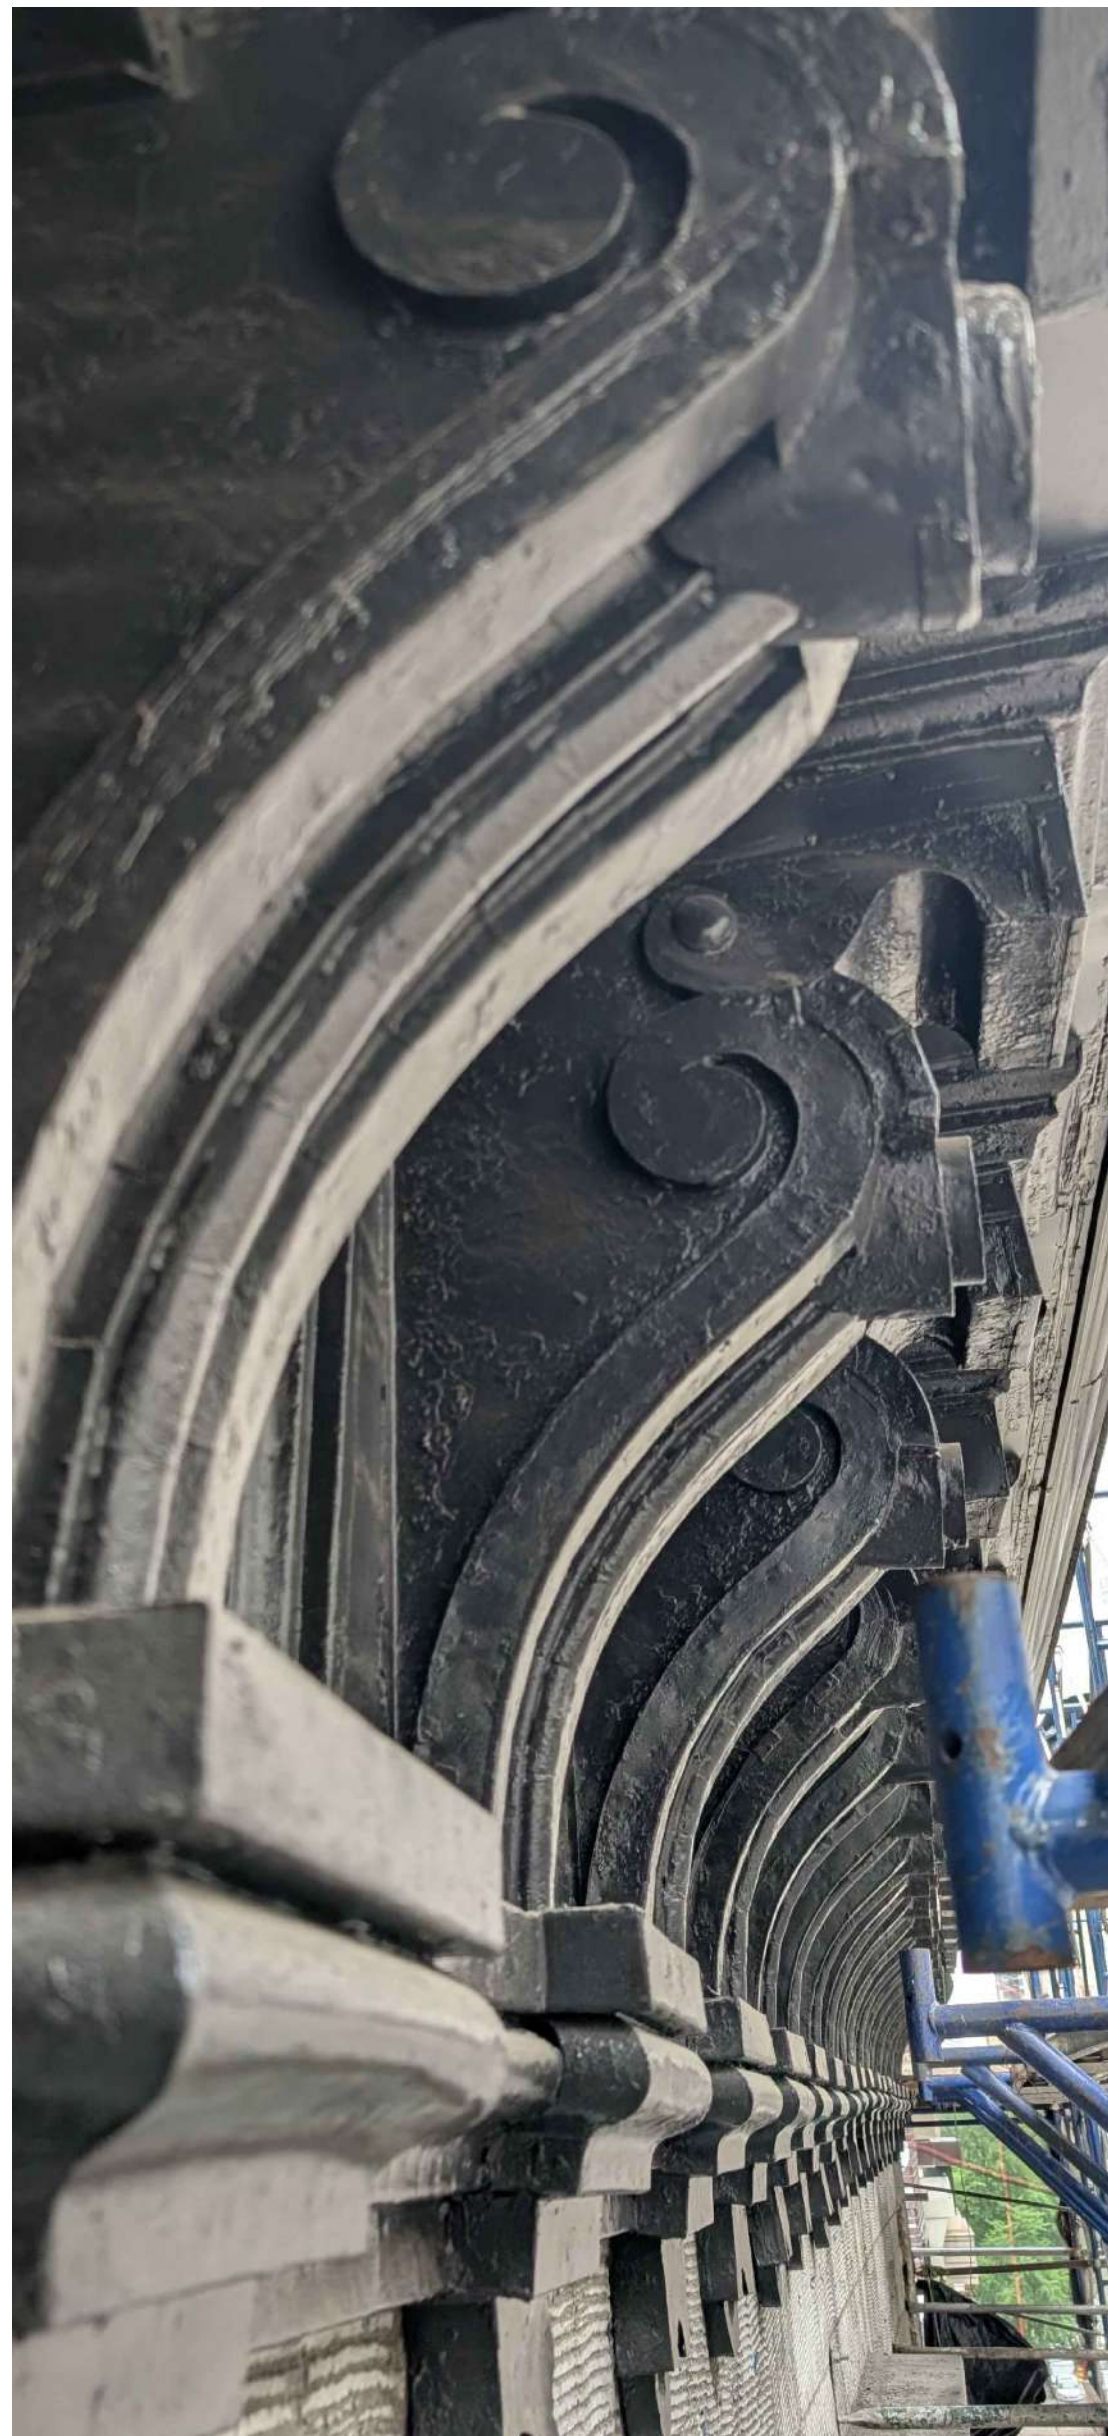
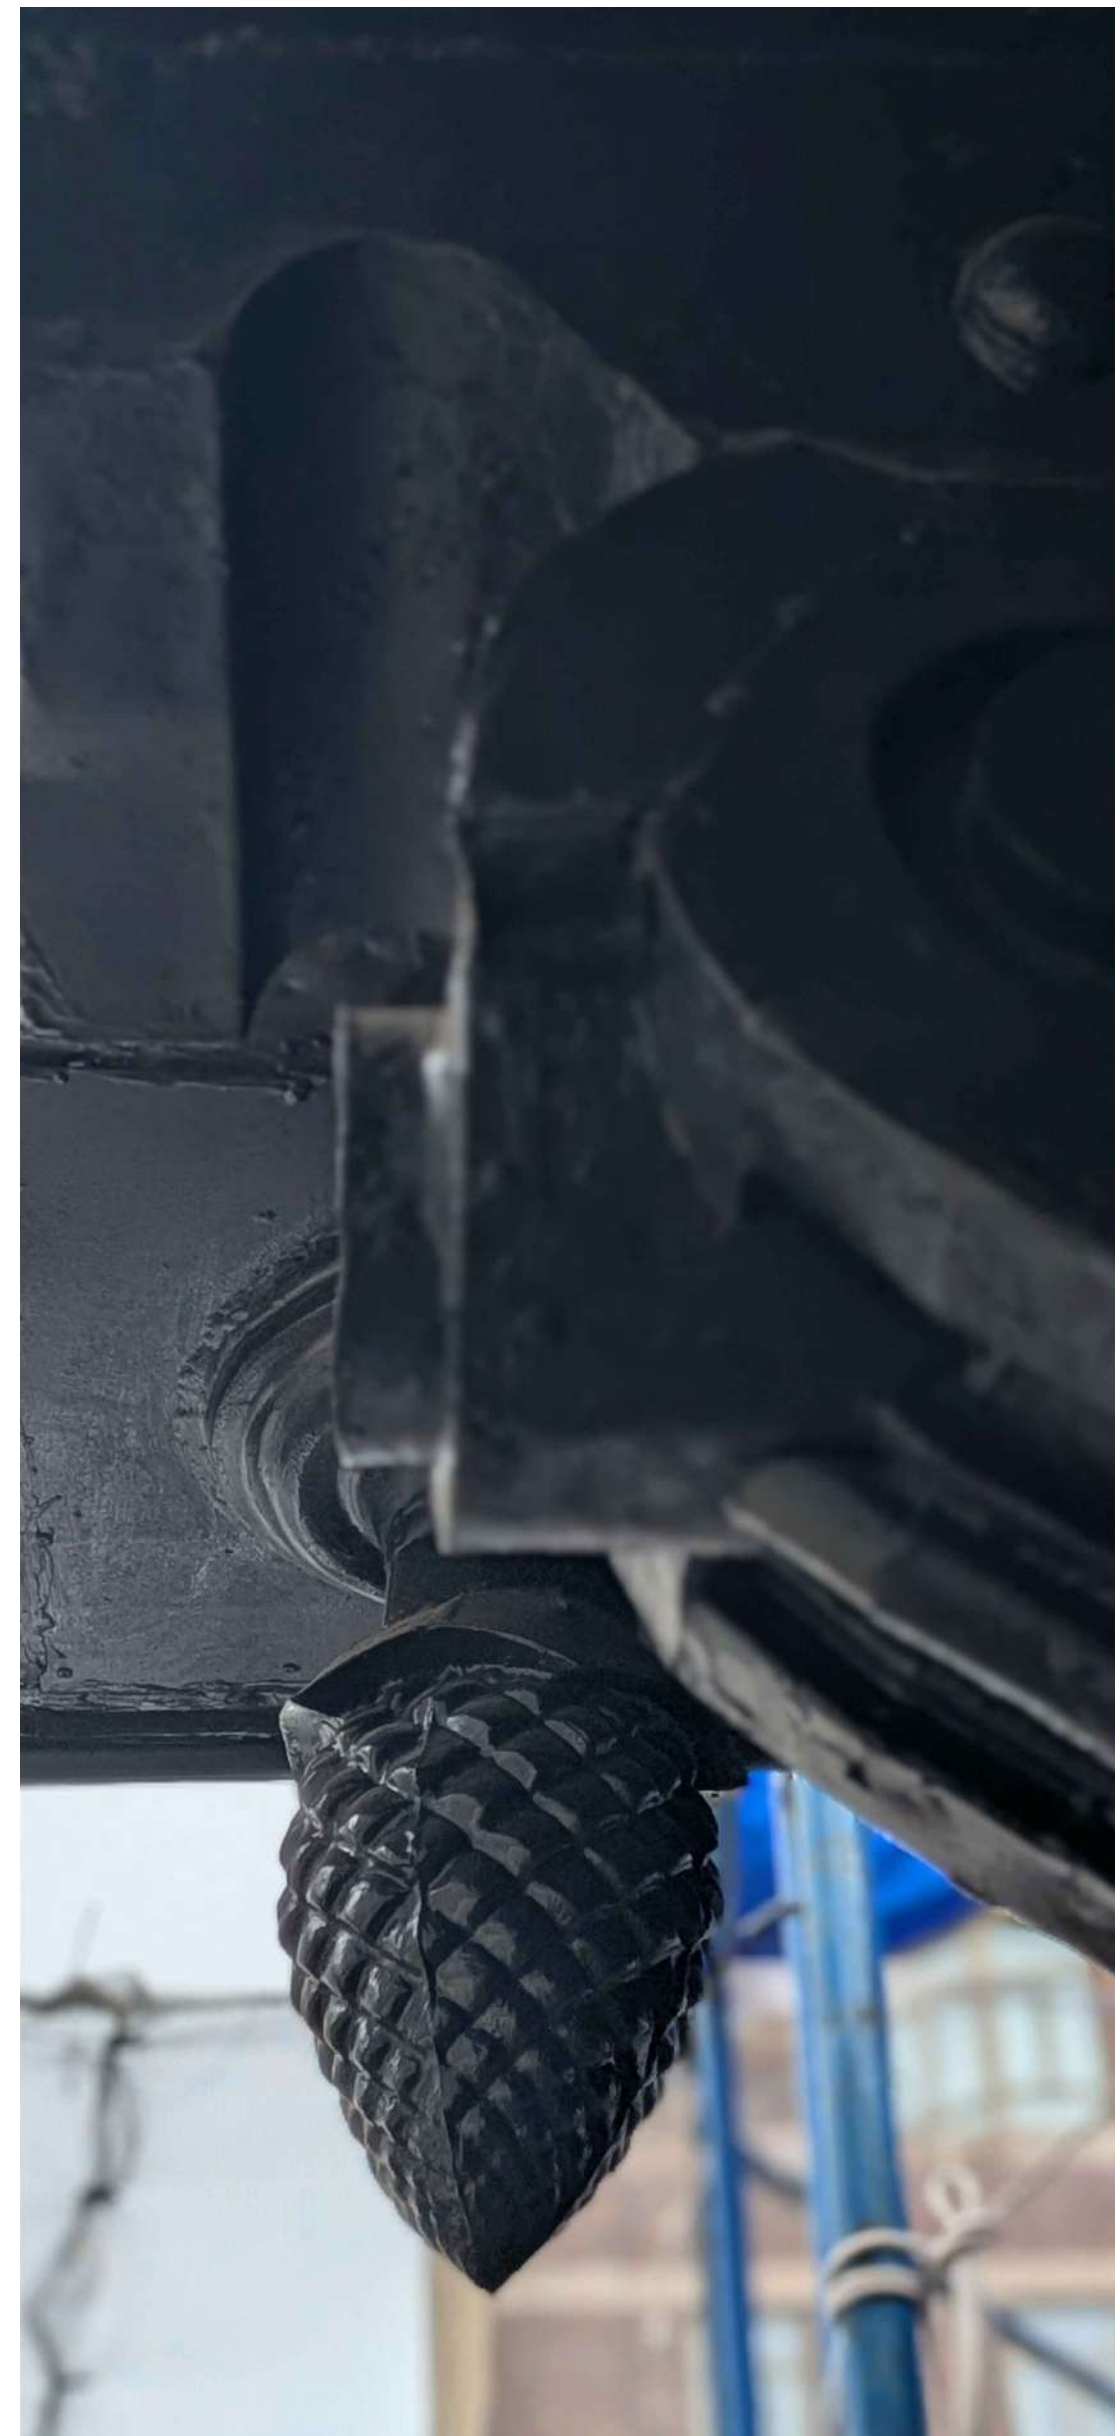
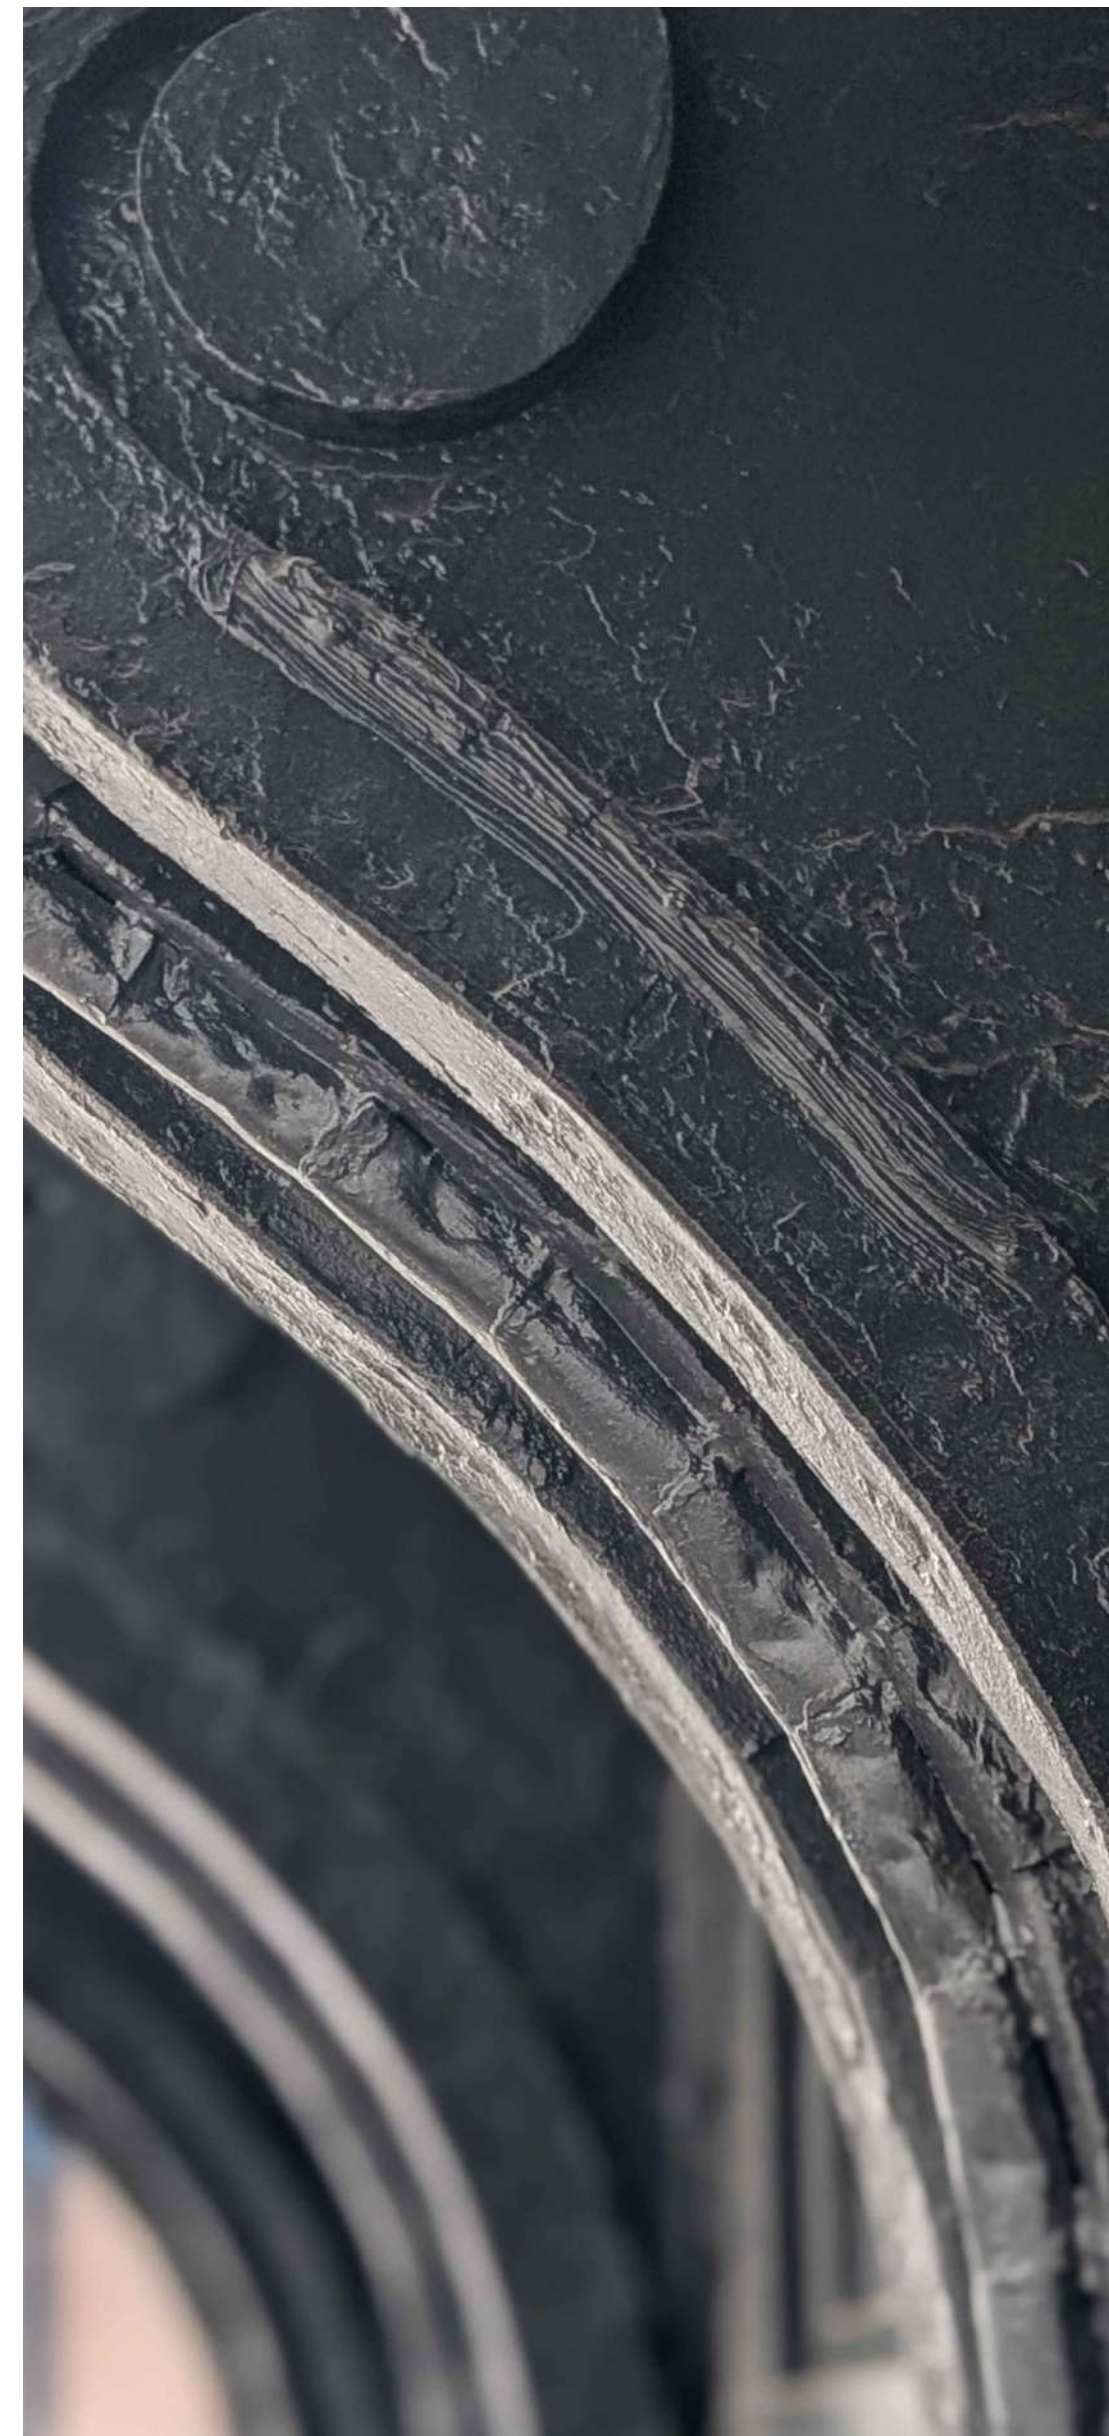
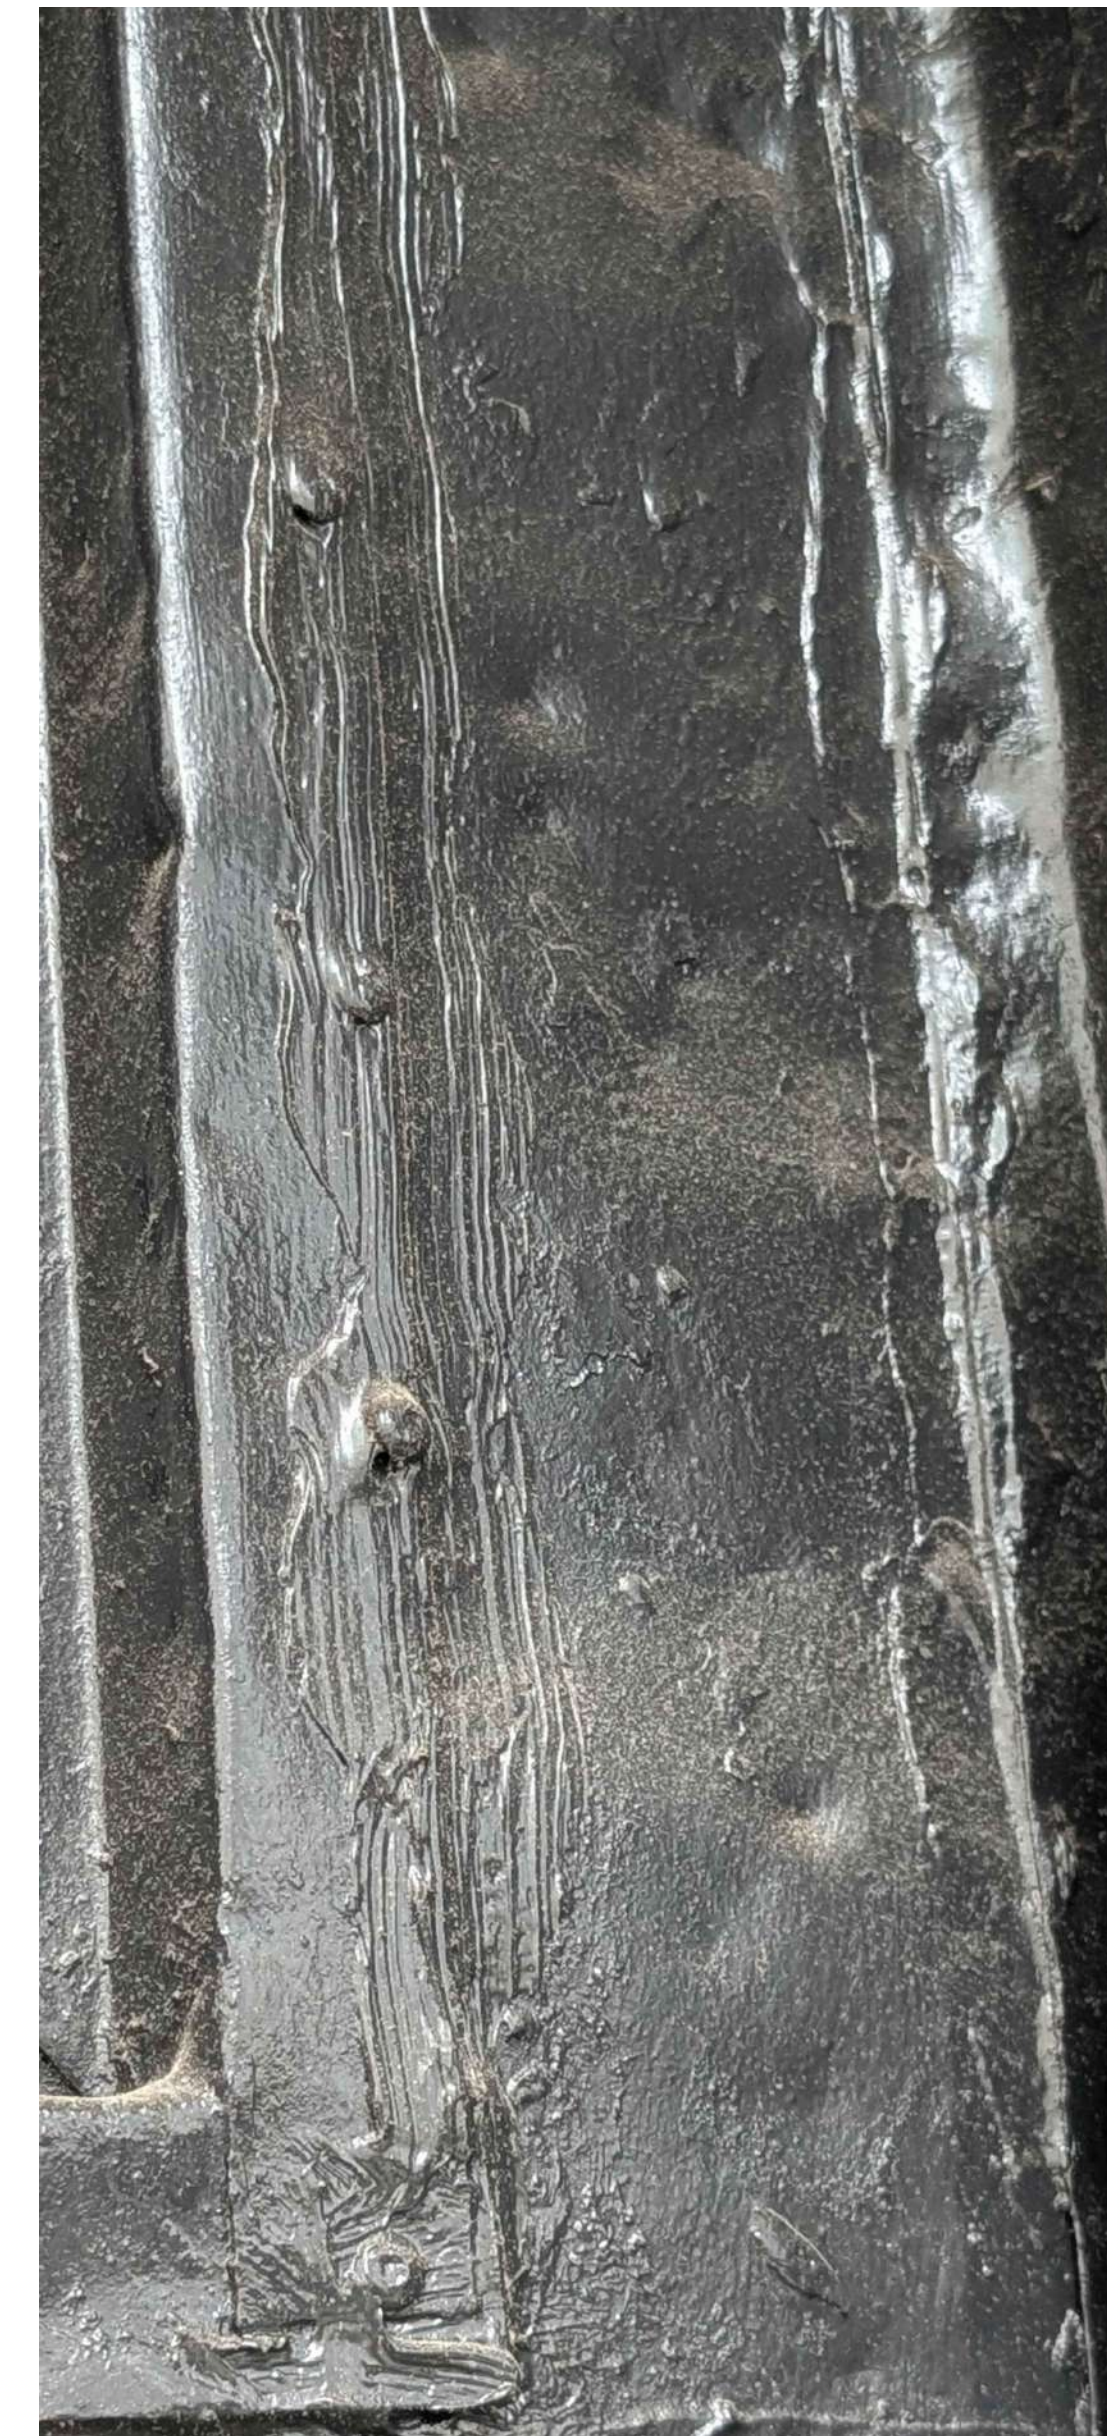
PHOTOS SHOWING  
POST-RESTORATION  
CONDITIONS  
OF 673 MADISON AVE  
BUILDING TOP CORNICE

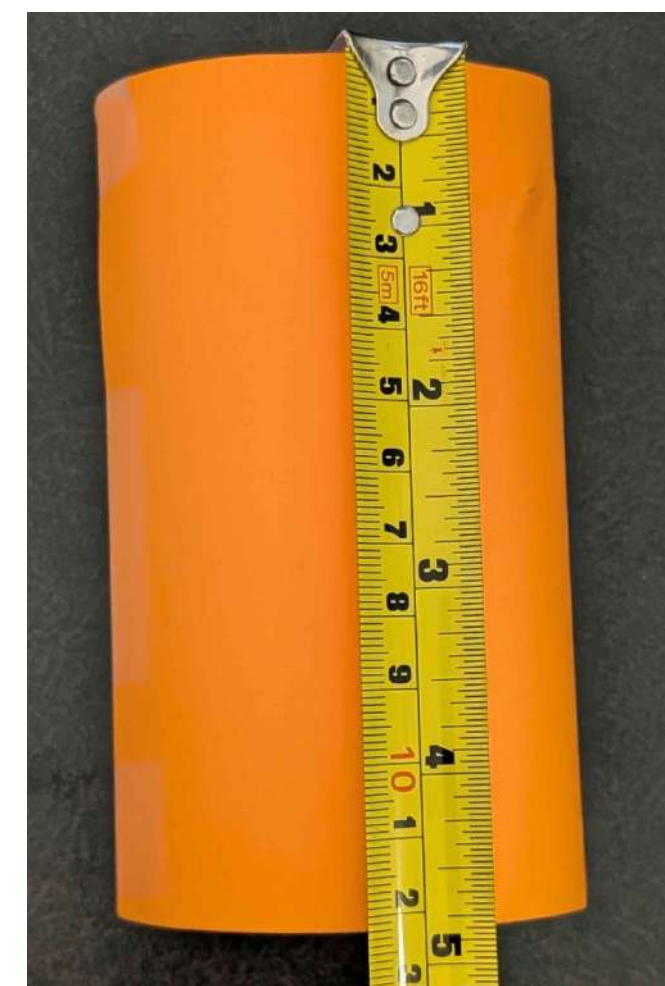
**PHOTO 1.**  
MOCKUP OF CYLINDER  
LIGHT

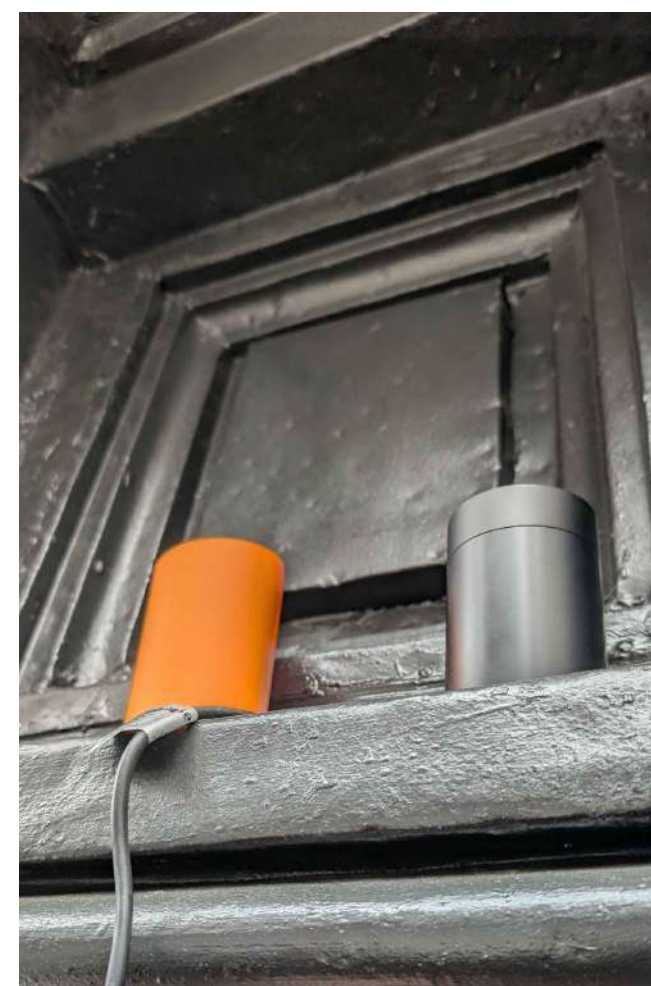
**PHOTO 2.**  
MOCKUP OF CYLINDER LIGHT  
AND REAL LIGHT FIXTURE  
PLACED AT TOP CORNICE

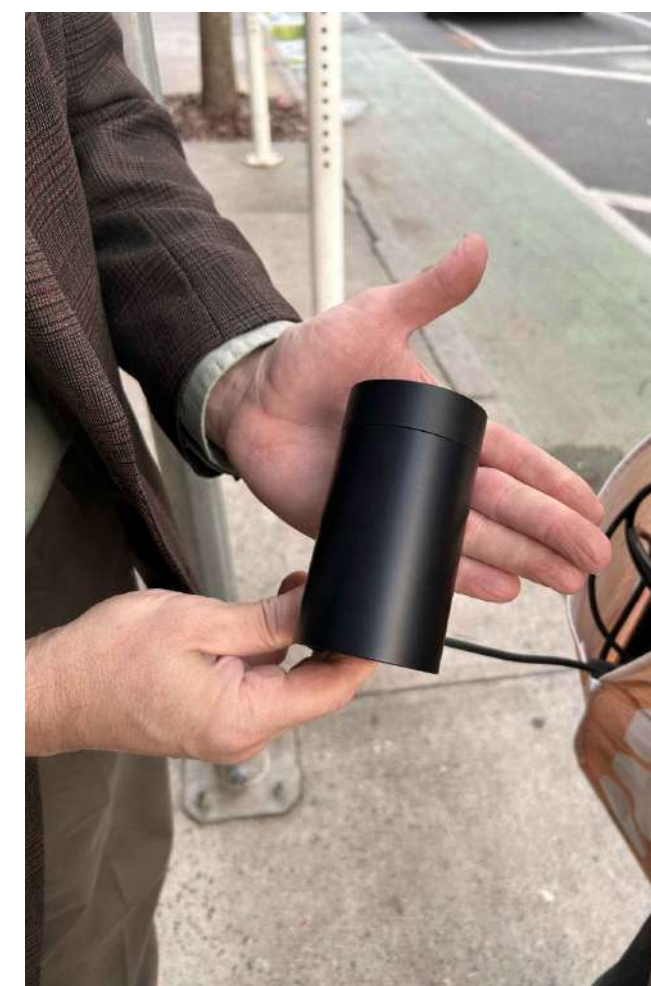
**PHOTO 3.**  
FIXTURE SCALE  
IN RELATION TO  
HUMAN HAND

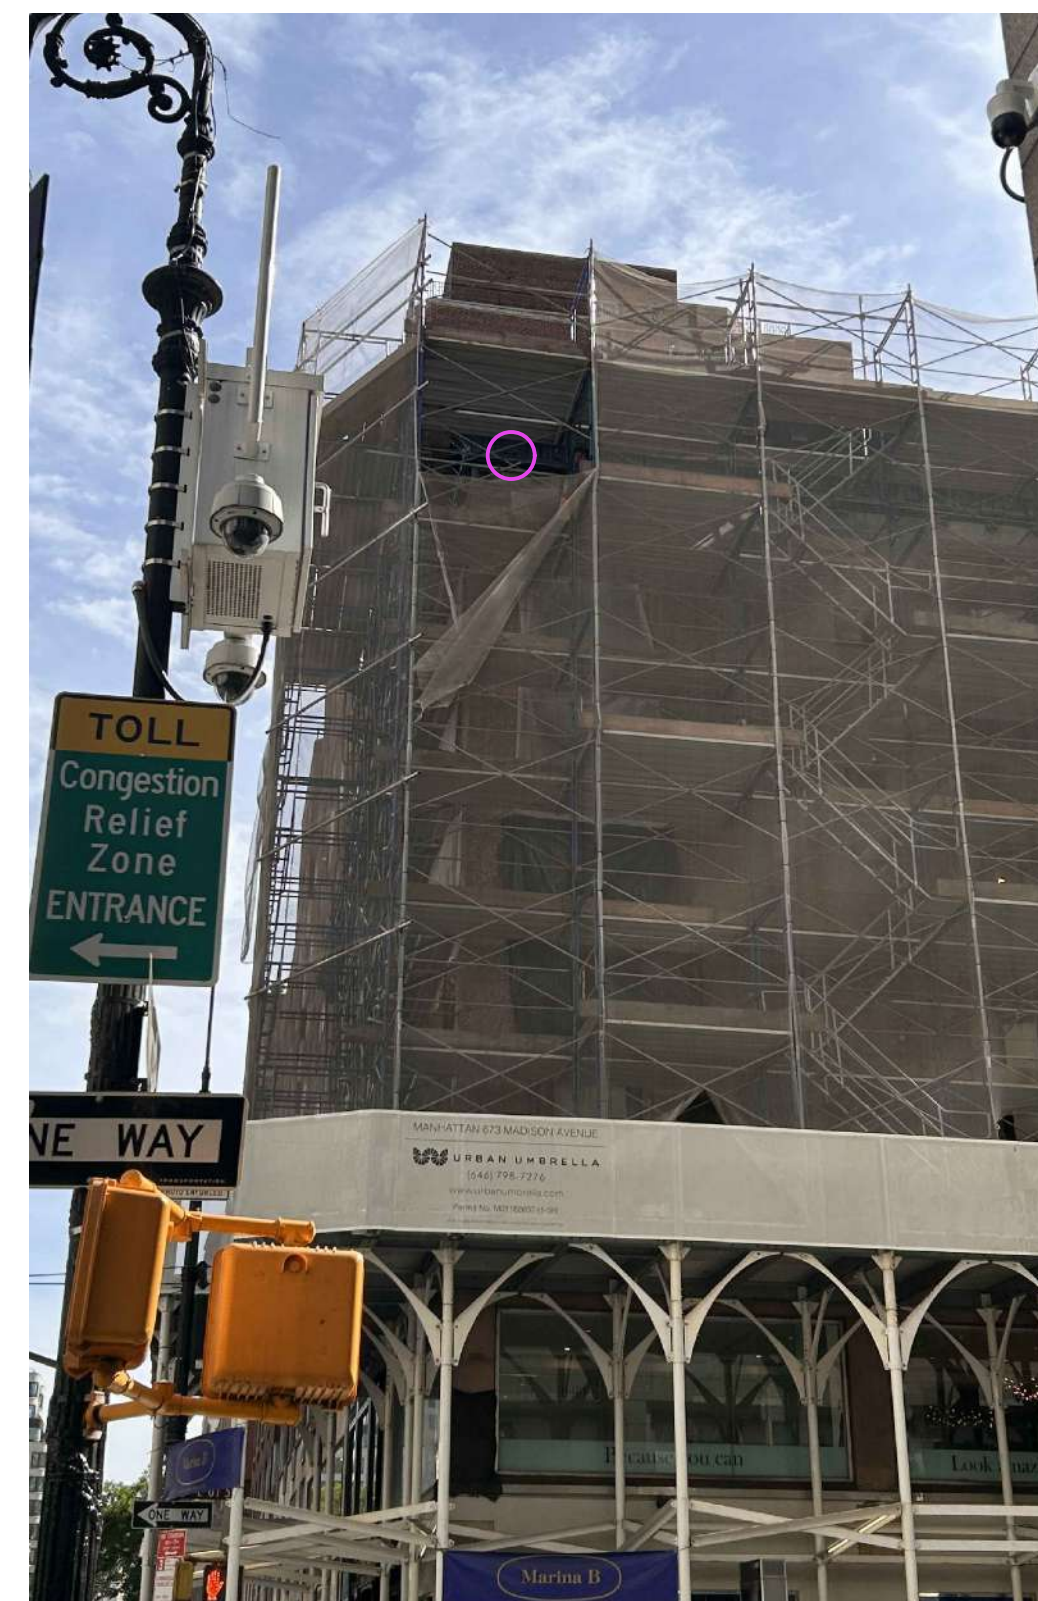
**PHOTO 8. POINT D.**  
BLACK FIXTURE  
ISN'T VISIBLE @ TOP CORNICE

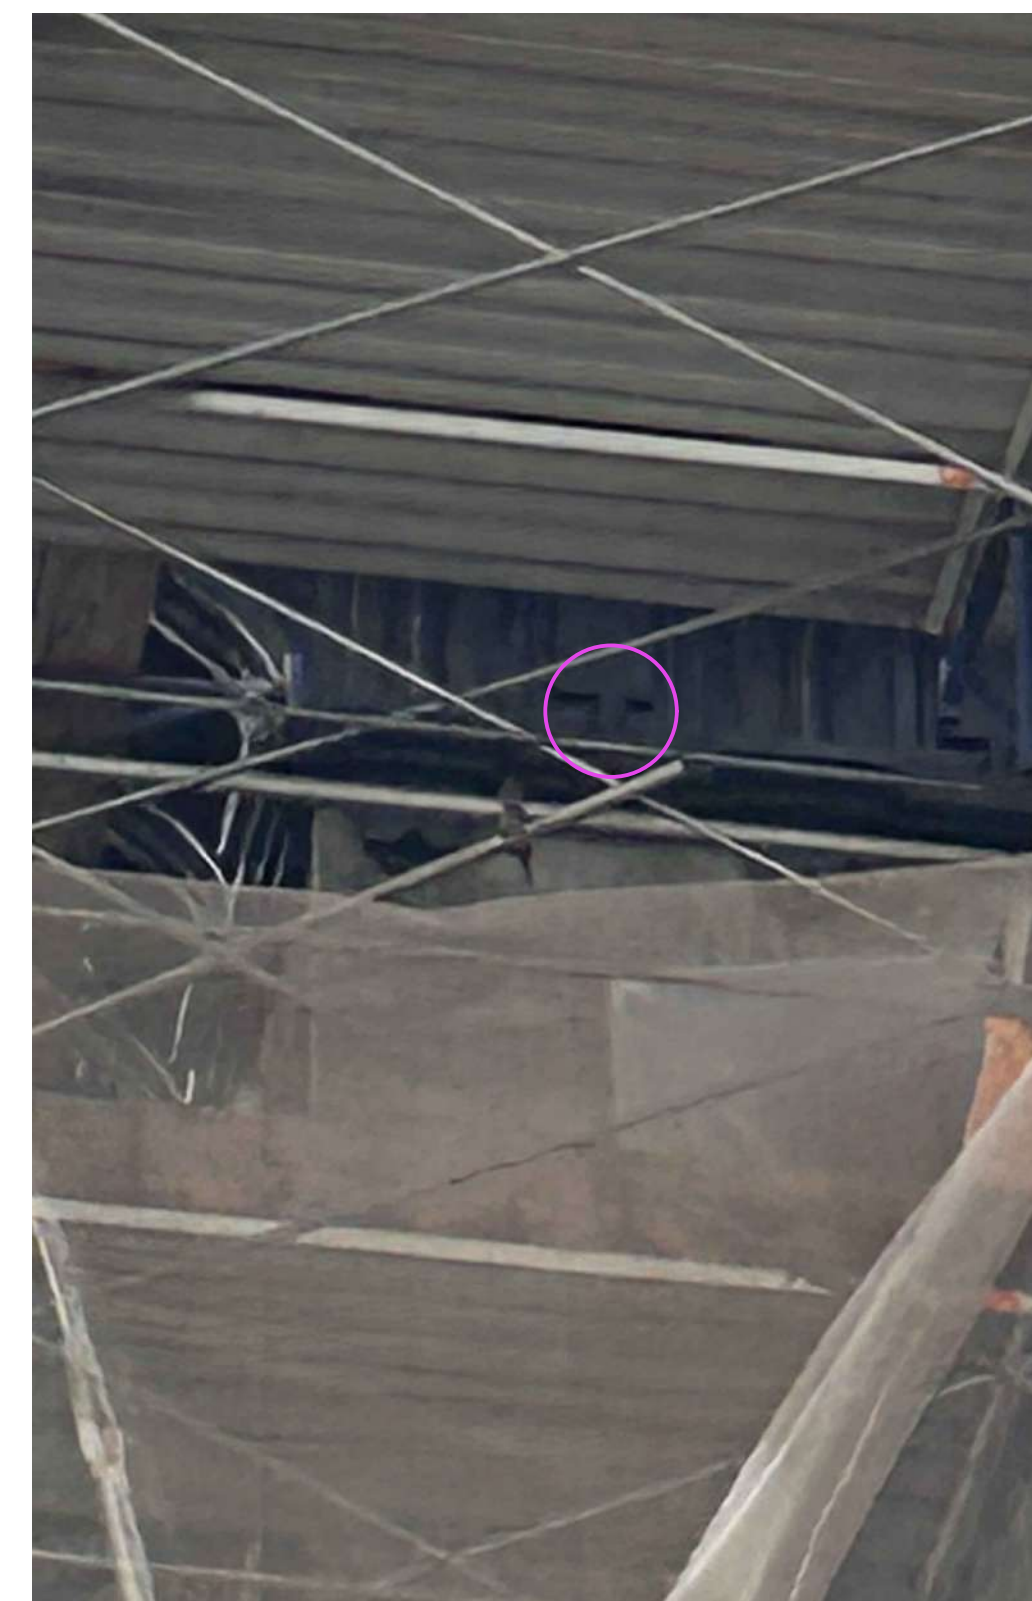
**PHOTO 9. POINT D.**  
CLOSE-UP PHOTO  
OF BLACK FIXTURE  
@ TOP CORNICE
