# 673 MADISON AVENUE

**673 MADISON AVENUE - CORNICE LIGHTING  
PUBLIC HEARING JULY 13, 2026**

**PROPOSED FACADE LIGHTING SCHEME (OVERALL)**

**673 MADISON AVENUE - CORNICE LIGHTING**

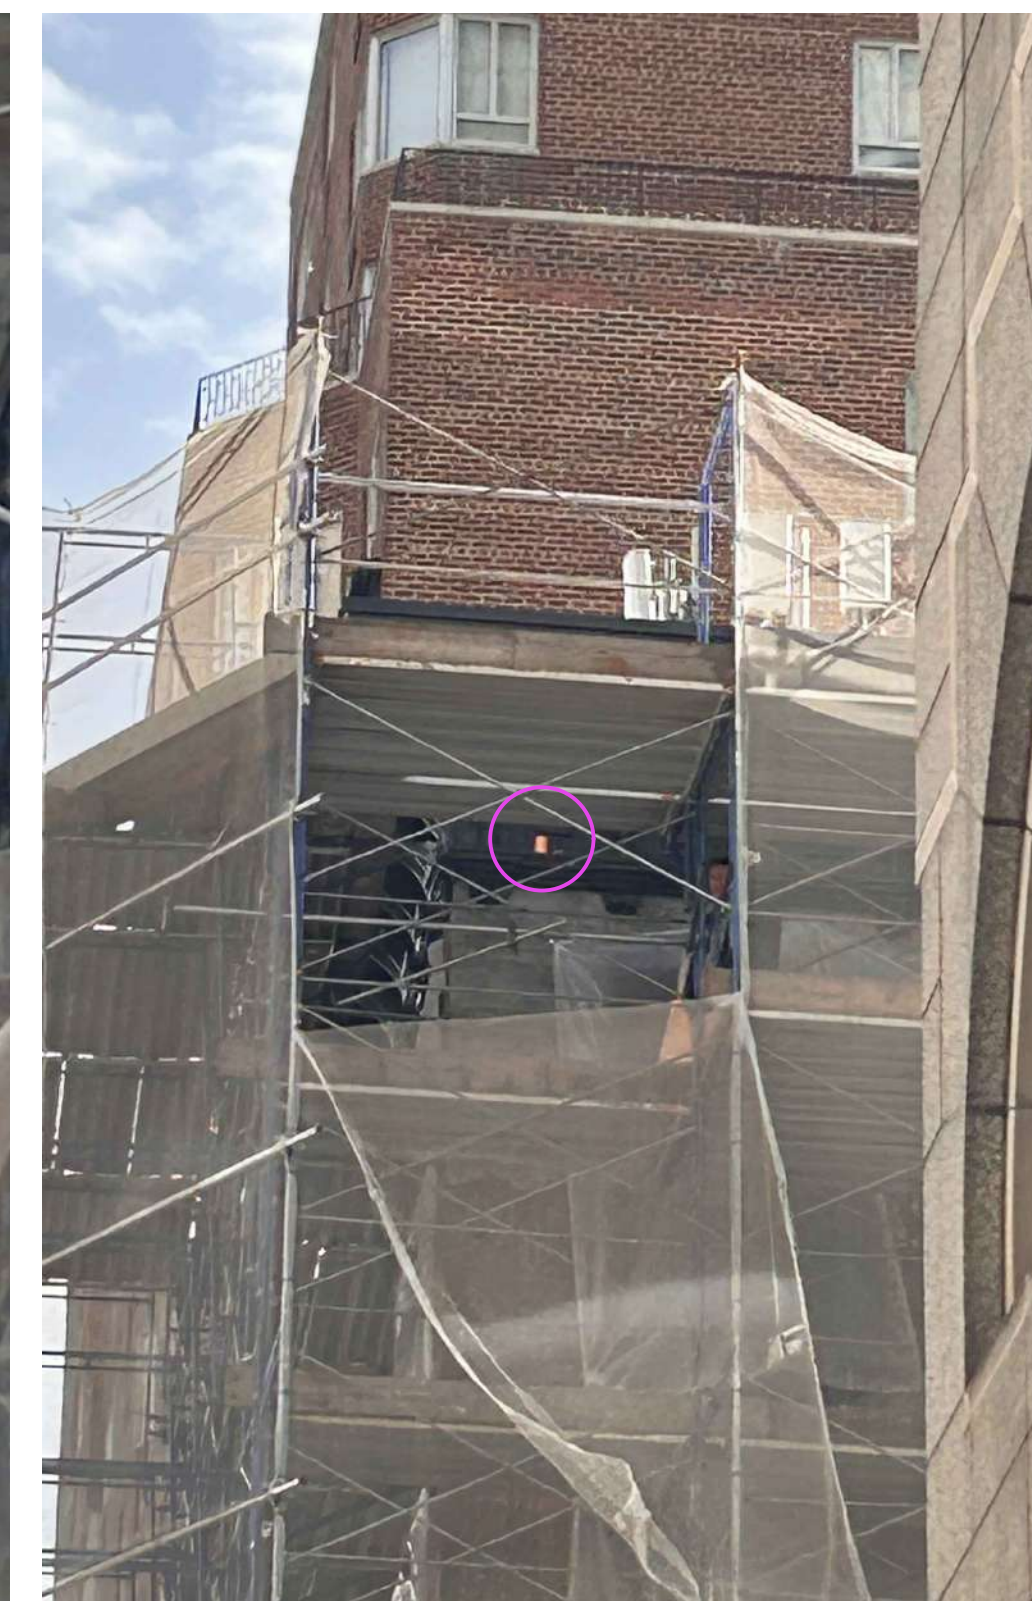
**PHOTO 10. POINT D.**  
ORANGE CYLINDER MOCKUP  
VISIBLE, BUT BLACK FIXTURE  
ISN'T VISIBLE @ TOP CORNICE

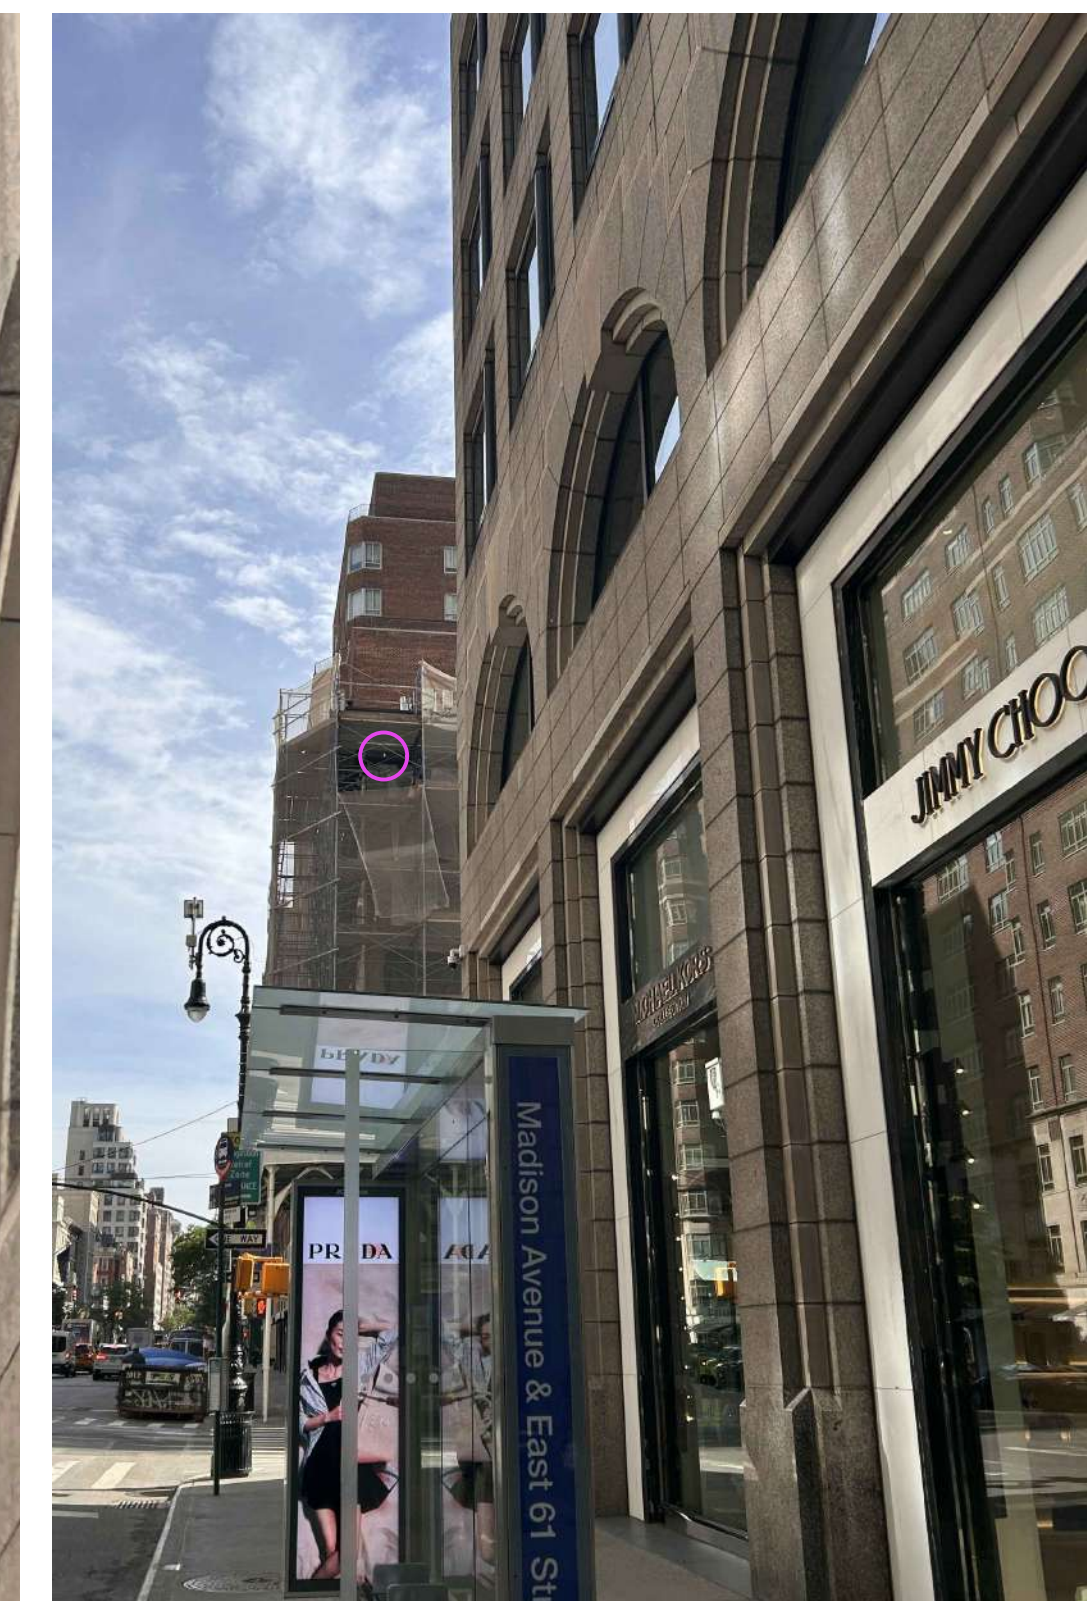
**PHOTO 11. POINT D1.**  
ORANGE CYLINDER MOCKUP  
VISIBLE, BUT BLACK FIXTURE  
ISN'T VISIBLE @ TOP CORNICE

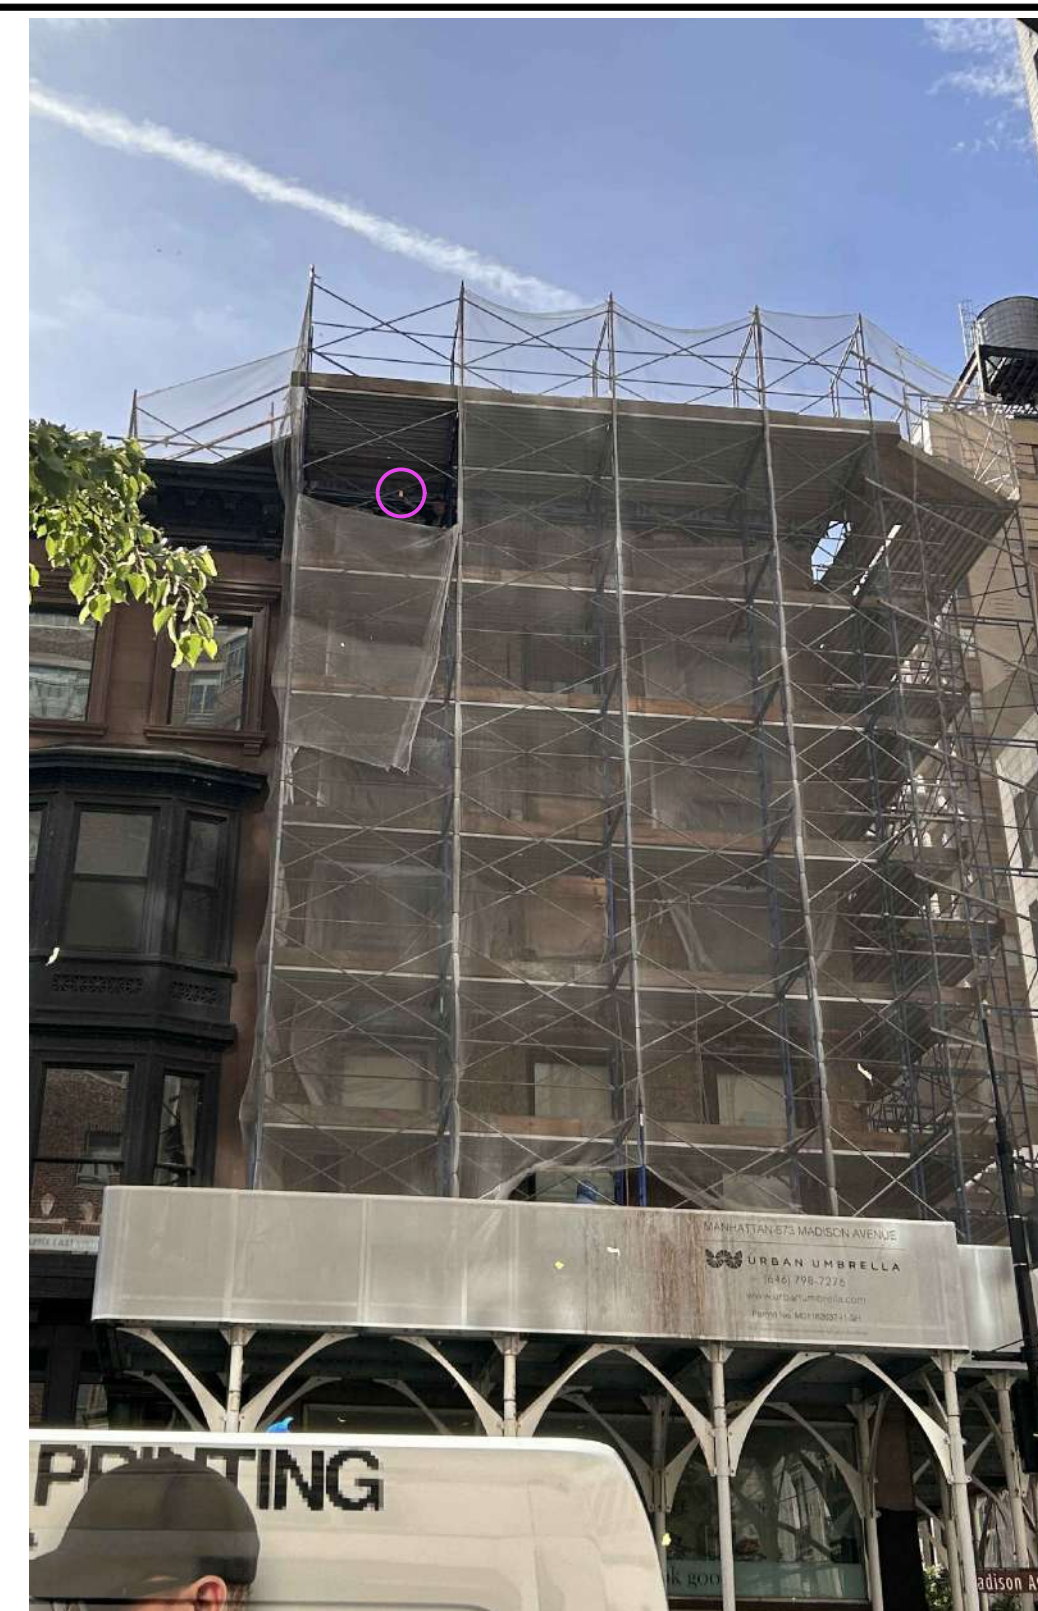
**PHOTO 4. POINT A.**  
ORANGE CYLINDER MOCKUP  
VISIBLE, BUT BLACK FIXTURE  
ISN'T VISIBLE @ TOP CORNICE

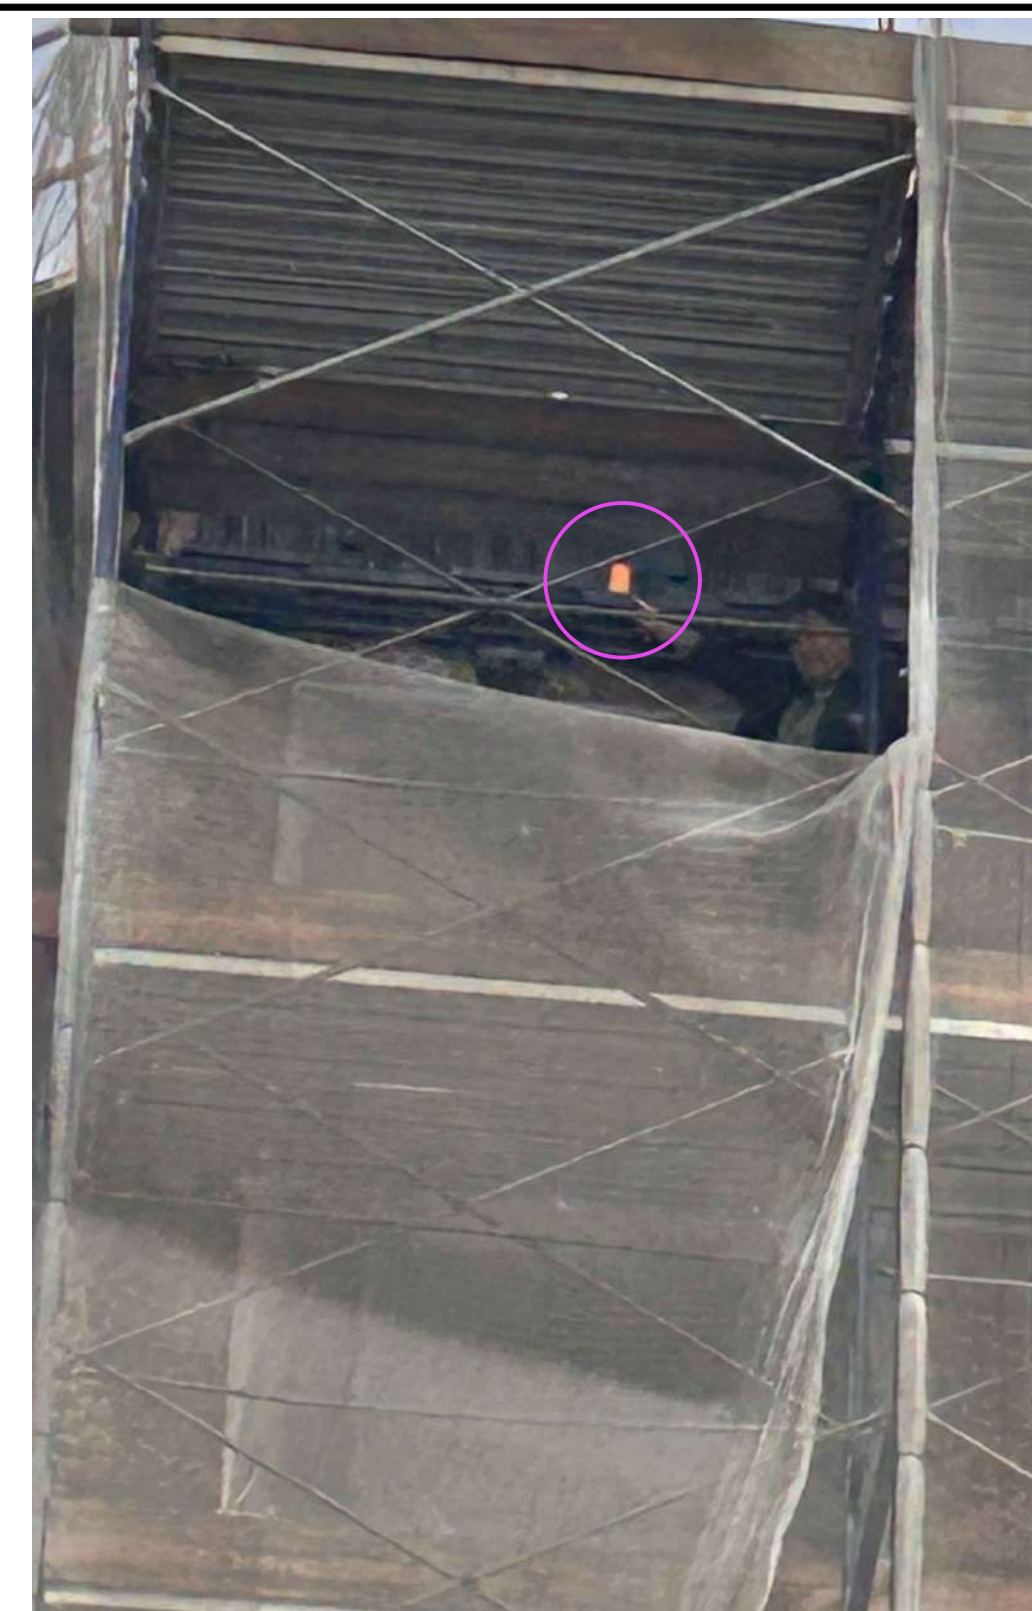
**PHOTO 5. POINT A.**  
CLOSE-UP PHOTO:  
ORANGE CYLINDER MOCKUP  
VISIBLE, BUT BLACK FIXTURE  
ISN'T VISIBLE @ TOP CORNICE

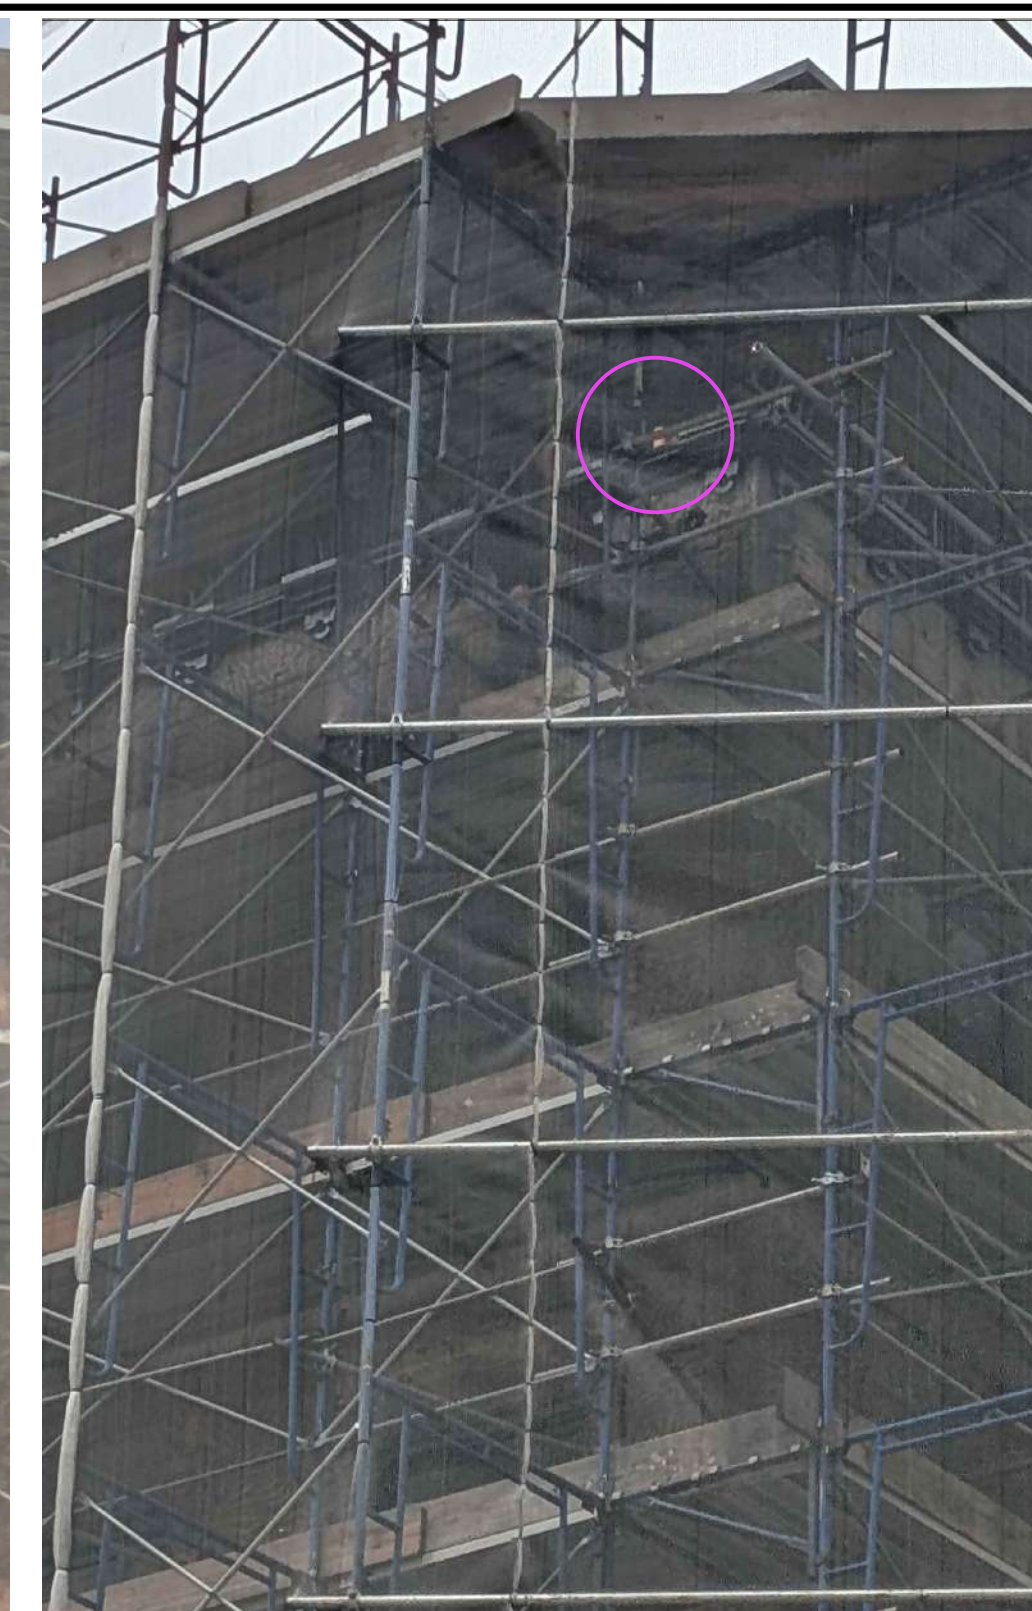
**PHOTO 6. POINT B.**  
ORANGE CYLINDER MOCKUP  
VISIBLE, BUT BLACK FIXTURE  
ISN'T VISIBLE @ TOP CORNICE

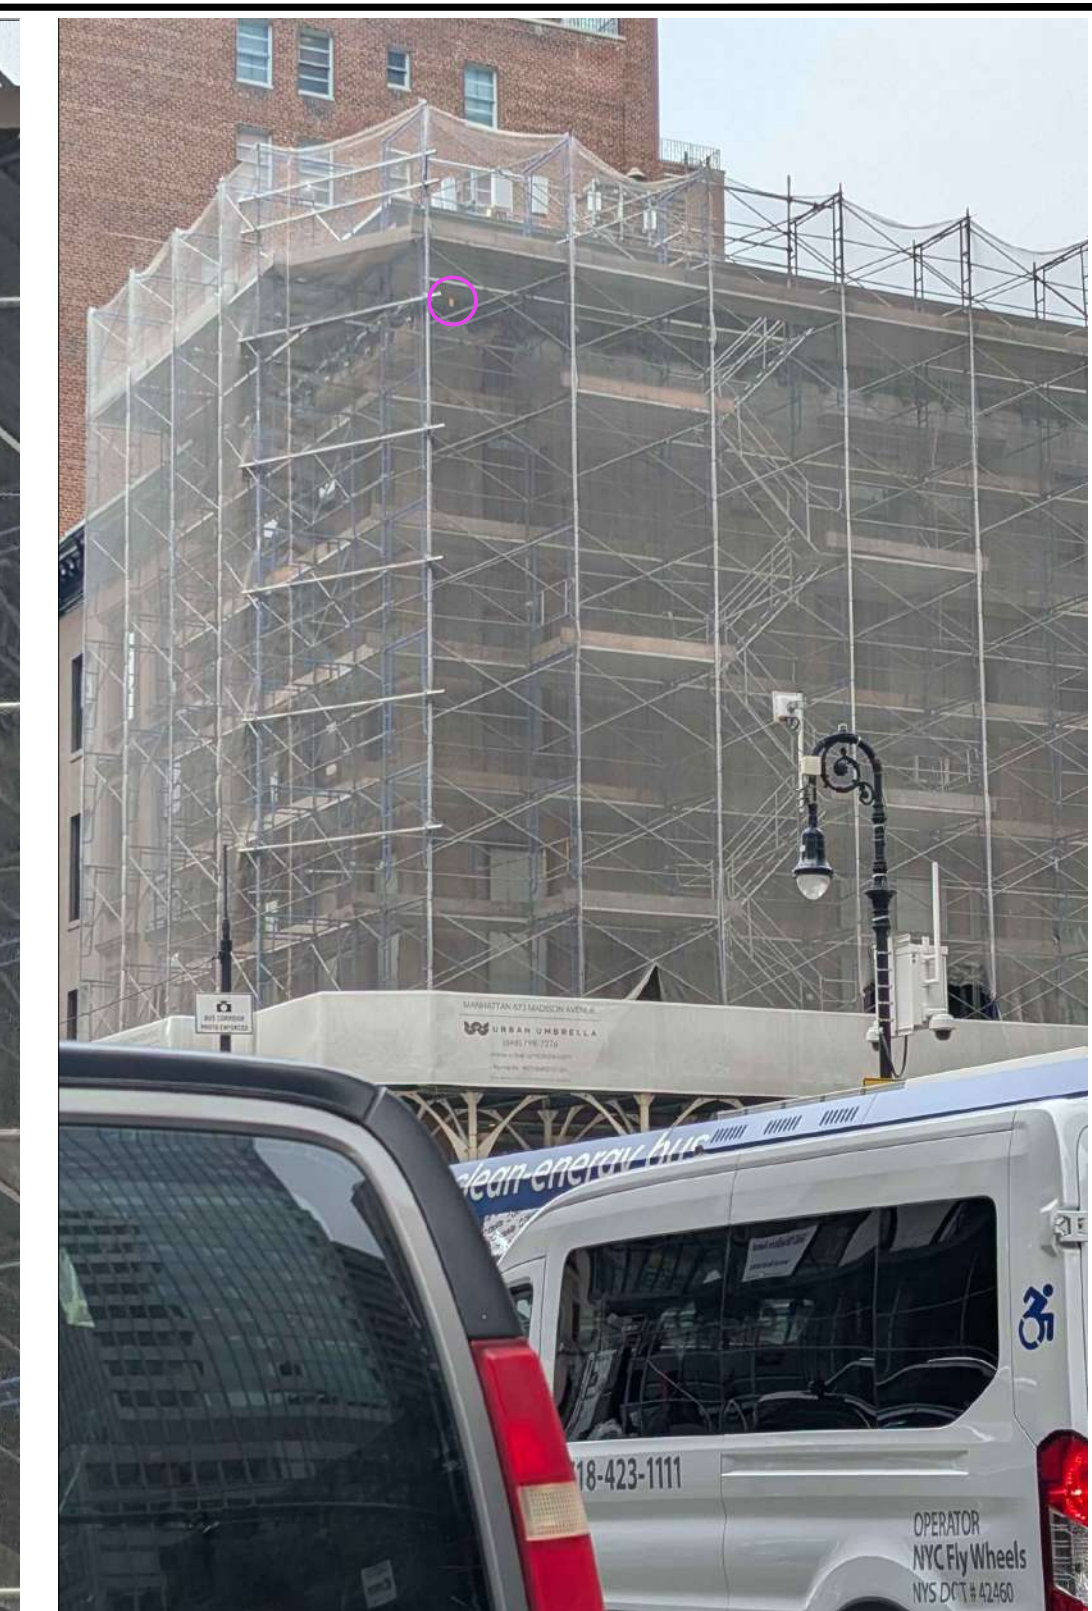
**PHOTO 7. POINT C.**  
ORANGE CYLINDER MOCKUP  
VISIBLE, BUT BLACK FIXTURE  
ISN'T VISIBLE @ TOP CORNICE
