**NYC Parks**

# **East River Esplanade**

Work in Progress & Planned Capital Work

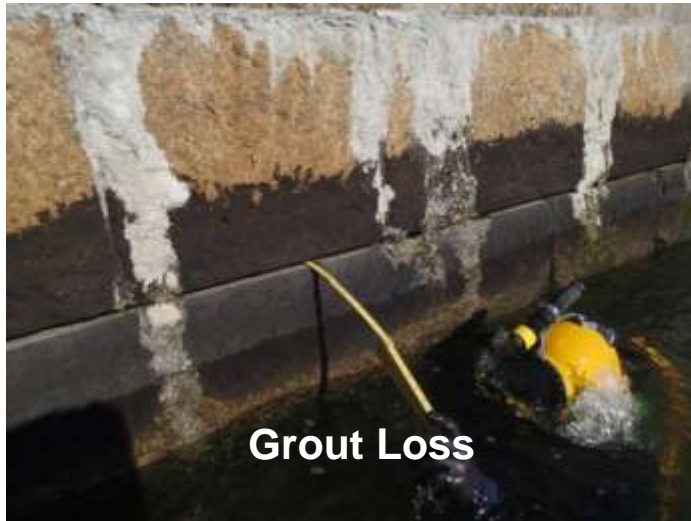
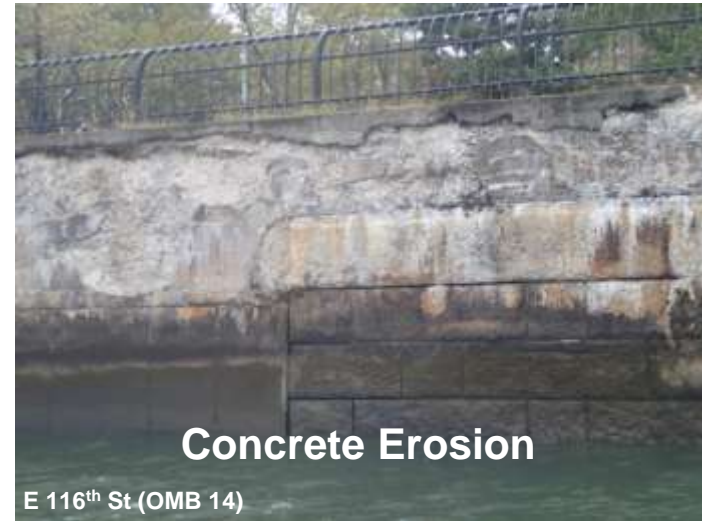
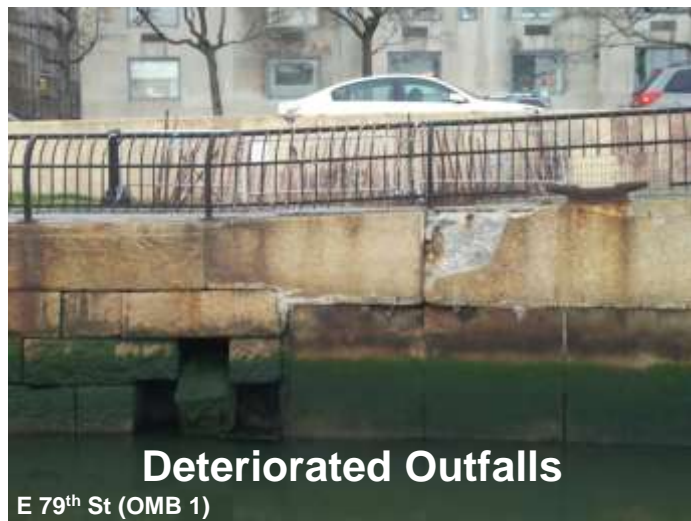
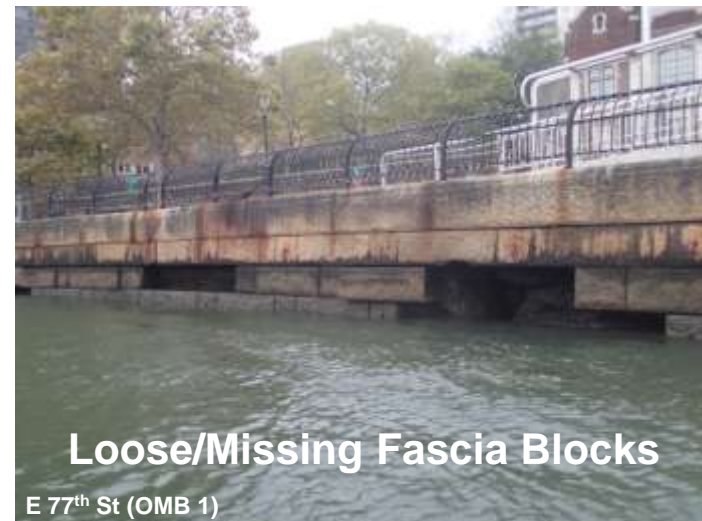
## Findings: Gravity Retaining Wall Structures

- Over 10,000 linear feet inspected
- Characteristic grout loss along granite fascia block joints
- Loose/displaced/missing fascia blocks in various locations
- Exposed concrete seawall surfaces exhibit cracking, spalling and/or erosion

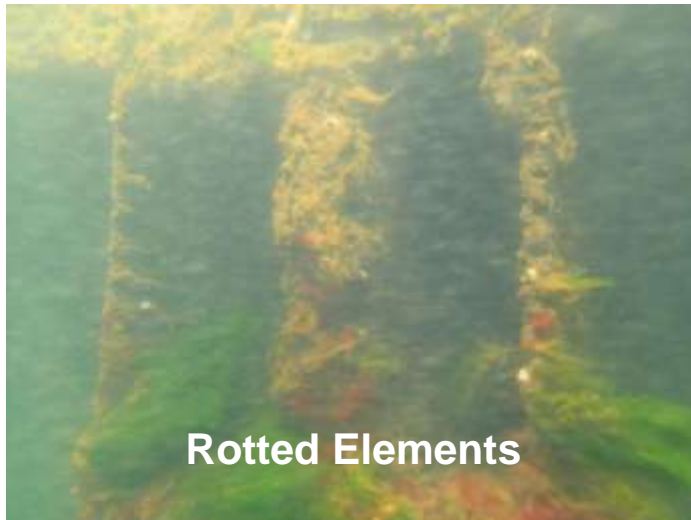
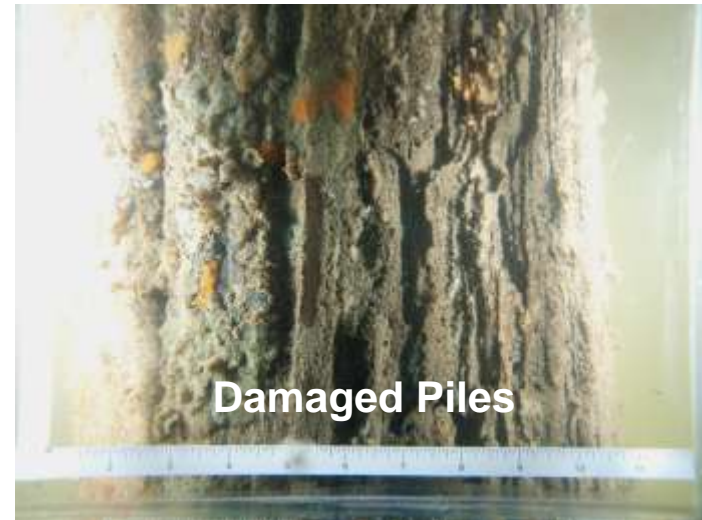
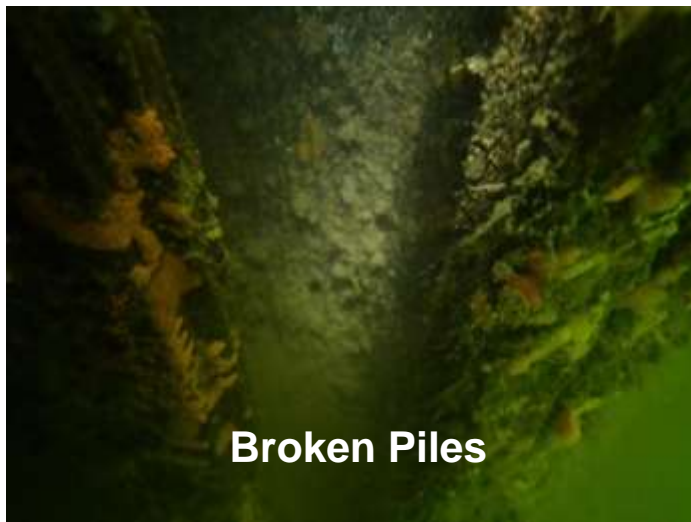
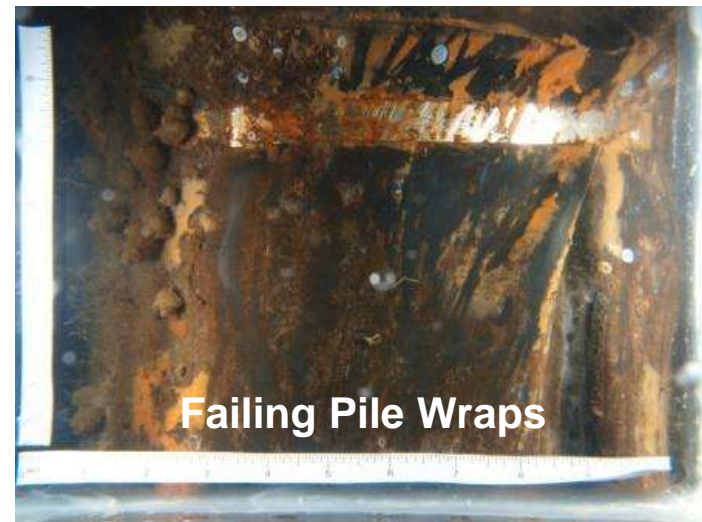
## Findings: Timber-Support Platform Structures (Below Water Photos)

- Over 11,000 linear feet inspected
- Overall moderate marine borer activity observed
- Minor to severe timber deterioration along the East River
