## **829 MADISON AVENUE**

PRESENTATION TO THE  
LANDMARKS PRESERVATION COMMISSION

OCTOBER 27, 2022

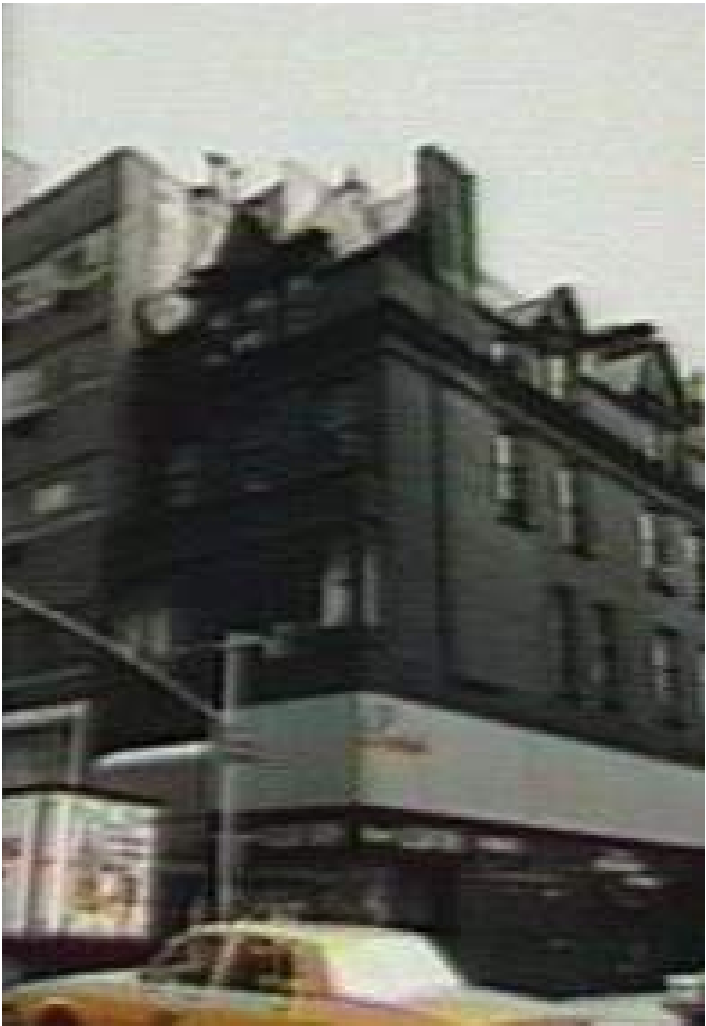
C. 1980'S TAX DEPT. PHOTO

ALTERATIONS THROUGH OUT THE DECADES:

- SOUTH ENTRANCE STAIRS REMOVED AND FACADE ALTERED. ENGLISH BASEMENT LIGHT WELL FILLED.
- WEST FACADE BAY WINDOW REMOVED, RIBBON WINDOWS AT SECOND AND THIRD FL ADDED. GROUND FLOOR STORE FRONT AND AWNING ADDED.
- CORBELED CHIMNEY CAP REMOVED. THREE WINDOWS ENLARGED AT SOUTH FACADE.
- BUILDING FACADE PAINTED BLACK.

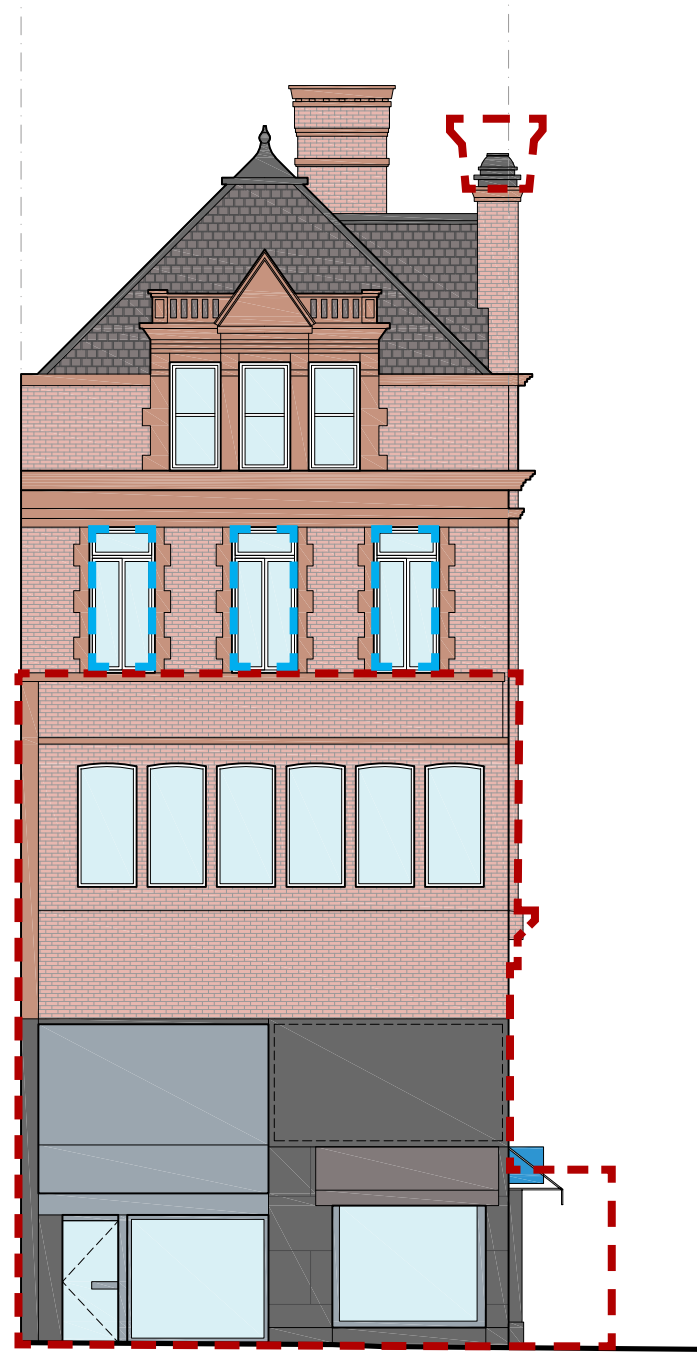
WEST ELEVATION (MADISON AVENUE)

- SOUTH ENTRANCE STAIRS REMOVED AND FACADE ALTERED. ENGLISH BASEMENT LIGHT WELL FILLED.
- WEST FACADE BAY WINDOW REMOVED, RIBBON WINDOWS AT SECOND AND THIRD FL ADDED. GROUND FLOOR STORE FRONT AND AWNING ADDED.
- CORBELED CHIMNEY CAP REMOVED. THREE WINDOWS ENLARGED AT SOUTH FACADE.
- BUILDING FACADE PAINTED BLACK FROM 1960'S TO 2000'S, WINDOW TYPE ALTERATIONS - NINE WINDOWS ALTERED FROM DOUBLE HUNG TO CASEMENT WINDOWS.

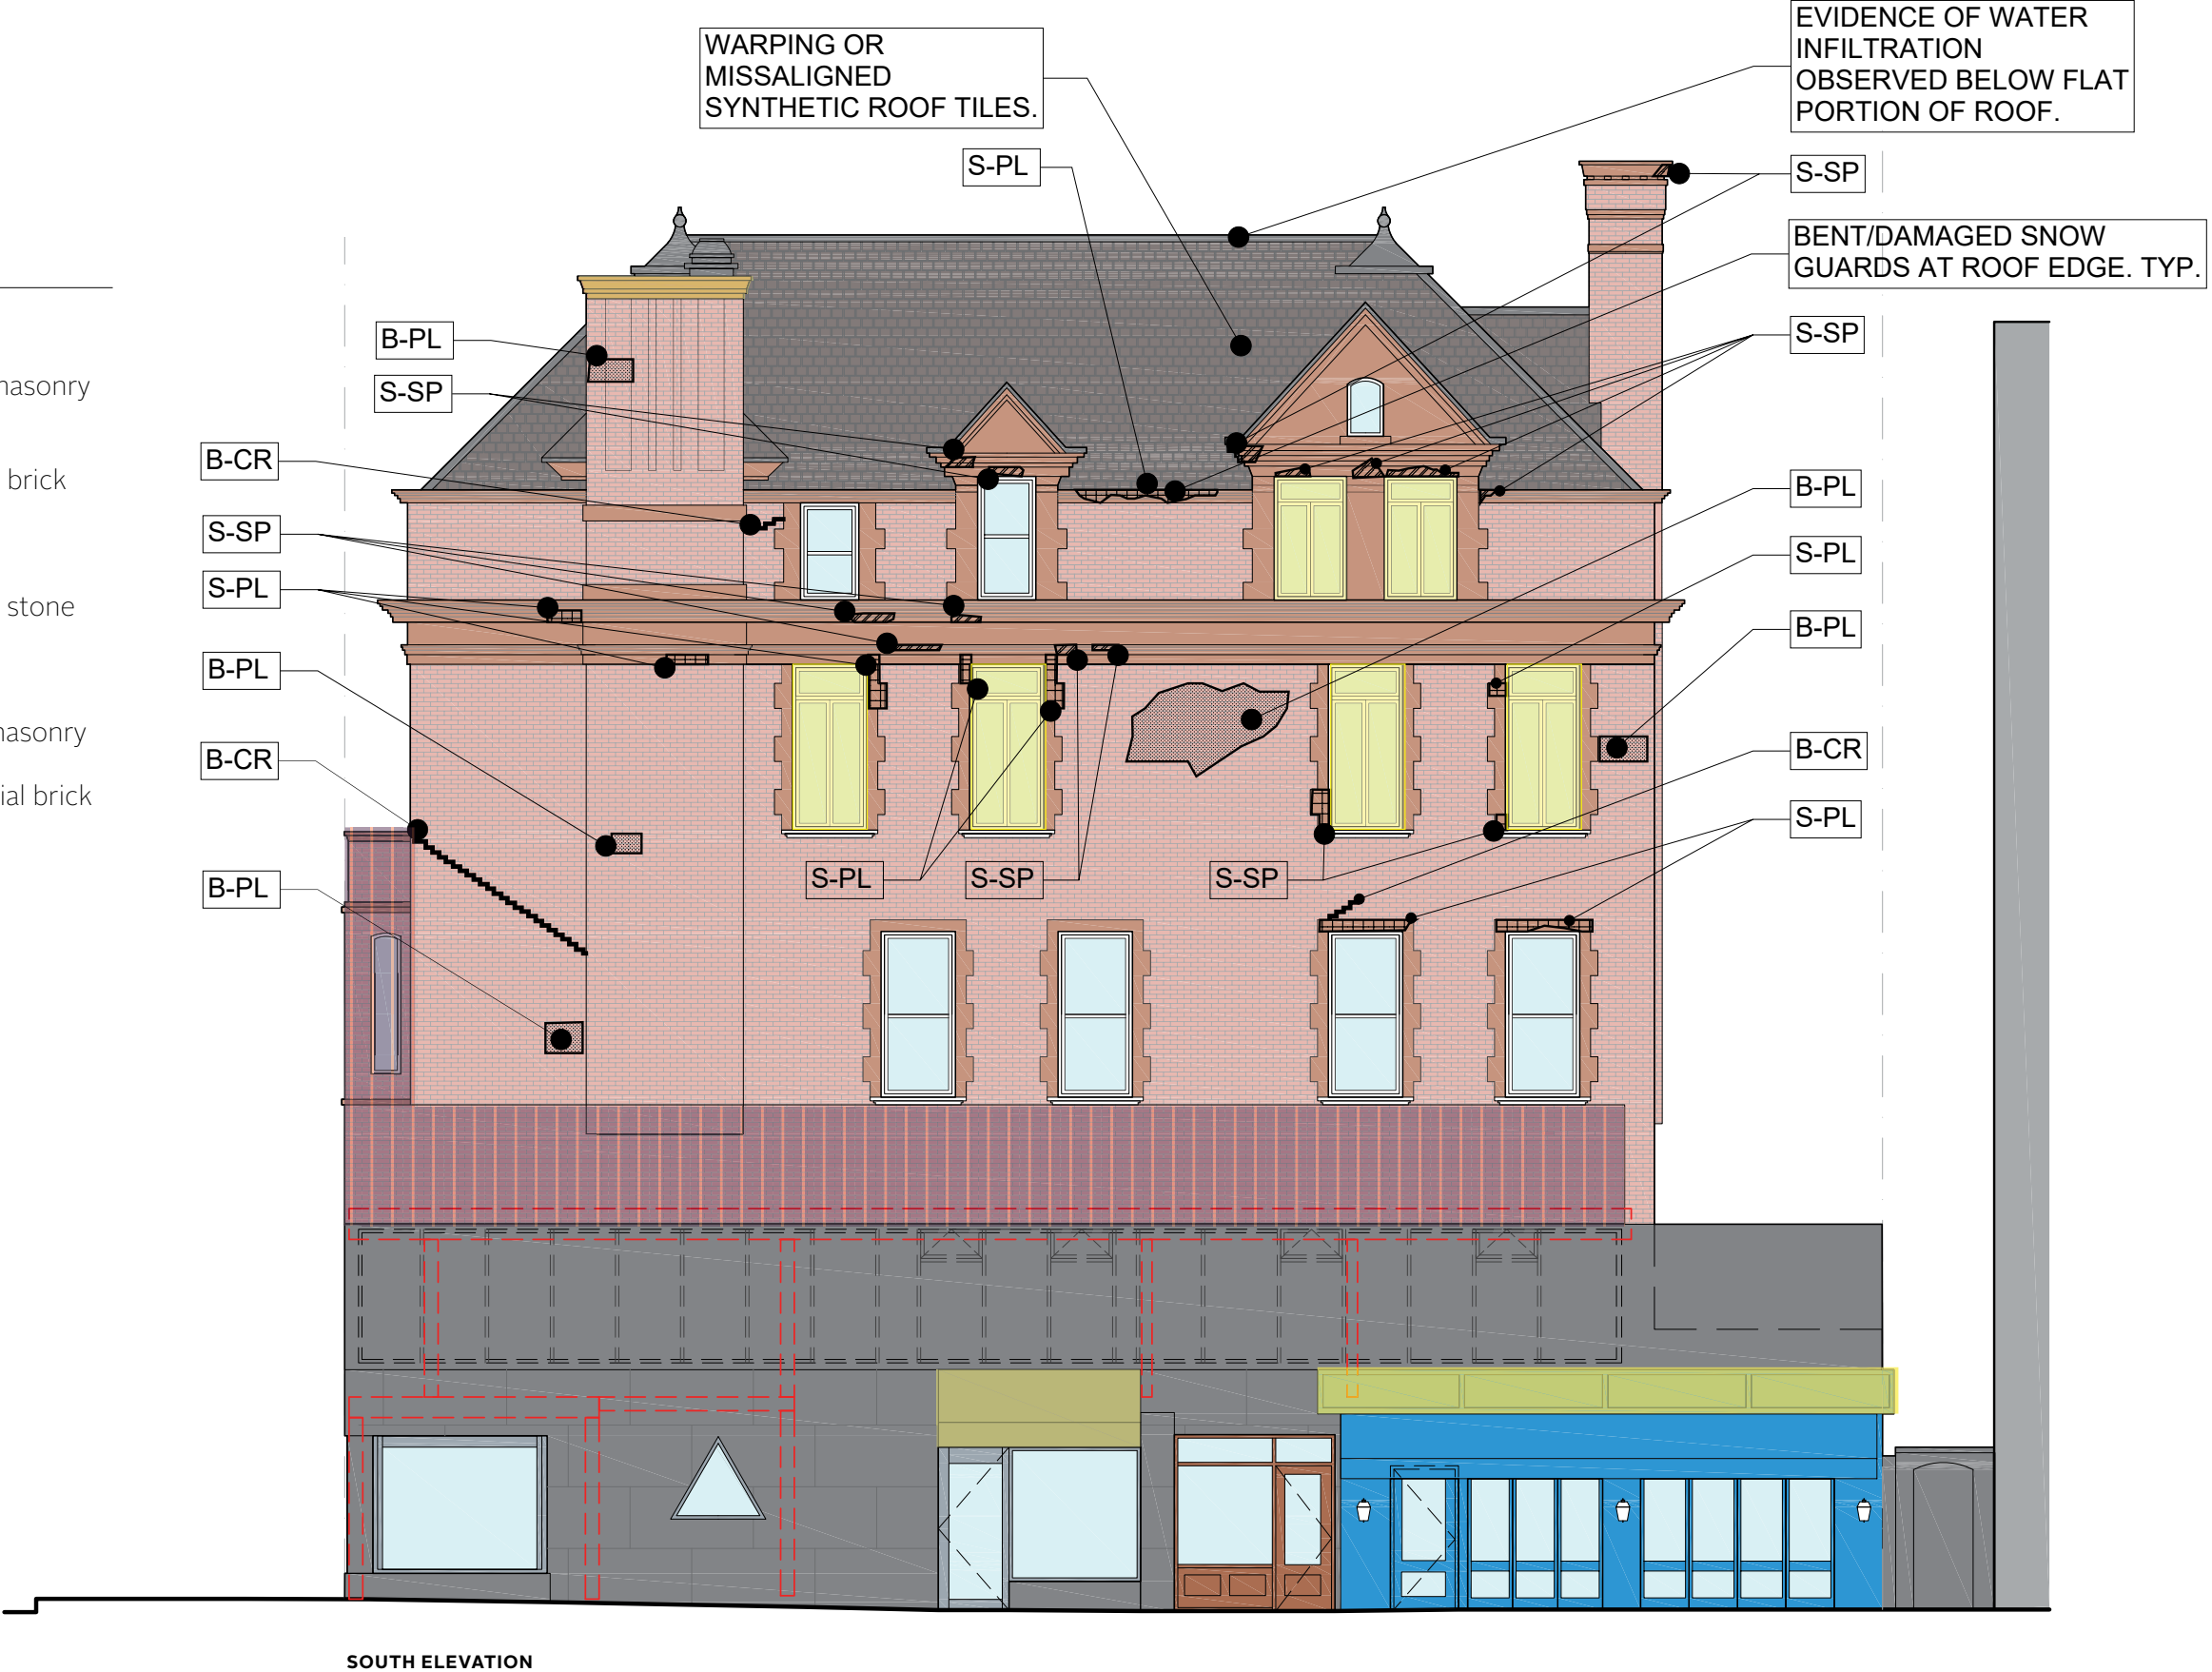
- LEGEND:
- / B-CR:  
Crack at brick masonry
  - B-PL:  
Peeling paint at brick masonry
  - S-PL:  
Peeling paint at stone masonry
  - S-SP:  
Spall at stone masonry
  - Assumed artificial brick
  - LPC Violation

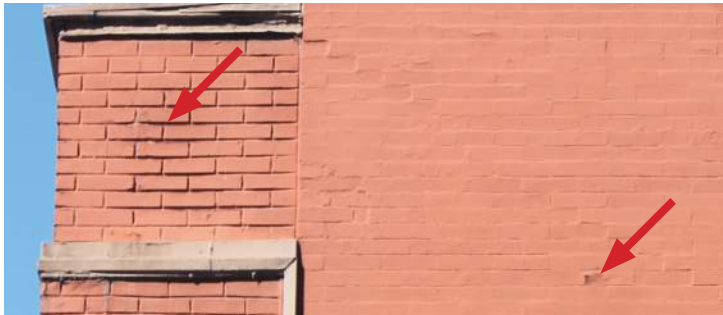
SOUTH ELEVATION: Peeling paint at brick masonry and newer brick veneer.

- B-PL:**
- Proposed treatments:**
1. Remove all existing paint coatings using chemical paint removers designed for use on historic brick.
  2. Clean exposed brick surfaces and survey for damaged bricks or missing mortar which were previously concealed by paint coatings.
  3. Replace cracked or damaged bricks with new bricks to match existing.
  4. Repoint open or damaged mortar at joints with new mortar to match existing.
  5. Provide mineral silicate coating designed for use on porous, historic masonry, may be considered in a color approved by LPC.

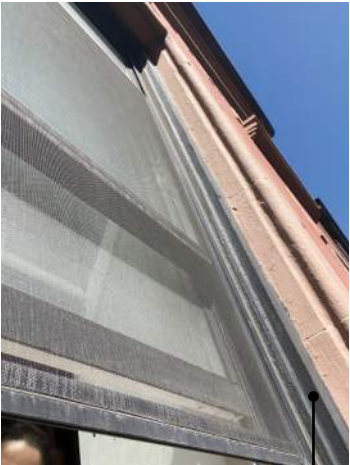
PHOTO OF EXISTING WOOD  
BRICK MOLD AT THIRD FL  
WINDOW

ORIGINAL PAINTED WOOD  
BRICK MOLD AT 3RD FL  
WINDOW, 1-1/2" WIDE X  
1" DEEP

EXISTING NINE CASEMENT WINDOWS TO BE REPLACED WITH ONE OVER ONE DOUBLE HUNG WINDOWS WITH HISTORIC PROFILE BRICK MOLD.
