1022 LEXINGTON AVENUE
Landmarks Preservation Commission - Docket # 20-09550

9-7-20	ISSUED TO CB8	OK
Date:	Rev. No.	Remarks:
PLOT PLAN SANBORN MAP TAX & BLOCK MAP		
LEX 73 HOLDINGS LLC		
1022 LEXINGTON AVENUE NEW YORK, NY 10021		
BODNAR ARCHITECTURE P.C. 675 Madison Avenue Suite 3R, New York NY 10065 P. 212 921 4466 - F. 212 730 1246		
Scale: NTS	Drawn by: OK	Checked by: TB
Drawing No. LPC-001.00	Date: 9/3/2020	Page No. 1 OF 15

CELLAR, BASEMENT & 1ST FLOOR REMOVAL PLANS

WINDOW AND DOOR DETAILS

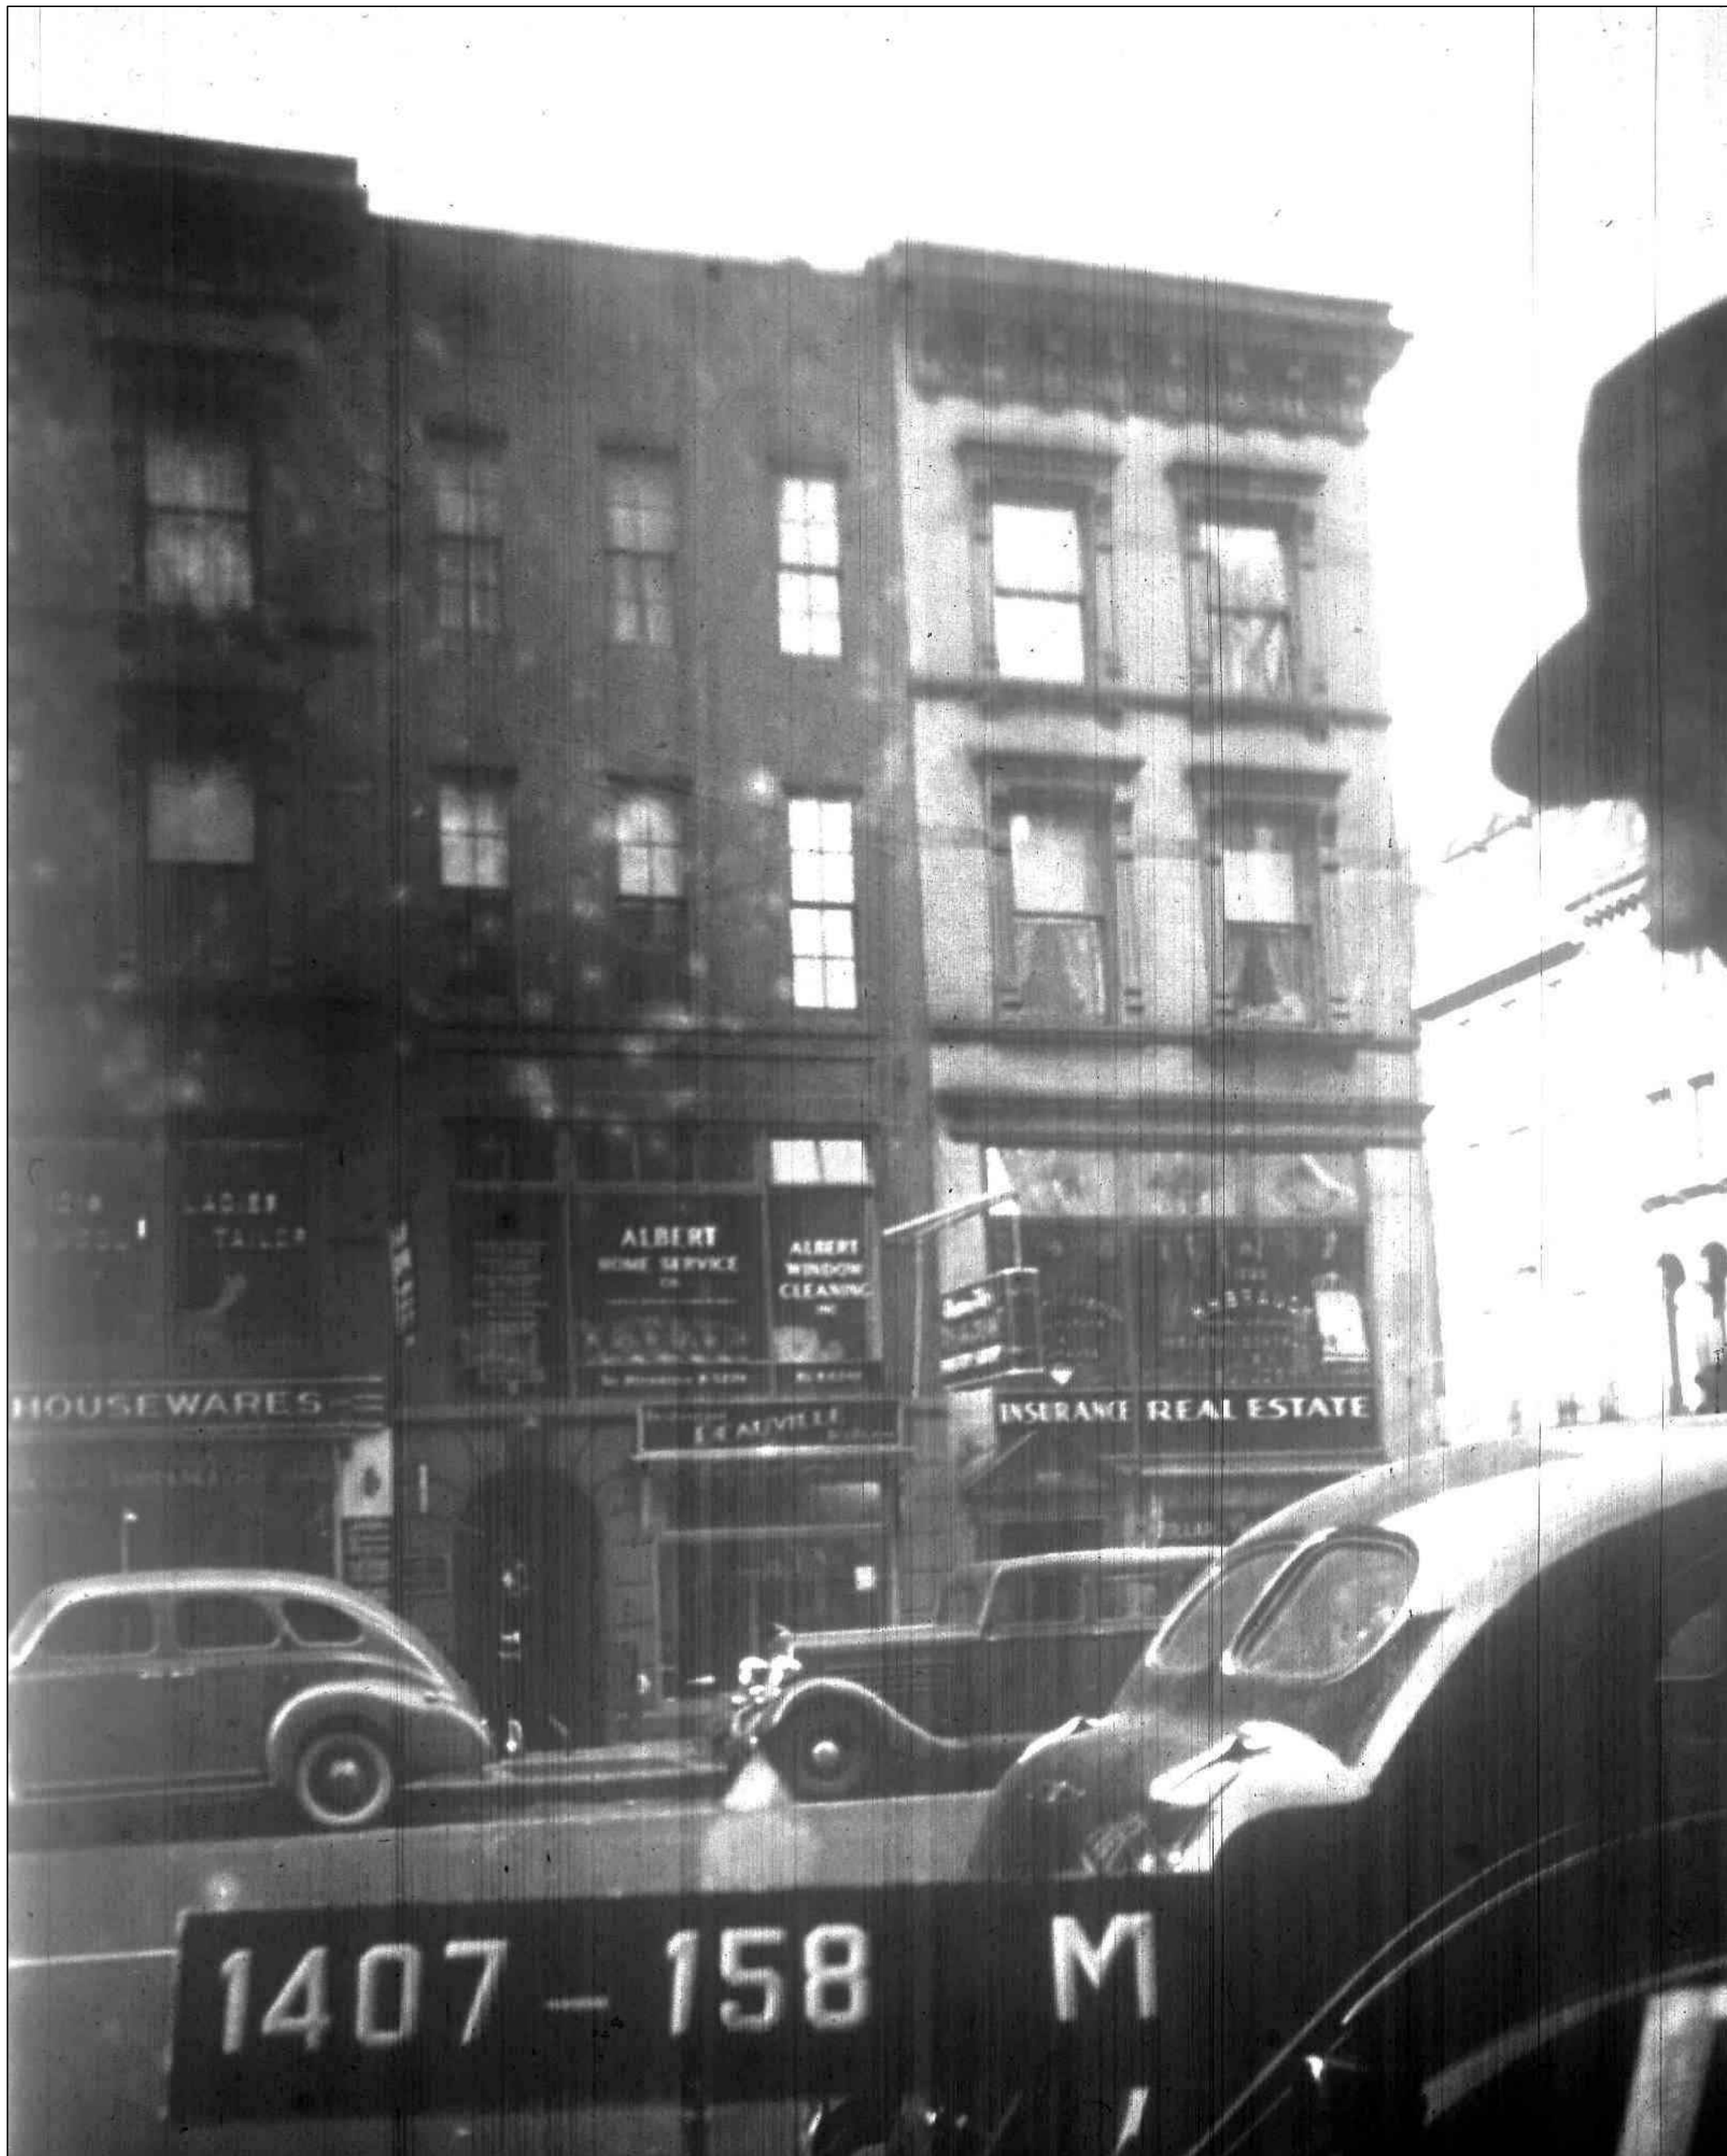
1 1940 TAX PHOTO
SCALE: 1/4"

1022 Lexington Avenue (aka 138-140 East 73rd Street) Three-story and basement neo-Grec style brick row house with two visible primary facades and one partially-visible rear elevation. **Lexington Avenue Facade:** Two bays wide; commercial alterations to basement and parlor floor; historic alterations to parlor floor include the creation of a single large display window opening with a narrow molded blind transom panel above, topped with a projecting molded beltcourse; upper floors feature rectangular window openings with projecting enframements consisting of molded lintels with scrolled brackets, incised pilasters, and bracketed sills; projecting beltcourses run between the windows along the line of the window sills on the upper floors; galvanized iron cornice with a frieze of rosettes alternating with block modillions and incised pendants. **East 73rd Street Facade:** Facade consists of a wider section at left containing four bays of irregularly spaced and sized window openings, a narrower section at right containing three bays of regularly spaced and sized window openings, and a two-story extension at rear of building at far right; commercial alterations to basement floor and a portion of the parlor floor at left; the left-most bay of window openings in left section is separated from those to the right by a slightly projecting chimney; the parlor floor of left section features, from left to right, a single large rectangular display window, the projecting chimney, a smaller display window, a larger display window, and a rectangular window opening with projecting enframing; the three large display window openings on the parlor floor have multi-pane windows with narrow molded transom panels, topped by a projecting molded beltcourse; the second and third stories of the left section contain, from left to right, a single bay of residential window openings with the projecting beltcourses on the main facade returning along the line of the window sills, the projecting chimney, a bay of small bathroom windows; another bay of residential window openings, and another bay of small bathroom window openings, where the residential window openings have projecting enframements similar to those on the upper floors of the Lexington Avenue facade and the bathroom window openings have simple projecting sills; the window openings in the right section are similar to those on the upper floors of Lexington Avenue facade, with the exception of the left opening on the parlor floor, which was previously an entrance and is slightly larger with a similar enframing; the building’s cornice returns along the entire length of the East 73rd Street facade; the two-story extension has commercial alterations to ground floor, while the upper floor features two bays of window openings with enframements similar to those on the primary facade; extension has a corbelled brick cornice with a decorative wrought-iron railing installed above. **West Facade:** Rear facade partially visible from street level; two bays of rectangular window openings; ornamental wrought-iron balconies installed in front of both windows at third story; the building’s cornice returns along entire width of rear facade.

Alterations: Basement along the Lexington Avenue facade features a sunken and recessed entrance vestibule at left with a stucco enframing ornamented with raked detailing, with a storefront at right consisting of a single large opening fitted with a large plate glass window flanked by two smaller single-pane windows; basement is clad with horizontal wood strips; retractable cloth awning installed above basement storefront; parlor floor display window replaced with a multi-pane casement window; basement along East 73rd Street level features two separate storefronts, the left of which returns from the main facade; the left storefront contains four large storefront openings and a smaller service entrance at right, and is clad with horizontal wood strips; retractable cloth awnings are installed above the width of this storefront; the right storefront contains, from left to right, a large display window opening fitted with a single pane of glass, a recessed commercial entrance accessed by a single step and fitted with single-pane glass door, another large display window opening, and a recessed service entrance fitted with a metal door; storefront is clad with cementitious material; four holes for through-wall air-conditioning units have been punched through the facade; upper floor windows on both primary facades replaced; facade painted.

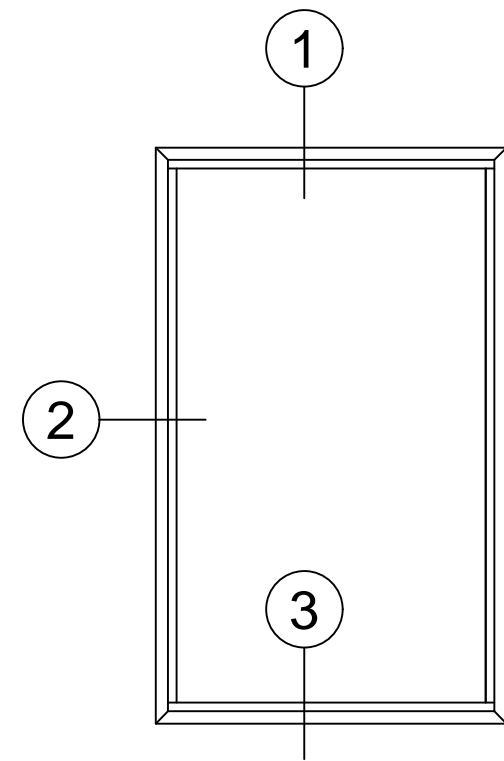
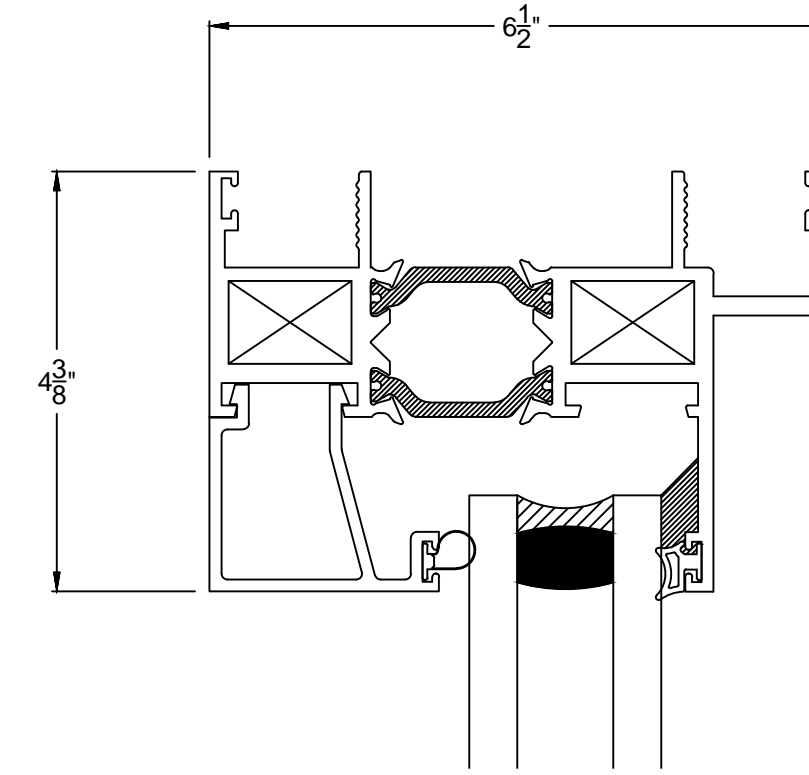
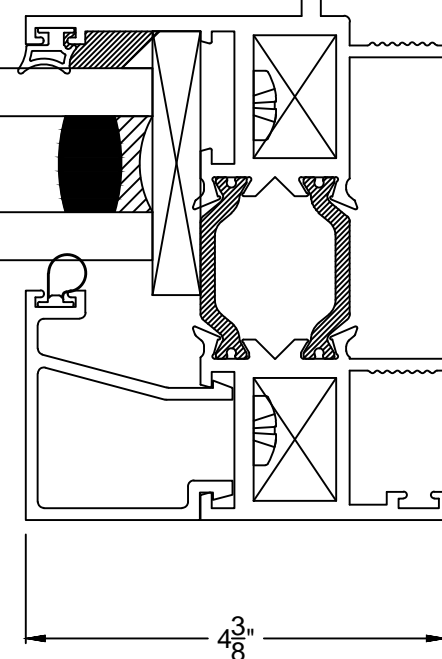
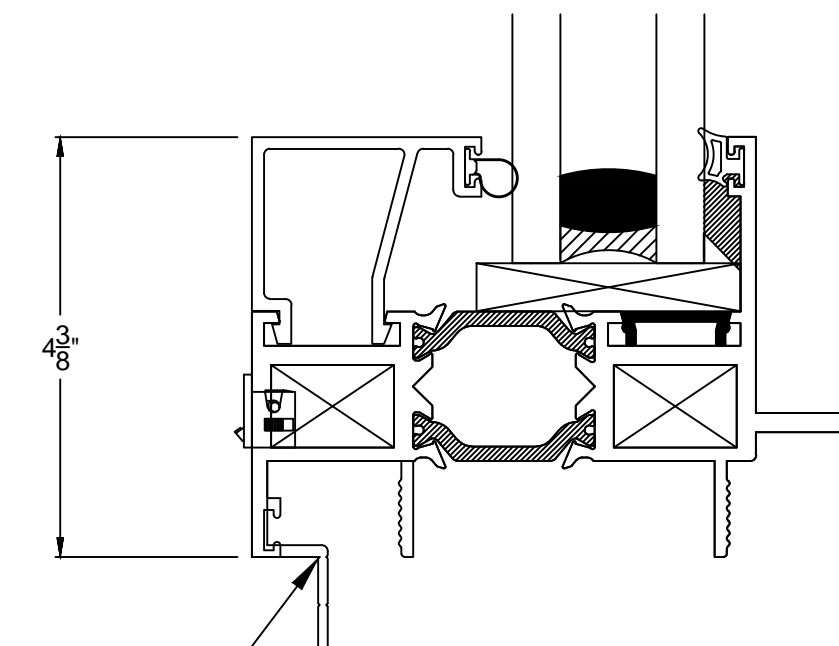
1 TYP.WINDOW SILL/HEAD/JAMB DETAILS
SCALE: NTS

1 FIXED HEAD

2 FIXED JAMB

3 SILL FIXED

NOTES:
GLASS TO BE TEMPERED
COLOR OF ALUMINUM FRAME - BLACK TO MATCH EXISTING

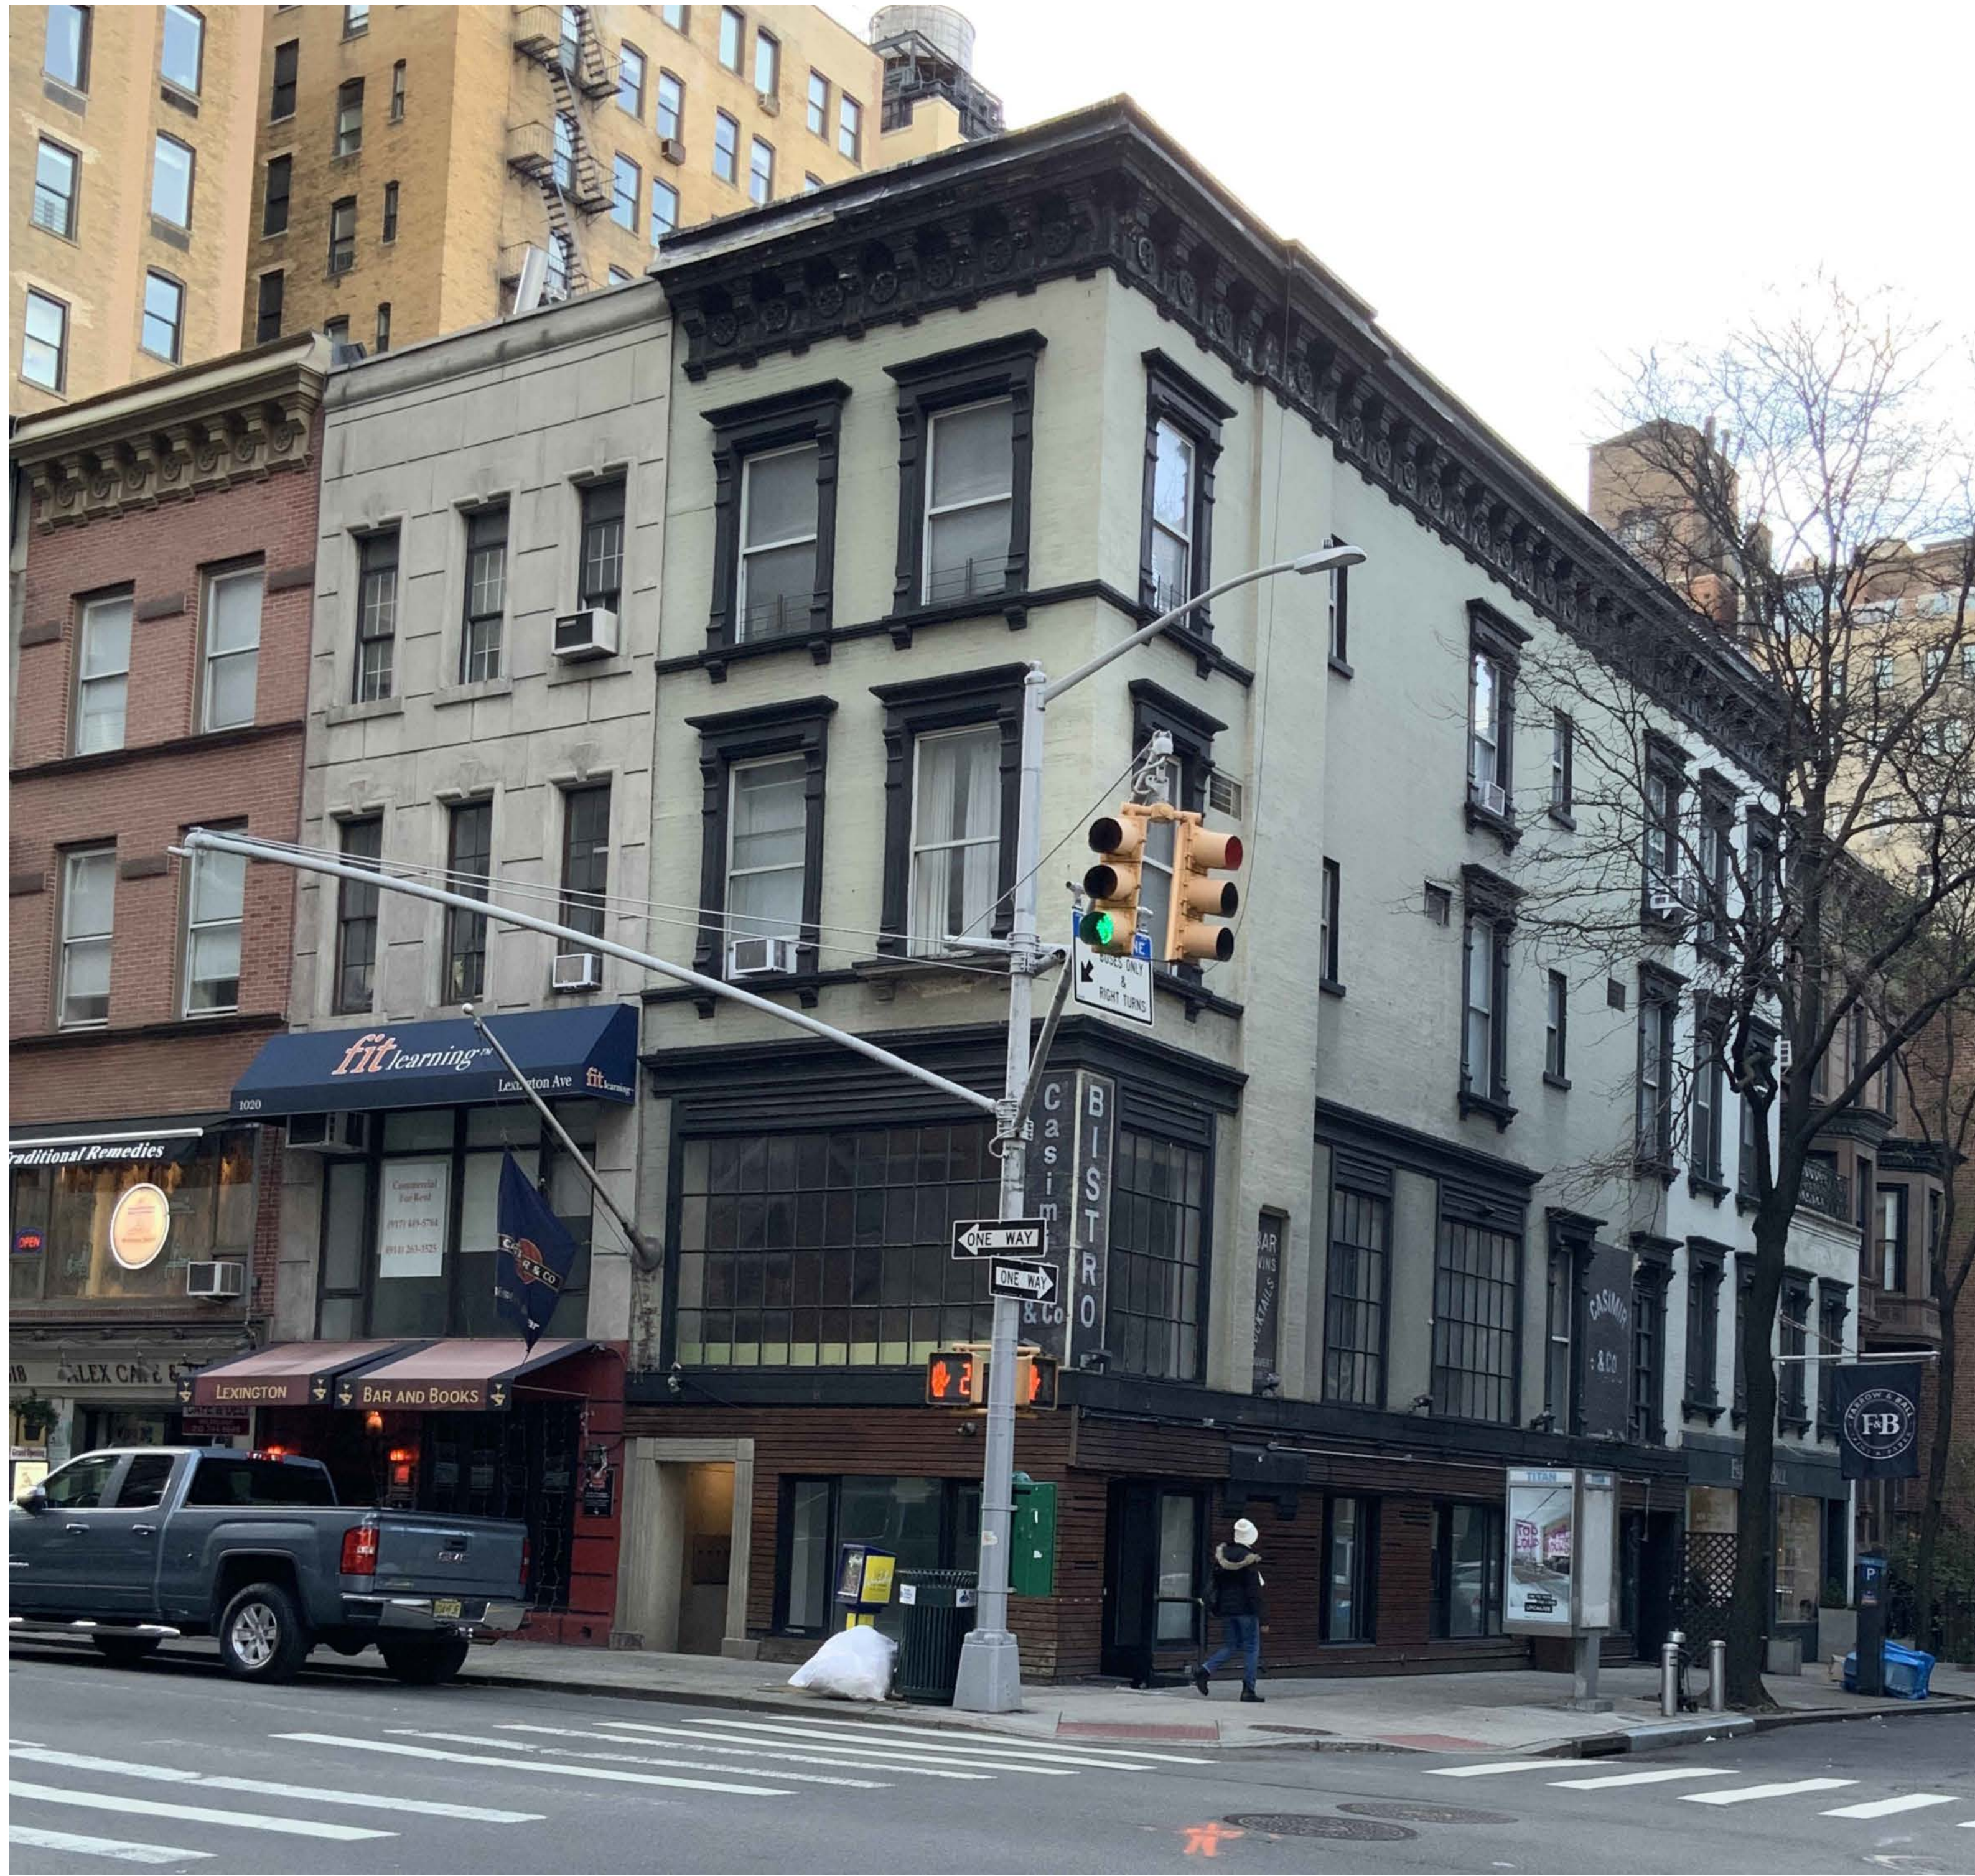
PIC.1. CORNER OF LEXINGTON AVENUE & EAST 73 STREET

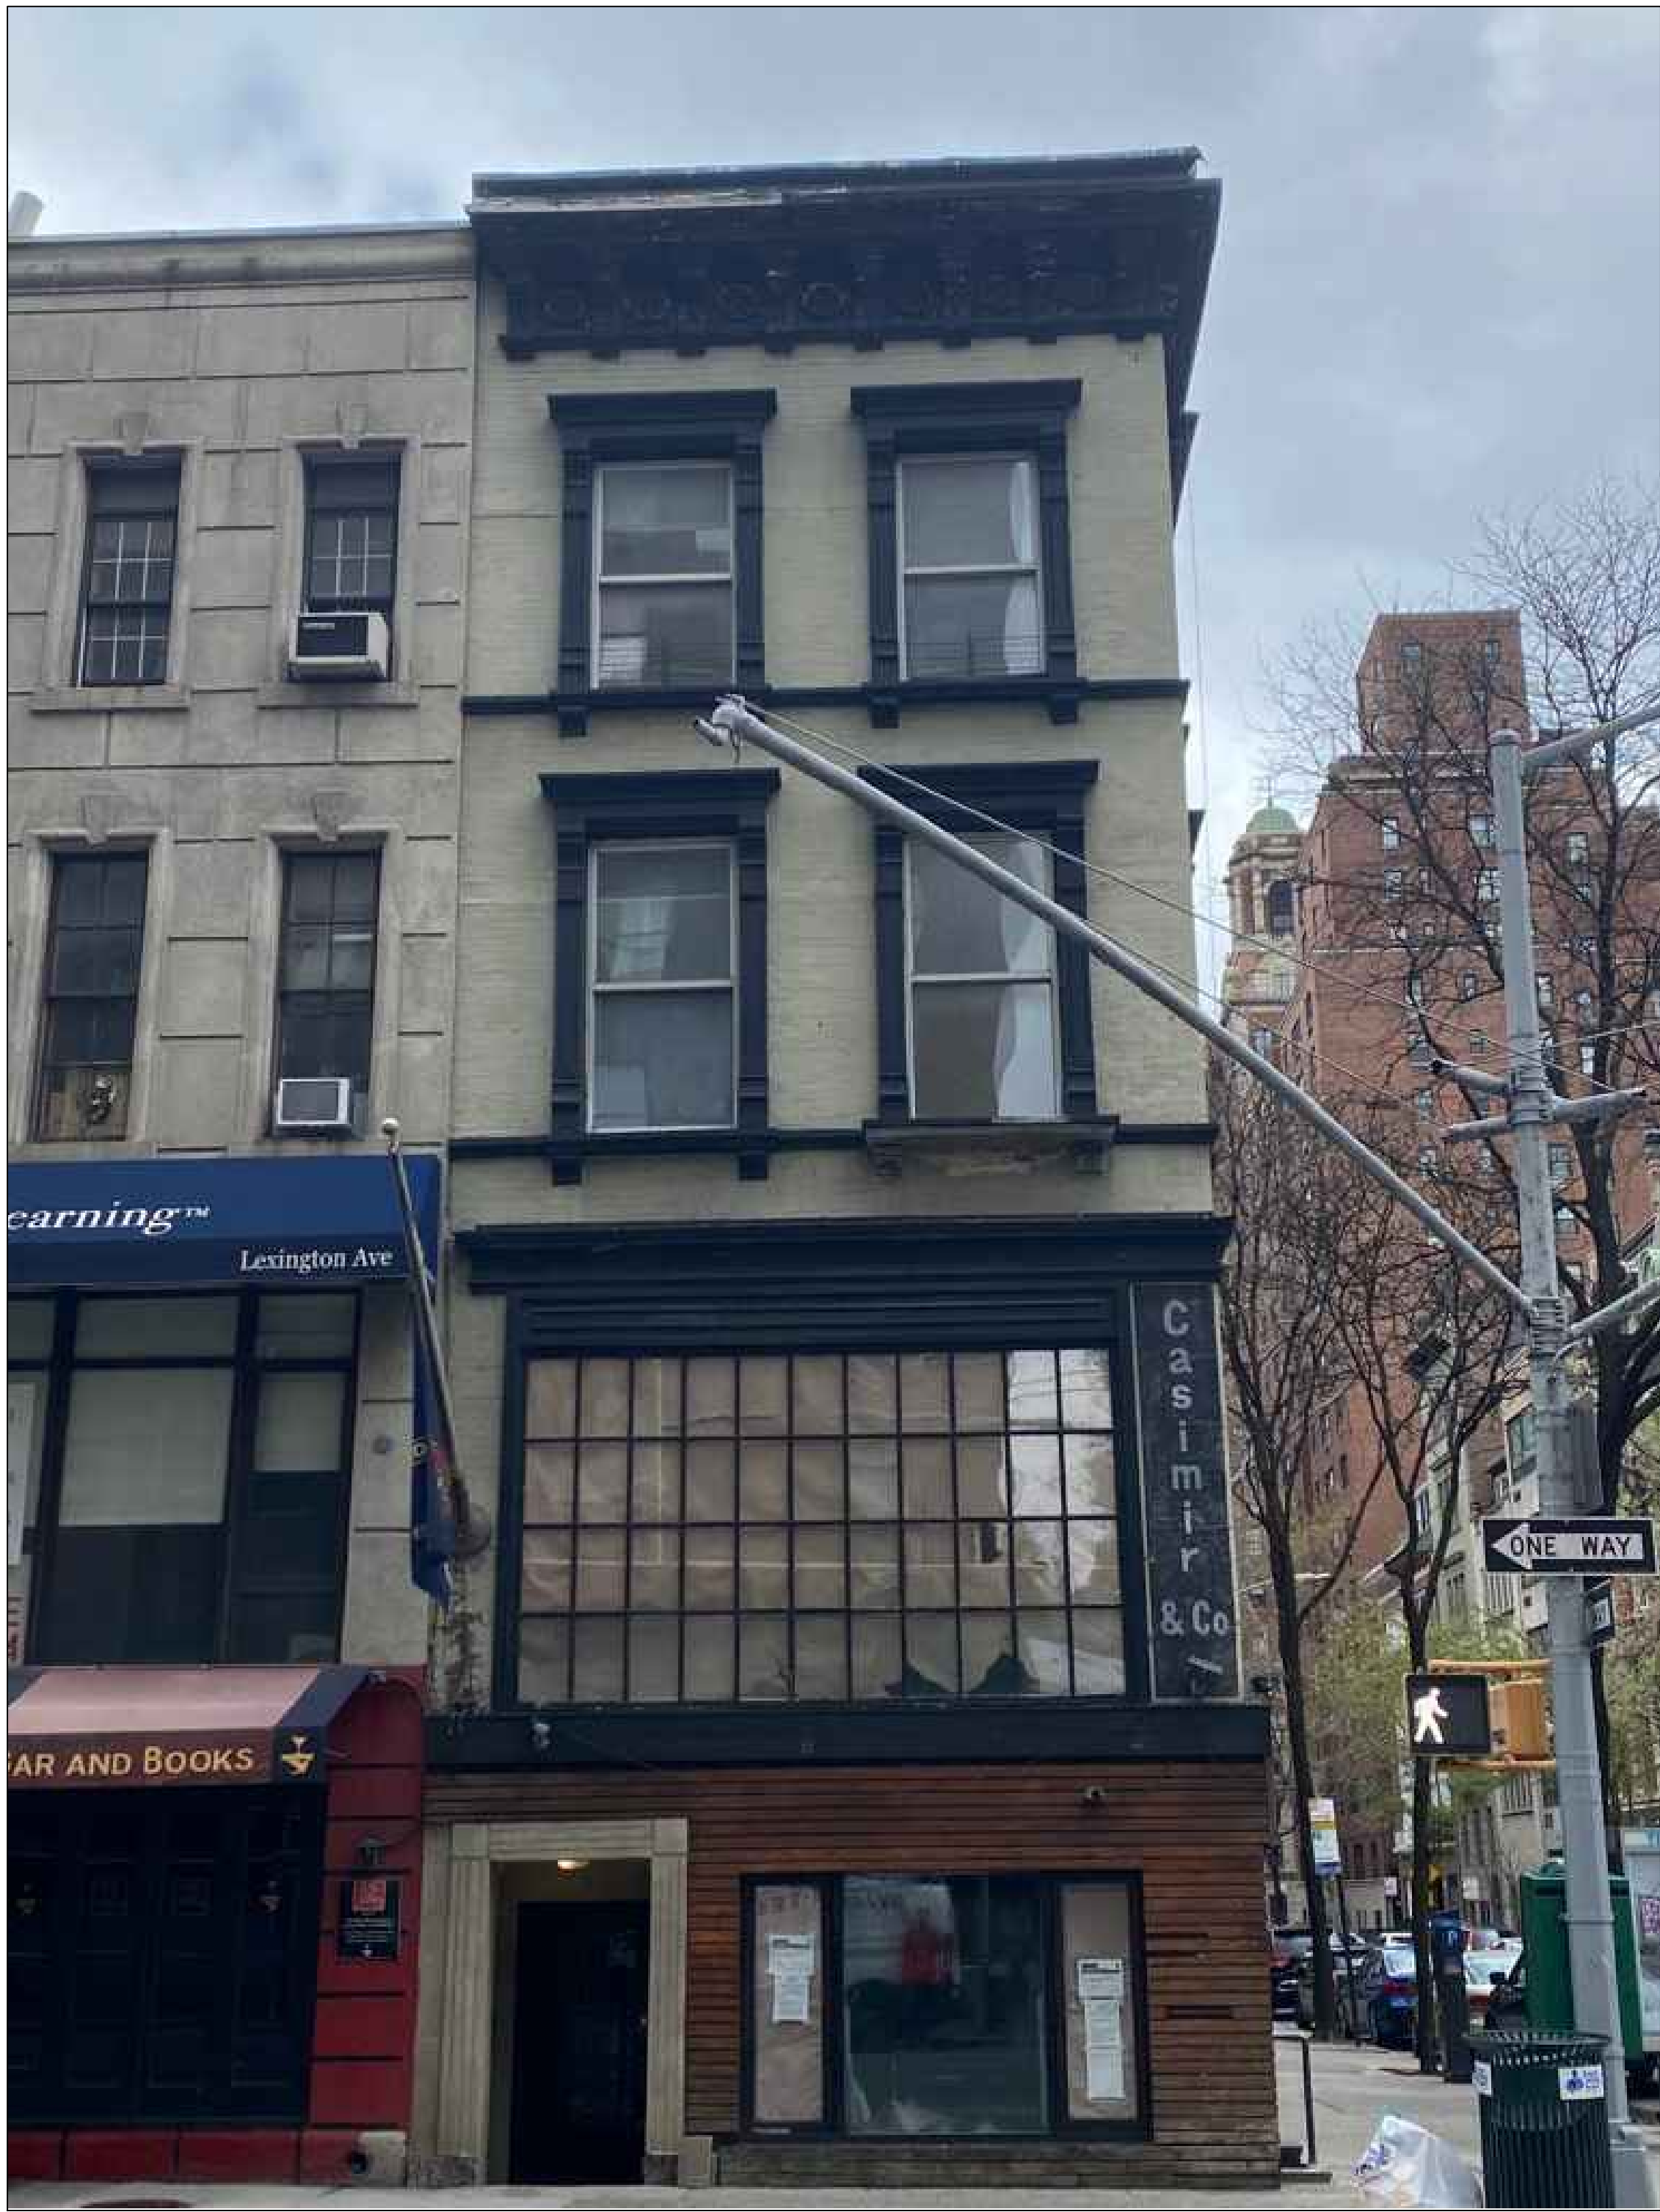
PIC.2. LEXINGTON AVENUE

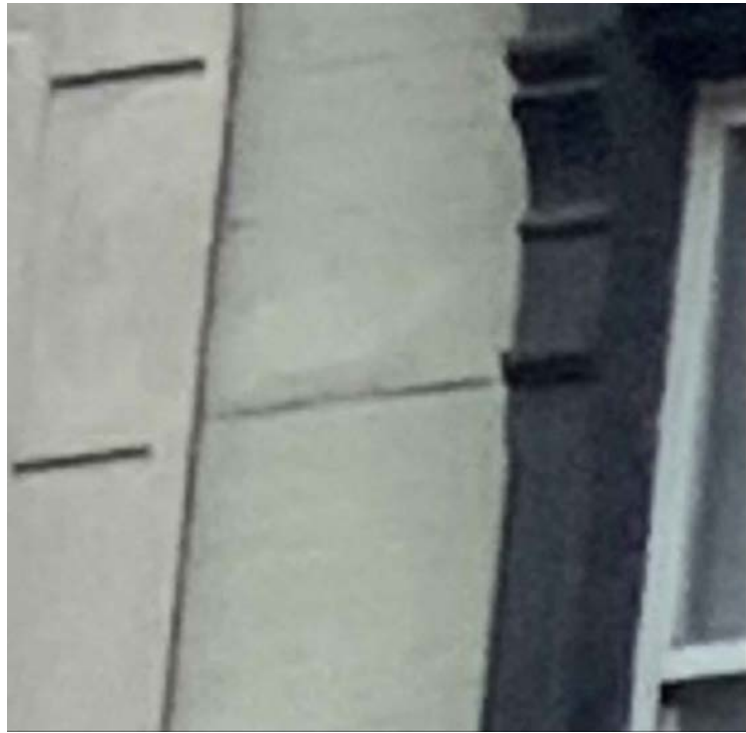
PIC.3

CRACK IN BRICK TO BE CLEANED OUT AND REPAIRED

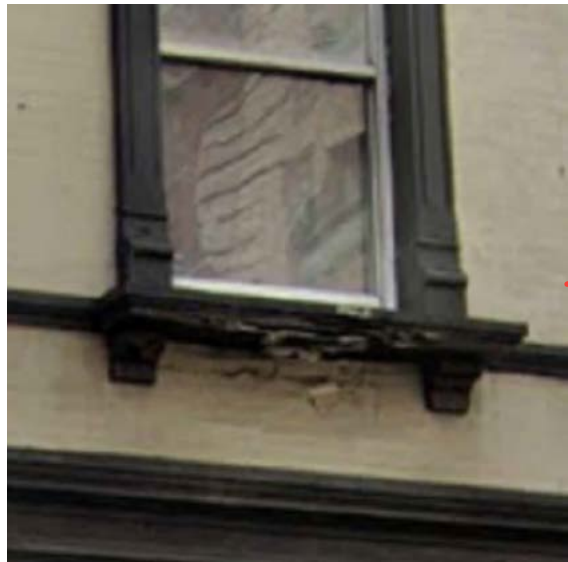
PIC.4

EXIST.WINDOW SILL TO BE REPAIRED AND PAINTED (BLACK MATTE COLOR TO MATCH EXISTING)
CRACKS IN BRICK UNDER WINDOW SILL TO BE CLEANED OUT AND REPAIRED. REPOINT BRICK JOINTS

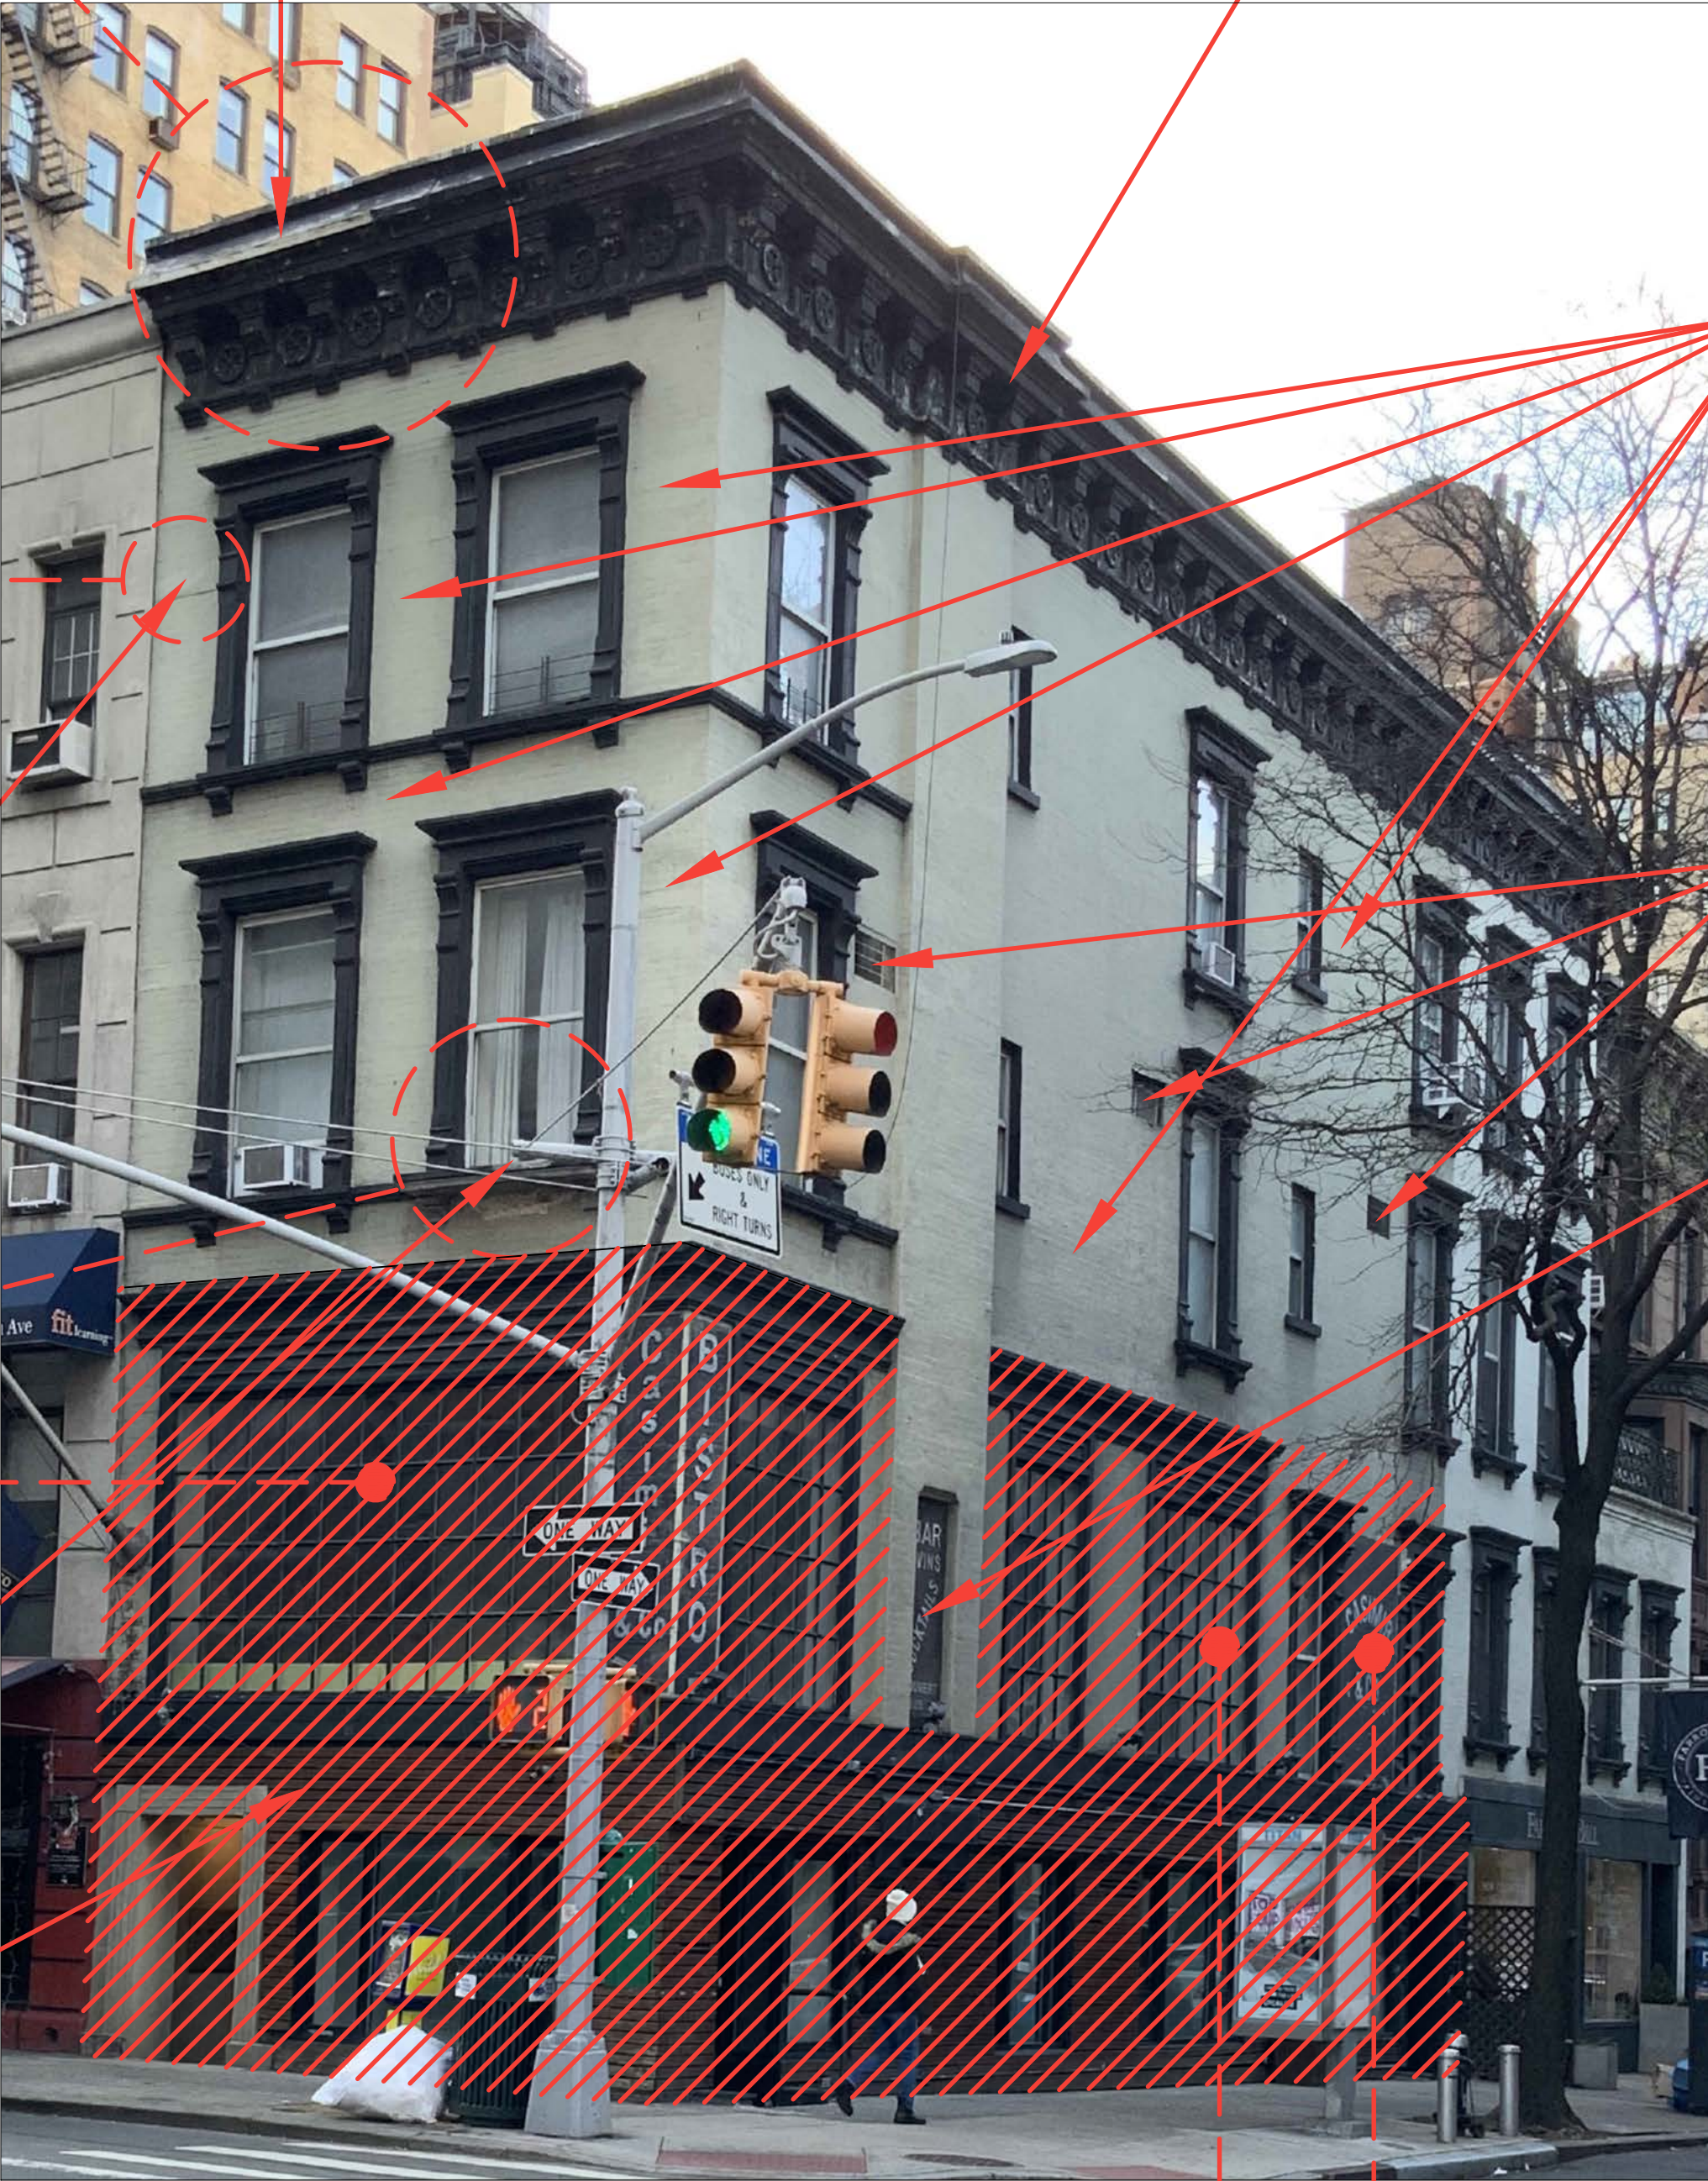
PIC.1. EAST 73 STREET

HATCHED AREA: NEW BRICK, WINDOWS AND DOORS TO BE INSTALLED AS PER PROPOSED ELEVATIONS @ LM-006, LM-007 SHEETS

RE-POINTING OF EXISTING MASONRY JOINTS PER LANDMARKS SPECIFICATIONS TO ENSURE WATER TIGHTNESS

EXIST. A/C UNITS TO BE REMOVED.
INFILL OPENINGS WITH BRICK TO MATCH EXISTING

EXIST. BLACK PAINT AND LETTERING TO BE REMOVED. PREPARE BRICK TO RECEIVE NEW PAINT

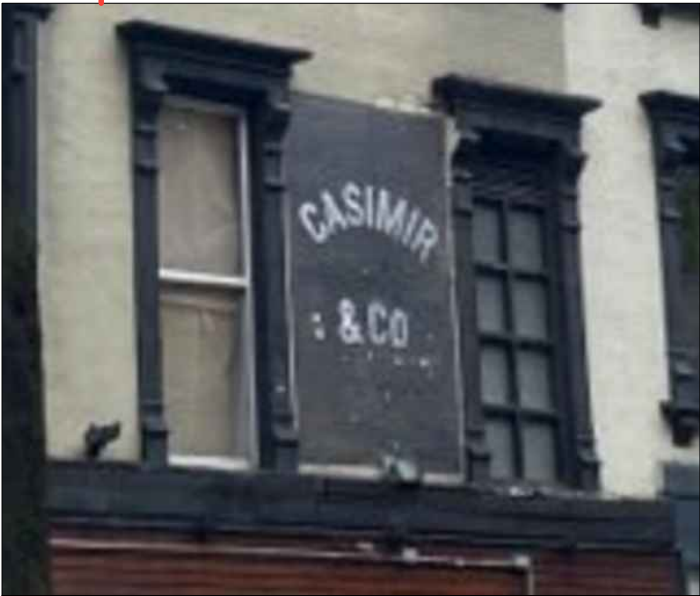
PIC.7

EXIST. CORNICE TO BE REPAIRED AND REPAINTED (BLACK MATTE COLOR TO MATCH EXISTING)

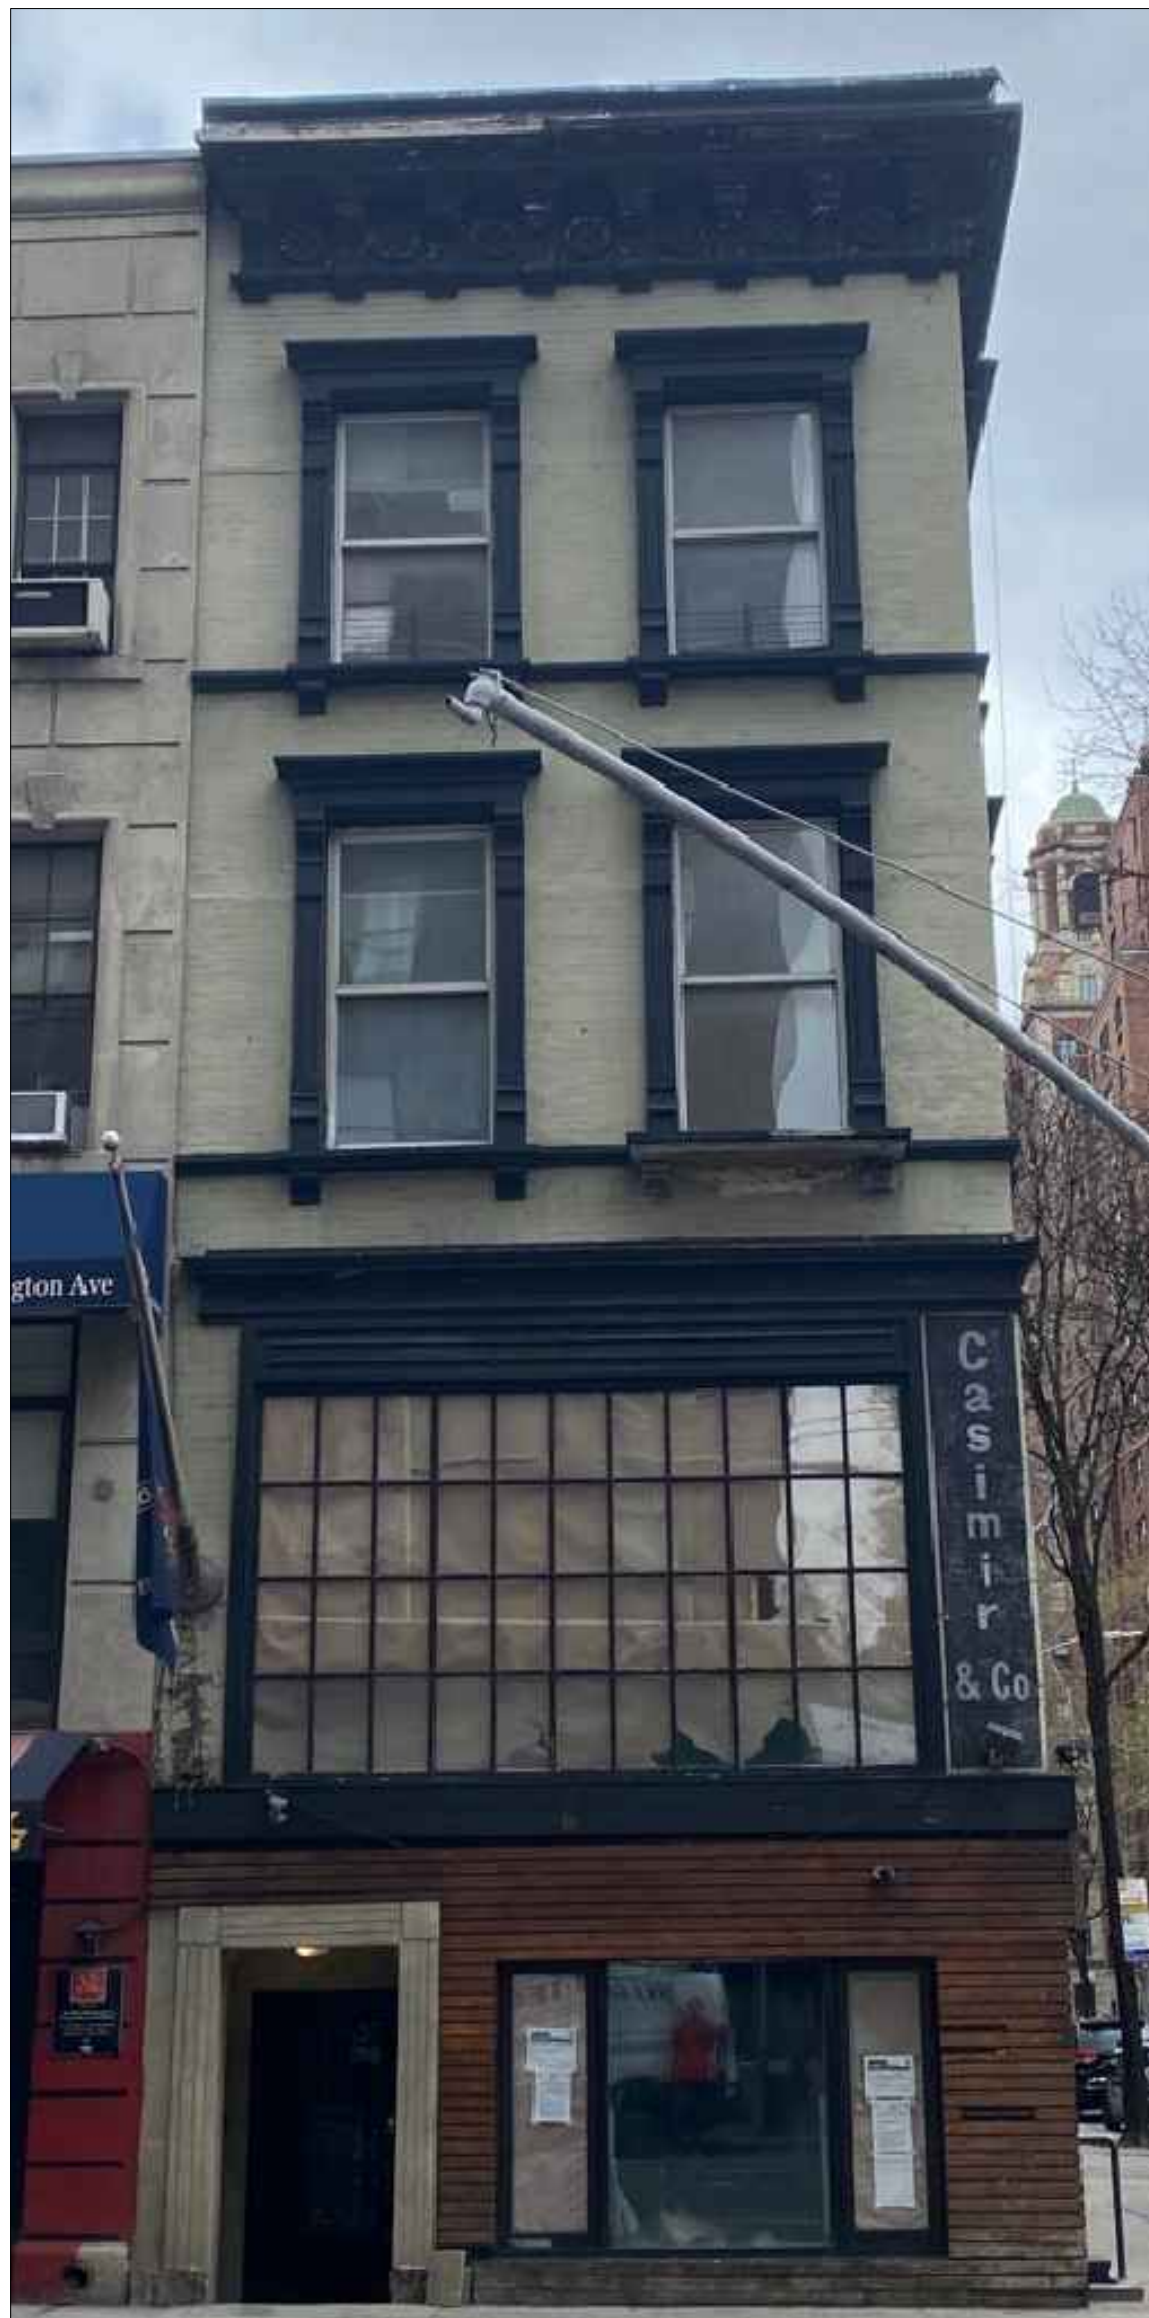
PIC.1. EXIST.FACADE
(LEXINGTON AVENUE)
