1022 LEXINGTON AVENUE
Landmarks Preservation Commission - Docket # 20-09550

9-7-20	ISSUED TO CB8	OK
Date:	Rev. No.	Remarks:
PLOT PLAN SANBORN MAP TAX & BLOCK MAP		
LEX 73 HOLDINGS LLC		
1022 LEXINGTON AVENUE NEW YORK, NY 10021		
BODNAR ARCHITECTURE P.C. 675 Madison Avenue Suite 3R, New York NY 10065 P. 212 921 4466 - F. 212 730 1246		
Scale: NTS	Drawn by: OK	Checked by: TB
Drawing No. LPC-001.00	Date: 9/3/2020	Page No. 1 OF 15

CELLAR, BASEMENT & 1ST FLOOR REMOVAL PLANS

WINDOW AND DOOR DETAILS

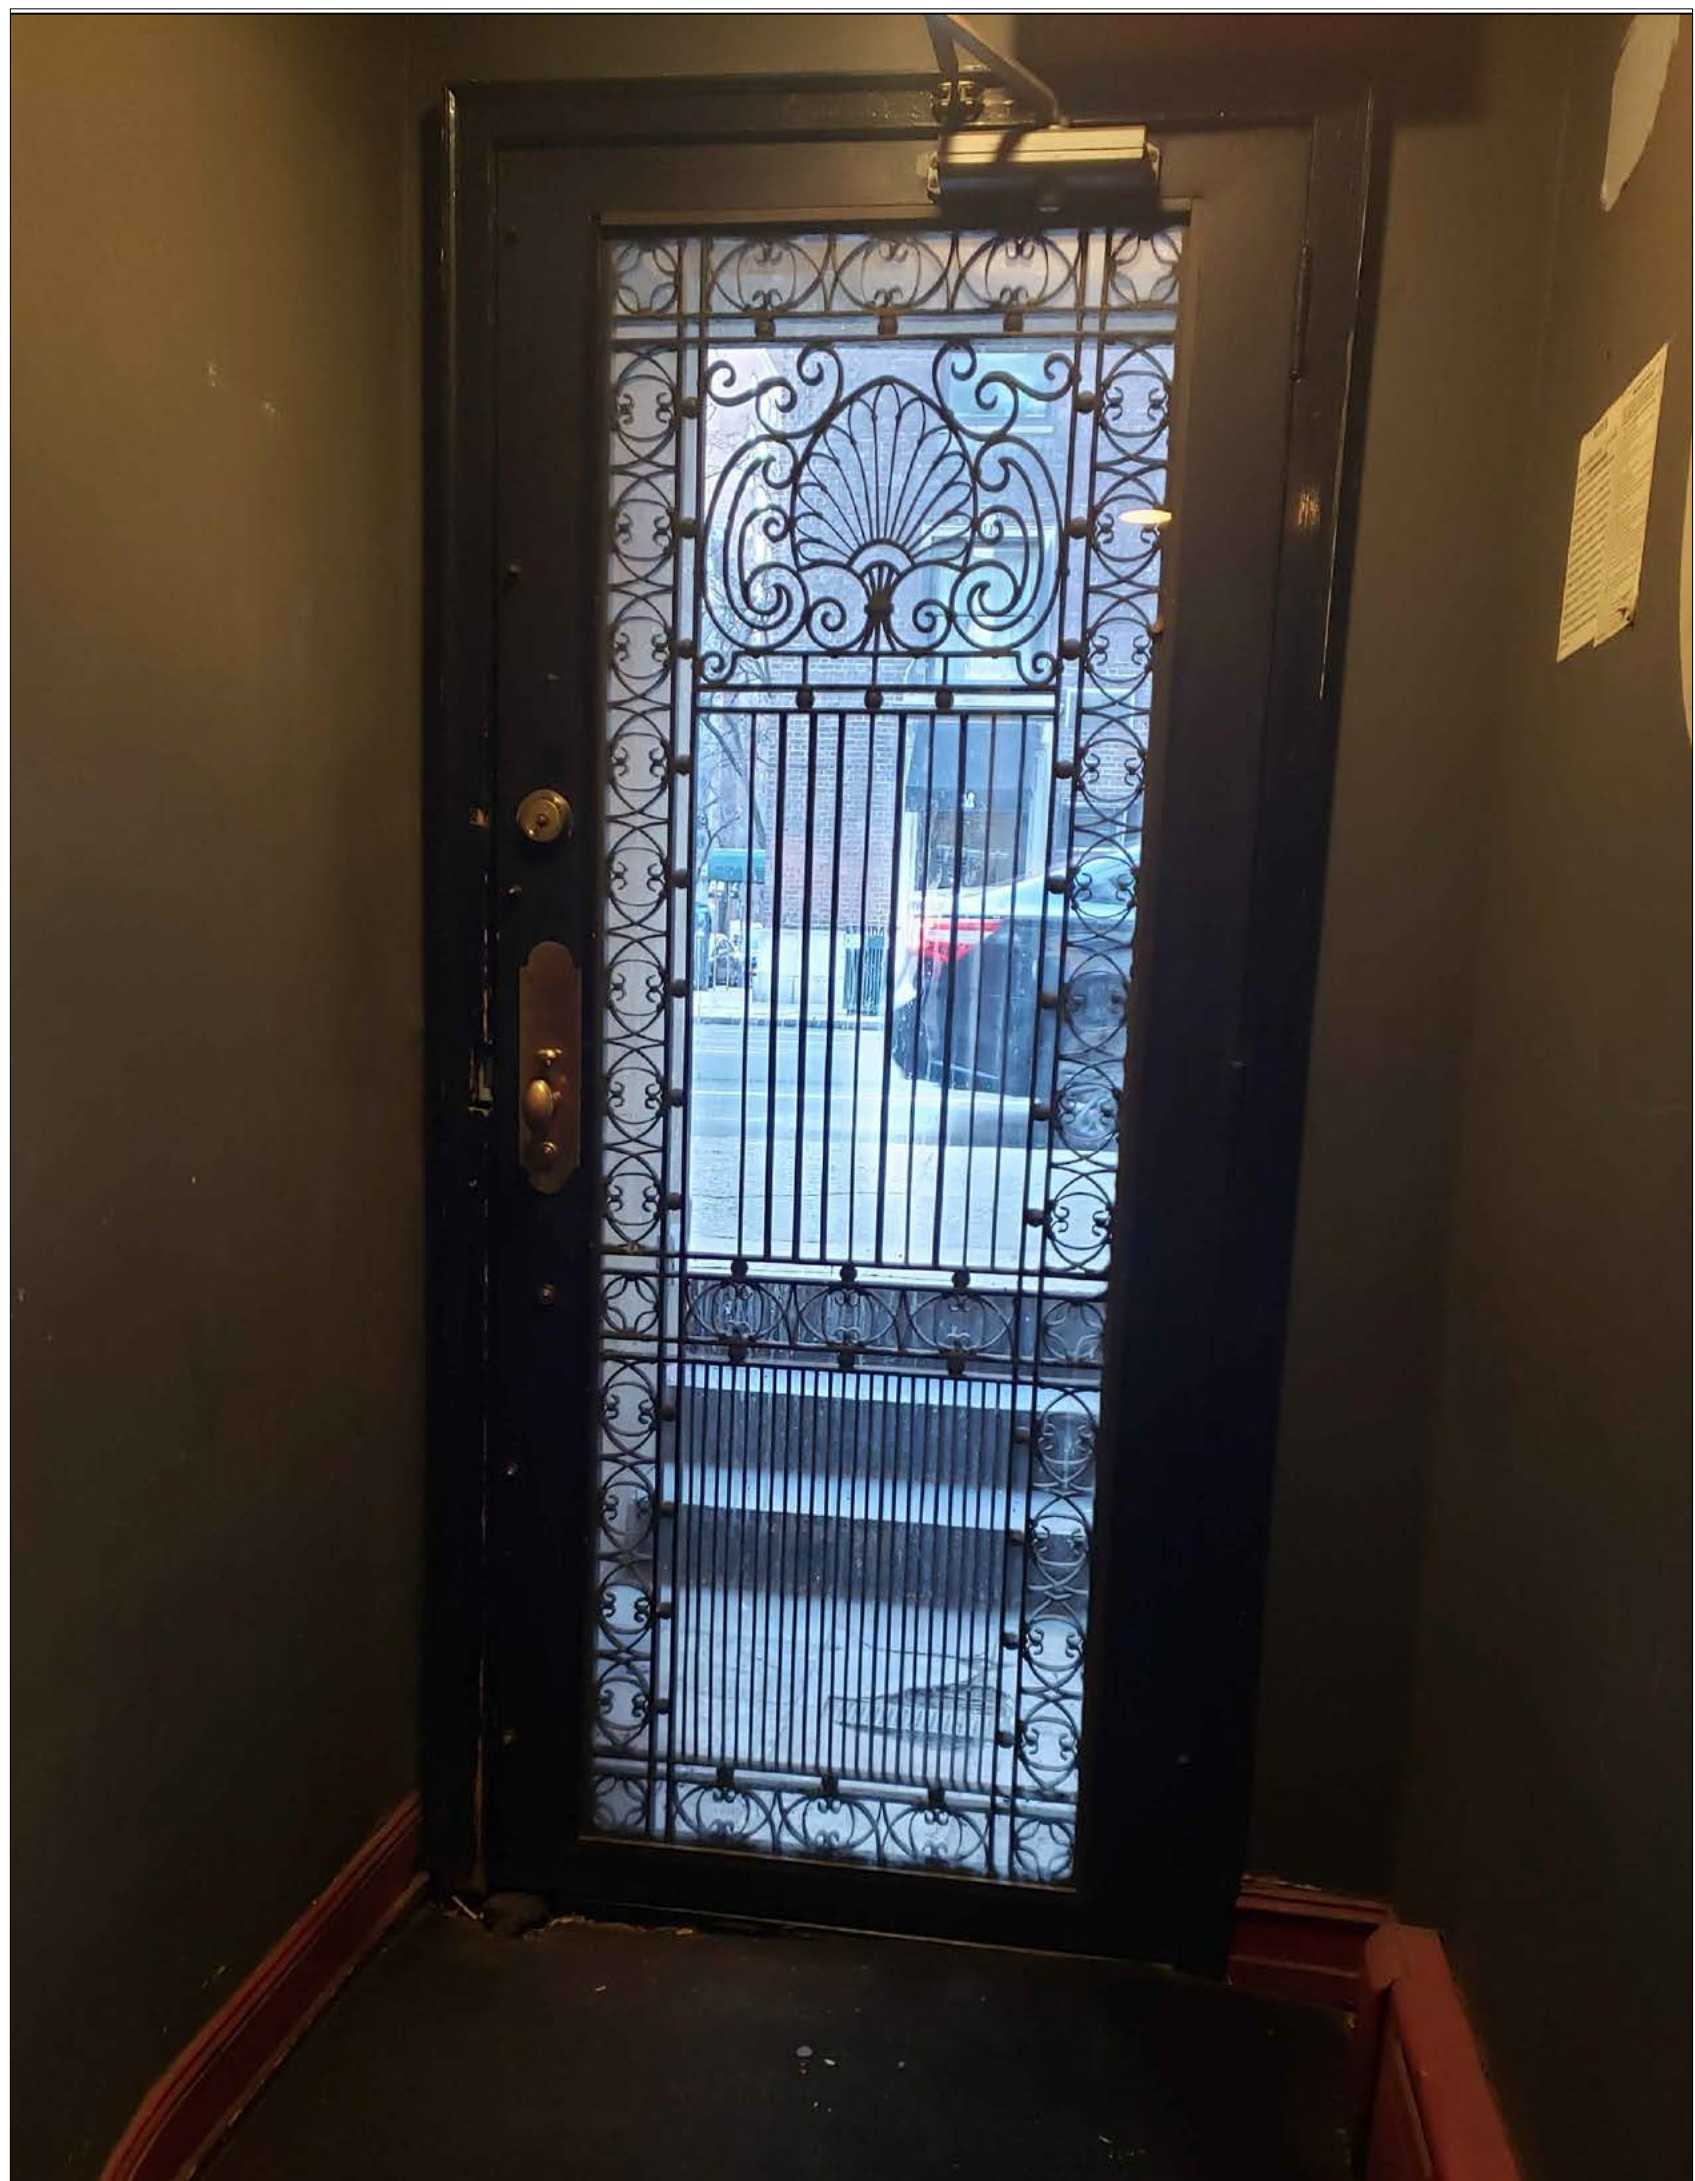
PIC.3. CLOSE-UP PICTURE OF EXIST. DOOR
FROM INSIDE (LEXINGTON AVENUE)

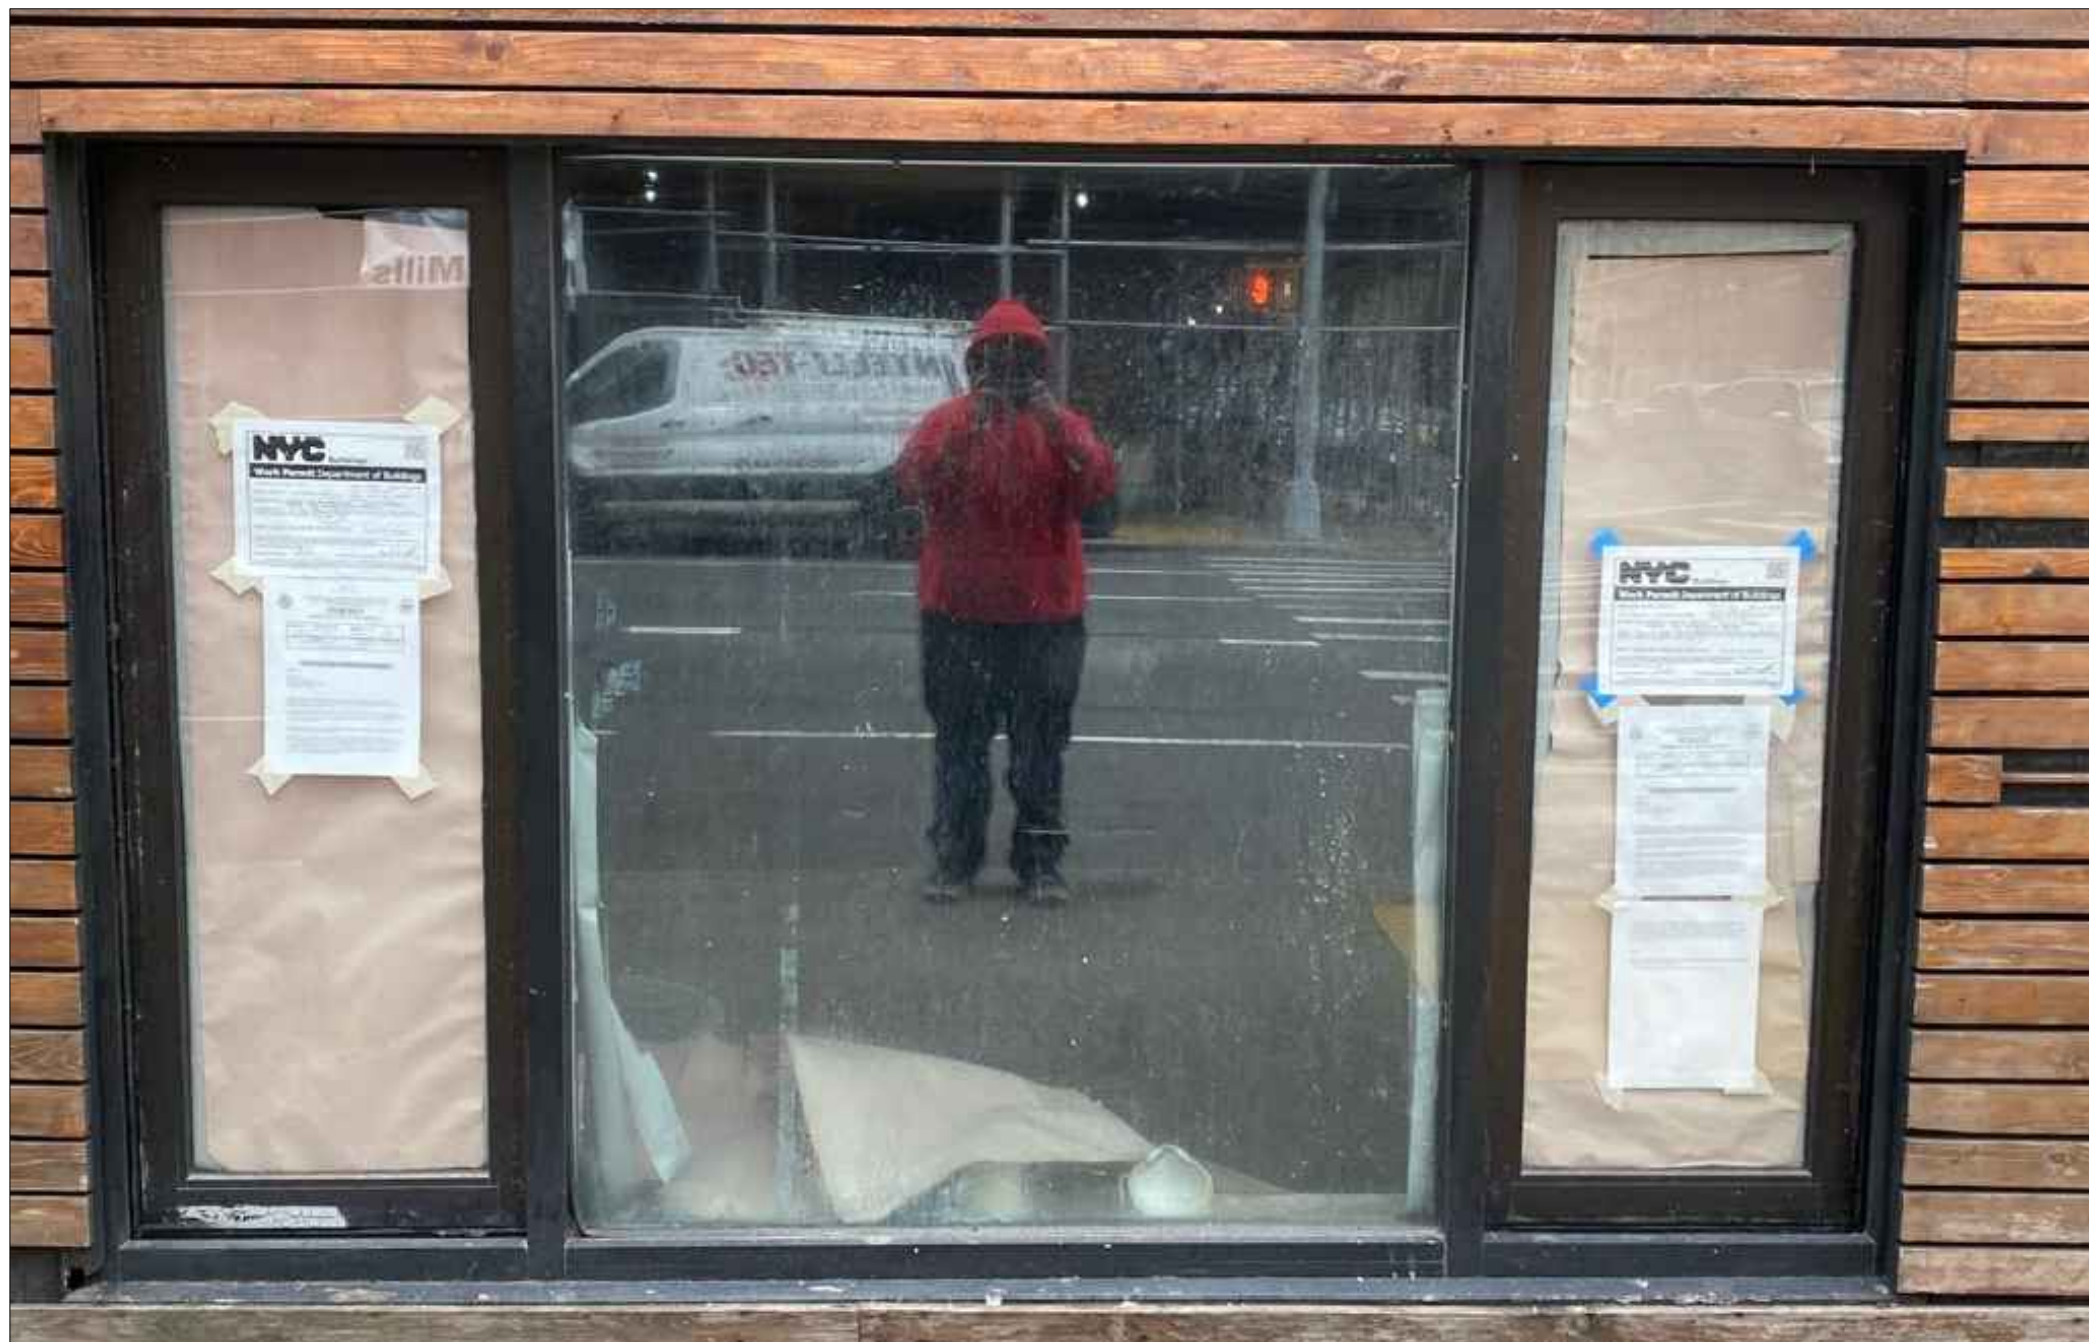
PIC.4. CLOSE-UP PICTURE OF EXIST. GROUND FLOOR
WINDOWS (LEXINGTON AVENUE)

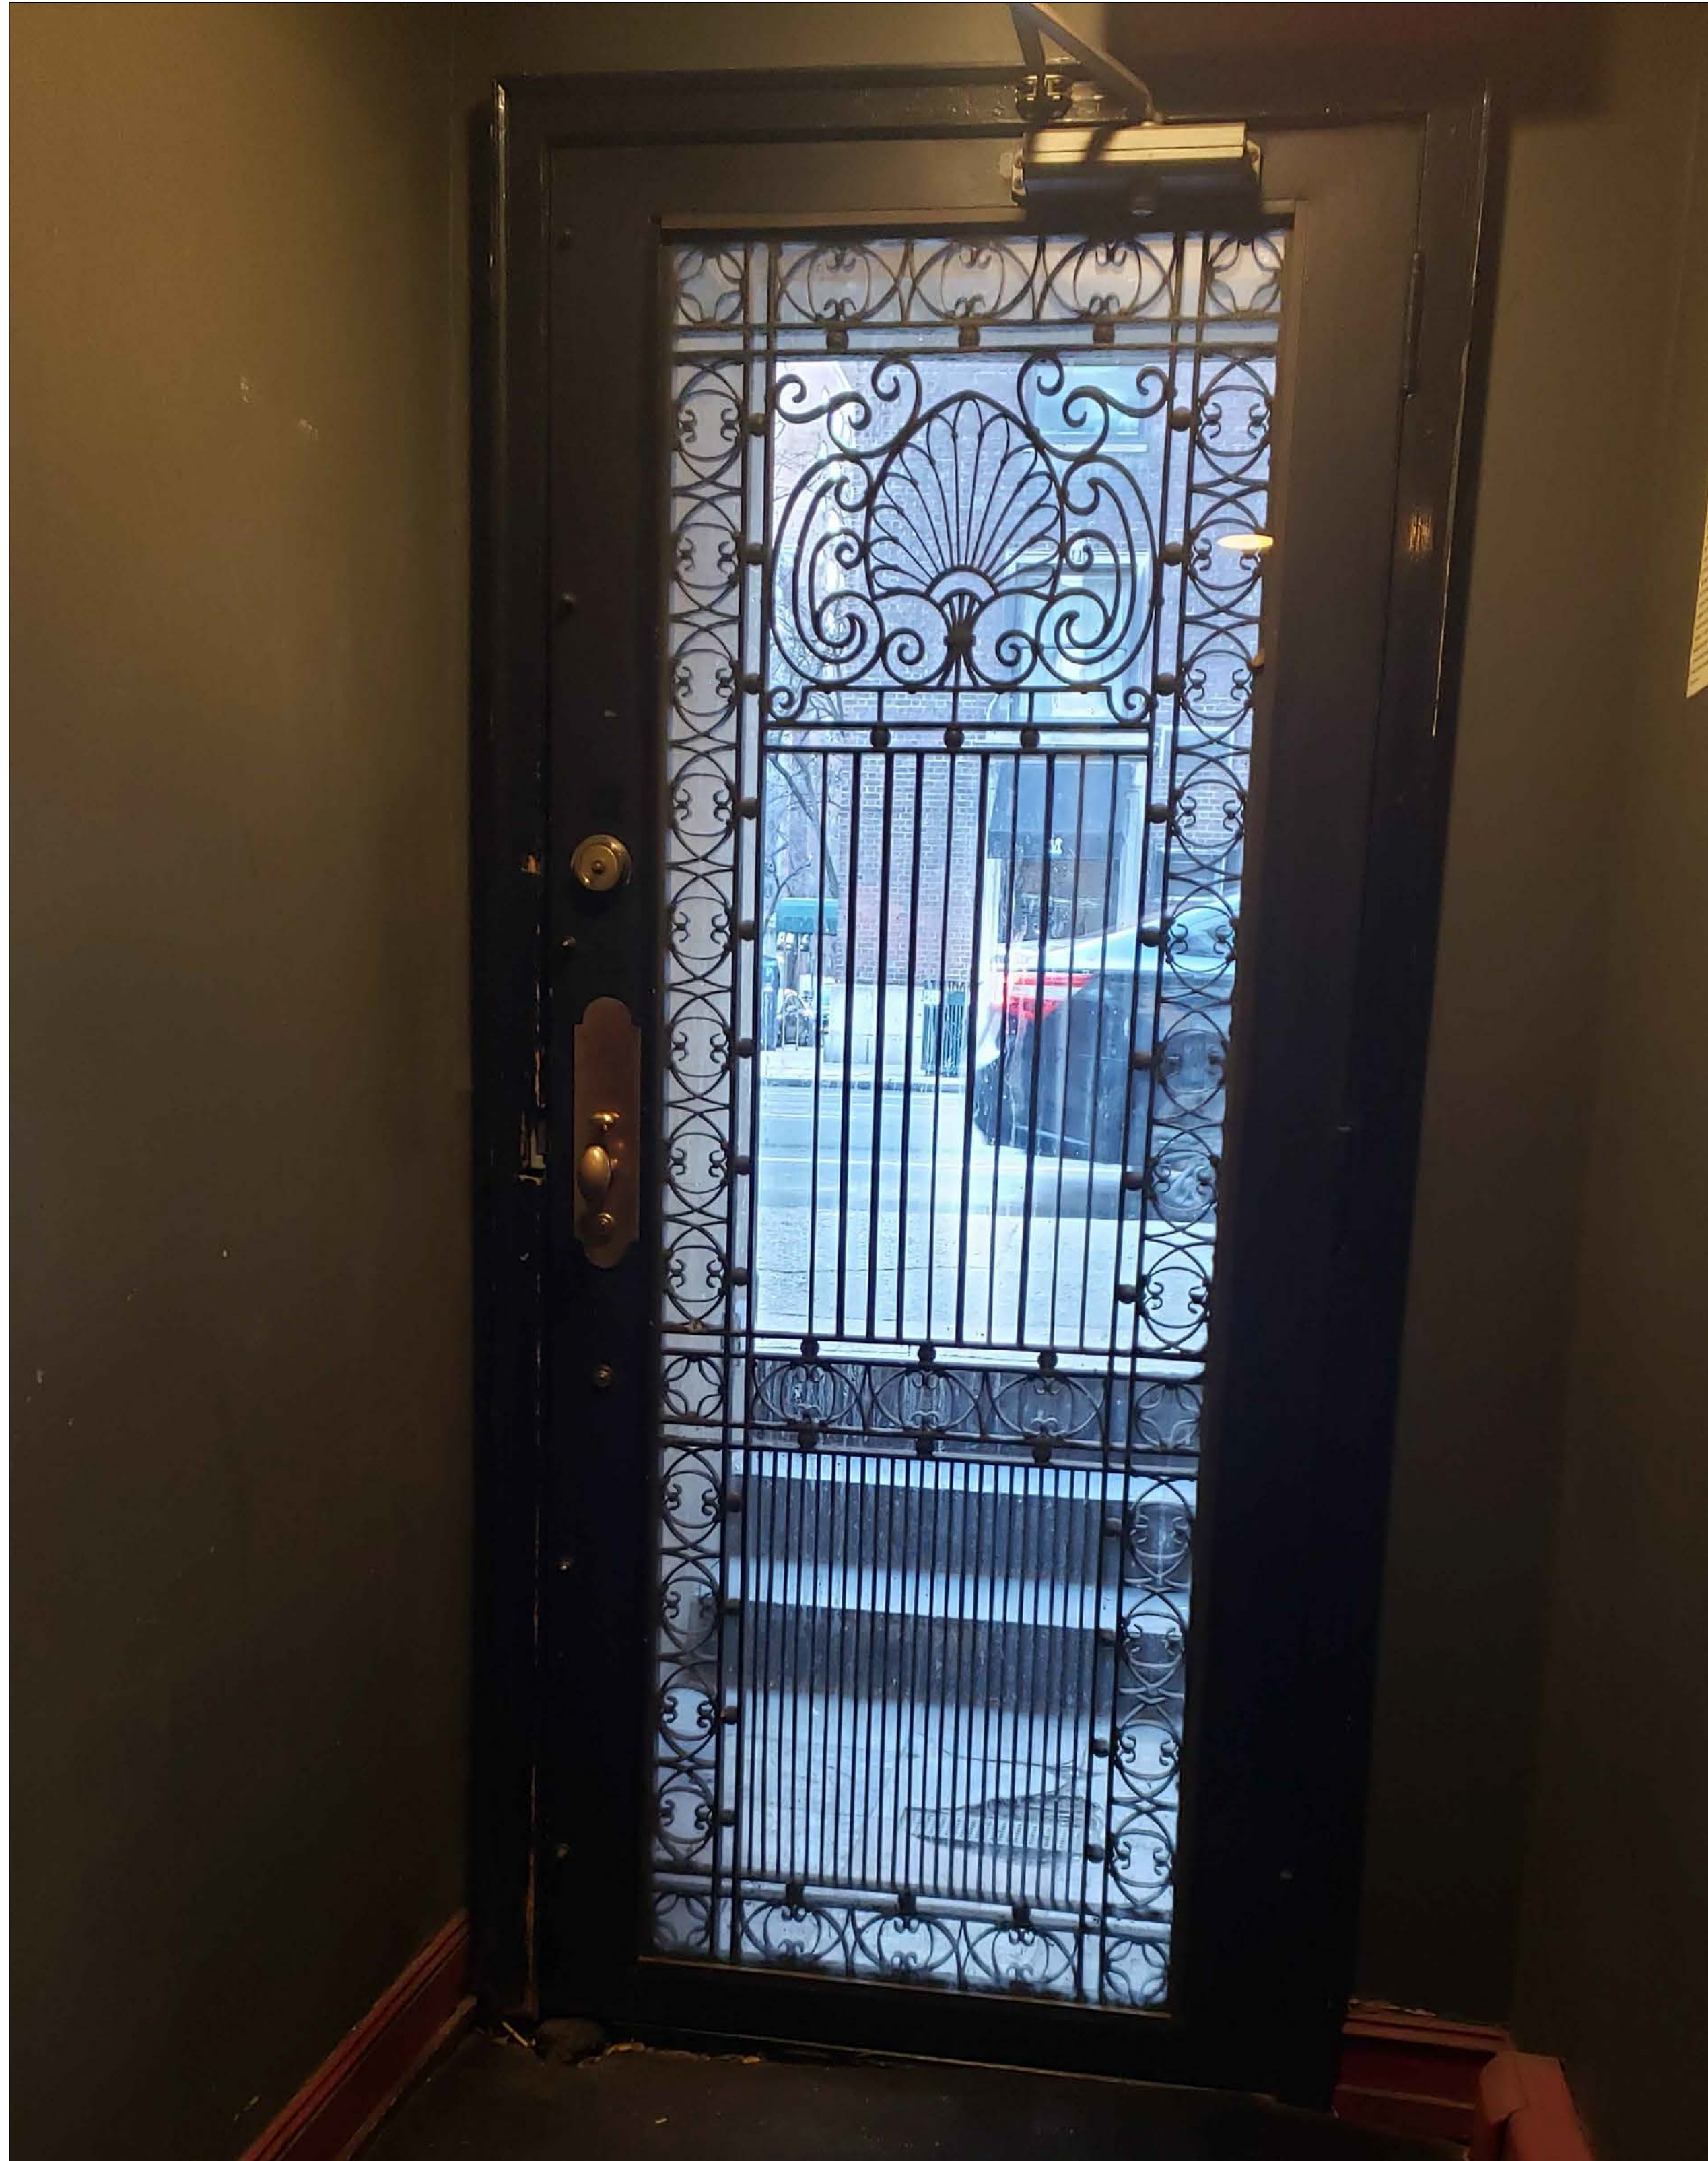
PIC.1. CLOSE-UP PICTURE OF EXIST. DOOR
FROM INSIDE (LEXINGTON AVENUE)

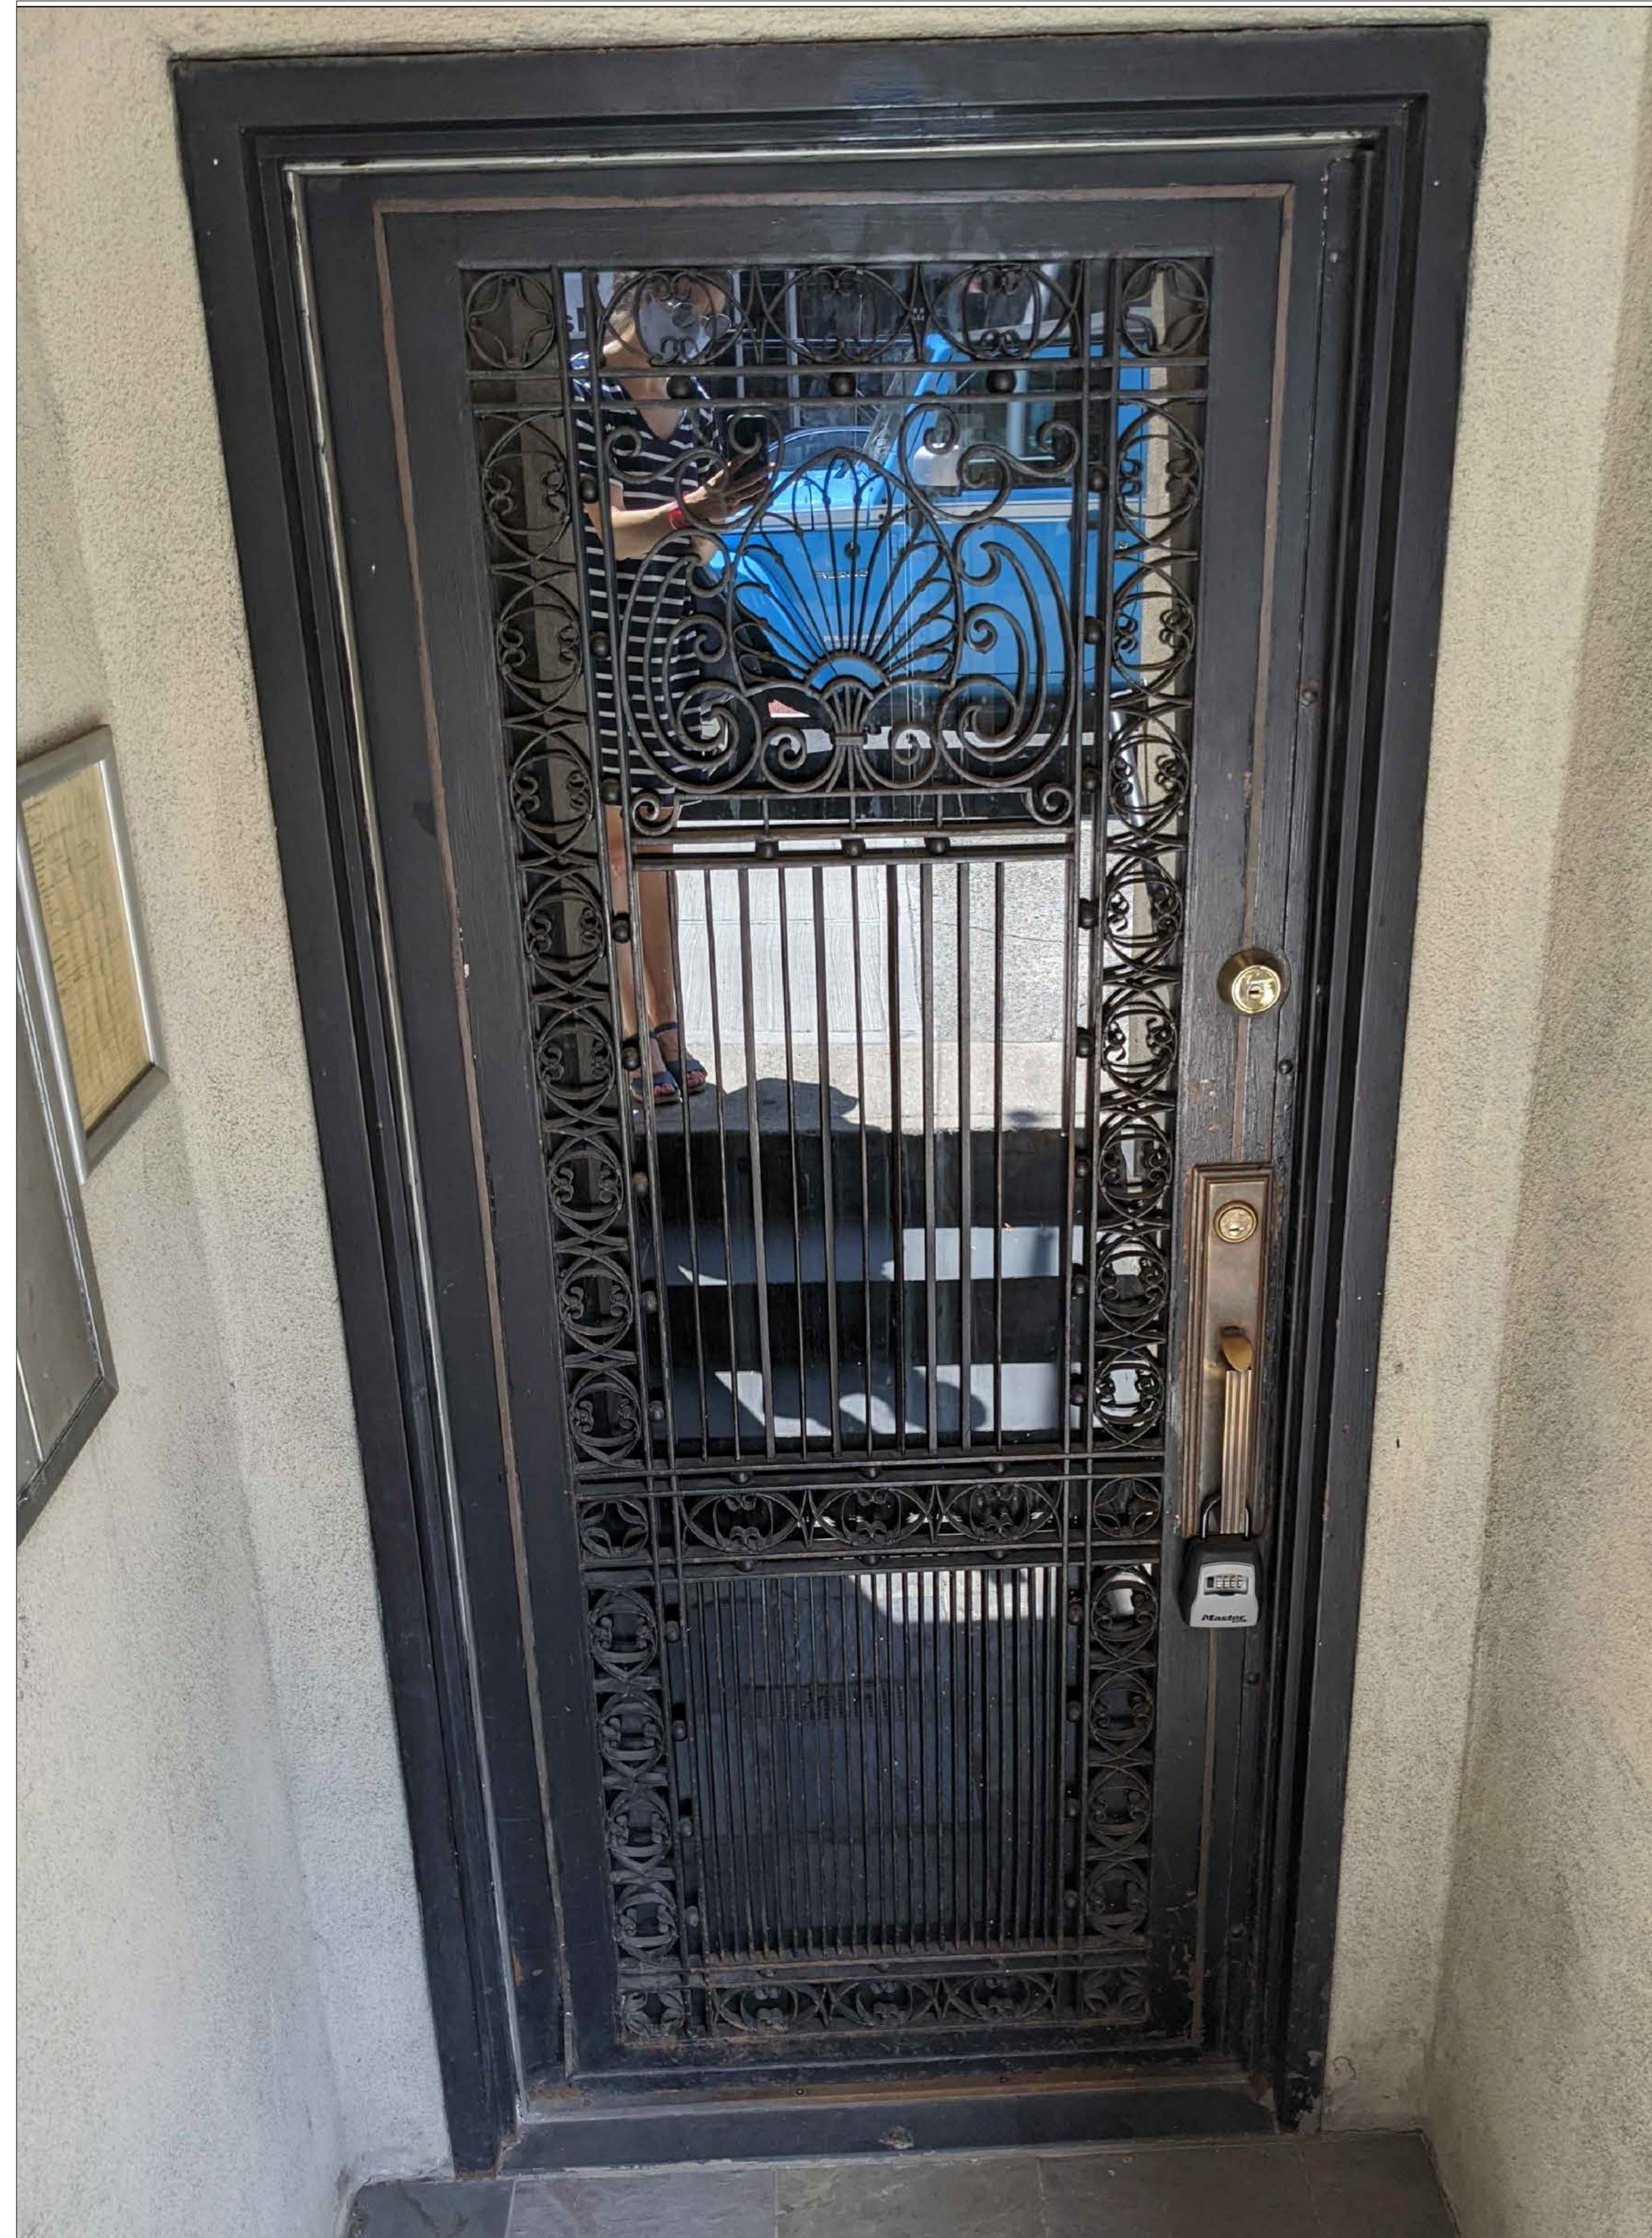
PIC.2. CLOSE-UP PICTURE OF EXIST. DOOR
FROM OUTSIDE (LEXINGTON AVENUE)
