WINDOW REPLACEMENT
RESIDENCE OF THE SWISS CONSUL GENERAL
640 PARK AVENUE - 12TH FLOOR
NEW YORK, NY 10065

WINDOW REPLACEMENT
640 PARK AVENUE 12th FLOOR
NYC

LPC PRESENTATION

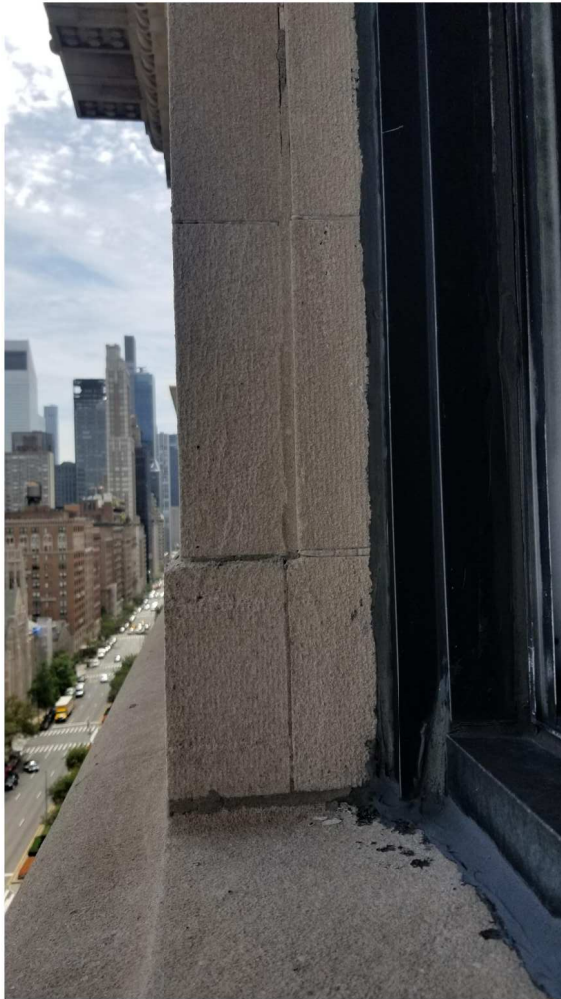
VIEW LOOKING SOUTH AT DEEP FENESTRATION OF EXISTING ALUMINUM REPLACEMENT WINDOWS

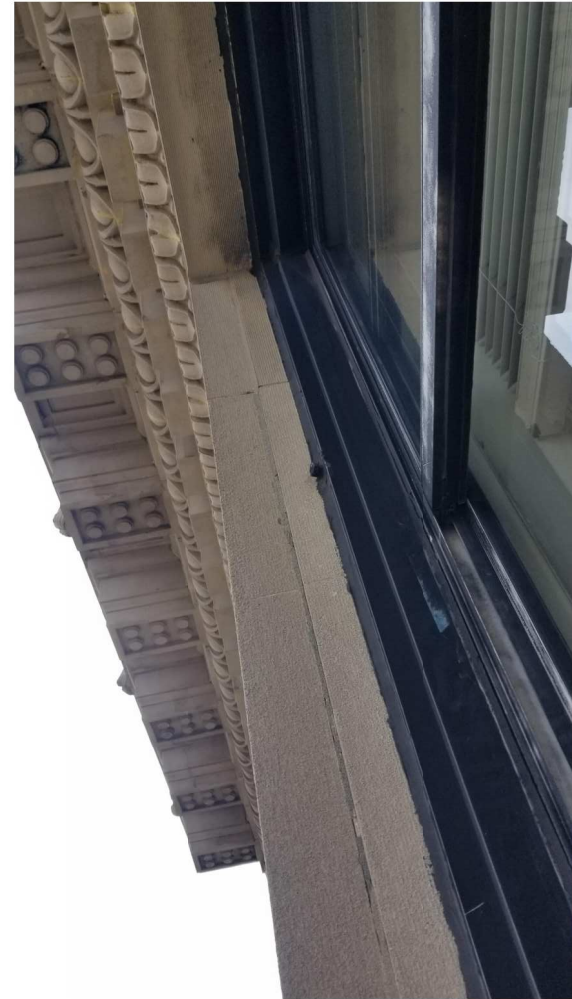
VIEW UP TOWARDS STRIKE & HEAD OF EXISTING ALUMINUM REPLACEMENT WINDOWS

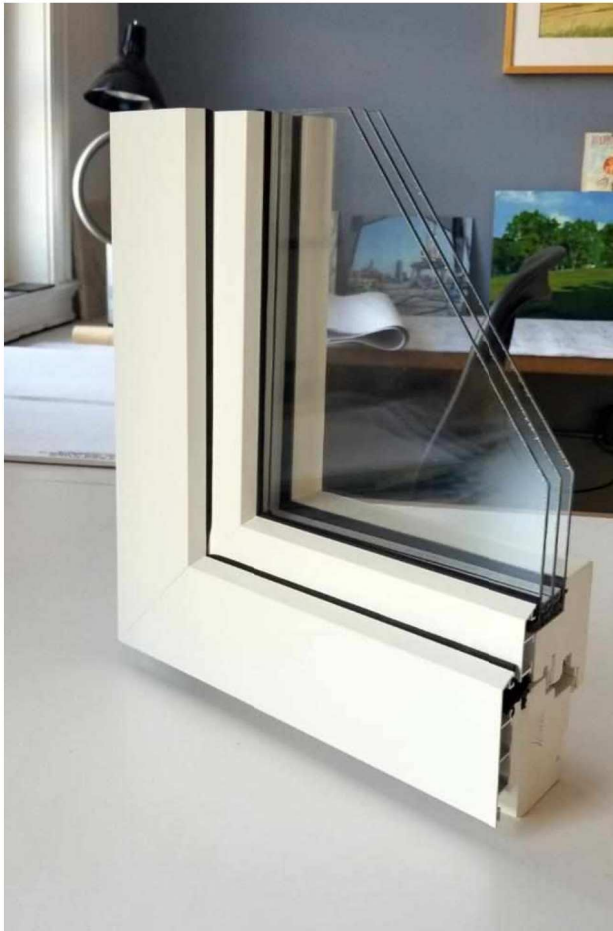
PROPOSED:
PHOTO OF SAMPLE WINDOW

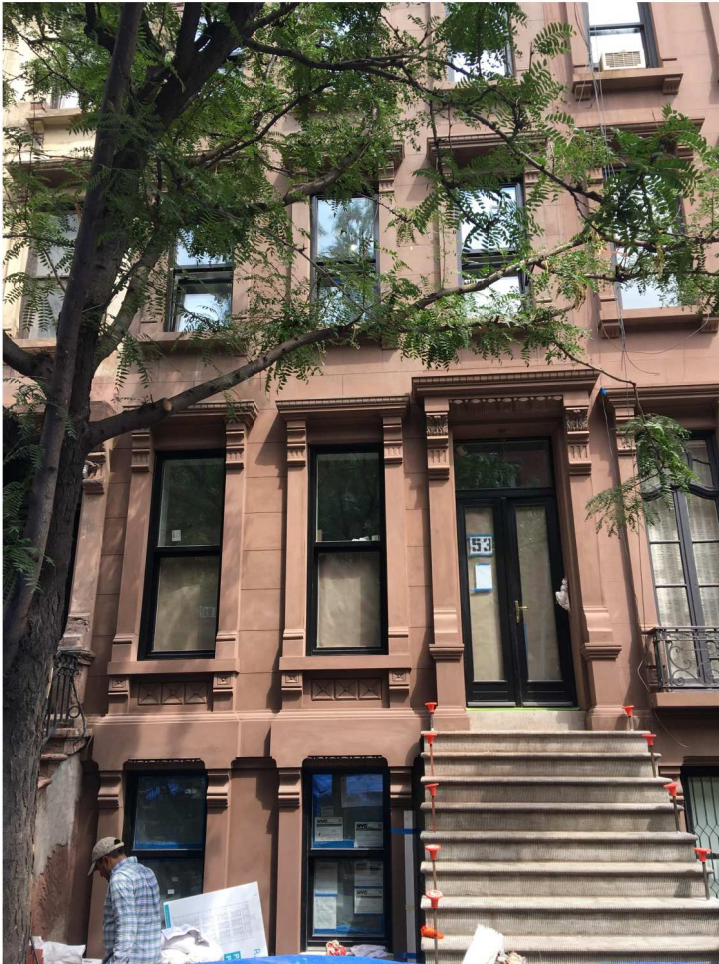
LPC APPROVED SIMULATED DOUBLE-HUNG WINDOWS UPPER WEST SIDE, MANHATTAN

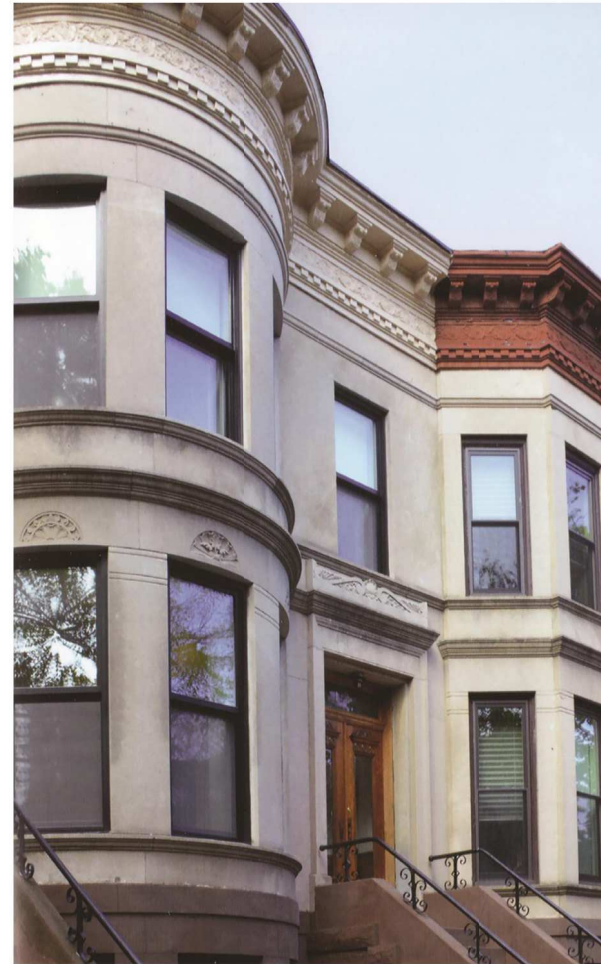
LPC APPROVED SIMULATED DOUBLE-HUNG WINDOWS IN BROOKLYN
