Church of St. Ignatius Loyola
09/16 Pre-Hearing Submission

Issue To: Community Board 8

September 16th 2024

Acheson Doyle Partners Architects
ARCHITECTURAL DESIGN | PLANNING | PRESERVATION

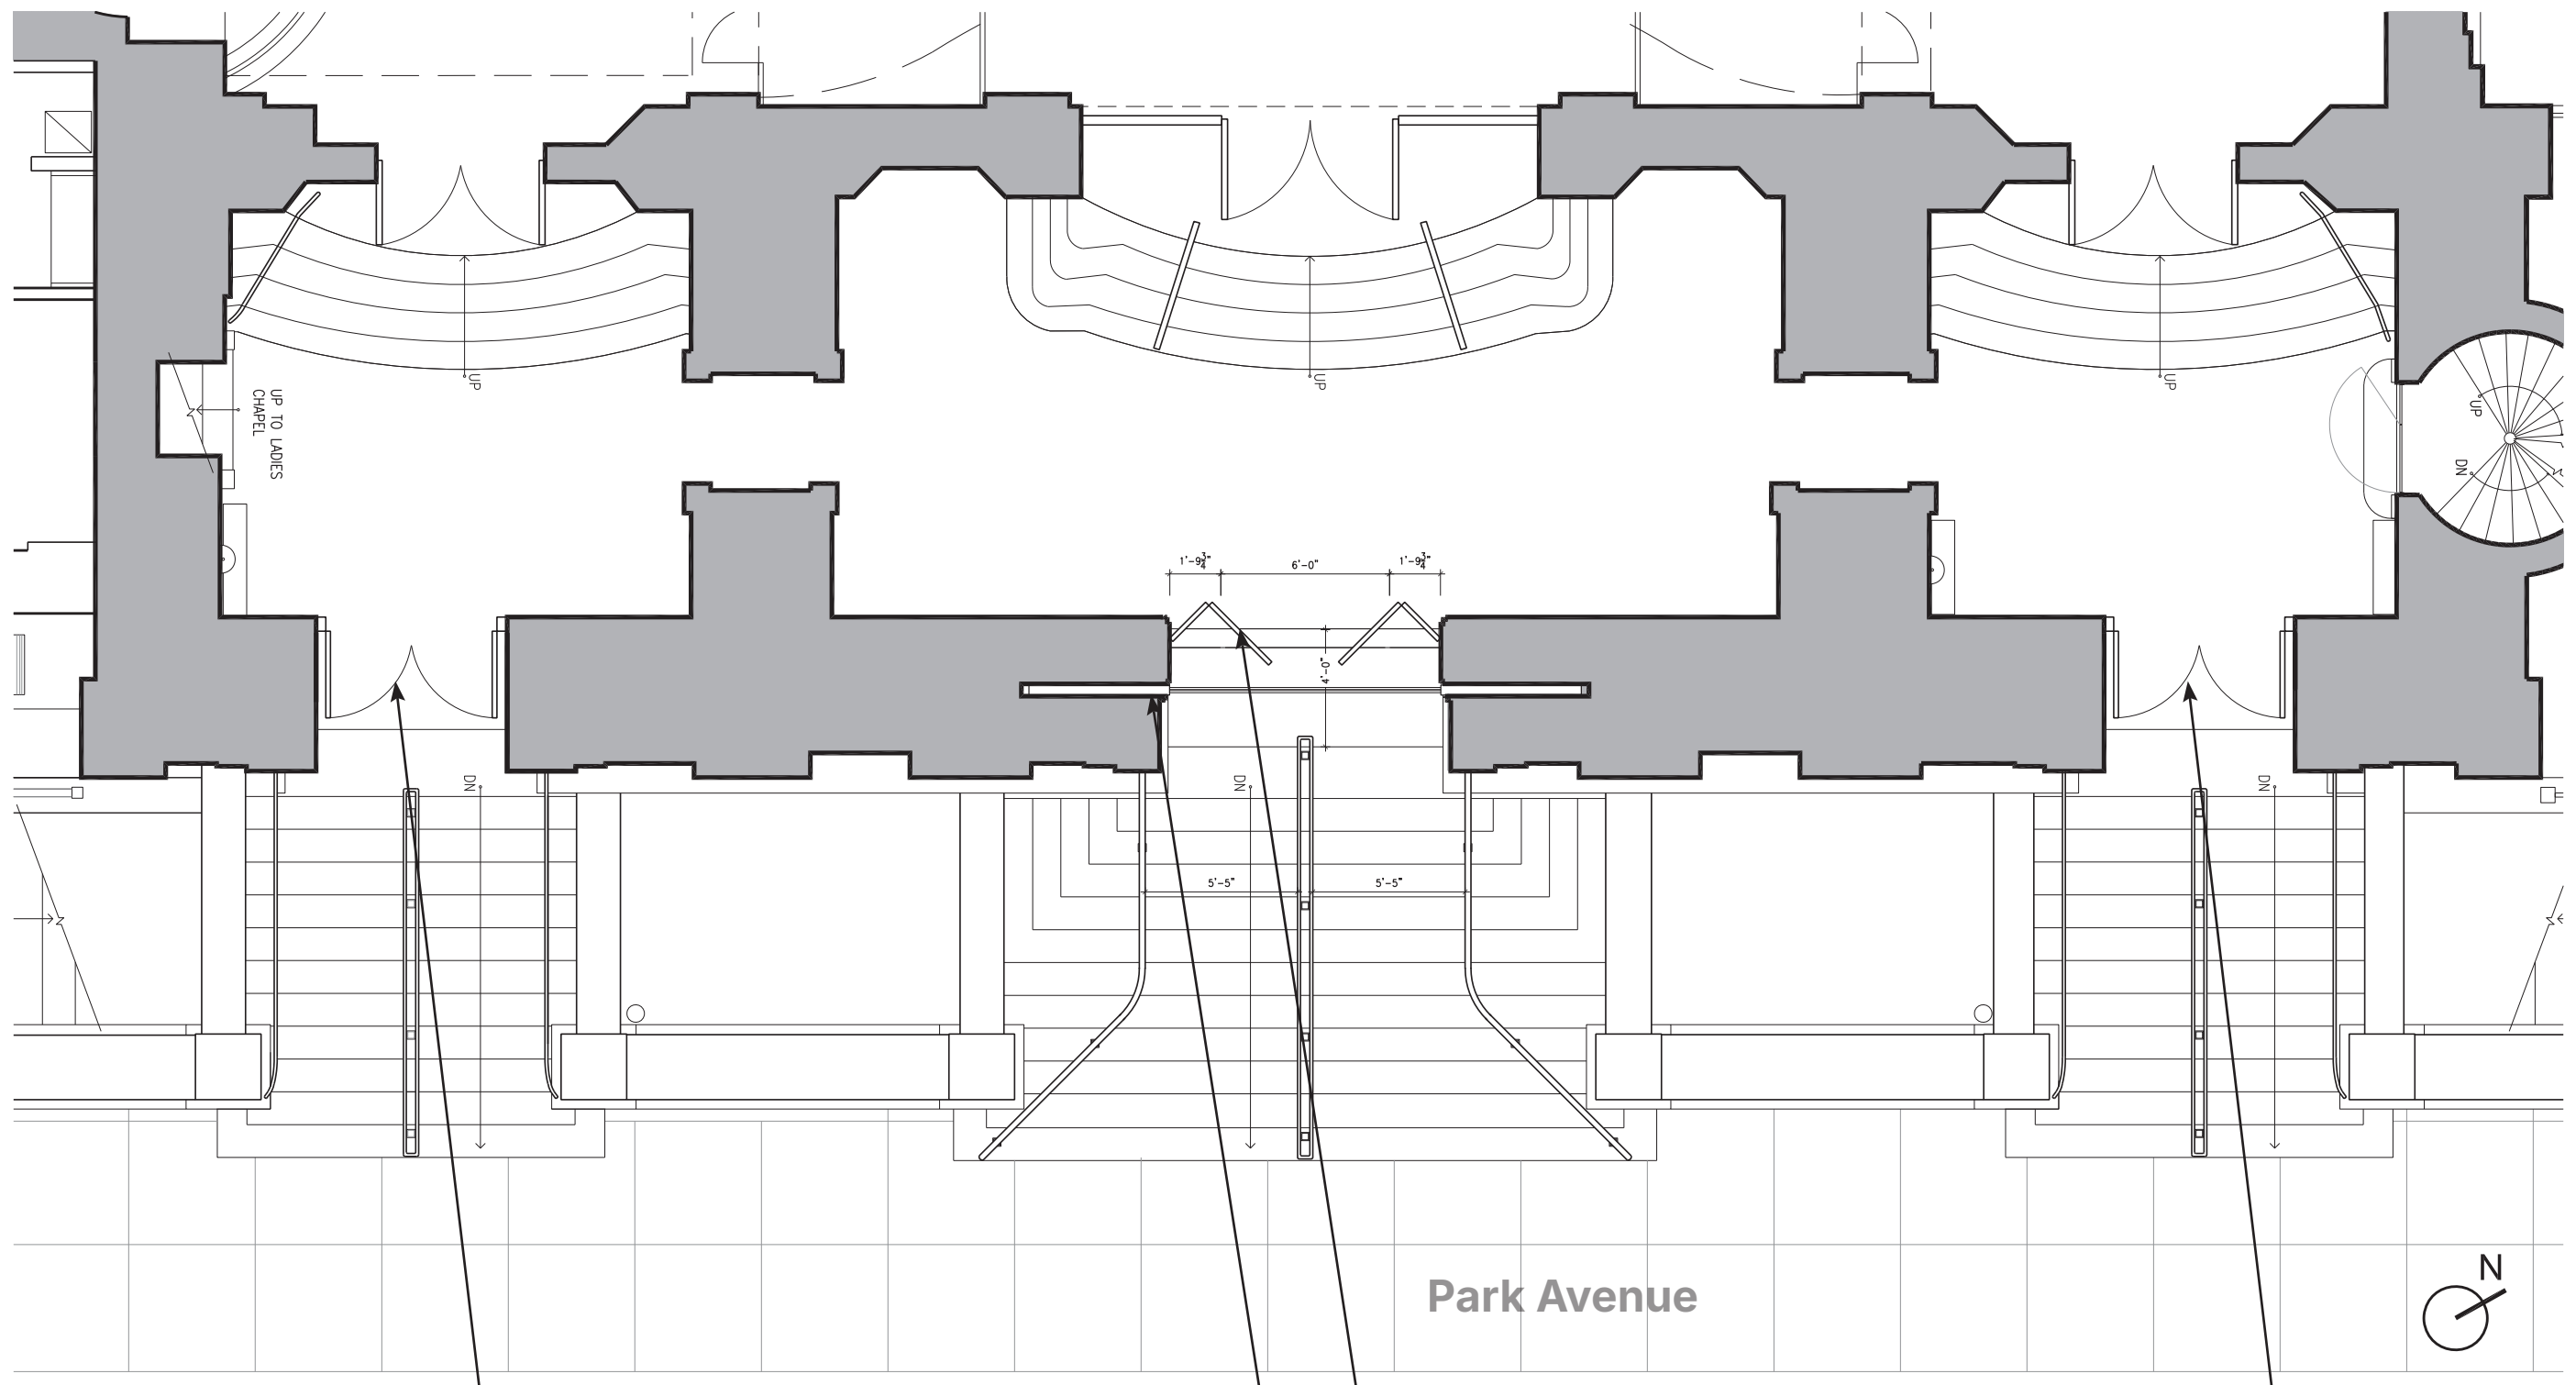
Plan of Proposed Doors

Left Swing Door

Central Swing Doors

Right Swing Door

Central Sliding Doors Restoration

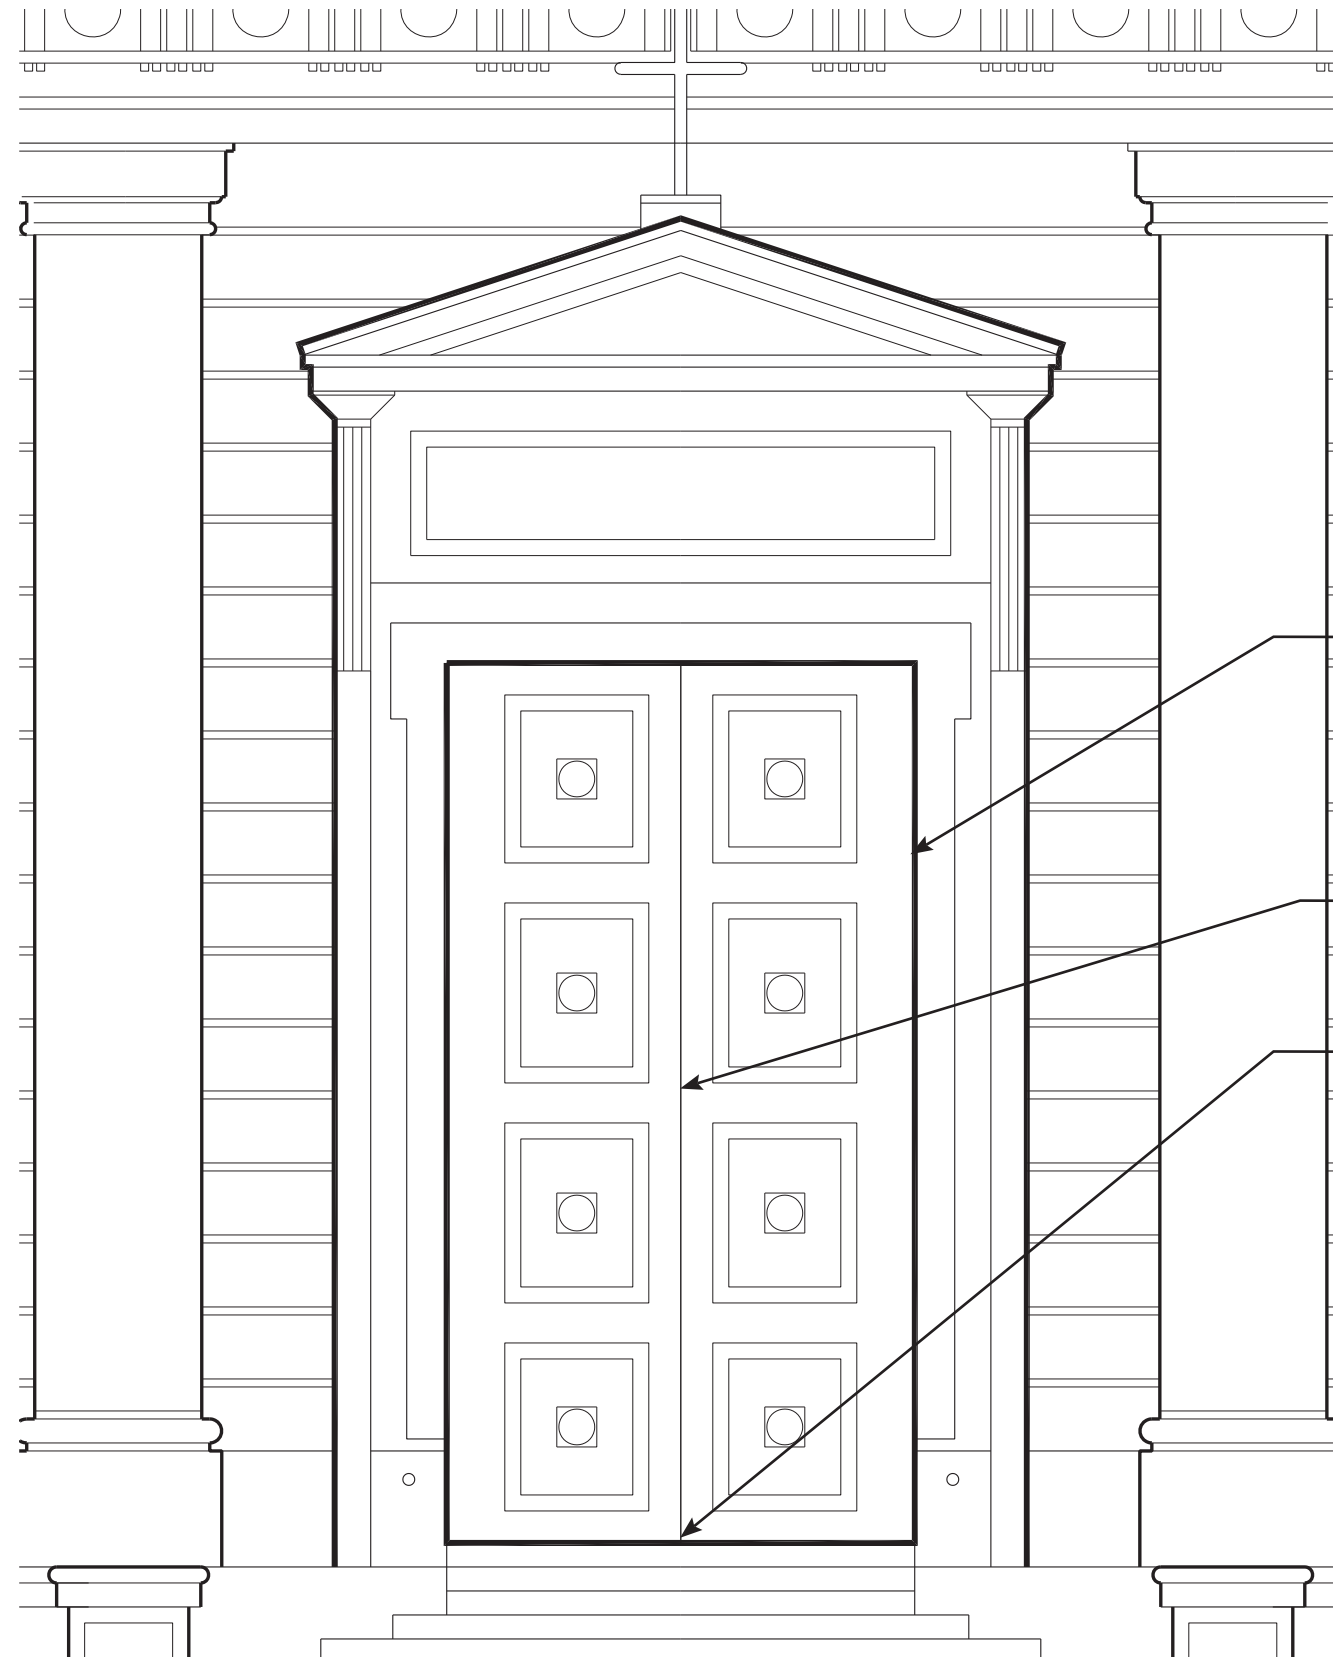
Elevations of Proposed Door Restoration

1. BRONZE DOOR FRAME

- Replace missing screws and historically inappropriate holes at frame

2. BRONZE DOOR

- Clean and restore bronze surface

3. RIGHT SLIDING DOOR LEAF

- Re-cast and repair wheel & track system at floor

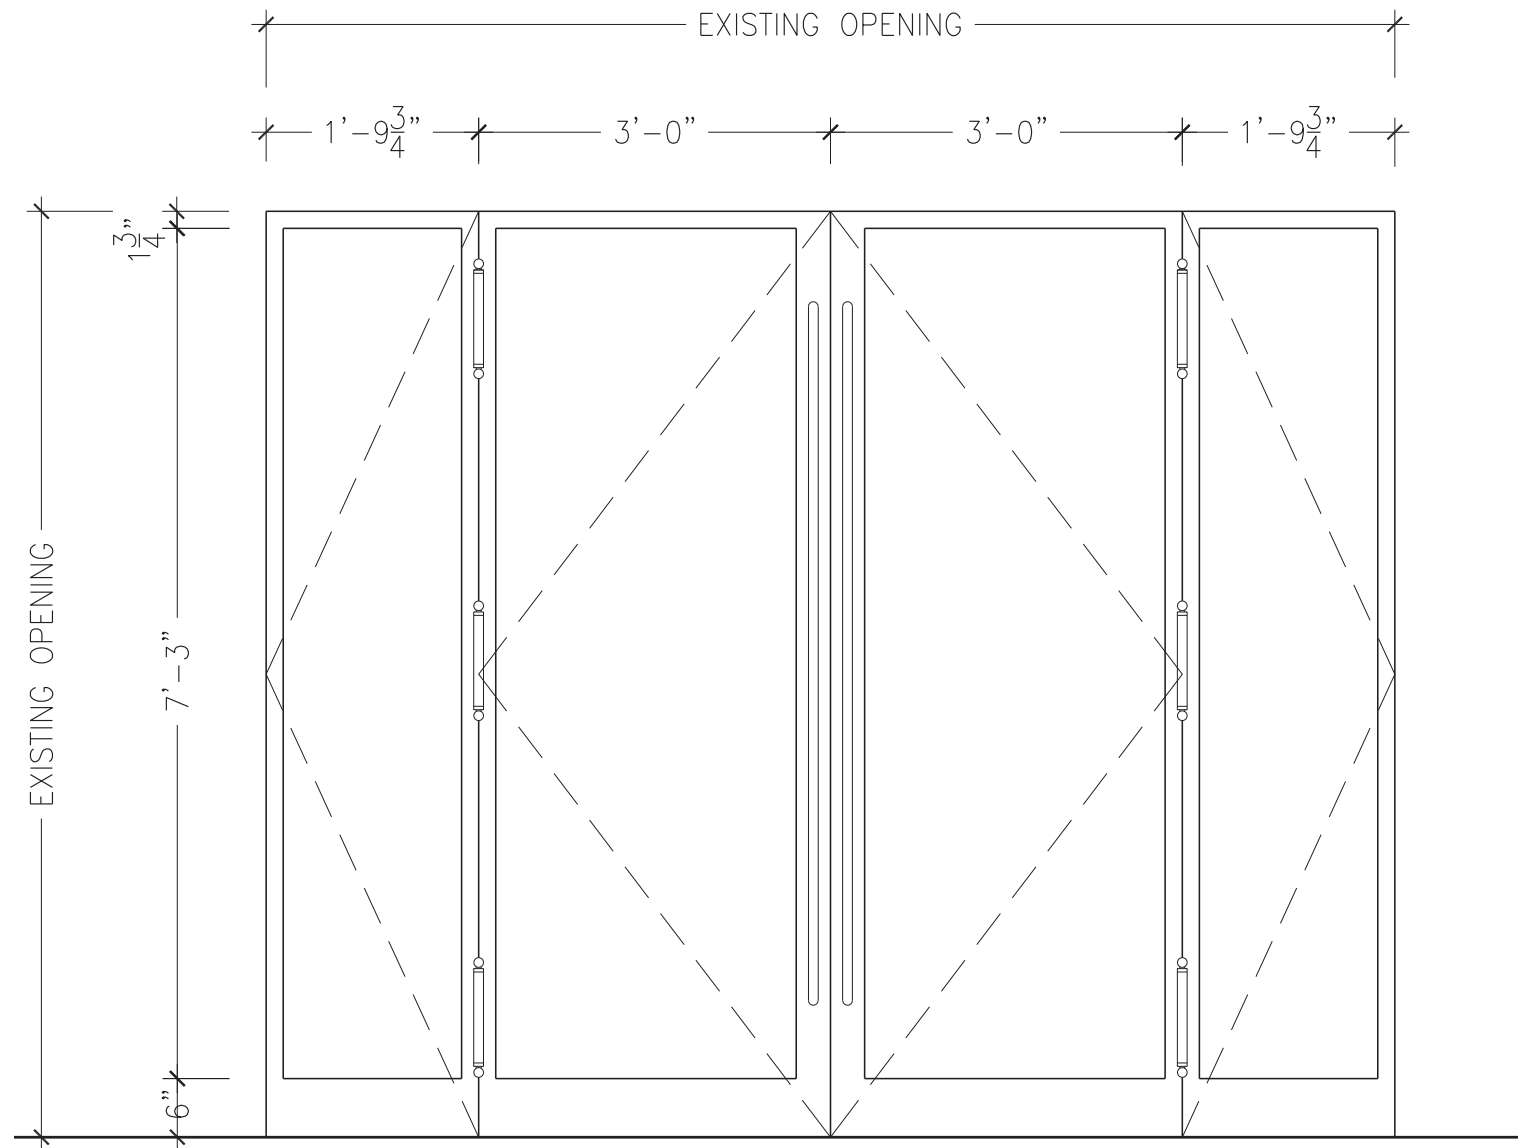
**Central Swing Doors Facing Park Ave.
1 Unit**

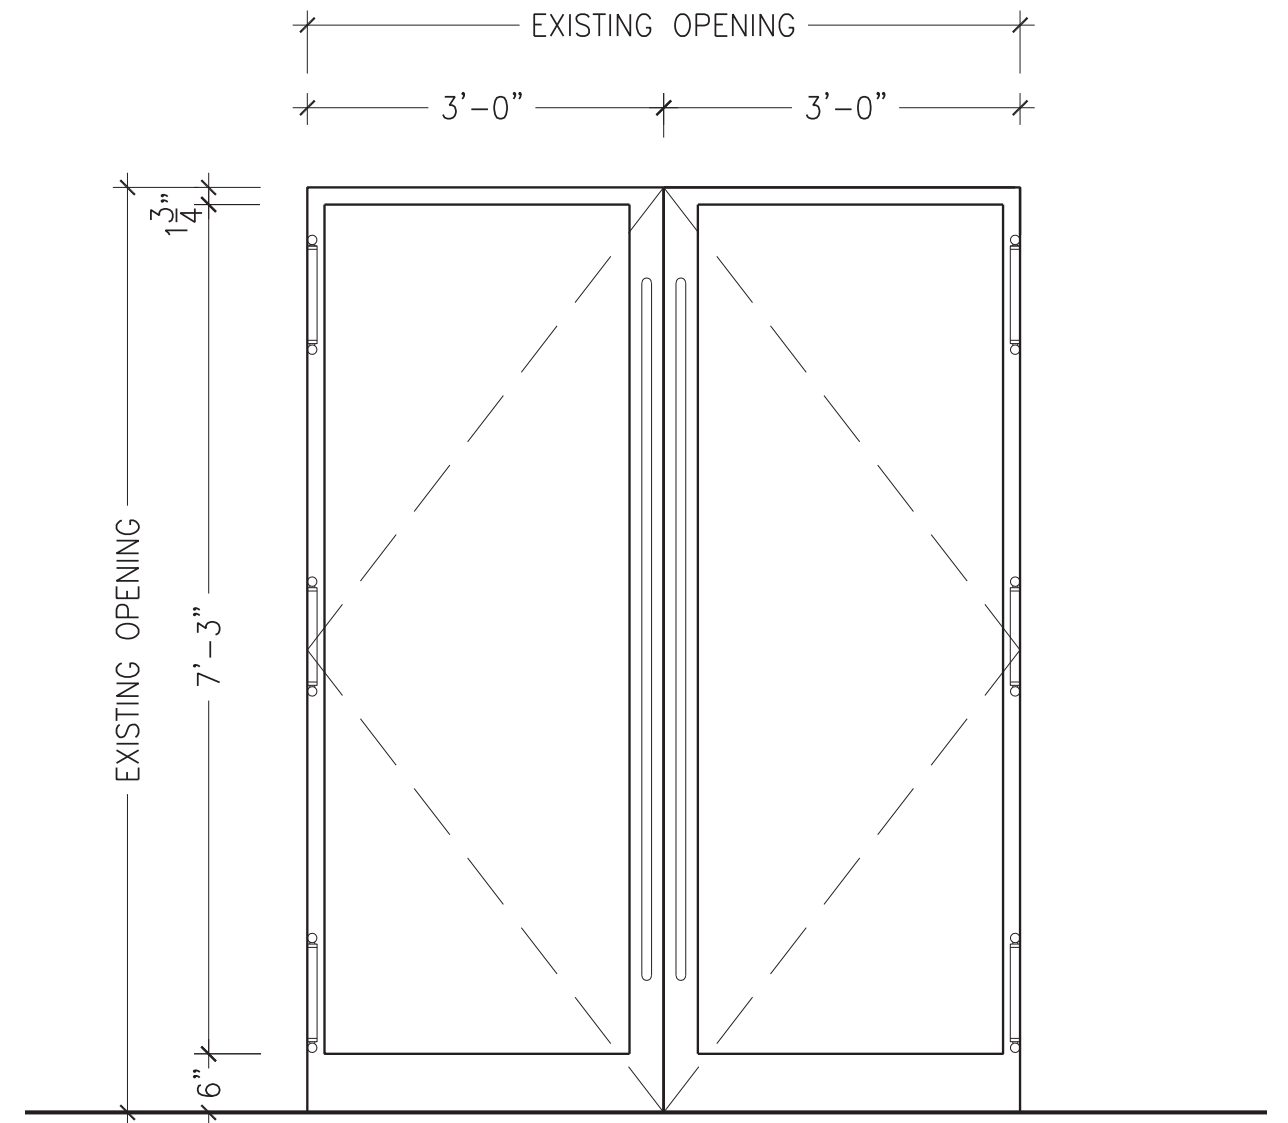
**Side Swing Doors Facing Park Ave.
2 Units (Left and Right)**

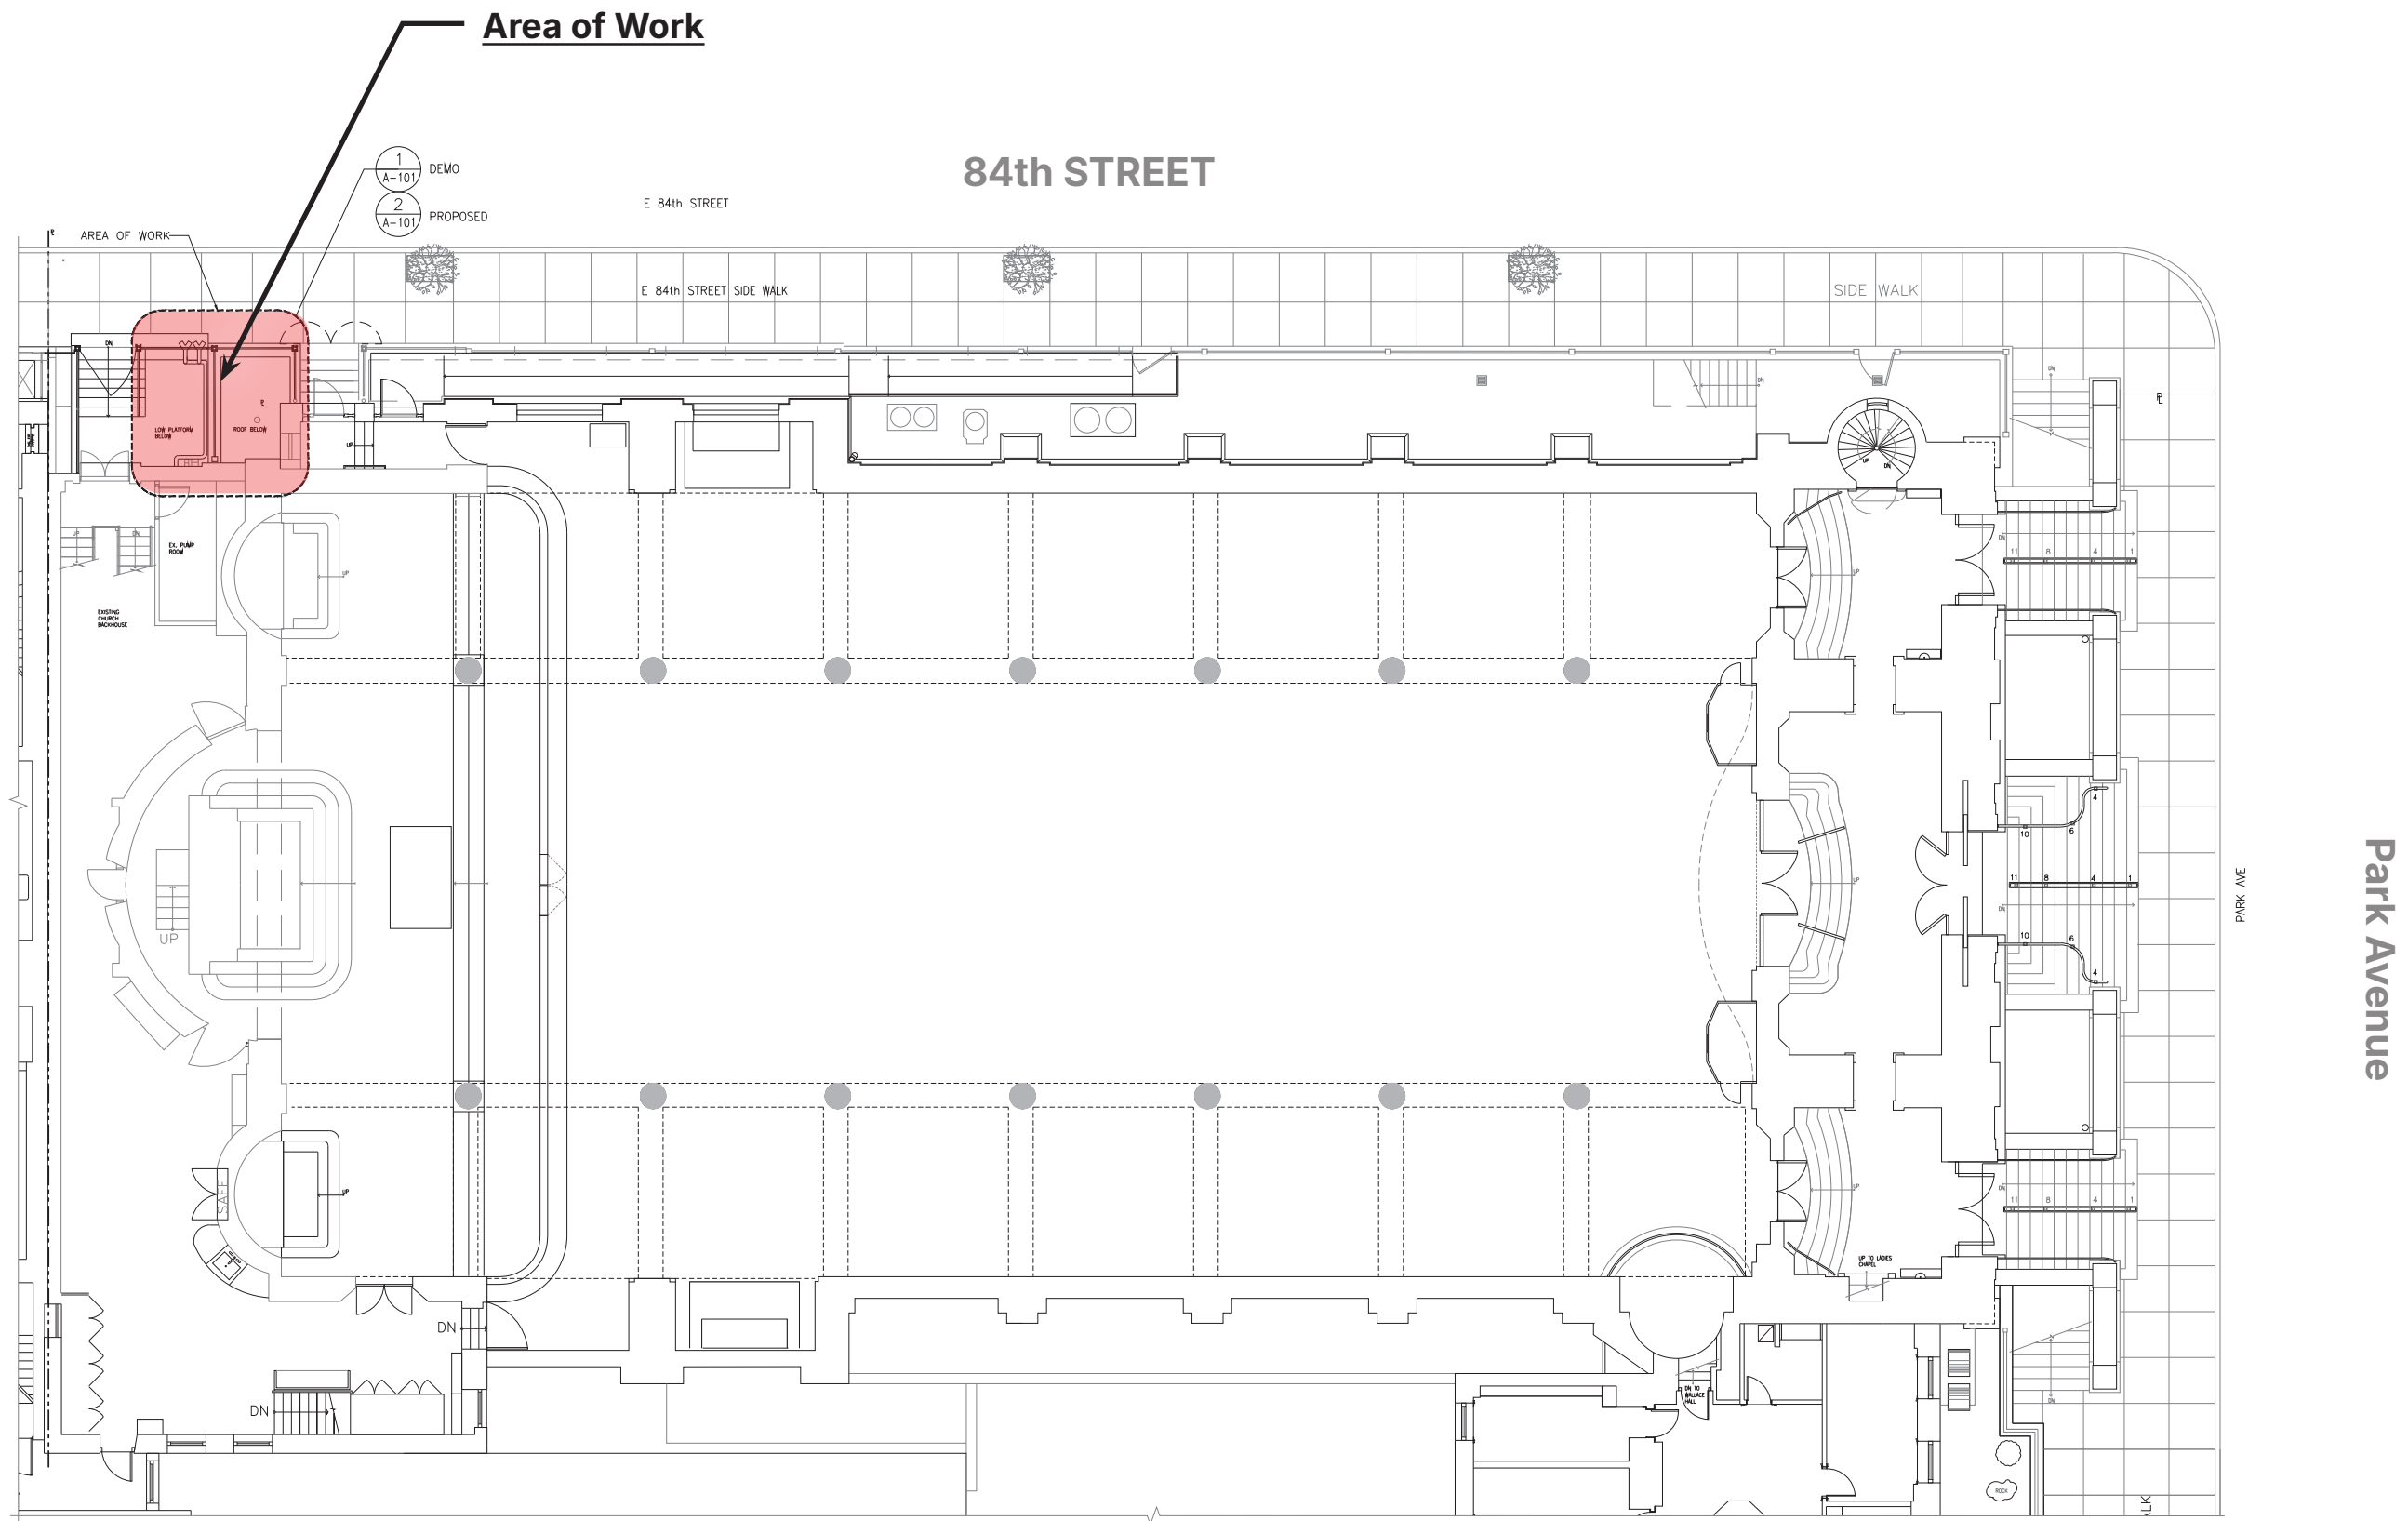
Site Plan of Proposed Rubbish Platform

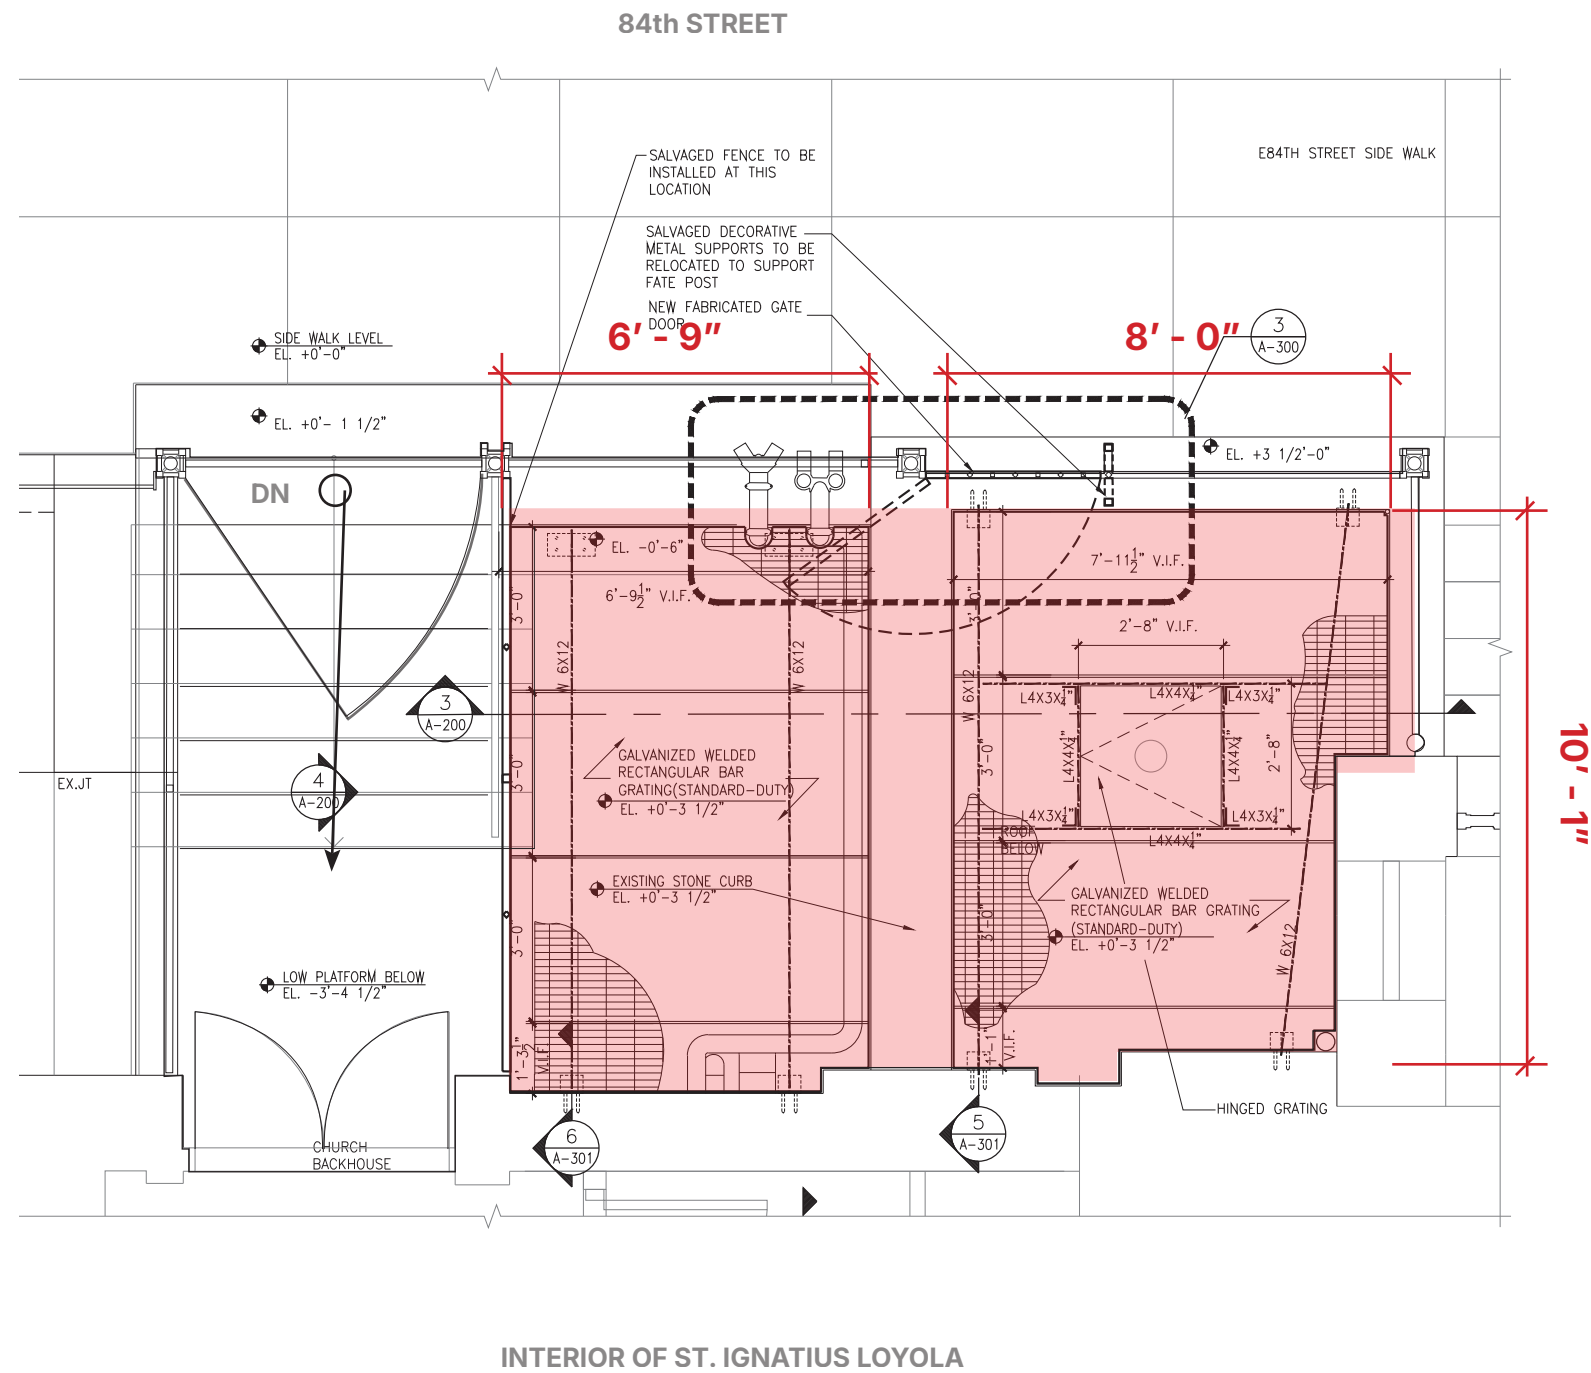
Plan of Proposed Rubbish Platform

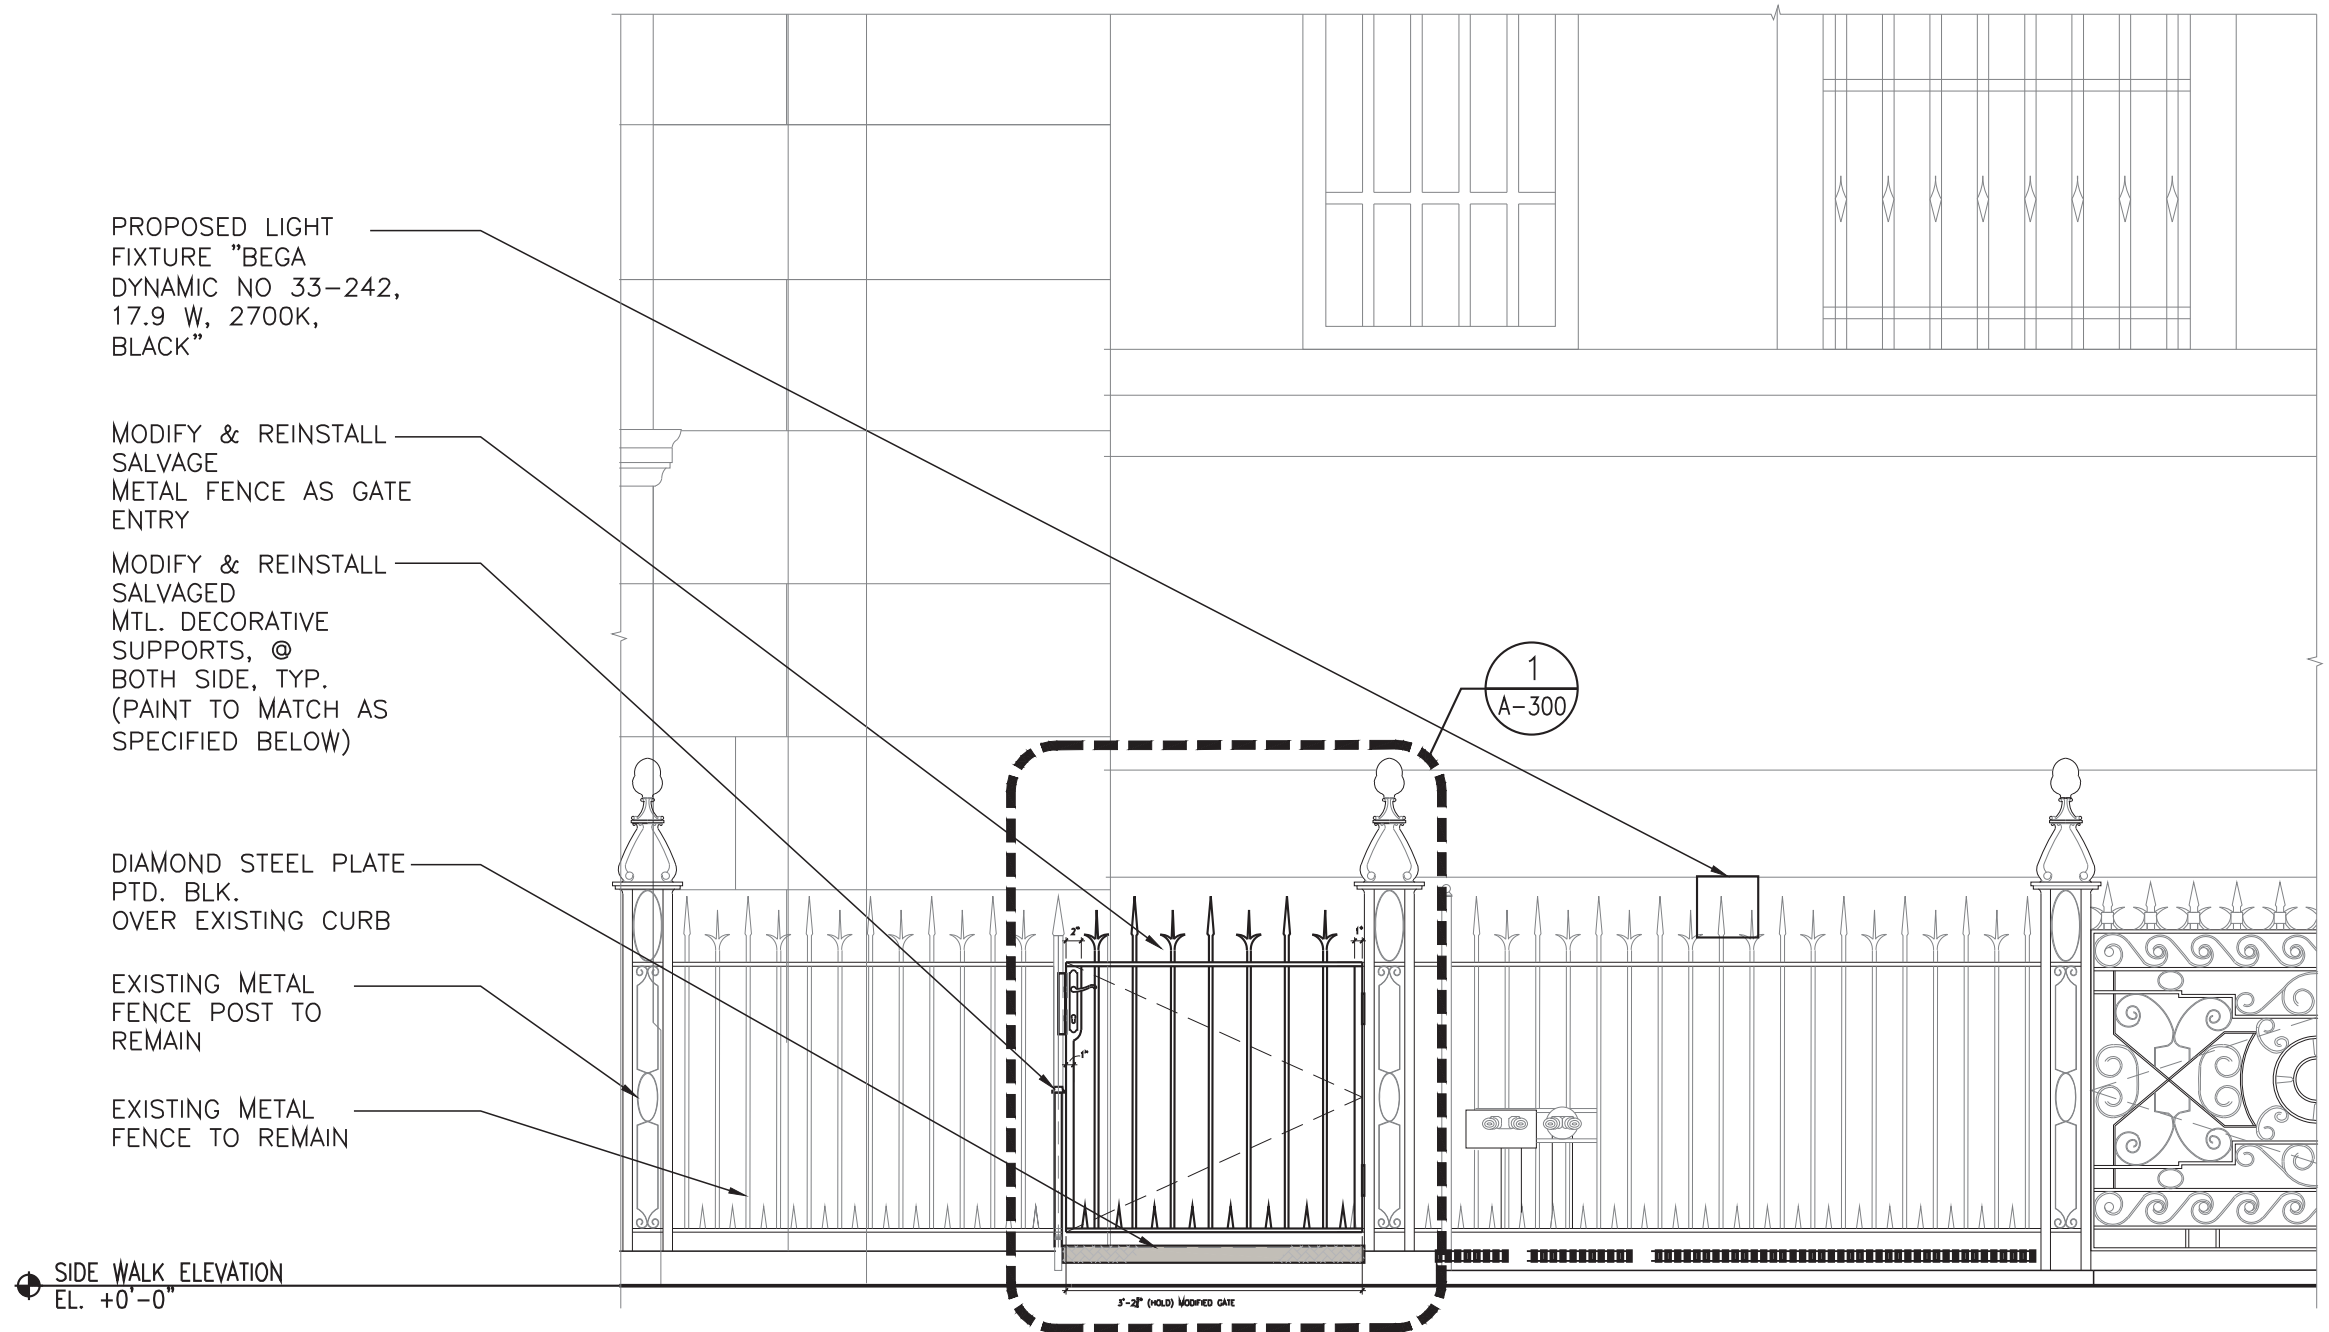
Elevation from 84th Street

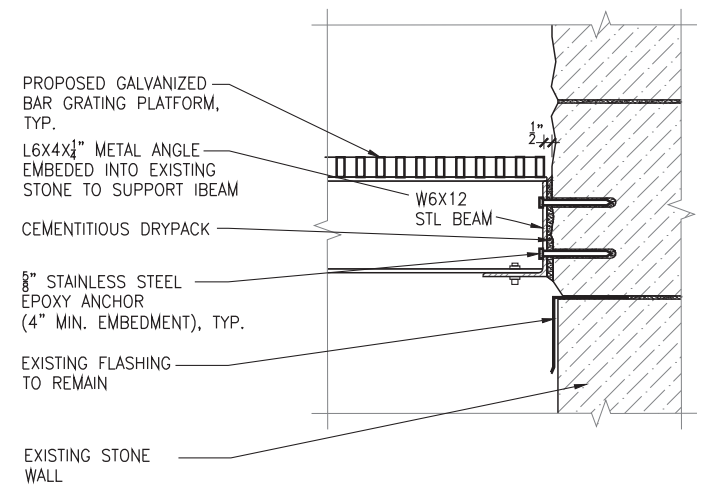
Section Detail
